Development of *MASH* TL-2 Crashworthy W-Beam Terminals For Low-Speed/Volume Roads

Publication No. FHWA-FLH-23-004

Test Report No. 615181-01

Sponsored by
**Federal Highway Administration
Office of Federal Lands Highway**

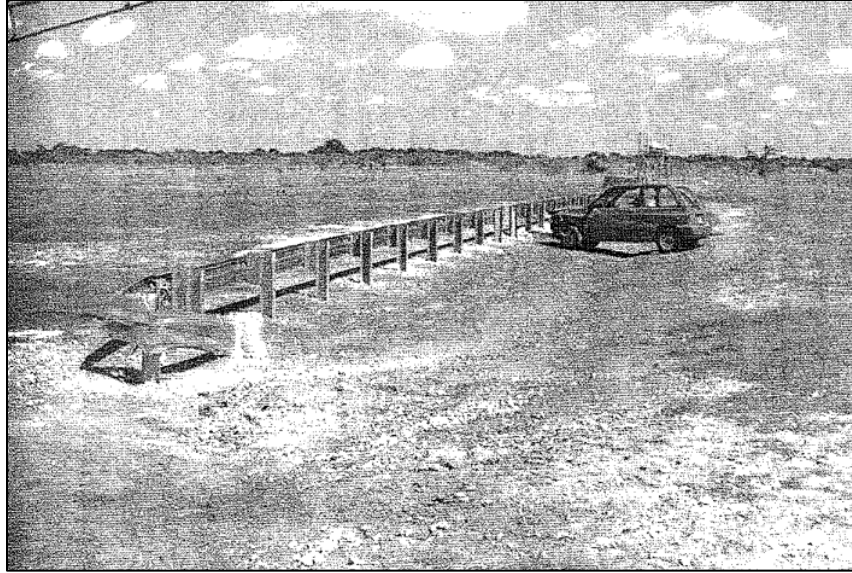
Figure 1.2. Vehicle and Test Installation after Test 2-30 (2).

deflected down toward the ground as the vehicle traversed over it. The end rail section bent backward during vehicle impact and was curved around the second post. There was minimal movement of the other posts. The damage to the vehicle was acceptable, and the occupant risk values were within the limits. Figure 1.2 shows the vehicle and test installation after the crash test.

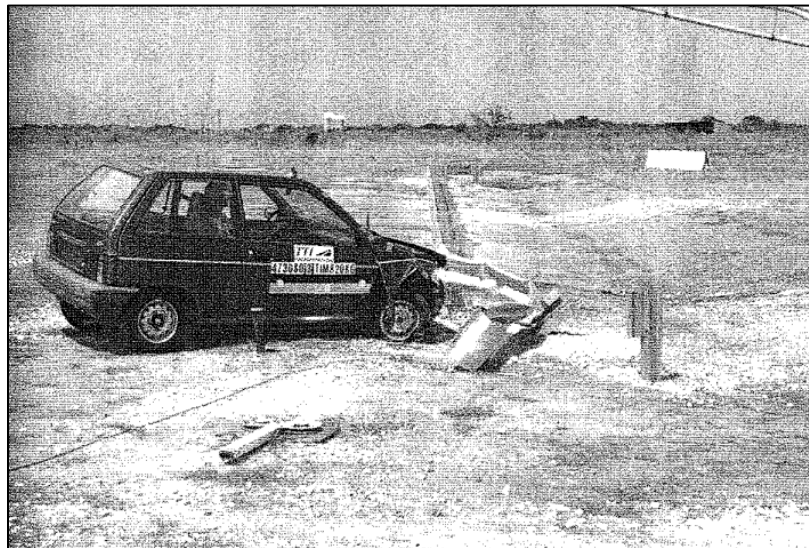
Figure 1.3. Vehicle and Test Installation after Test 2-34 (2).

For NCHRP Report 350 Test 2-34, the small car vehicle came to a controlled stop after impacting the end terminal. The second steel post yielded during vehicle impact and was deflected down toward the ground. The rail end section detached at posts 1 and 2. No other significant damage was noted for the installation. The damage to the vehicle was acceptable, and the occupant risk values were within the limits. Figure 1.3 shows the vehicle and test installation after the crash test.

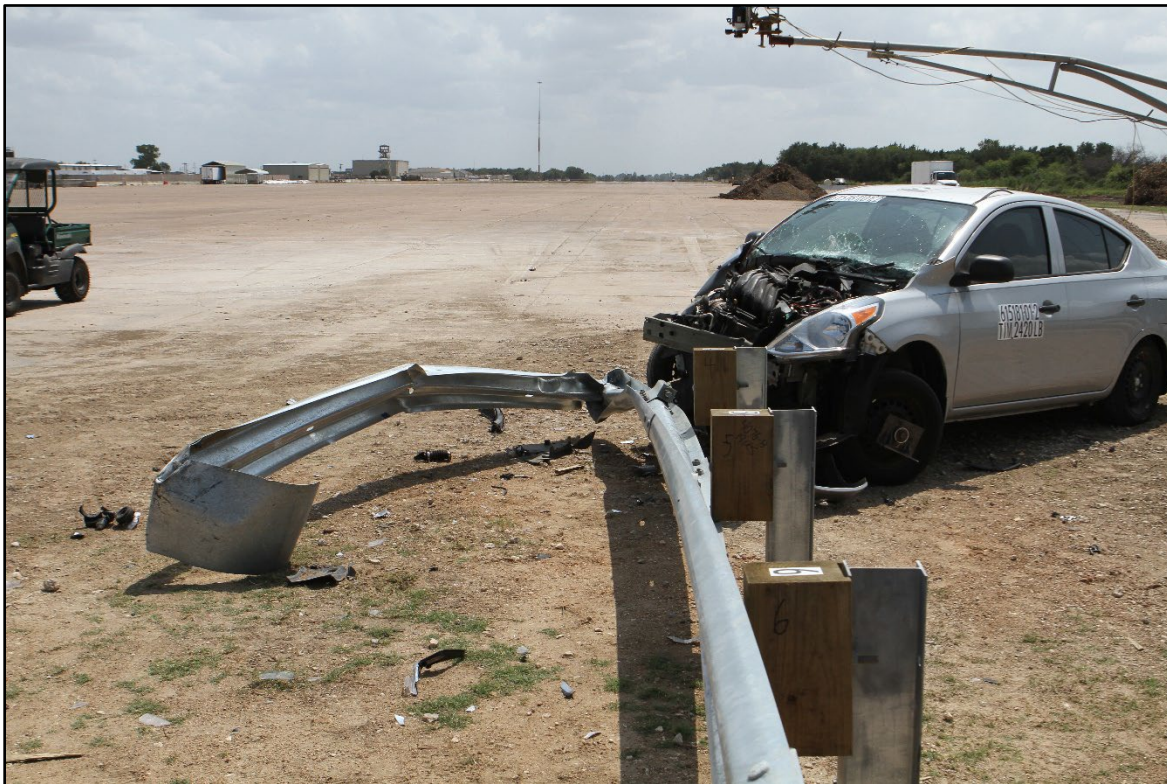
Figure 3.10. TL-2 Terminal on MGS Post Impact for Crash Test 615181-01-2.

The TL-2 Terminal for *MASH* Test 2-30 crash test 615181-01-2 did not meet the performance criteria for *MASH* TL-2 Gating Terminals. The rail impacted and tore the windshield, thus showing potential for penetration of the occupant compartment, which is considered a failure under *MASH* Evaluation Criteria D, as detailed in Chapter 6. The installation was redesigned, and the details of the 615181-01-10 installation for *MASH* Test 2-30 are presented in section 3.3.

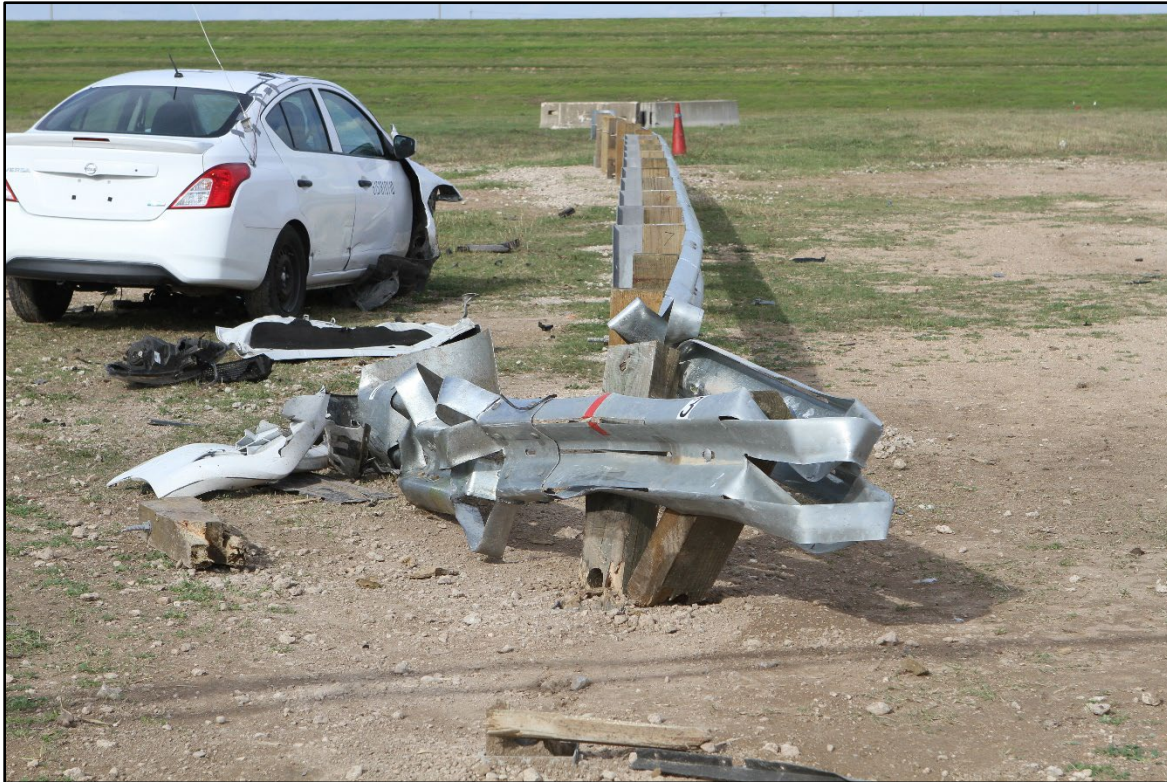
Figure 3.17. TL-2 Terminal on MGS Post Impact Crash Test 615181-01-10.

The TL-2 Terminal for crash test 615181-01-10 did not meet the performance criteria for *MASH* TL-2 Gating Terminals. The rail impacted and tore the windshield thus showing potential for penetration of the occupant compartment, which is considered a failure under *MASH* Evaluation Criteria D as detailed in Chapter 6. The installation was redesigned, and the details of the 615181-01-9 installation and crash test are presented in section 3.3.

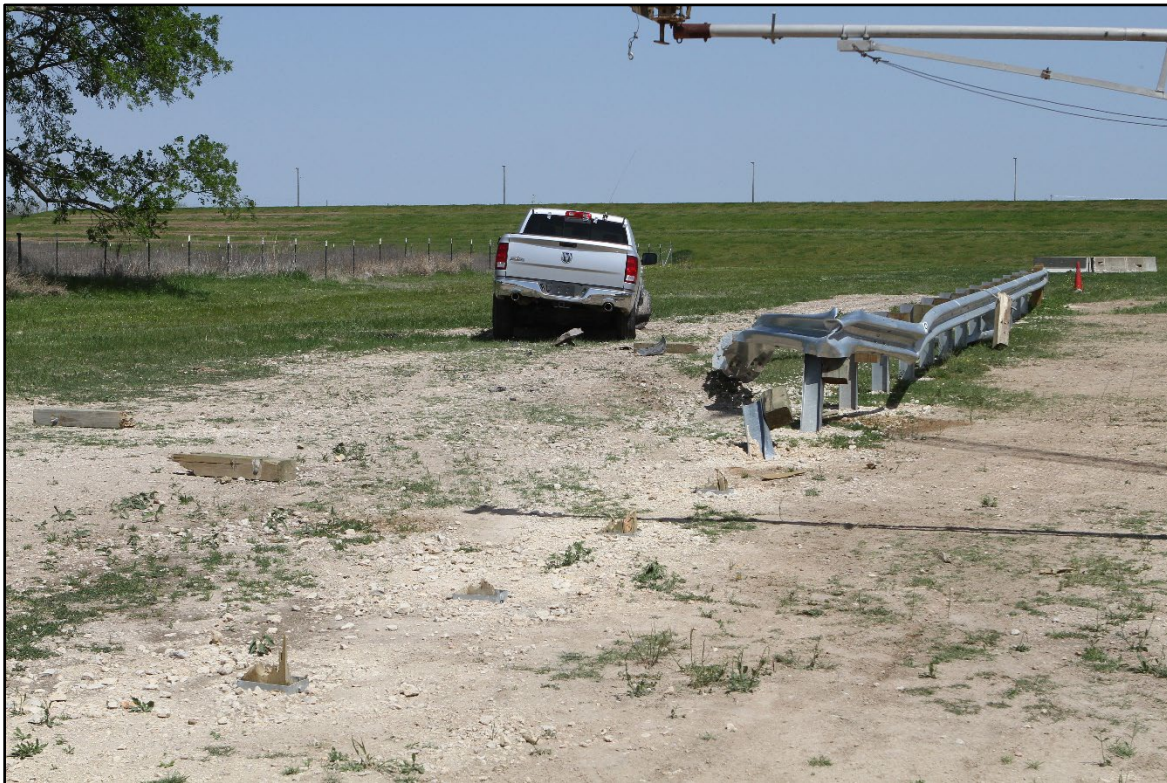
Figure 3.29. TL-2 Terminal on MGS Post Impact for Crash Test 615181-01-8.

The TL-2 Terminal for crash test 615181-01-8 did not meet the performance criteria for *MASH* TL-2 Test 2-35 for Gating Terminals. The installation did not redirect the vehicle, which is considered a failure under *MASH* Evaluation Criteria A as detailed in Chapter 6. The installation was redesigned, and the details of the 615181-01-4 installation and crash test are presented in section 3.7.

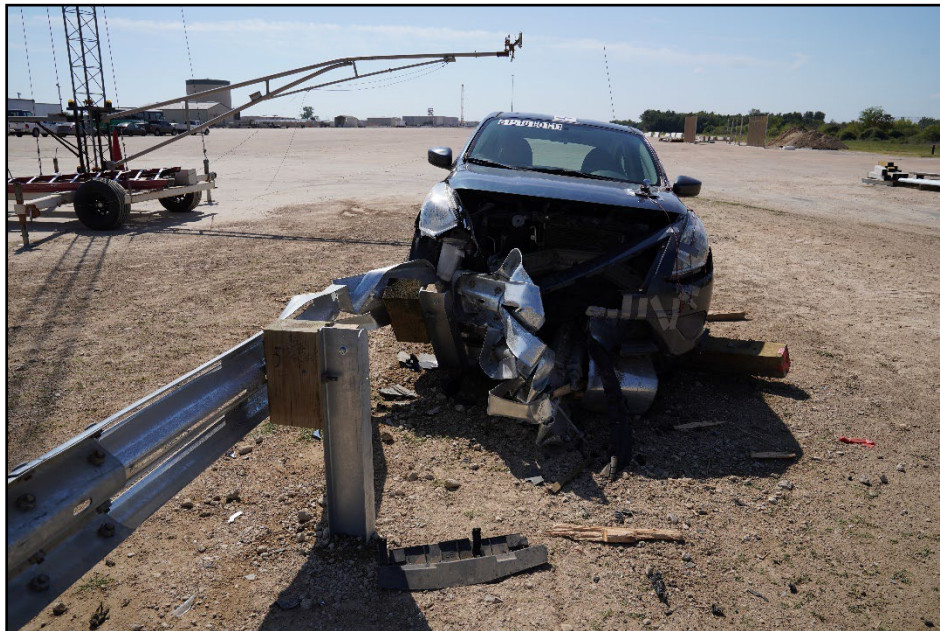
Figure 10.5. TL-2 W-beam End Terminal after Test at Impact Location 615181-01-11.

Posts 1 through 3 were broken off at grade. Post 4 was leaning downstream 30° and post 5 was leaning downstream 54°. The rail released from posts 1 through 5, and it was crumpled in front of the small car. Figure 10.5 and Figure 10.6 show the damage to the TL-2 W-beam End Terminal.

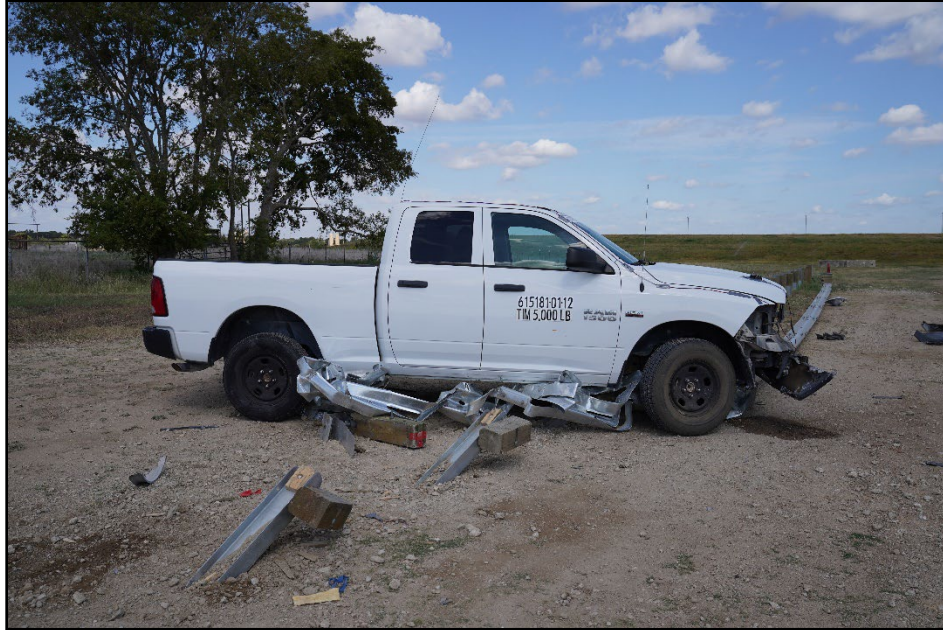
Figure 11.5. TL-2 W-beam End Terminal after Test at Impact Location 615181-01-12.

The rail released from all posts and was shifted 7 inches downstream. Posts 1 through 3 were broken off at grade and Posts 4 through 6 were leaning 15° downstream from vertical. Posts 21 and 23 were split, and 22 and 24 were broken off at grade. Post 25 was leaning over, and post 26 released from the rail. Posts 22 through 24 had a 1/8-inch gap in the soil on the downstream side. Figure 11.5 and Figure 11.6 show the damage to the TL-2 W-beam End Terminal.

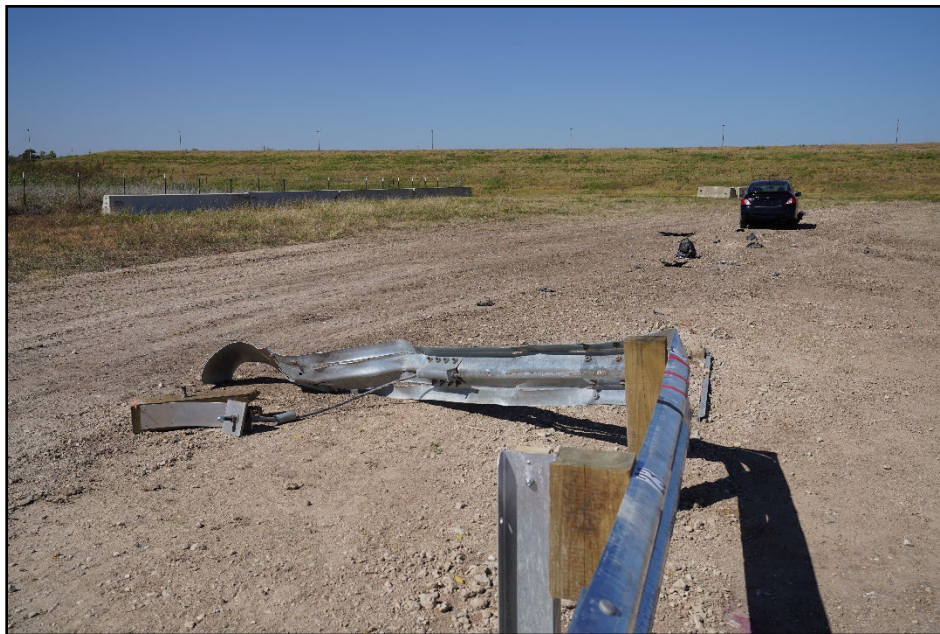
Figure 12.5. TL-2 W-beam End Terminal after Test at Impact Location 615181-01-13.

The soil was disturbed at post 23, and post 24 was leaning 3.5° back from vertical. Posts 25 and 26 broke off at grade and released from the rail. Figure 12.5 and Figure 12.6 show the damage to the TL-2 W-beam End Terminal.
