Safety Edge_{SM}
HMA Demonstration Project
Jasper County, Iowa

Field Report
June 6, 2011

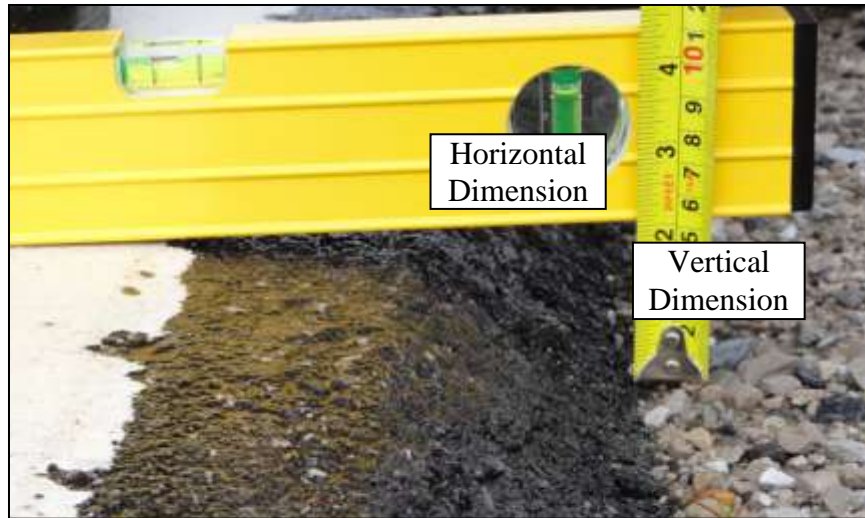
Figure 3. Slope measurement technique.

The vertical measurement was also the thickness at the edge of the mat which is not always the case. For example when HMA is allowed to slide down the slope during paving the true edge thickness is obscured. Figure 3 shows the technique in measuring the edge slope.

The average slope of the Safety Edge_{SM} was calculated to be 38° from the width and thickness measurements. Slope measurements are listed in Table A-1 and Table A-2 in Appendix A.

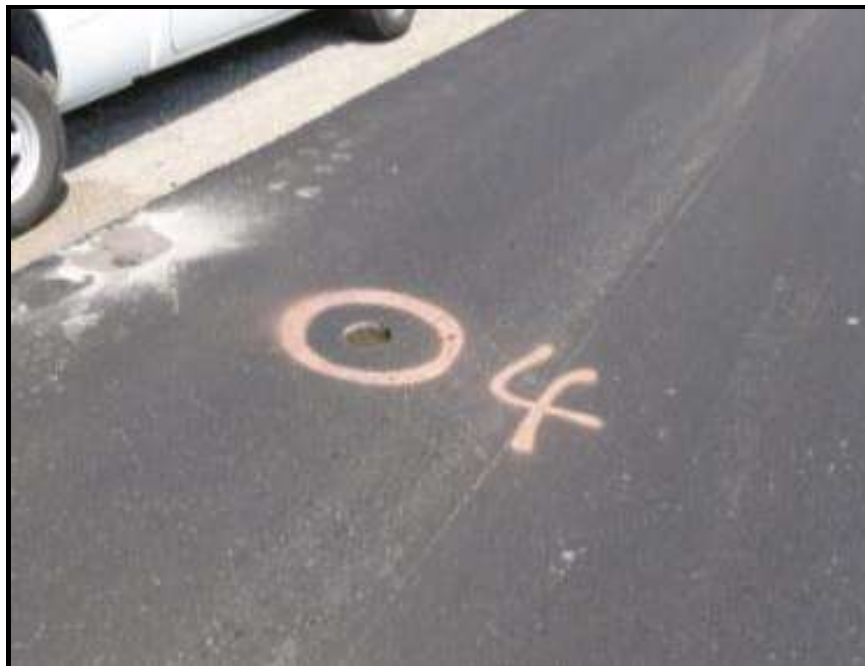
Figure 4. Safety Edge_{SM} section with cores cut adjacent to the edge and at 3 ft. from the edge.

Cores were cut from the mid-point of each test section. These cores were taken to measure thickness and for laboratory testing. Table 3 in the Appendix provides a summary of the core thickness results. Figure 4 shows the location of the cores taken adjacent to the pavement edge and 3 ft. away from the edge.

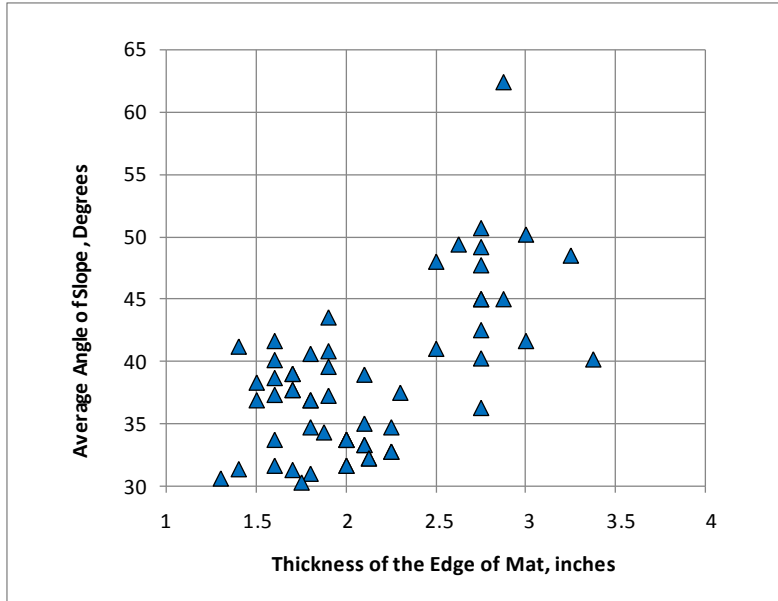
Figure 5. Comparison of slope and edge thickness.

Figure 5 compares the thickness of the intermediate course near the Safety Edge_{SM} and the slope of the Safety Edge_{SM}. As shown, the slope appears to increase with the thickness of the Safety Edge_{SM}.

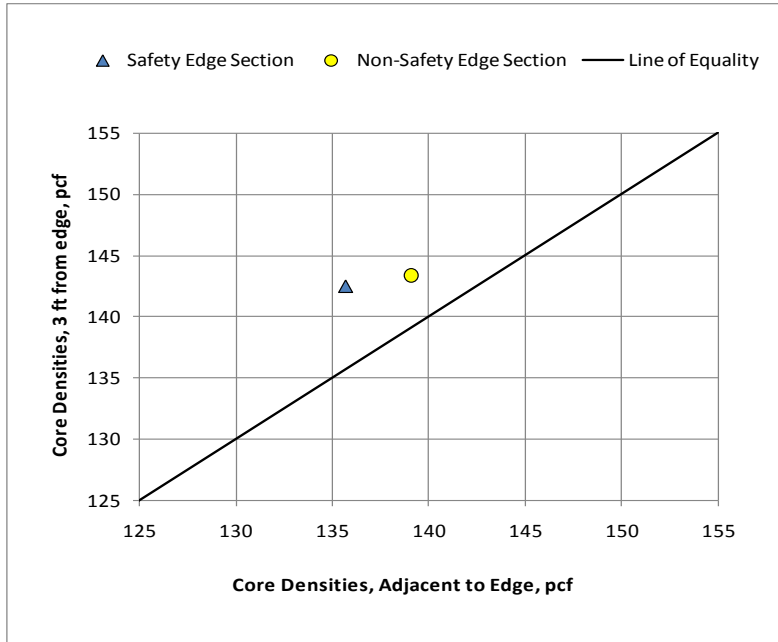
Figure 6. Comparison of core densities adjacent to the edge and 3 ft. from the edge.

Figure 6 shows the comparison of the core densities taken adjacent to the edge and at 3 ft. from the edge for the Safety Edge_{SM} and non-Safety Edge_{SM} sections. As expected the densities away from the edge where the mat received full coverage of the roller passes are significantly higher than near the edge of the pavement. This result reflects the relatively low degree of compactive effort applied to the Safety Edge_{SM} in comparison to standard compaction given to the non-Safety Edge_{SM} section.

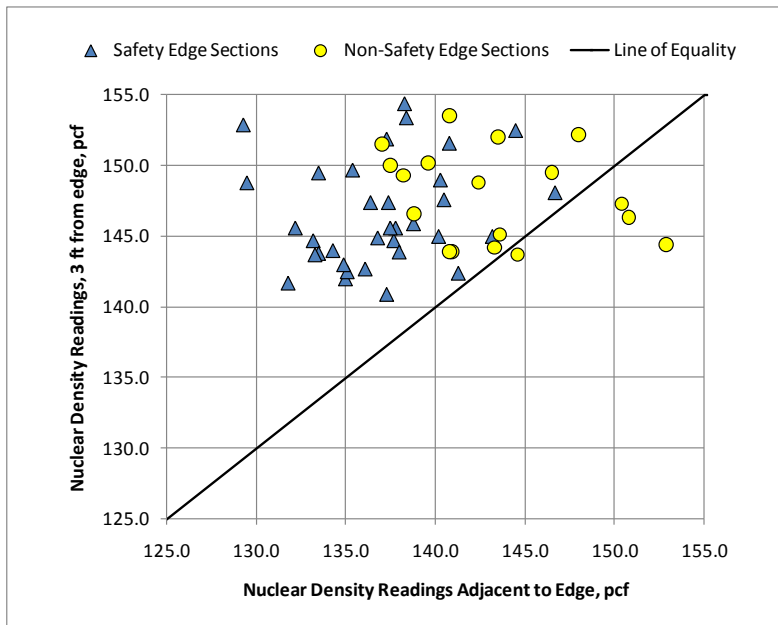
Figure 8. Comparison of densities adjacent to the edge and 3 ft. from the edge.

Figure 8 is a comparison of the adjusted nuclear density gauge readings taken adjacent to the edge and at 3 ft. from the edge. Figure 9 is a comparison of the HMA air voids between both areas. Generally, the two figures show densities were lower and the air voids were higher

adjacent to the edge than away from the edge. The same correlation holds true for comparing the Safety Edge_{SM} sections to the non-Safety Edge_{SM} sections, and it is recognized that the non-Safety Edge_{SM} sections received greater compactive effort from the rolling procedures.

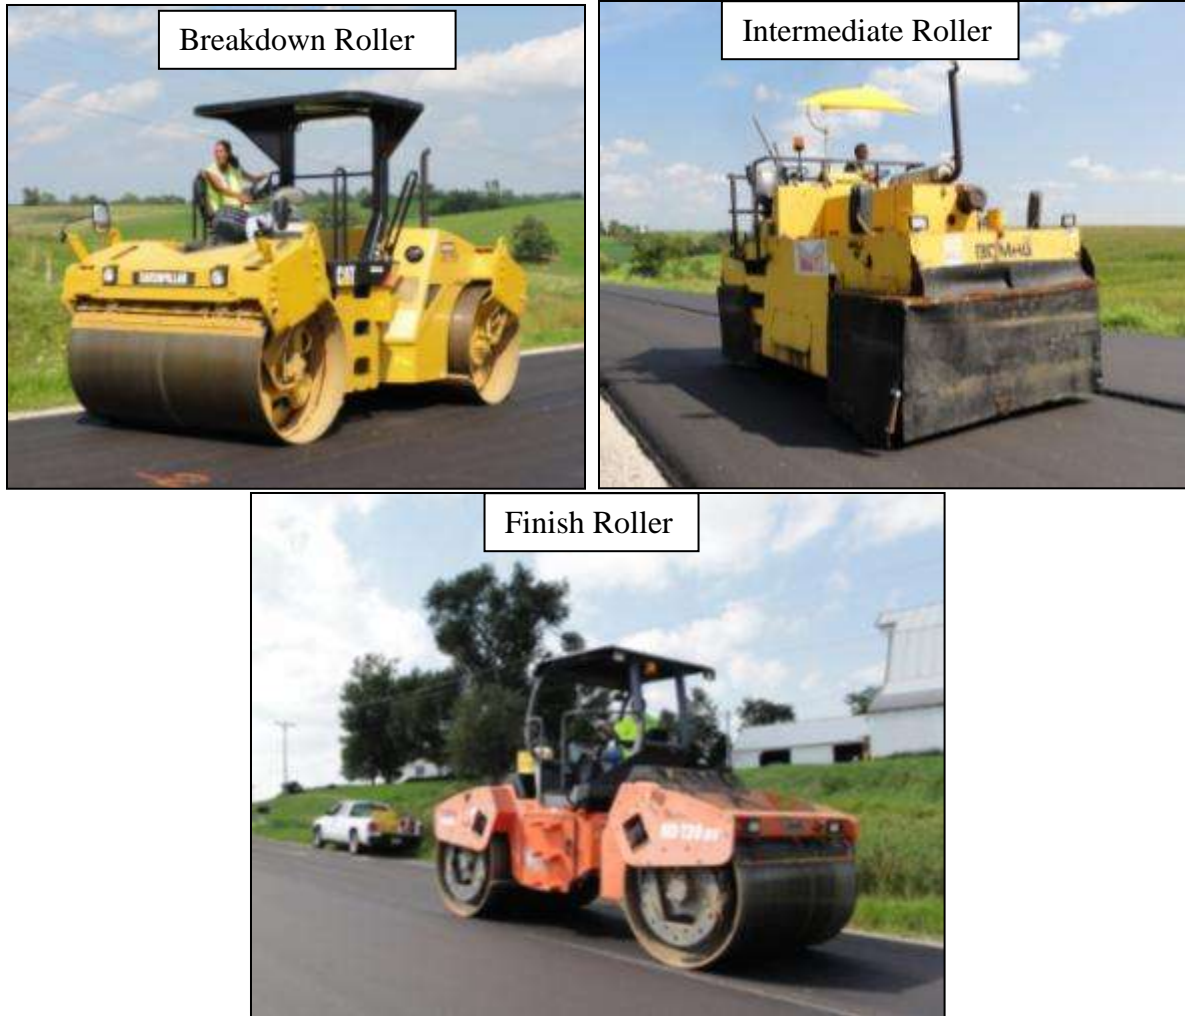
Figure 14. Compaction equipment.

Upon special request, the breakdown roller operator hung over the Safety Edge_{SM} of the mat about 2 inches on the first vibratory pass for a short section. Doing so caused the edge of the mat to displace horizontally and become steeper. This proved the slope of the Safety Edge_{SM} was sensitive to the rollers position. The vibratory first pass at the longitudinal centerline joint caused the mat to move approximately 0.75 inches horizontally.

Although paving and compaction operations were not observed for the non-Safety Edge_{SM} portion of this project, discussions with the contractor indicated normal rolling was conducted in which the breakdown roller made passes overhanging the edge and generally both the breakdown and intermediate rollers made passes closer to the edge. Thus, greater compactive effort was applied to the non-Safety Edge_{SM} sections compared to the Safety Edge_{SM} sections.
