FINAL REPORT

Oregon Route 224 Corridor Study: Phase 1 – Existing Conditions Assessment

October 2021

Prepared by:
Federal Highway Administration
Western Federal Lands Highway Division

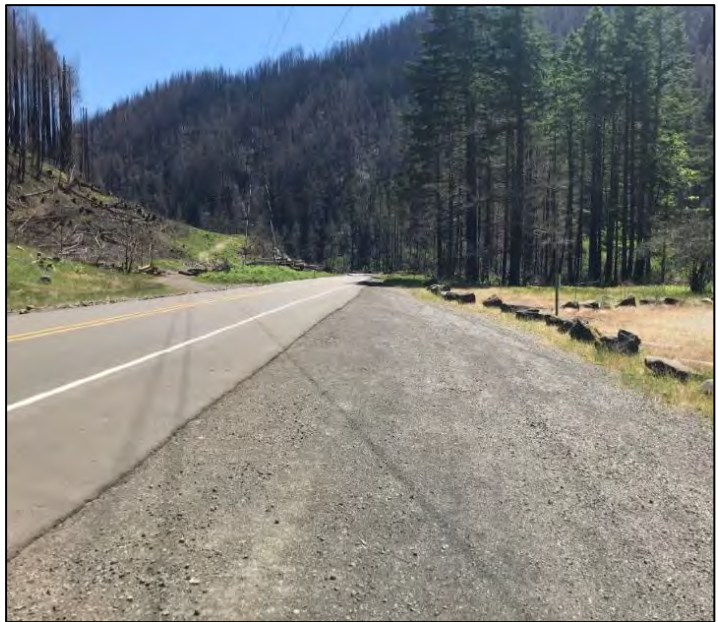
Other federal land management agencies are struggling with roadside parking in undesirable areas. A presentation provided to Yellowstone National Park, detailing the known methods of discouraging parking in undesirable areas, is included in Appendix A. These methods have all had mixed results, though no formal study has ever been completed on any areas in which these methods have been implemented. Based on the different uses of the OR 224 corridor, there will not likely be a 'one size fits all' solution. One example of an area where solutions to restrict parking and/or access may be needed is near MP 41.0, shown in Figure 4. Visitors either park on one side of the road to cross to the opposite (east) side or drive their vehicles into traversable areas on the east side that are not defined as access driveways. In addition to the earth disturbance, these visitors use the hillside on the east side for target shooting. There is a parking area on the west side which has space for picnicking or access to the river. The target shooting is in range of this parking area as well as the road. While target shooting is a draw to the forest, this is not the most appropriate area for it and methods of further discouraging use in this particular area are of interest.

Figure 4: Area of Concern for Parking and Access (OR 224, MP 41.0)

One method of parking discouragement discussed at the June 2021 site visit is guardrail installation. Guardrail is only recommended in areas where the crash as a result of a roadside departure is more severe than a crash caused by a vehicle striking the guardrail itself. Specific to areas of campgrounds or spot camping, a consideration for guardrail installation would be the clear zone width and location of the campers. Further discussion of guardrail and roadside design, including the clear zone, is included in the next section. Next steps include a review of the roadside slopes, a delineation of areas where parking should be discouraged, the location of the campgrounds compared to the clear zone width, and an analysis of the roadside condition.

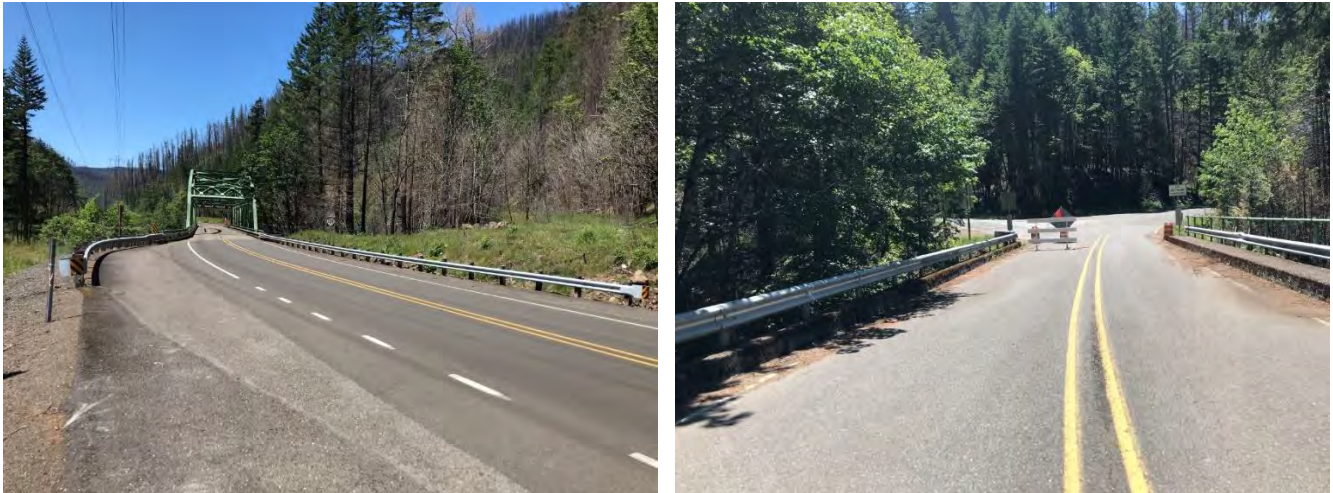
Figure 6: Apparently Undamaged Guardrail and Bridge Rail (OR 224, MP 31.2 and MP 49.97)

The final step relating to guardrail is to determine how much additional guardrail is needed, based on new conditions following the fire. New guardrail installation will likely have to be balanced between relative roadside departure risk and cost. To determine where new guardrail may be warranted, a full evaluation of the clear zone in locations where there is no existing guardrail is recommended. A special focus on the areas where there has been significant vegetation loss may be needed. Once the clear zone and roadside slopes and actual clear zone widths are documented (compared to recommended), guardrail warrants can be developed. However, it is likely that there will be budgetary restrictions on new guardrail installation. Rather than simply developing a list of locations where new guardrail is

warranted, it is recommended to develop a priority list for where guardrail and other roadside design treatments are most beneficial.

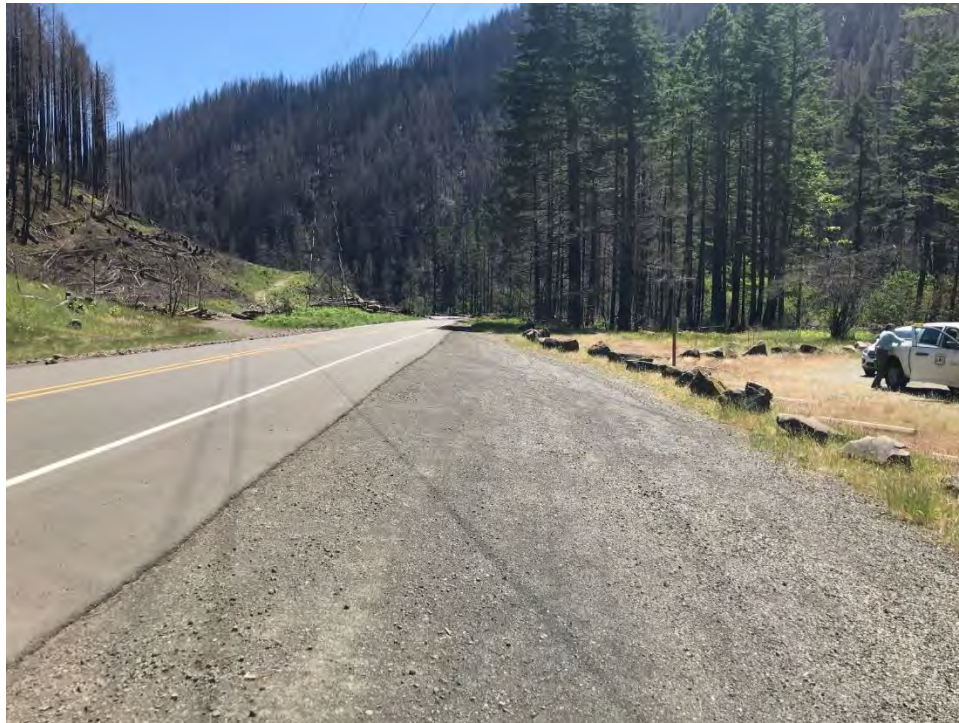
Other US National Forests, as well as other federal agencies, are struggling with roadside parking in undesirable areas. A presentation provided to Yellowstone National Park, detailing the known methods of discouraging parking in undesirable areas, is included in Appendix F. These methods have all had mixed results, though no formal study has ever been completed on any areas in which these methods have been implemented. Based on the different uses of the OR 224 corridor, there will not likely be a 'one size fits all' solution. One example of an area where solutions to restrict parking and/or access may be needed is near MP 41.0. Visitors either park on one side of the road to cross to the opposite (east) side or drive their vehicles into traversable areas on the east side that are not defined as access driveways. In addition to the earth disturbance, these visitors use the hillside on the east side for target shooting. There is a parking area on the west side which has space for picnicking or access to the river. The target shooting is in range of this parking area as well as the road. While target shooting is a draw to the forest, this is not the most appropriate area for it and methods of further discouraging use in this particular area are of interest.

Figure 2: Area of Concern for Parking and Access (OR 224, MP 41.0)

One method of parking discouragement discussed at the June 16, 2021 site visit is guardrail installation. Guardrail is only recommended in areas where the crash as a result of a roadside departure is more severe than a crash caused by a vehicle striking the guardrail itself. Specific to areas of campgrounds or spot camping, a consideration for guardrail installation would be the clear zone width and location of the campers. Further discussion of guardrail and roadside design, including the clear zone, is included in the next section. The next steps include a review of the roadside slopes, a delineation of areas where parking should be discouraged, the location of the campgrounds compared to the clear zone width, and an analysis of the roadside condition.

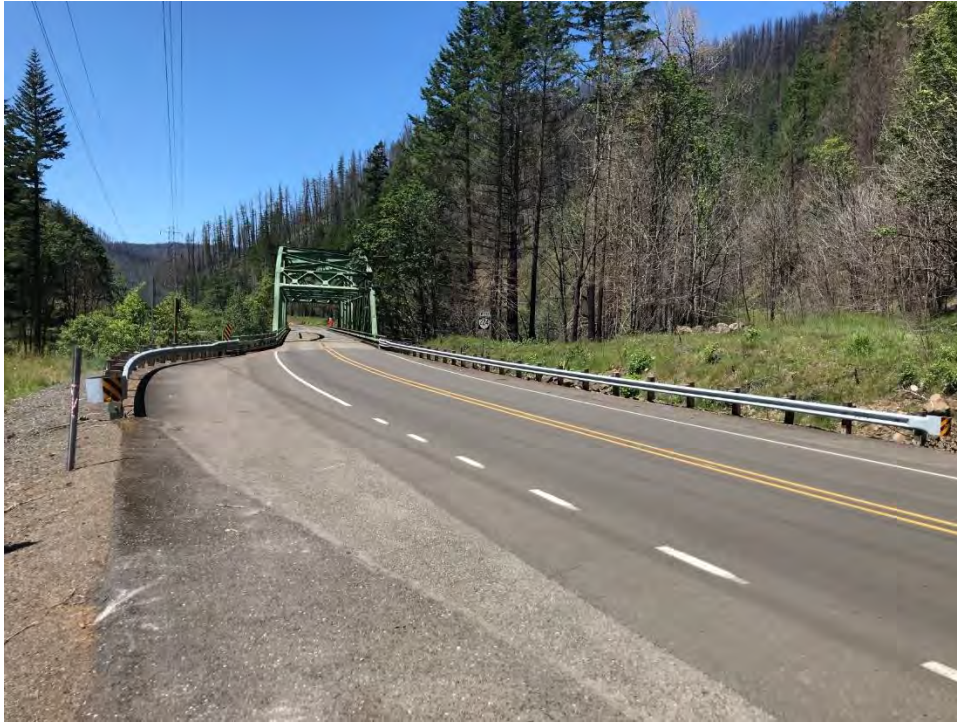
Figure 4: Apparently Undamaged Guardrail and Bridge Rail (OR 224, MP 31.2)

guardrail is recommended. A special focus on the areas where there has been significant vegetation loss may be needed. Once the clear zone and roadside slopes and actual clear zone widths are documented (compared to recommended), guardrail warrants can be developed. However, it is likely that there will be budgetary restrictions on new guardrail installation. Rather than simply developing a list of locations where new guardrail is warranted, it is recommended to develop a priority list for where guardrail and other roadside design treatments are most beneficial.

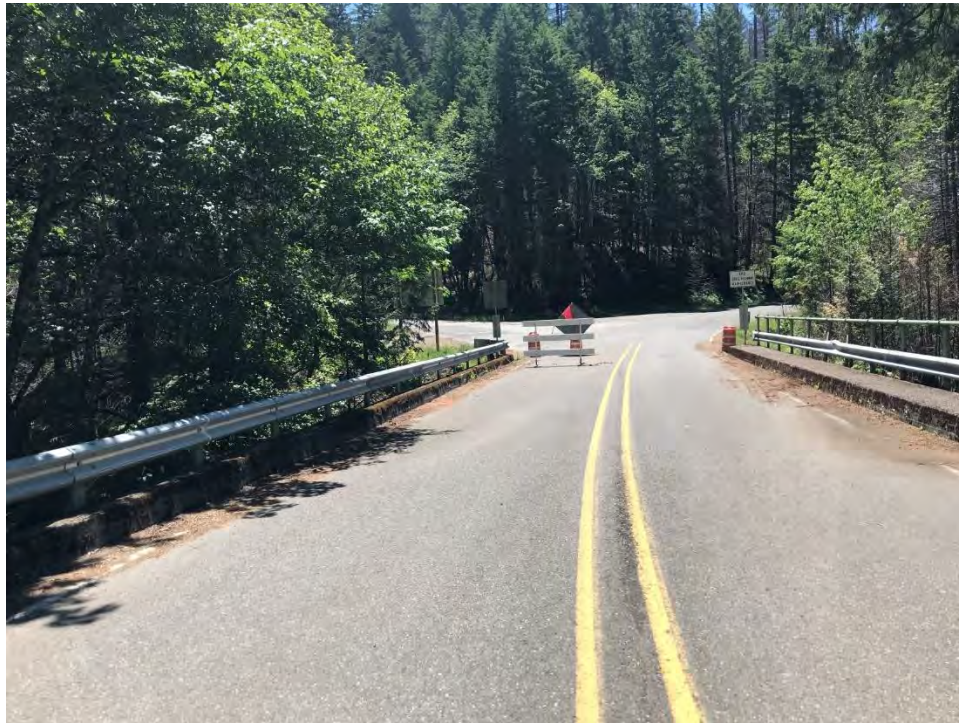
Figure 5: Apparently Undamaged Guardrail and Bridge Rail (OR 224, MP 49.97)
