SUBJECT: **REVISED Geotechnical Memorandum 03-20**
Preliminary Pretty Rocks Landslide Bridge Feasibility and Constructability
Pretty Rocks Landslide Investigation
AK NPS DENA 10(45)

Denali National Park Unstable Slope Corridor Assessment

**GEOTECHNICAL SUMMARY REPORT OF EXISTING
CONDITIONS**

Re: Geotechnical Report 05-20, AK NPS DENA 10(49), Geotechnical Summary Report of Existing Conditions

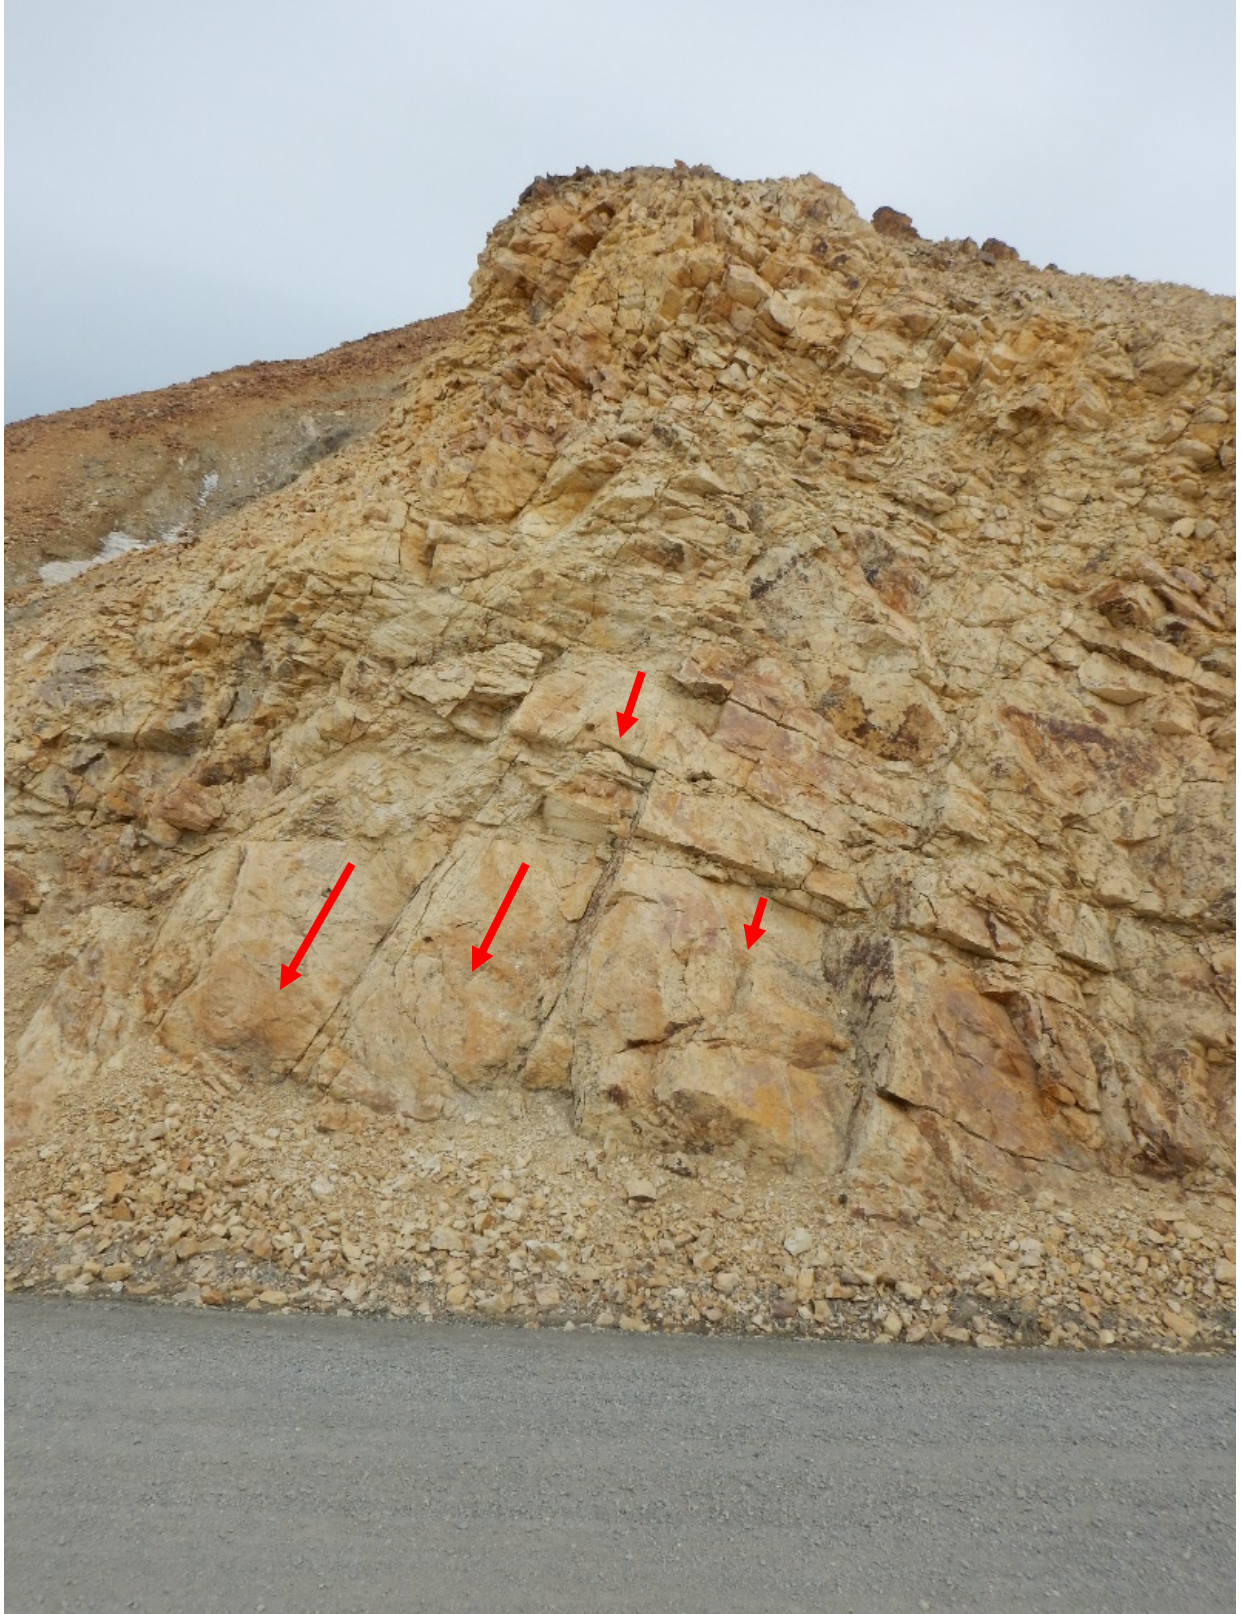
Figure 3. Photograph of the rhyolite bedrock outcrop near the east bridge abutment location. Red arrows show the direction of the controlling discontinuity.

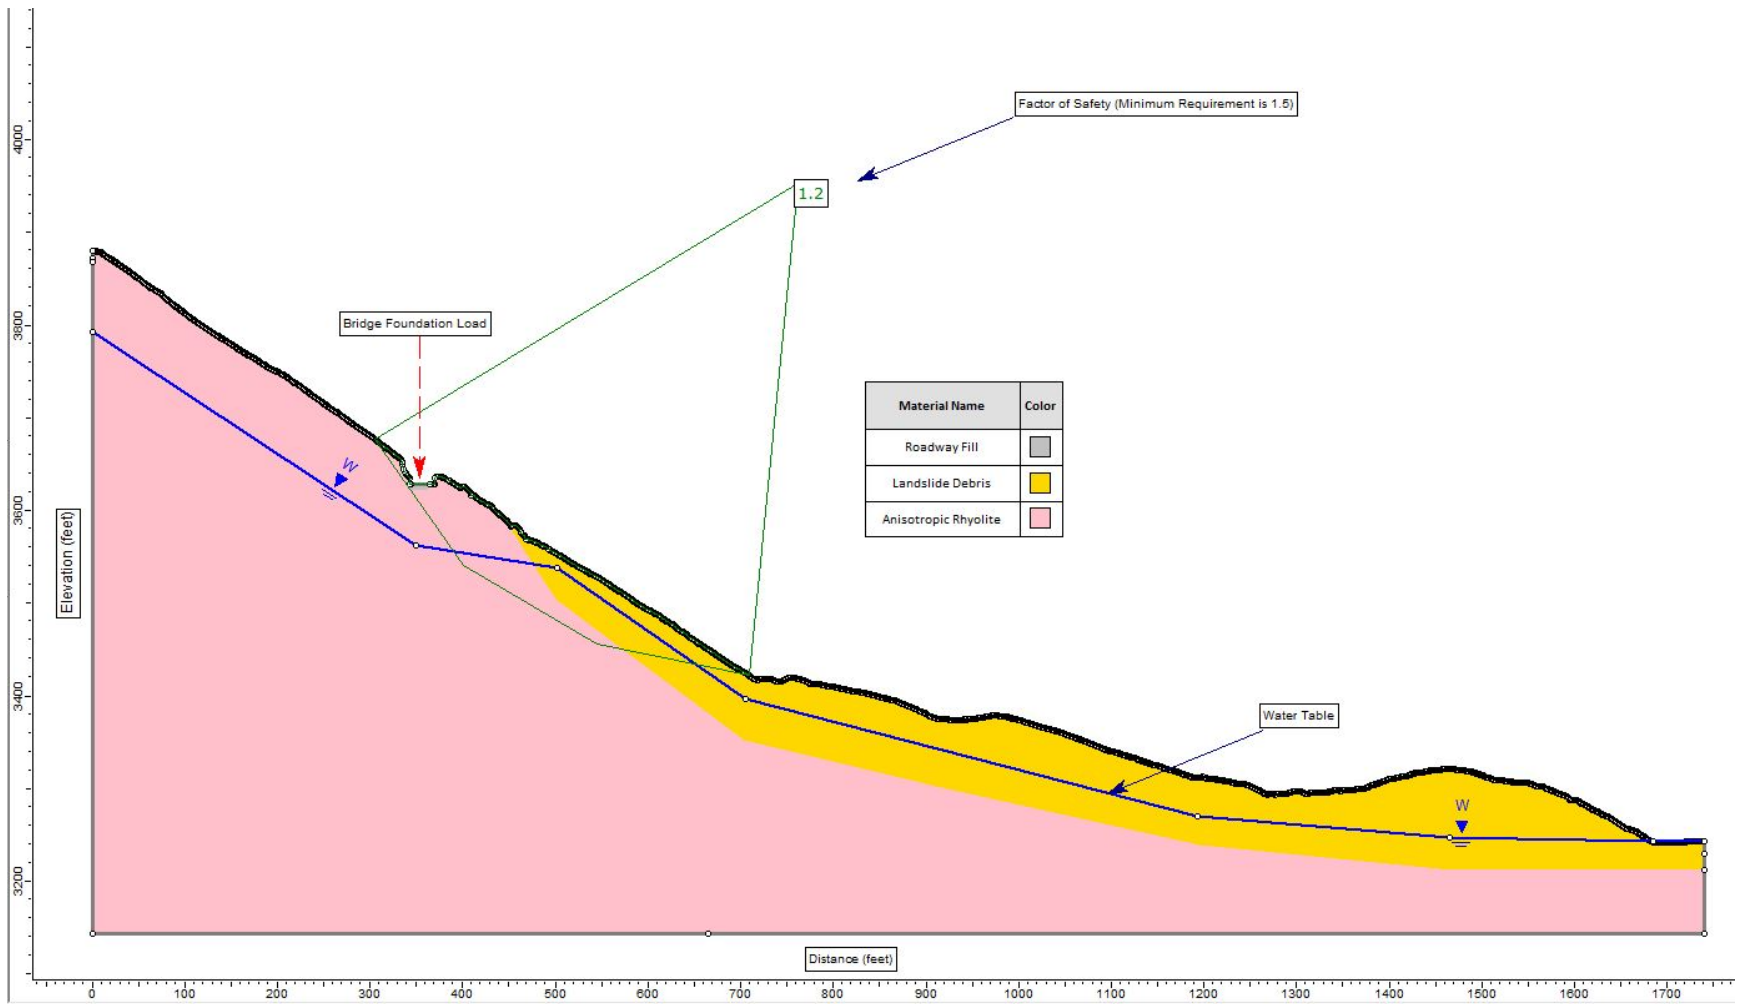
As shown in Figure 4, we do not meet this factor of safety, so deep foundation elements and/or rock reinforcement of the foundation area will likely be required to achieve a factor of safety of 1.50. We believe this can be achieved in this abutment location.

Figure 4. Slope stability analysis of east abutment location with the adverse, steeply dipping rhyolitic rock discontinuity and approximate bridge loads.

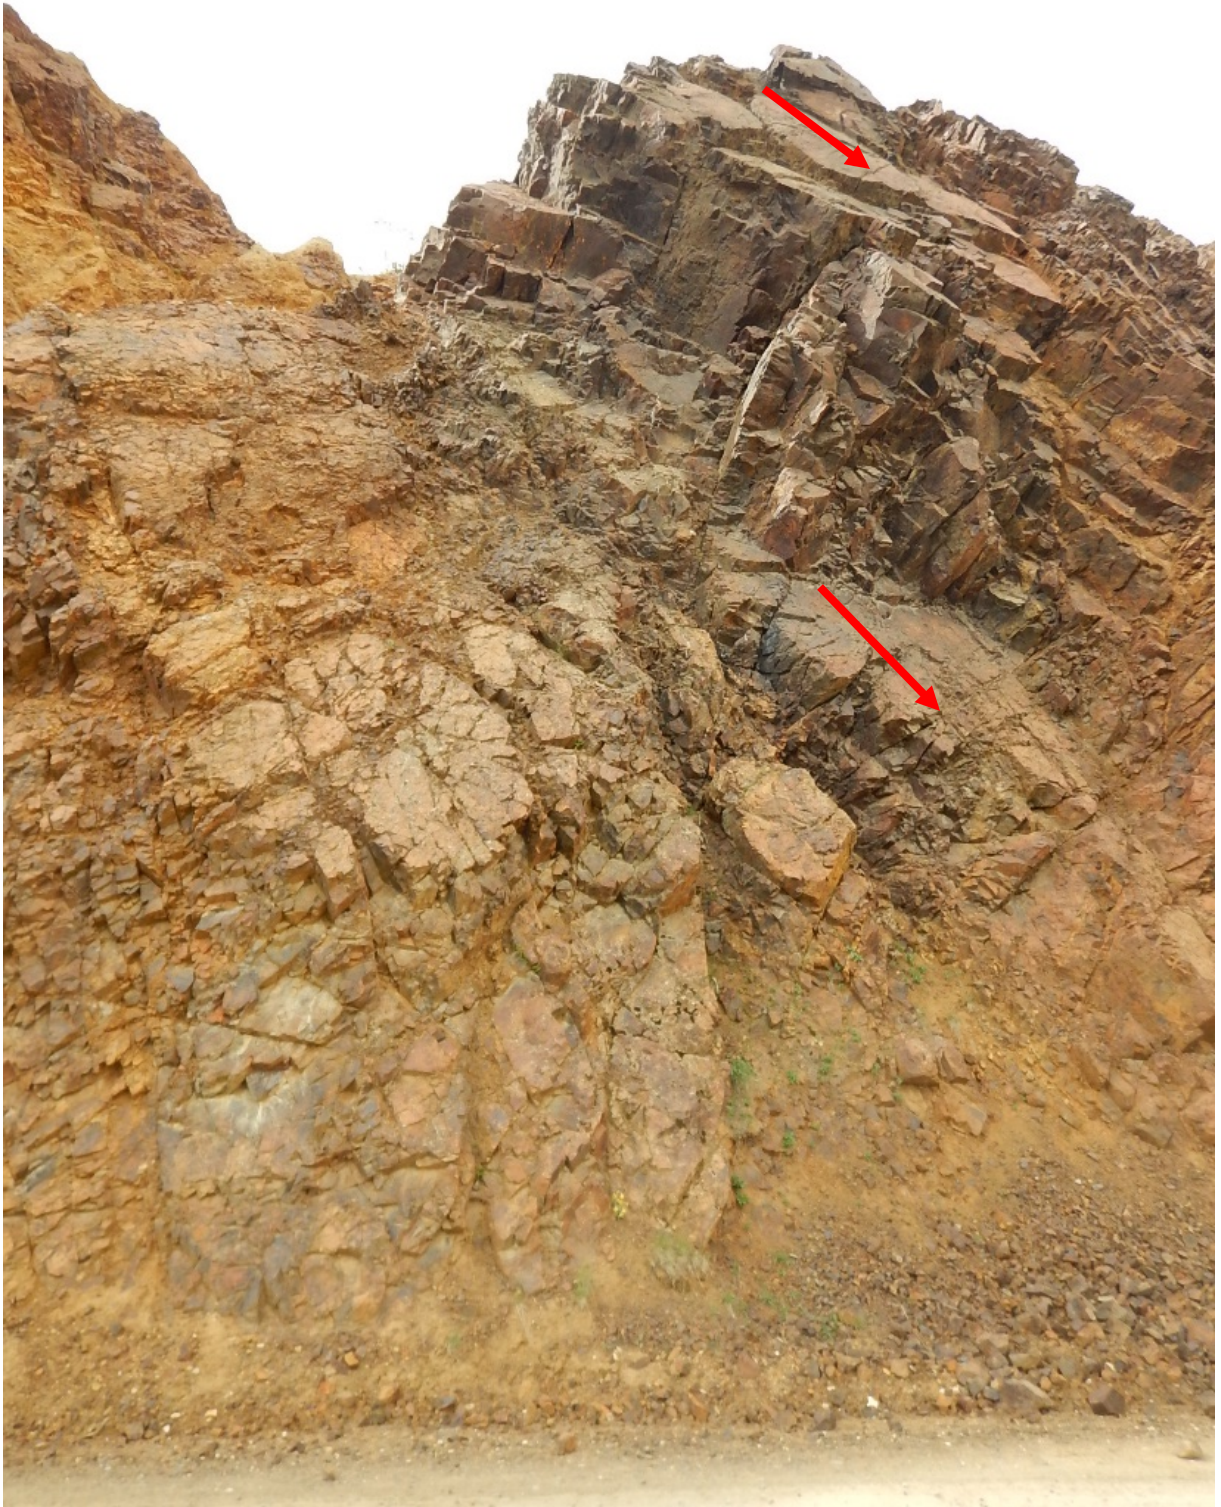
In the case of the basalt bedrock at the approximate west abutment location, there are two adverse rock structures but one of the rock discontinuities controls the stability of the slope. The low angle, 38 degree dipping rock discontinuity shown in Figure 5 displays the rock discontinuity of greatest concern for the basalt bedrock proposed foundation location. This rock discontinuity is likely a large contributor to the existing Pretty Rocks Landslide failure, and must be mitigated for the west abutment area. As shown in Figure 6, this location also does not meet the factor of safety of 1.50. *The initial evaluation suggests that this foundation location will likely require a complex and iterative mitigation strategy that may involve a combination of significant rock excavation, deep*

Figure 5. Photograph of the basalt bedrock outcrop at the approximate location of the west bridge abutment. Red arrows show the direction of the controlling discontinuity.

foundation elements, and specialized rock reinforcement strategies. While feasible, this west abutment location presents several design and mitigation complexities and may result in a less desirable bridge type option for the Park to achieve the spans for a stable foundation design. Other west abutment locations that were closer to the unstable landslide mass, and could have resulted in a shorter bridge span length, were evaluated. However, the stability analyses for these shorter bridge span length locations, informed by the test boring data, were not feasible.

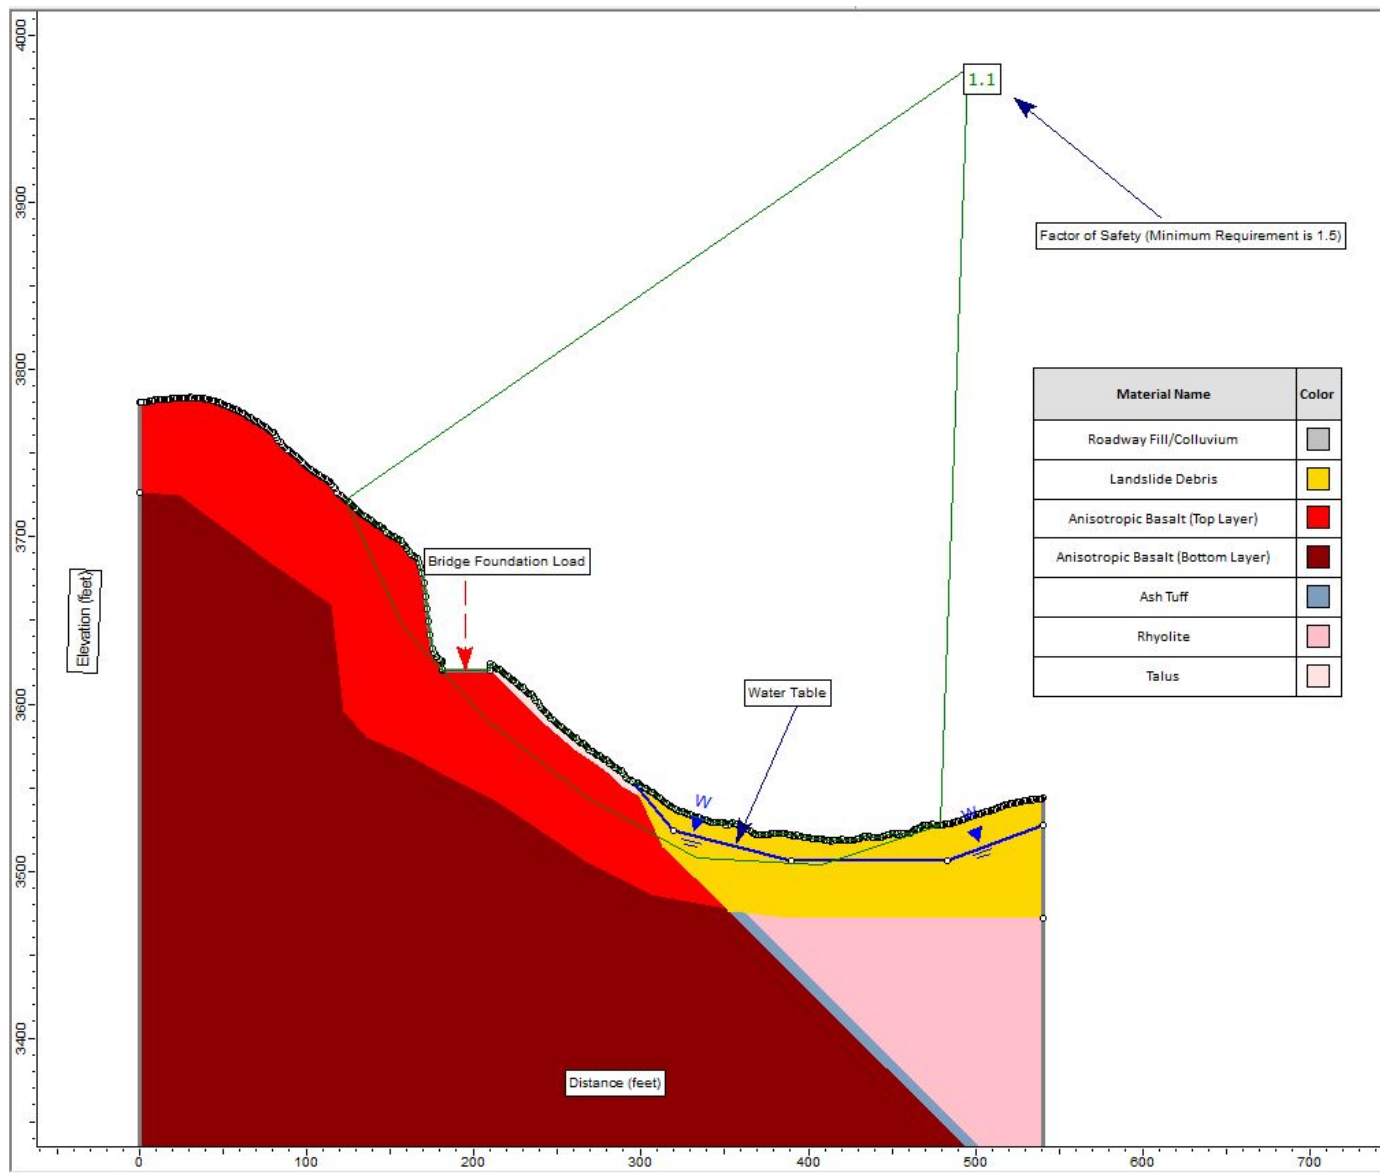
Figure 6. Slope stability analyses of the west abutment location with the adverse, low angle dipping basaltic rock discontinuity and approximate bridge loads.

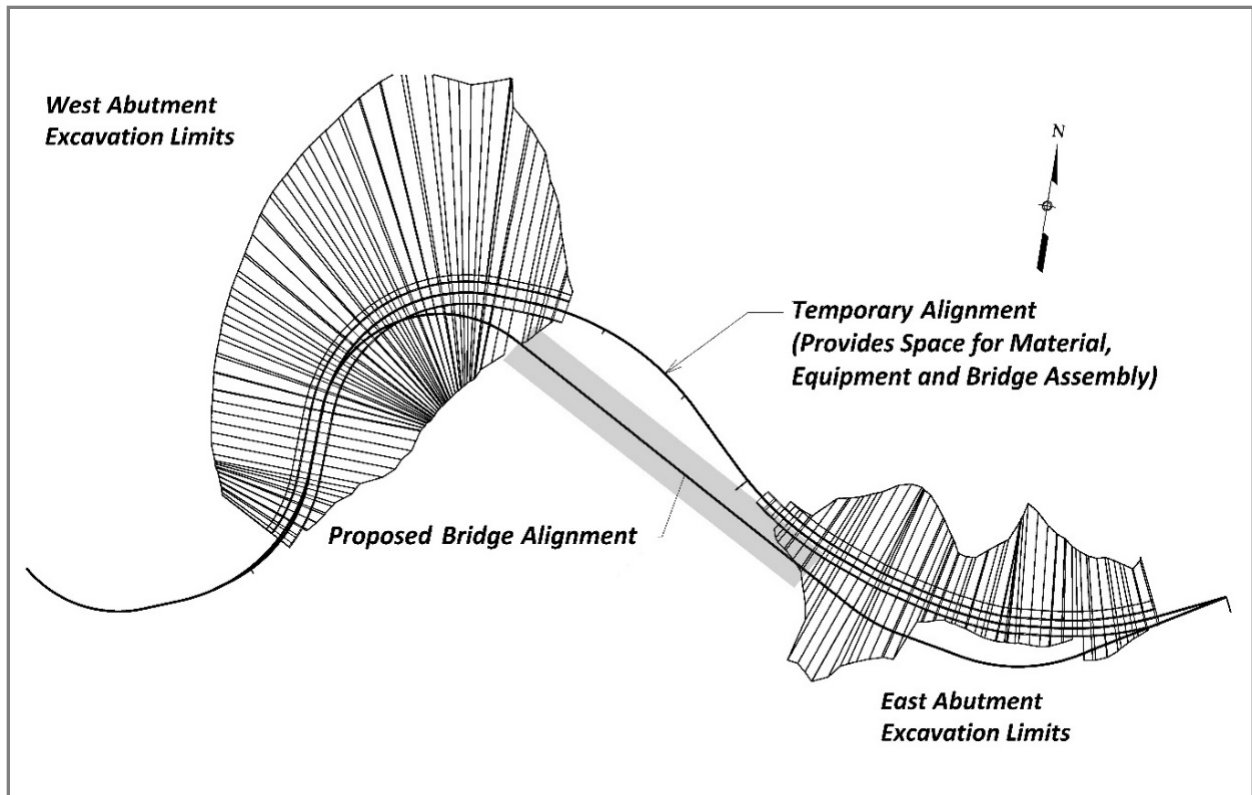
Figure 11. Excavation limits. East abutment excavation provides space for bridge assembly during construction and a rock fall ditch post construction. The west abutment excavation provides for the bridge approach road alignment (turning radius).

As discussed above in the preliminary foundation section, the bridge abutments will require additional rock excavation and a combination of deep foundations and rock reinforcement to meet design standards for bridge foundation stability. The modular steel truss bridge design is typically assembled behind the abutment and launched into place, limiting the space requirements for assembly. However, because of the road curvature at the east and west abutments, there is not sufficient space behind either abutment to assemble in this manner, so the bridge would likely be assembled on the existing road alignment across the landslide and lifted into place, as discussed in the bridge structure options section.

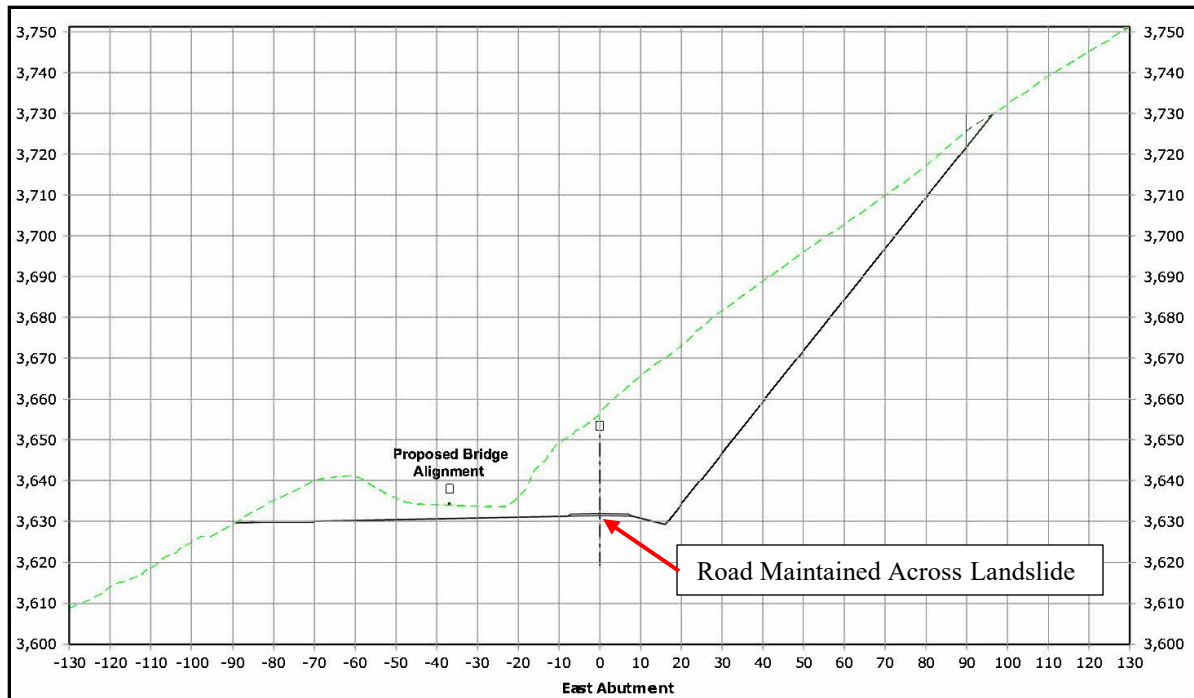
Figure 13. Cross section near the east abutment. Existing ground is represented by the green dashed line.

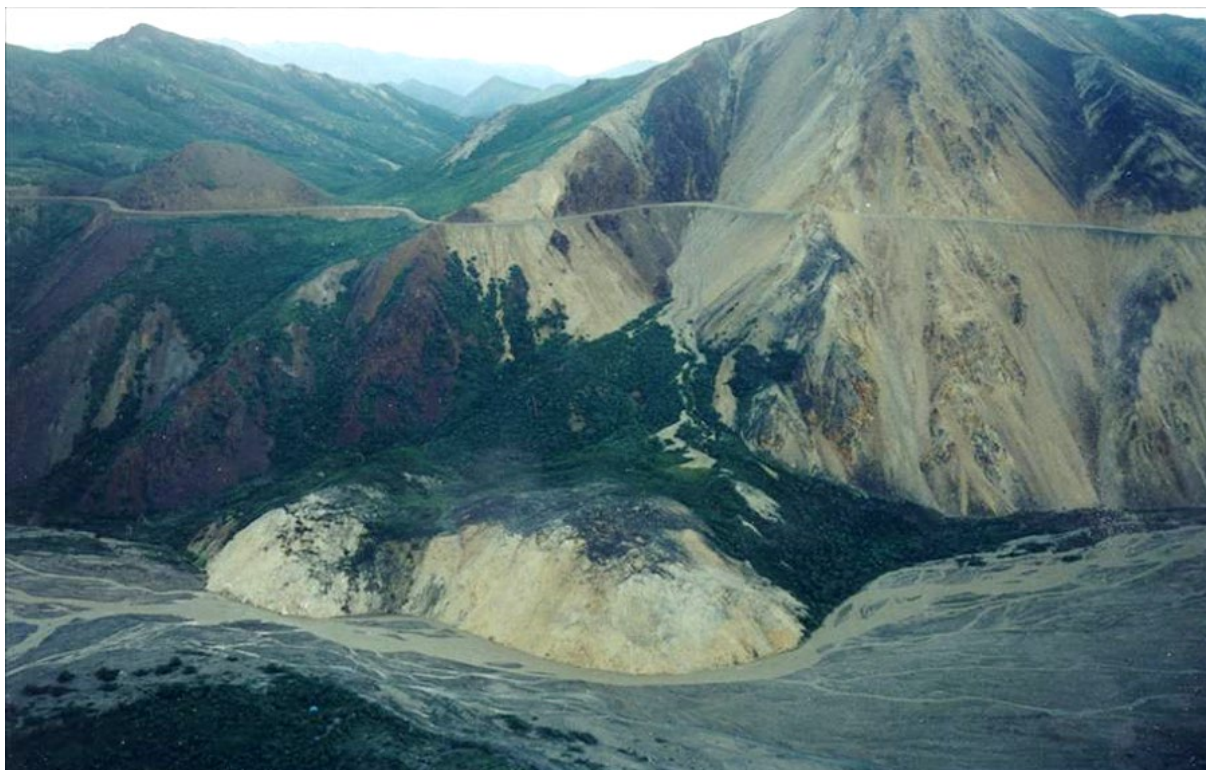
Figure 3-1. Denali Park Road at the Pretty Rocks Landslide. NPS photo (Date unknown).

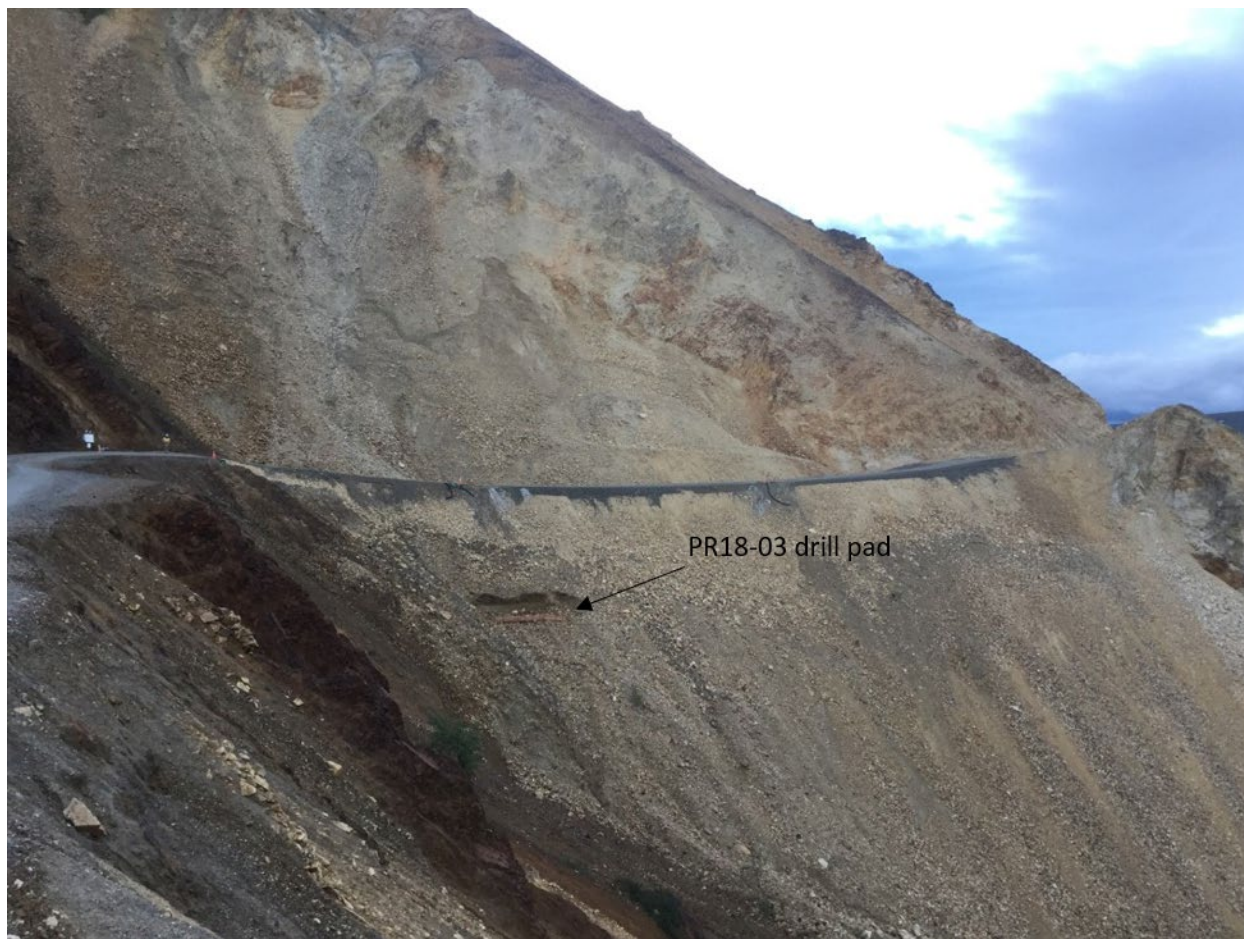
Figure 3-2. Denali Park Road at the Pretty Rocks Landslide. FHWA photo (2018).

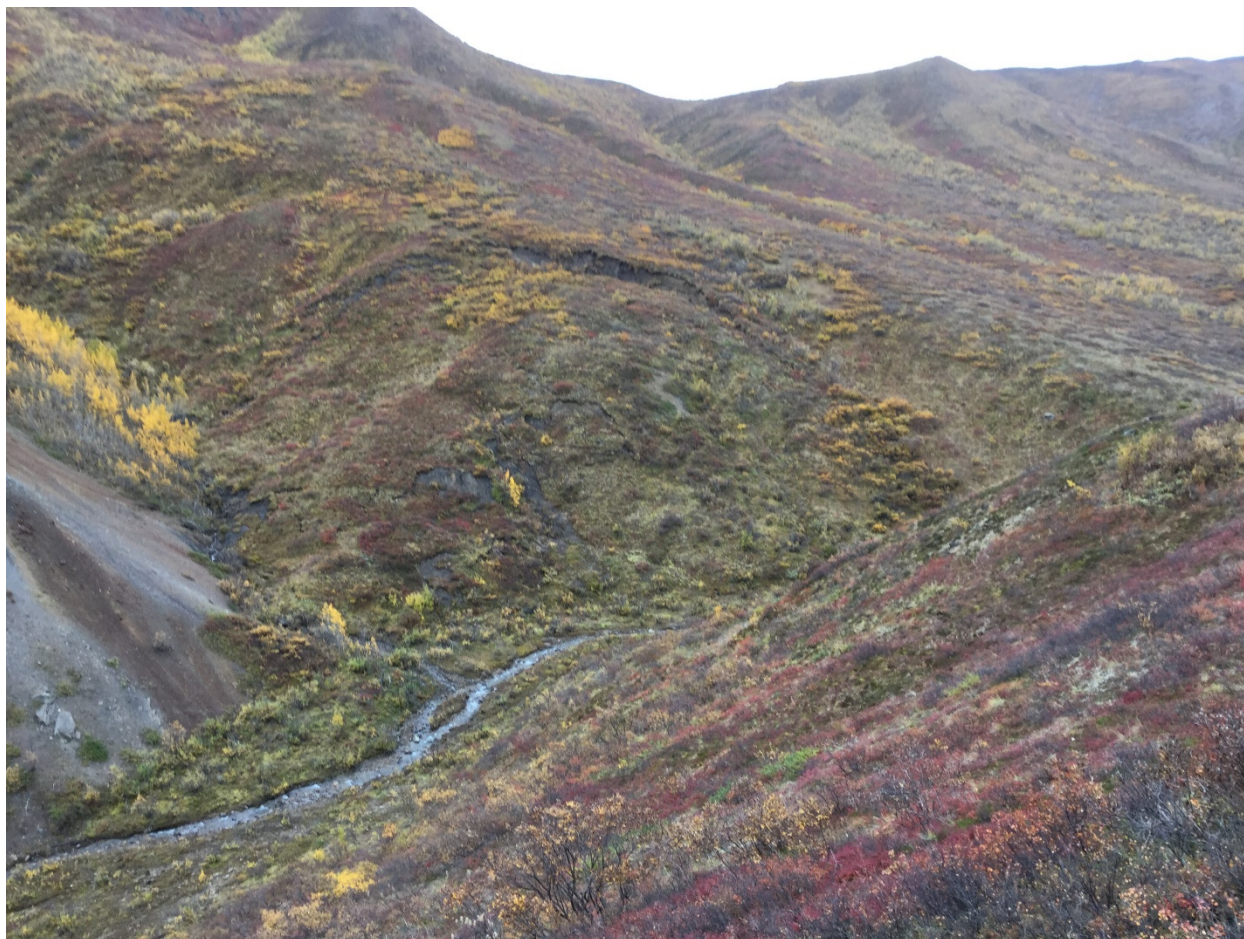
Figure 3-4. Landslide near north alignment. Note the stream at the bottom of the valley. Photo location shown as #103 in Figure 3-7. FHWA photo (2019).

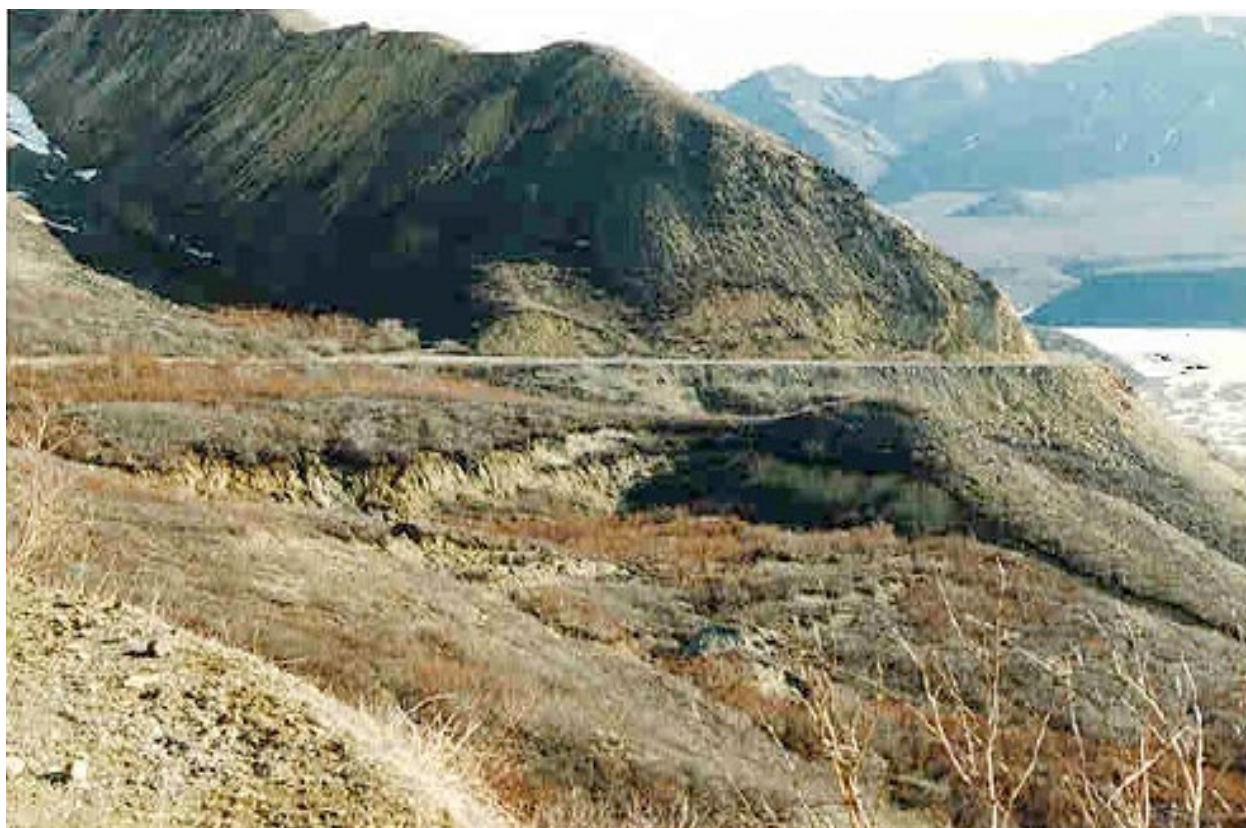
Figure 5-4. Looking east at the MP 45 (Bear Cave) Landslide from the west side of the landslide area in May 1996.

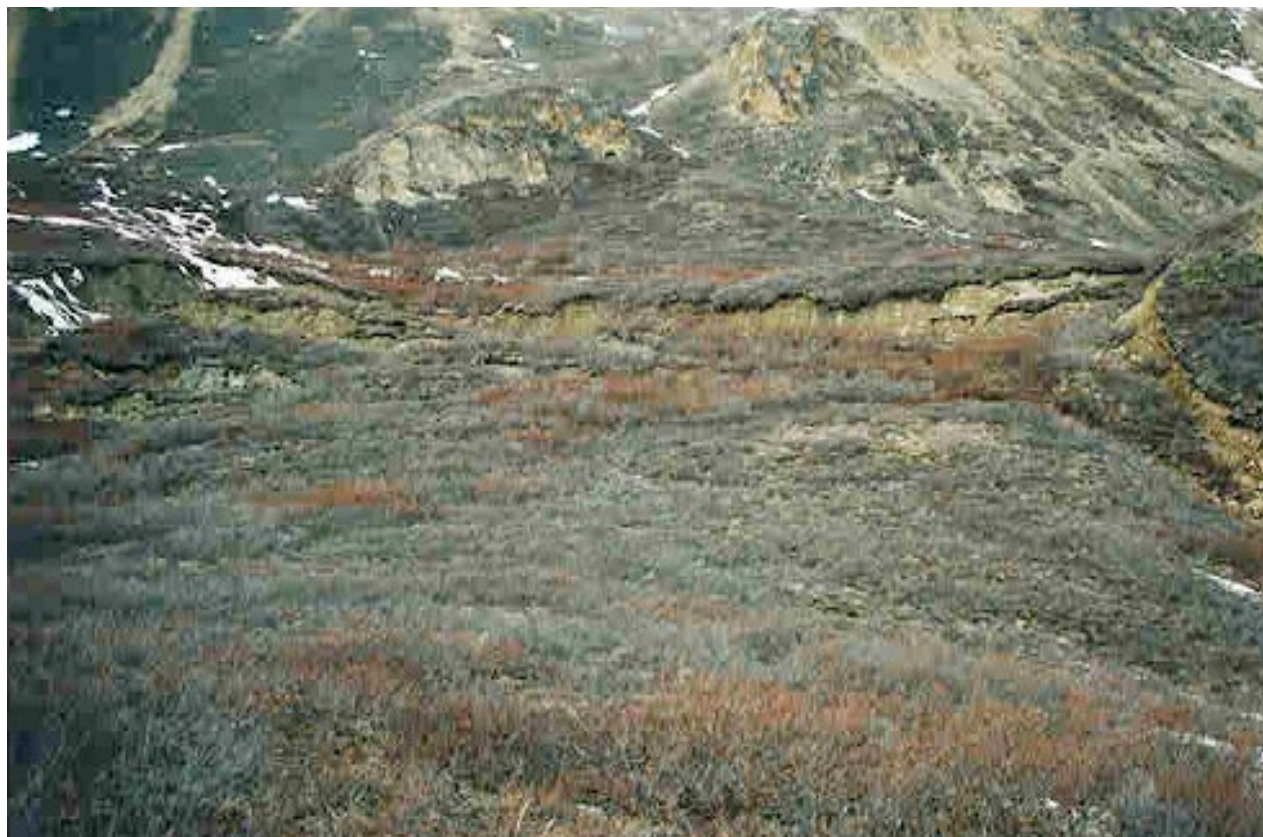
Figure 5-5. Looking upslope toward the MP 45 landslide headscarp from the lower center of the landslide.

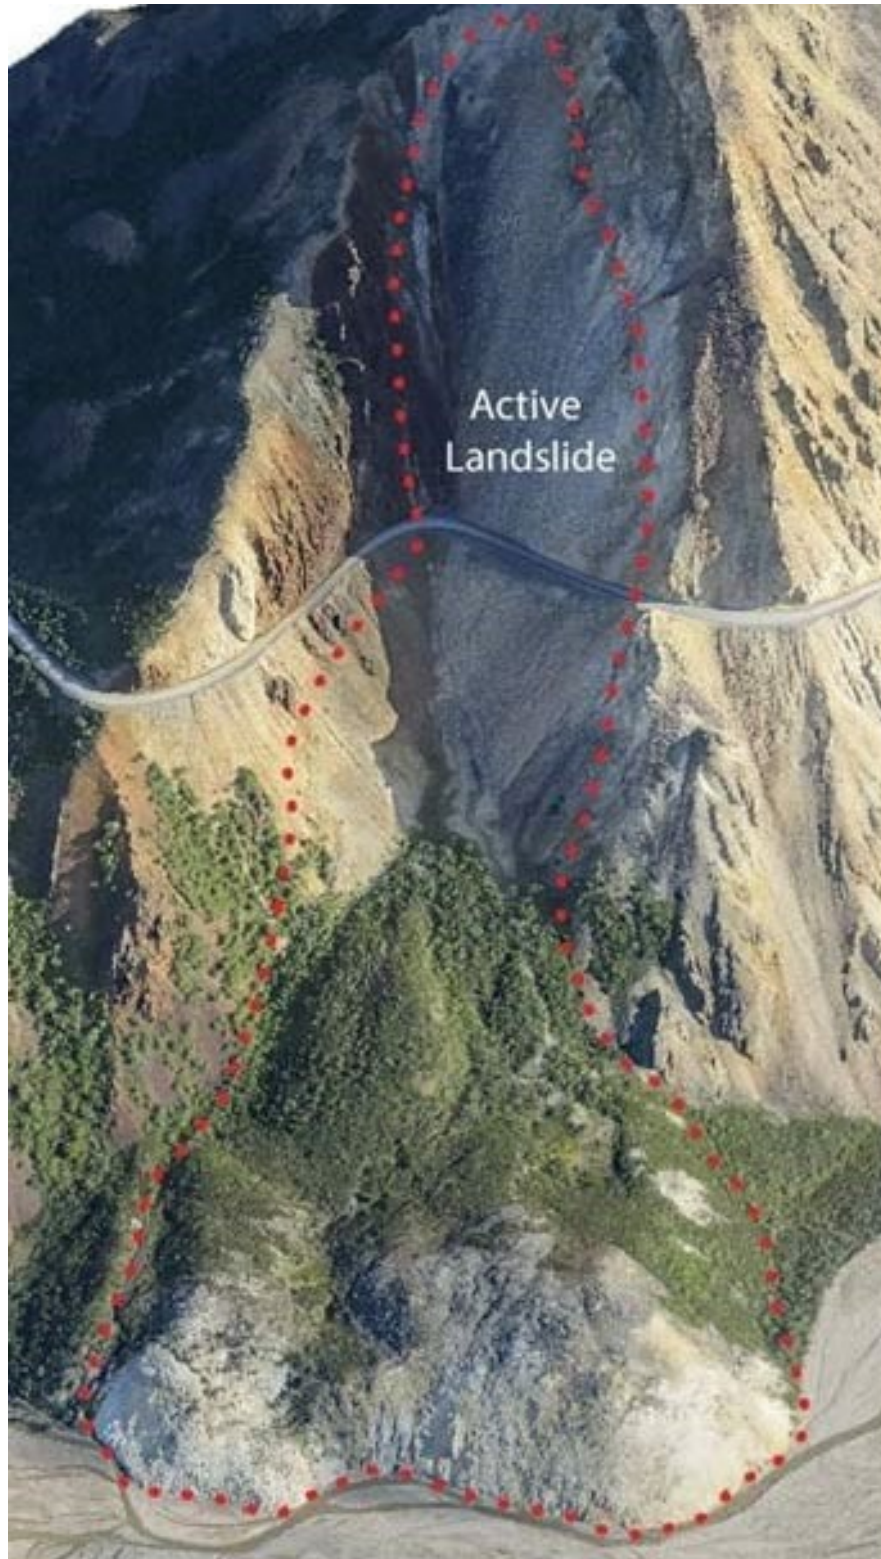
Figure 5-10. Oblique view of the Pretty Rocks Landslide. Image is from June 15, 2015 and the red dots outline the approximate landslide extents (NPS, 2020).

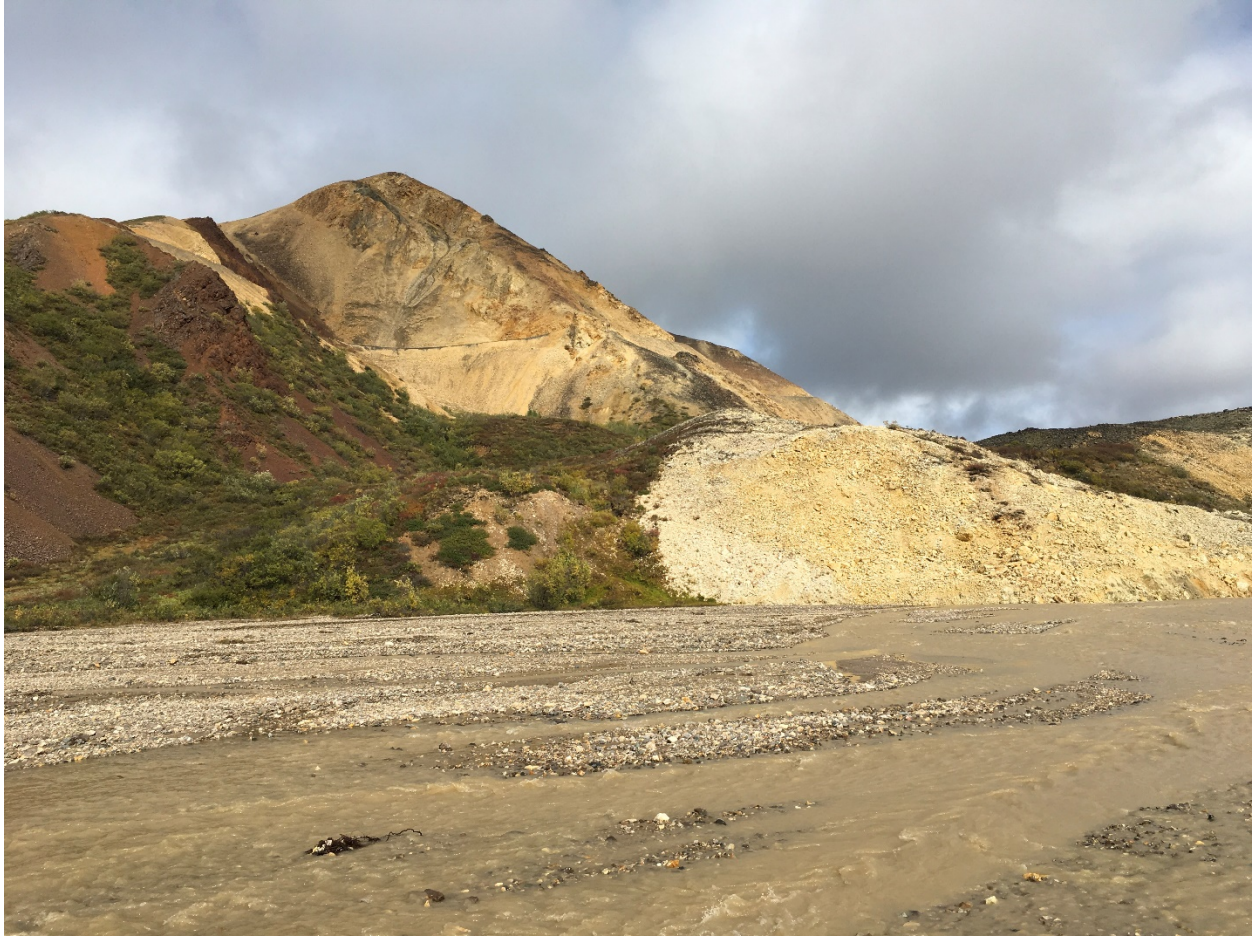
Figure 5-12. Looking at the western portion of the toe of the Pretty Rocks Landslide from across the Toklat River. FHWA photo (2019).

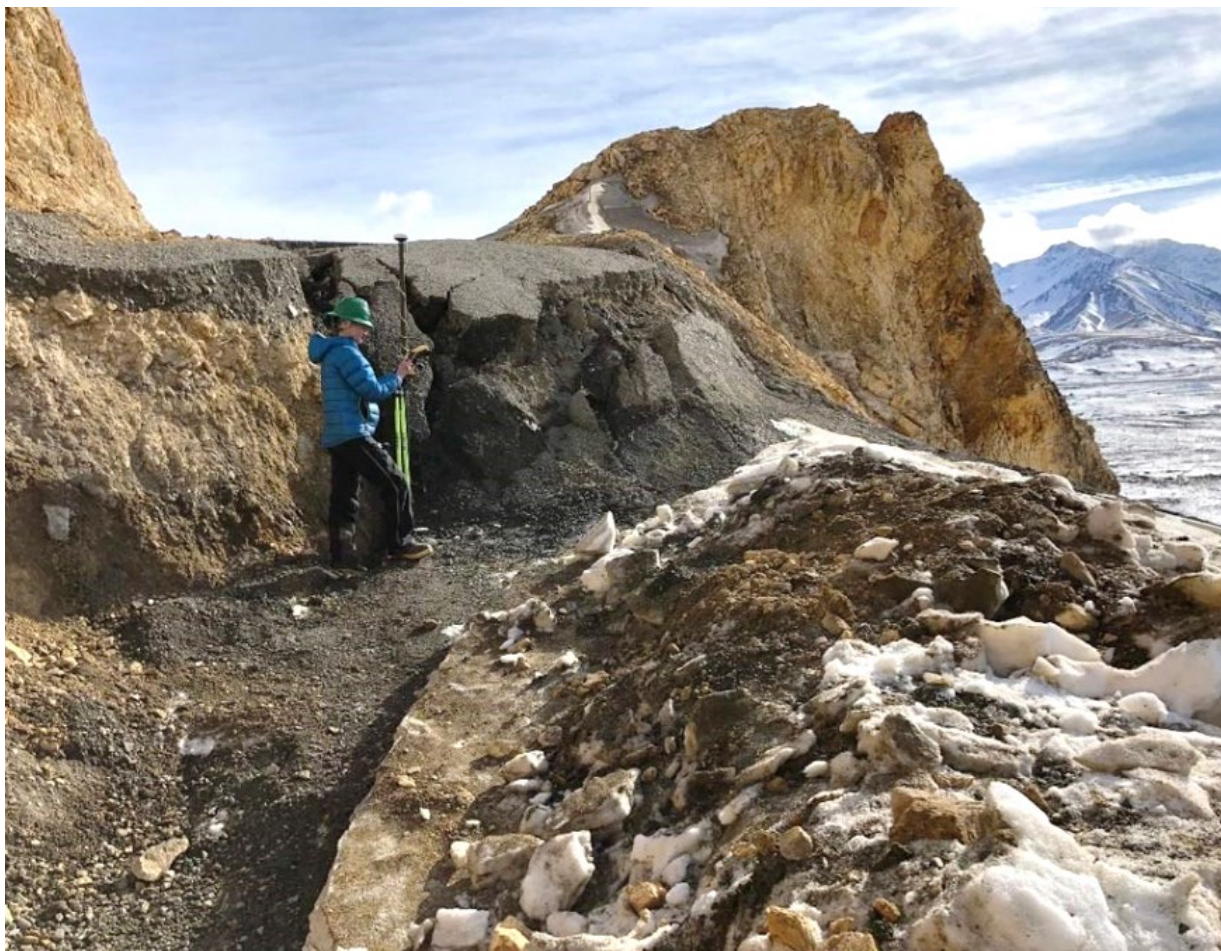
Figure 5-15. At the eastern Pretty Rock Landslide scarp. The area has fallen approximately 6.5 ft from September 2018 to when this photo was taken in March 2019 (NPS, 2020).

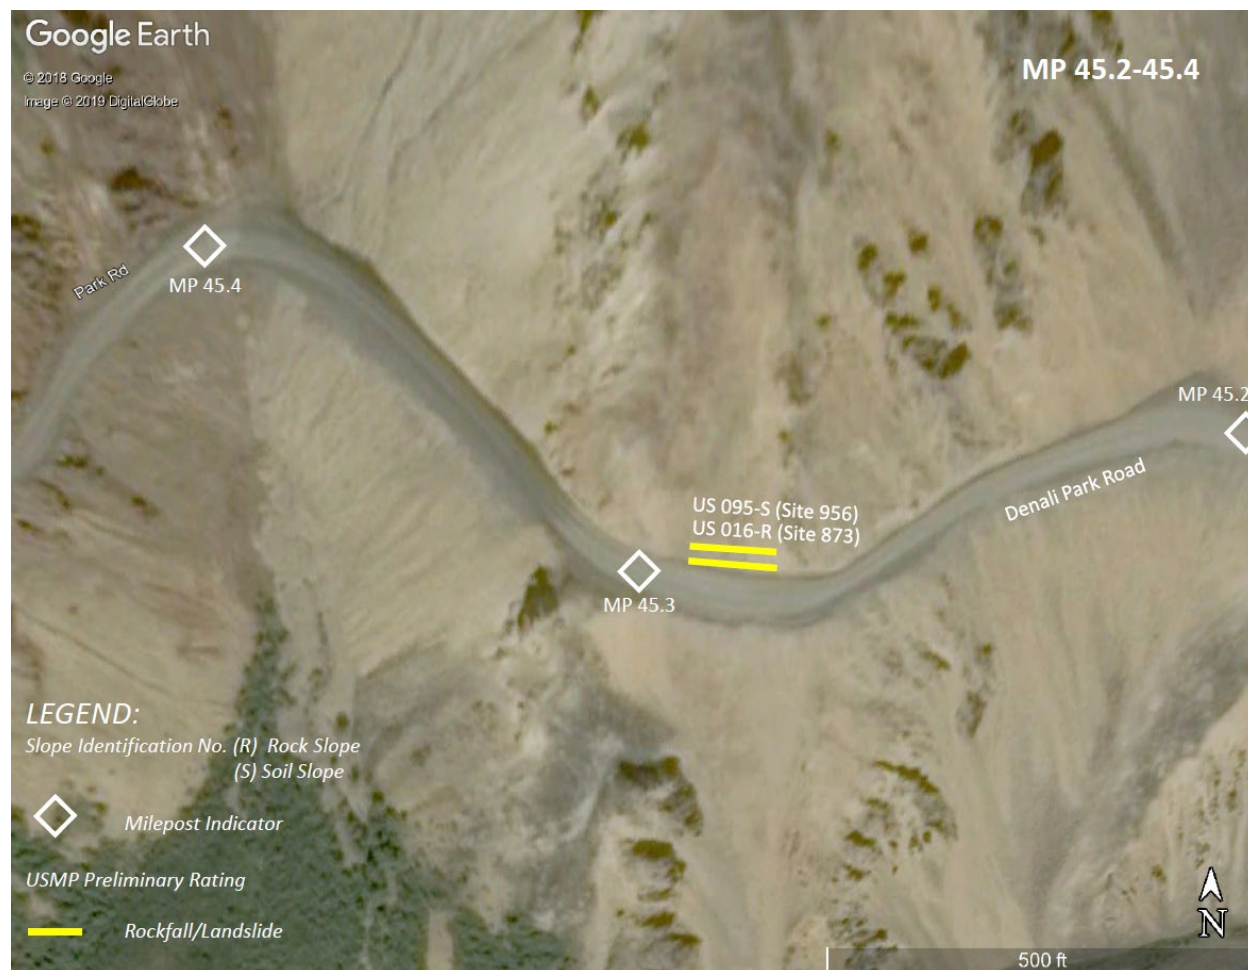
Site 873, also known as “Perlite Rockfall”, is slope with a maximum height of 140 feet that affects 125 feet of the Denali Park Road. It consists of decomposing rhyolite with intermittent layers of perlite that is producing structurally controlled planar, wedge, and indeterminate failures. The maximum block size is approximately one foot.

Site 956, also known as “Perlite Debris Slide”, is a slope with an axial length of 80 feet and a slope angle of approximately 39° that affects 45 feet of the Denali Park Road. The failures consist of rotational debris slide events in rhyolite, perlite, and colluvium materials. These events are triggered in part by a natural spring emitting from a geologic contact between the impermeable perlite layer and the rhyolitic colluvium in the slope. A large event on August 26, 2015 blocked and closed the road for two hours during the day. The road was also closed overnight after this event for additional debris cleanup.

Figure 5-26. Overview of Sites 873 and 956 between MP 45.32 and MP 45.34 on the Denali Park Road in Alaska (U.S Department of Transportation, December 2019).

offer the greatest benefit for risk reduction. The second option would consist of installing a cantilevered soldier pile wall backfilled with pervious rock material and installing horizontal drains (that possibly extend through the face of the wall) as described in Option 1 above. This option would require a geotechnical investigation for retaining wall foundation design. We have assumed the wall will be 15 feet high and 140 feet long and retaining wall tiebacks are not appropriate for this location due to the very weak strength of the perlitic ash materials in the cut slope. A conveyer belt or long-reach excavator will be required to backfill the wall up to the approximate spring location where the piping failures are occurring.

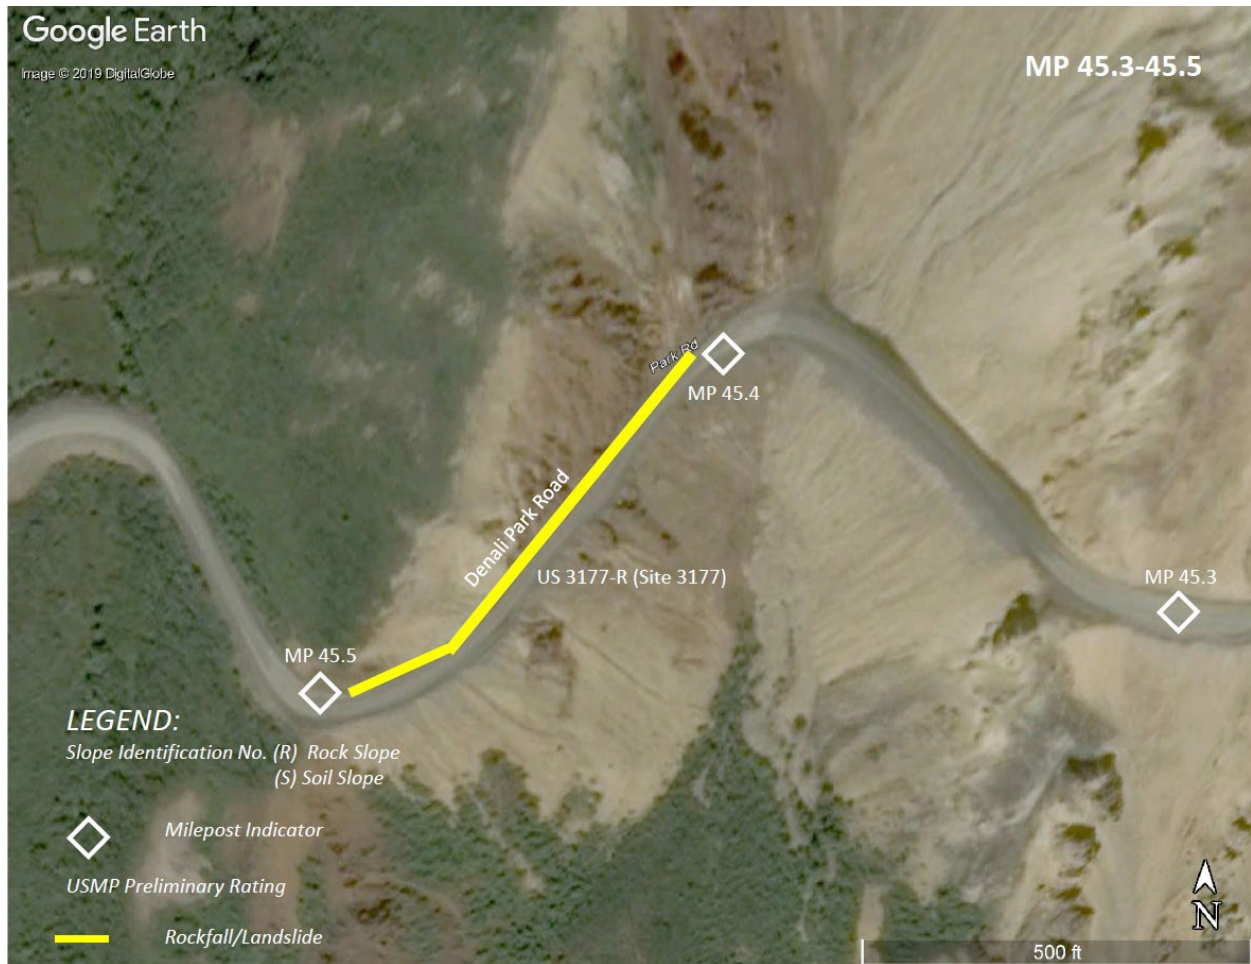
Figure 5-28. Overview of Sites 3177 between MP 45.41 and MP 45.48 on the Denali Park Road in Alaska (U.S Department of Transportation, December 2019).

the bridge. The bridge will need to be approximately 400 feet long and rock reinforcement of the bridge foundations will be required. Under the bridging option, Site 3177, the basaltic rock cut to the west of the landslide will need to be excavated to provide for turning at the west side of the bridge. An additional test boring will be required at the west abutment location to confirm the complex geologic conditions that will influence the foundation design requirements.
