SUBJECT: **REVISED Geotechnical Memorandum 03-20**
Preliminary Pretty Rocks Landslide Bridge Feasibility and Constructability
Pretty Rocks Landslide Investigation
AK NPS DENA 10(45)

Denali National Park Unstable Slope Corridor Assessment

**GEOTECHNICAL SUMMARY REPORT OF EXISTING
CONDITIONS**

Re: Geotechnical Report 05-20, AK NPS DENA 10(49), Geotechnical Summary Report of Existing Conditions

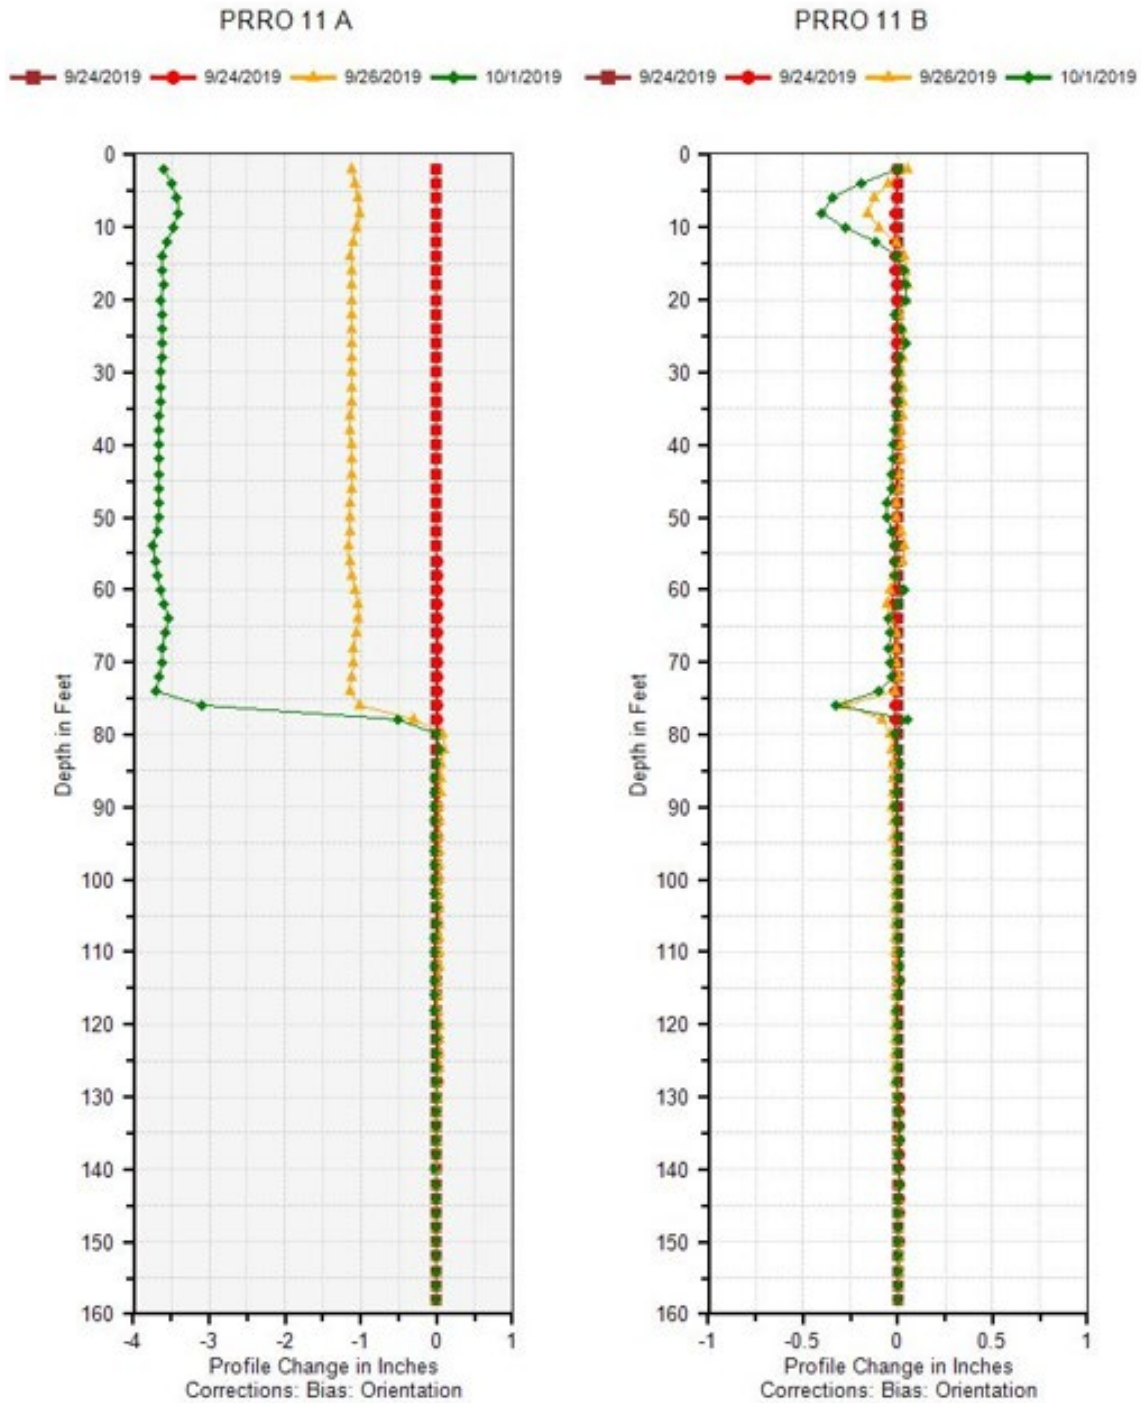
Figure 2. Slope inclinometer readings in the downslope direction (A) and from side to side (B) from September 24, 2019 to October 1, 2019. The slope inclinometer casing has sheared and is no longer usable for measurements. The rate of landslide movement indicated by these measurements is about 1.6 to 1.8 inches/day.

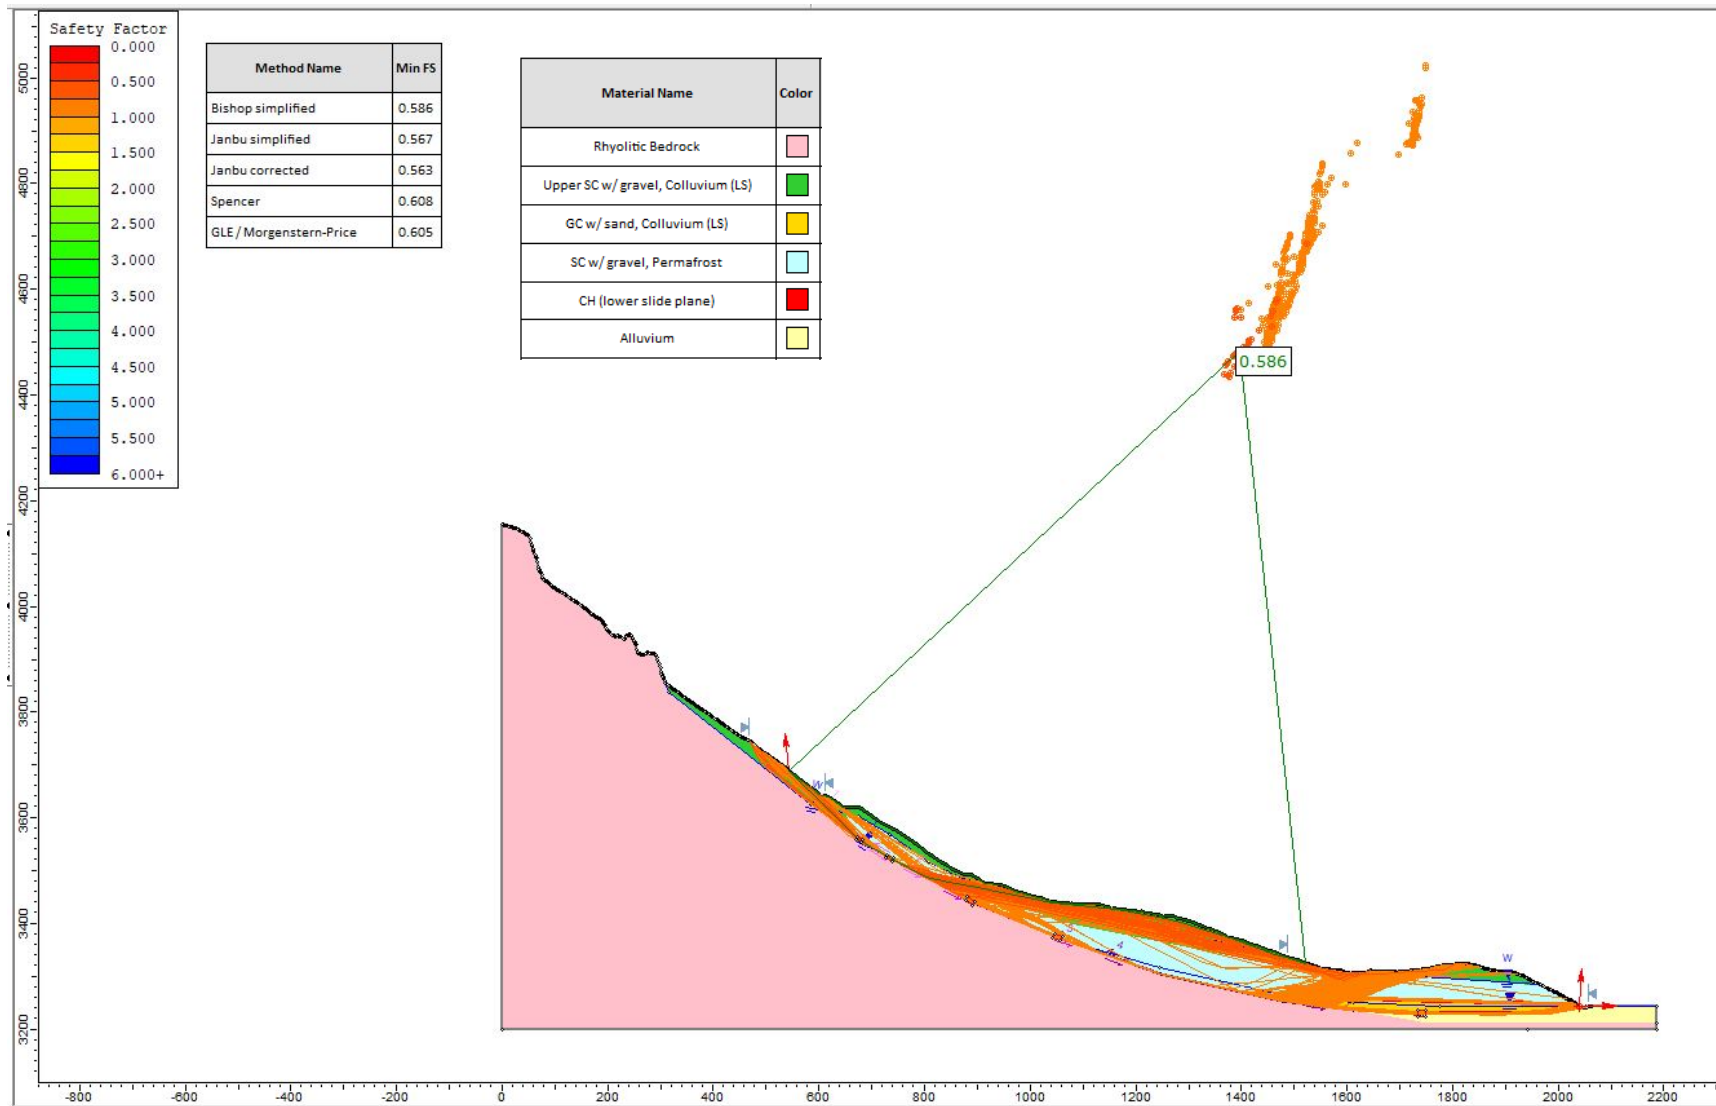
Figure 6. Revised 2019-2020 slope stability back analyses model following additional information from test boring PR19-11 information.

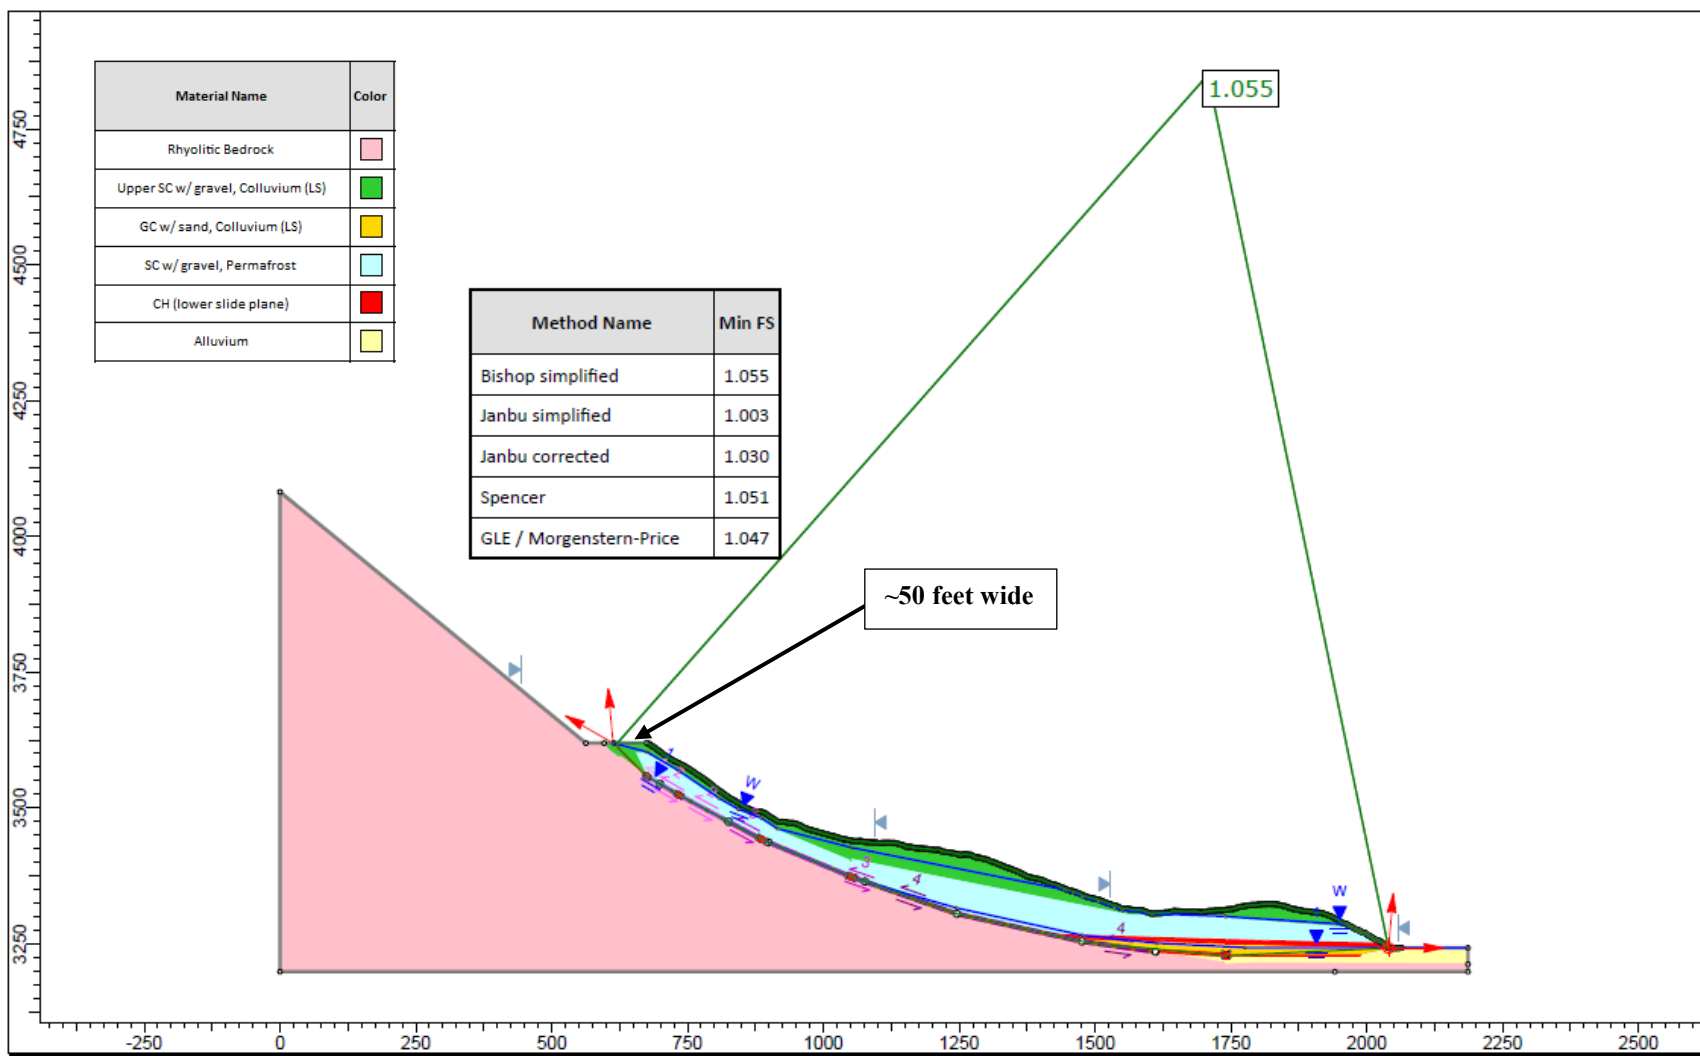
Figure 7. Slope stability analysis of the upper landslide material removed with the road shifted, and founded upon the very weak and altered bedrock. No material has been sidecast in this stability model.

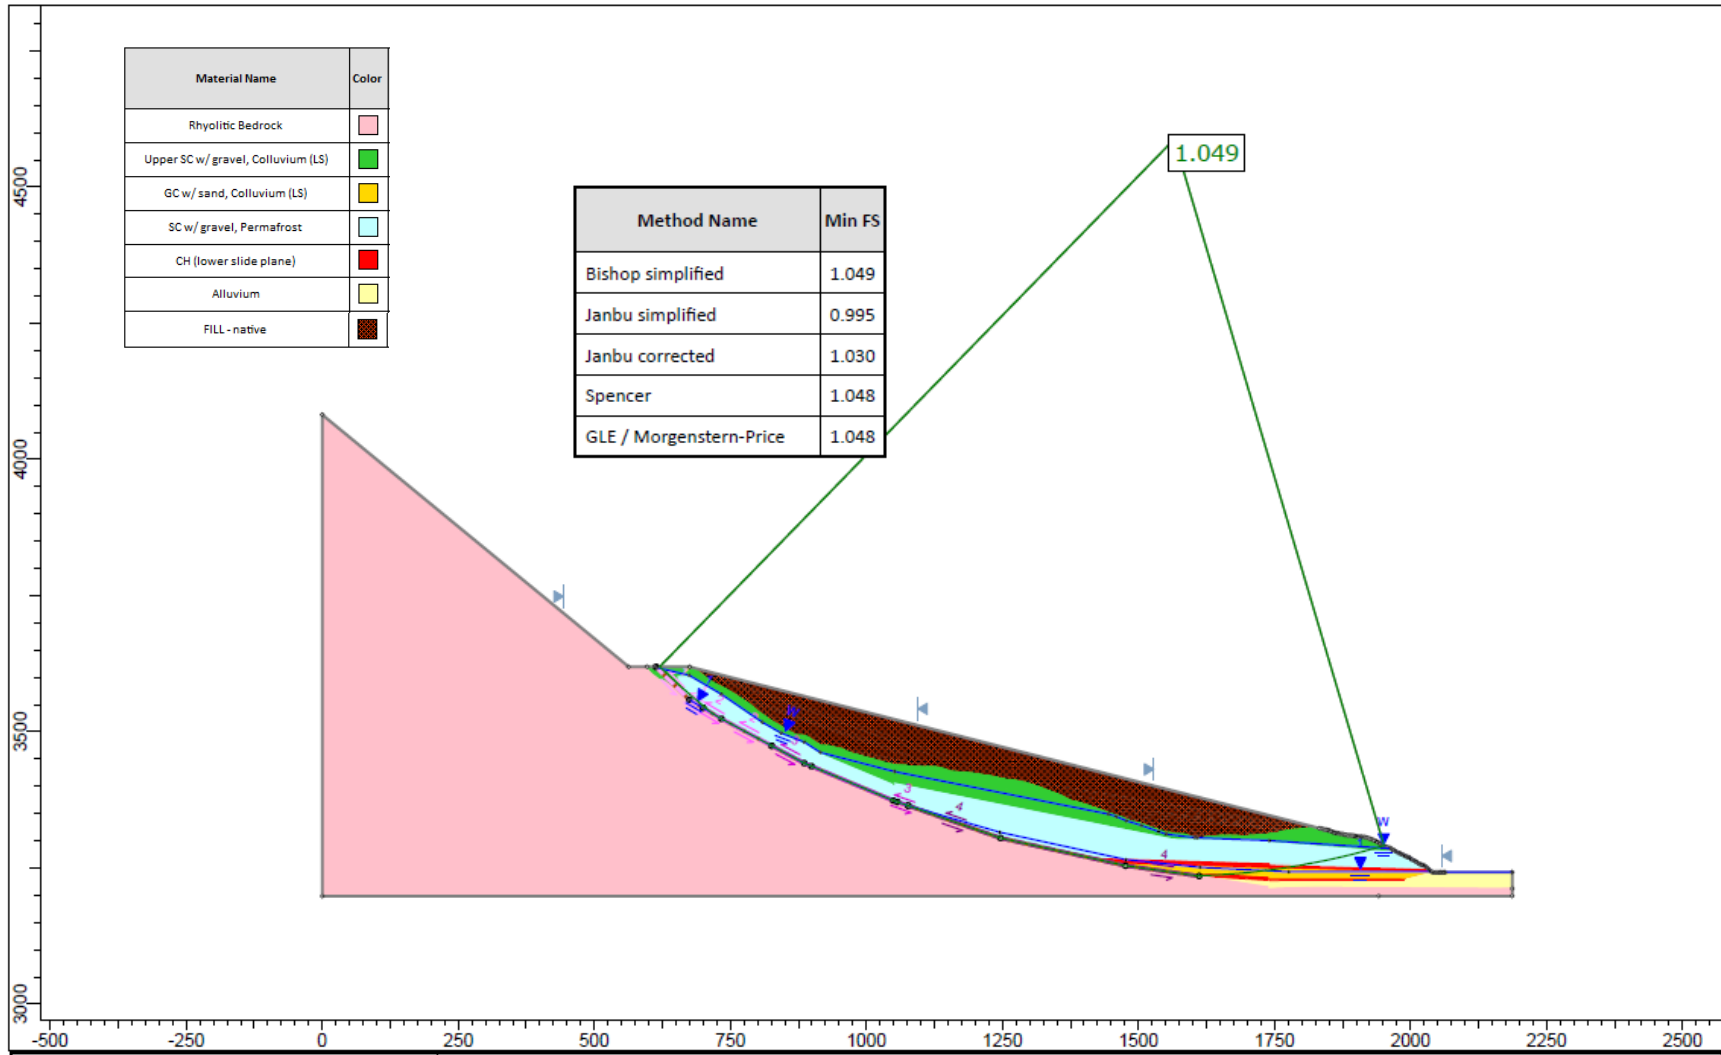
Figure 8. Slope stability analysis of the upper landslide material removed and placed below the road (brown) in a uniform (load) slope that provides some excavated material storage on the landslide, while attempting to minimize the instability during construction and maintain access to the lower landslide for work.

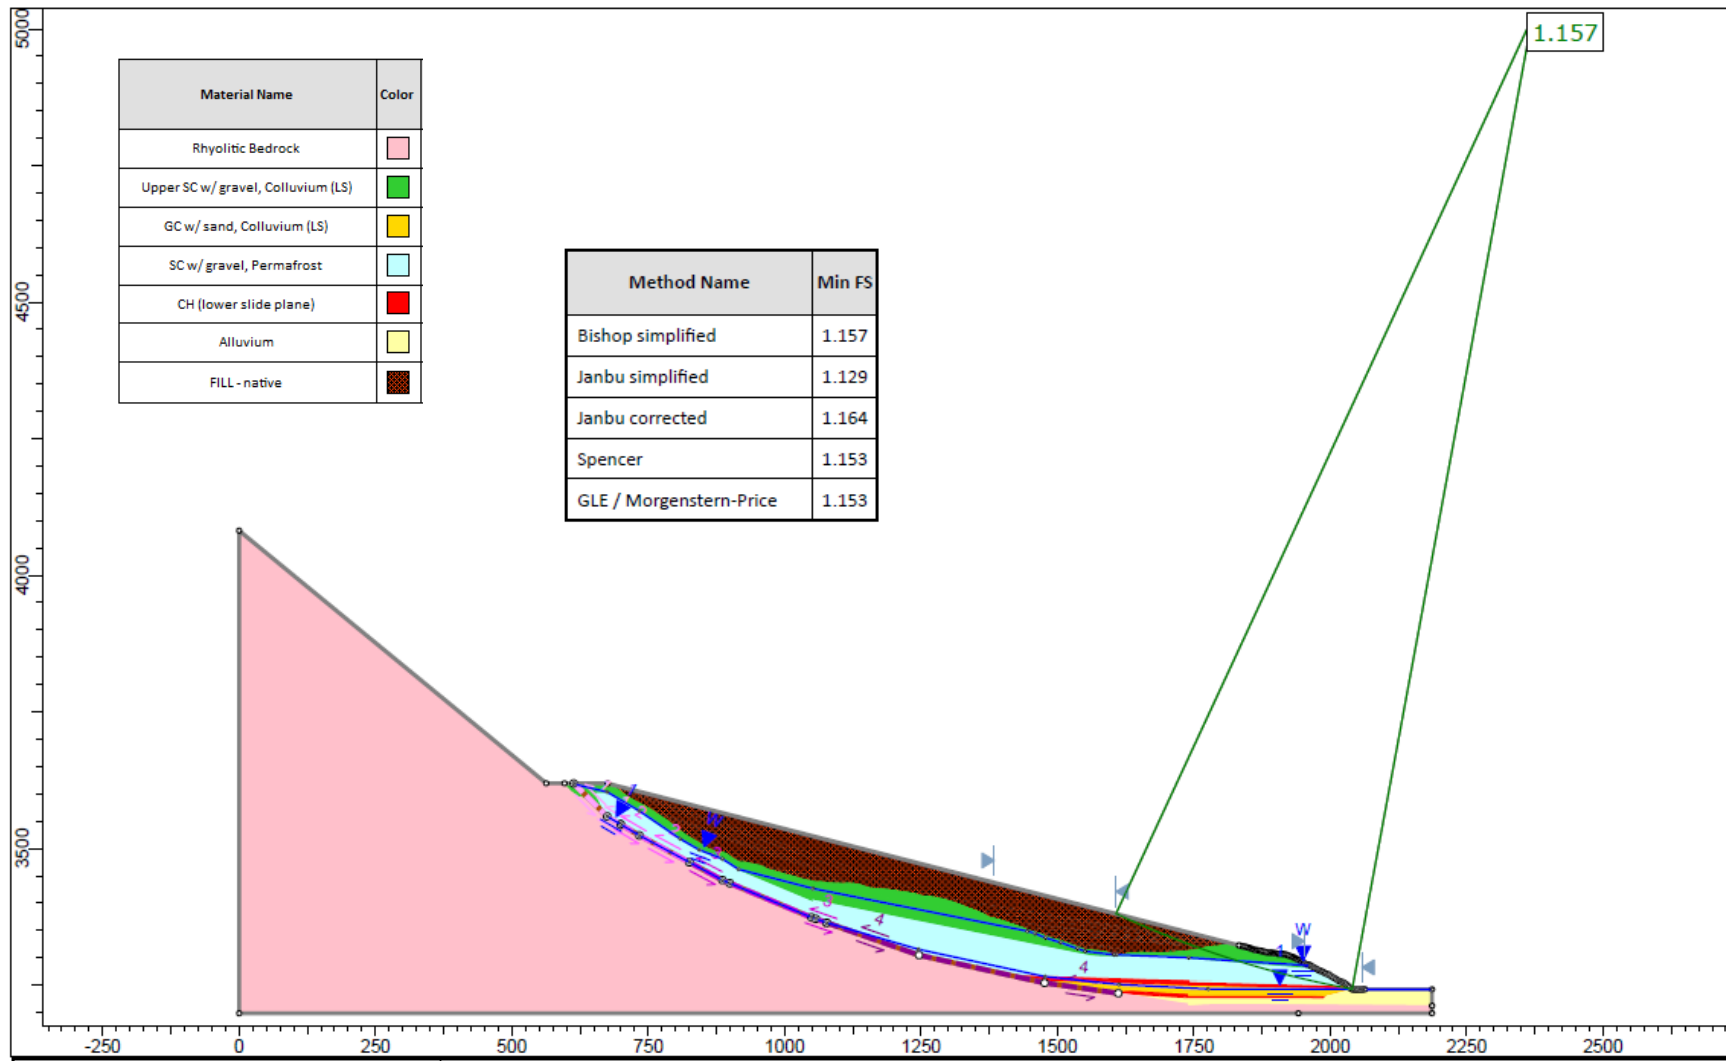
Figure 9. Slope stability analysis of the landslide toe area to determine if the load of the excavated material at the base of the slope will destabilize the lower landslide. The modeling suggests that it is globally, marginally stable.
