Geotechnical Report No. 11-20

**Pretty Rocks Landslide
2018-2019 Geotechnical Investigation and Conceptual
Design Alternatives Report**

**AK NPS DENA 10(45)
Denali National Park, Alaska
August 2020**

U.S. DEPARTMENT OF TRANSPORTATION
FEDERAL HIGHWAY ADMINISTRATION

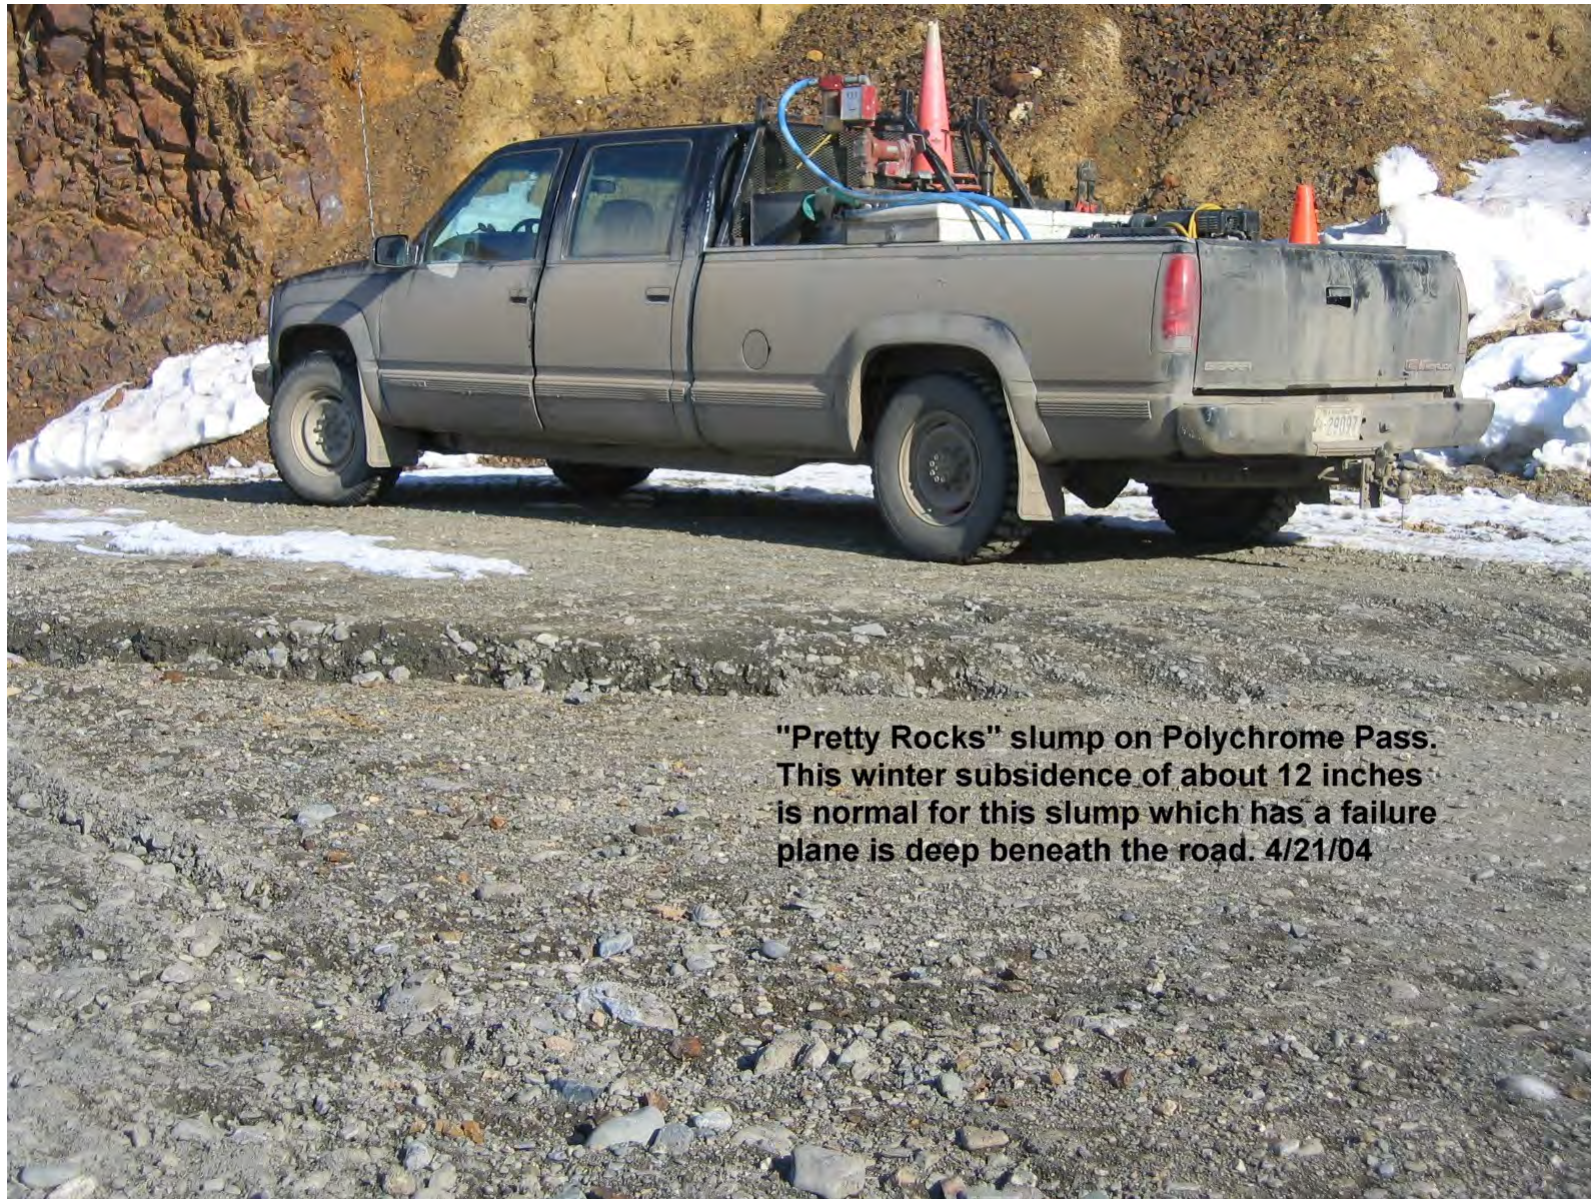
**"Pretty Rocks" slump on Polychrome Pass.
This winter subsidence of about 12 inches
is normal for this slump which has a failure
plane is deep beneath the road. 4/21/04**

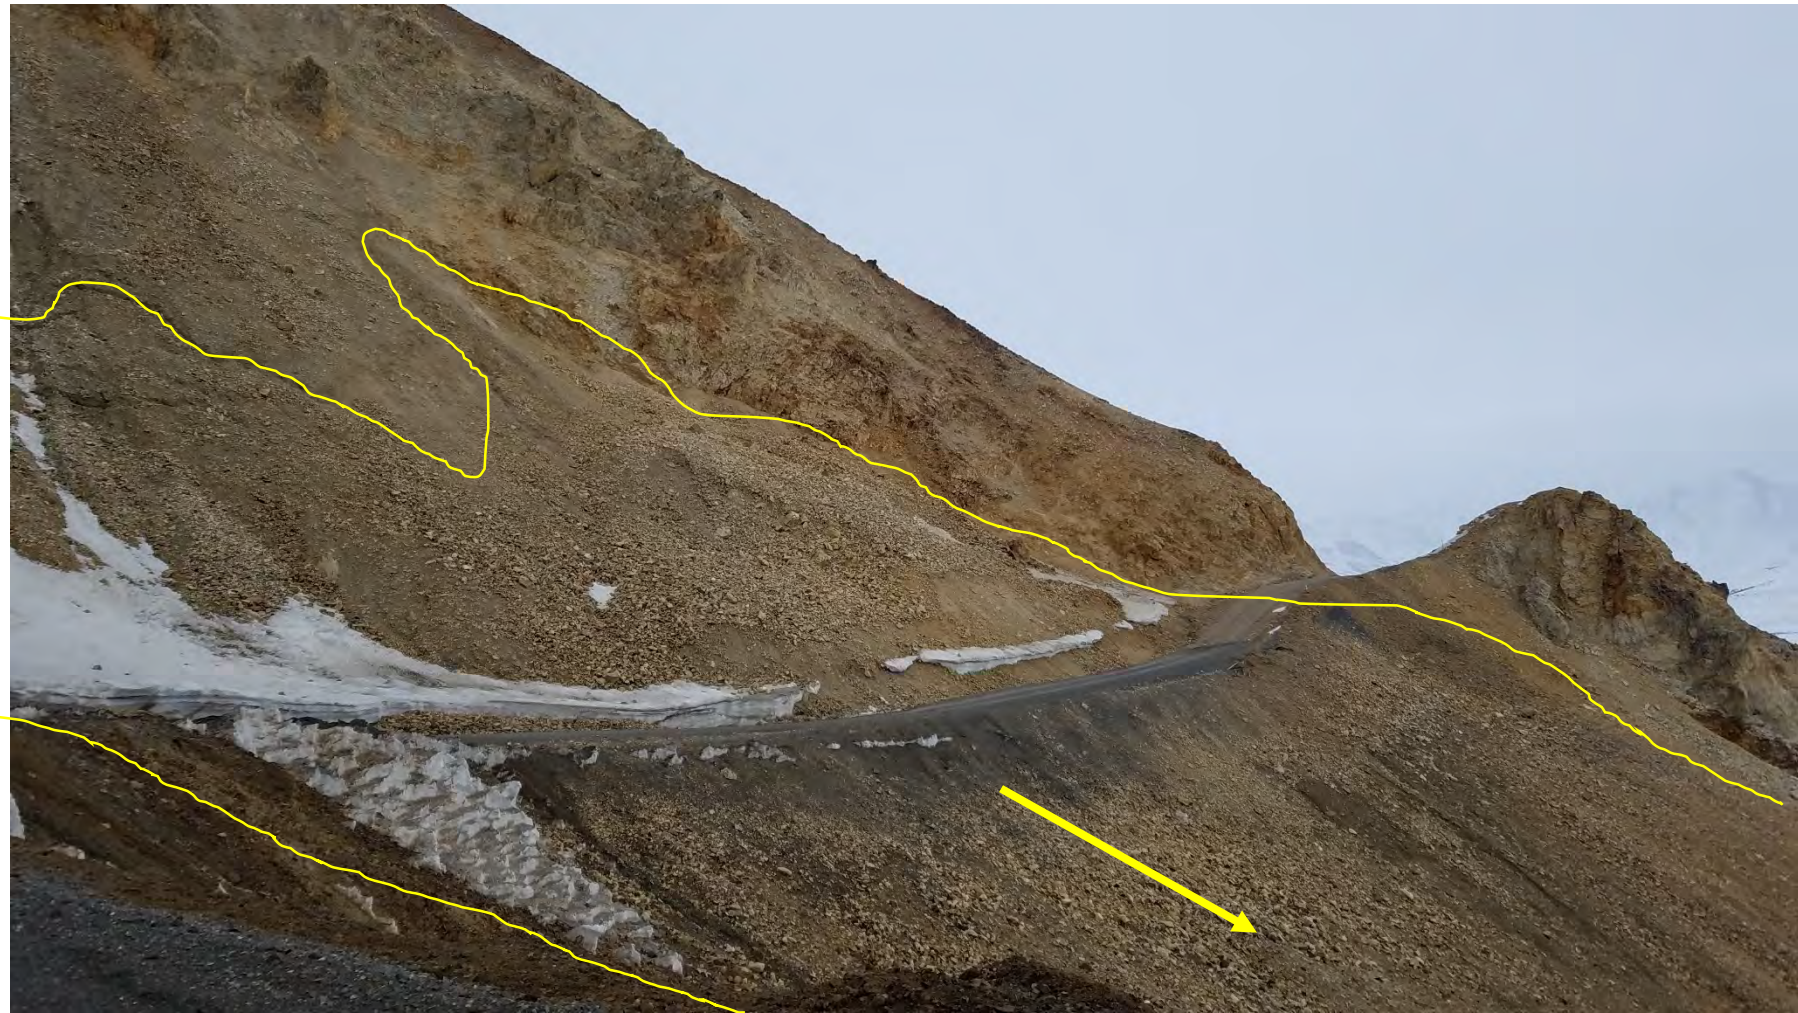
Figure 5. May 2018 Landslide headscarp and lateral scarp limits at road before Maintenance day labor project.

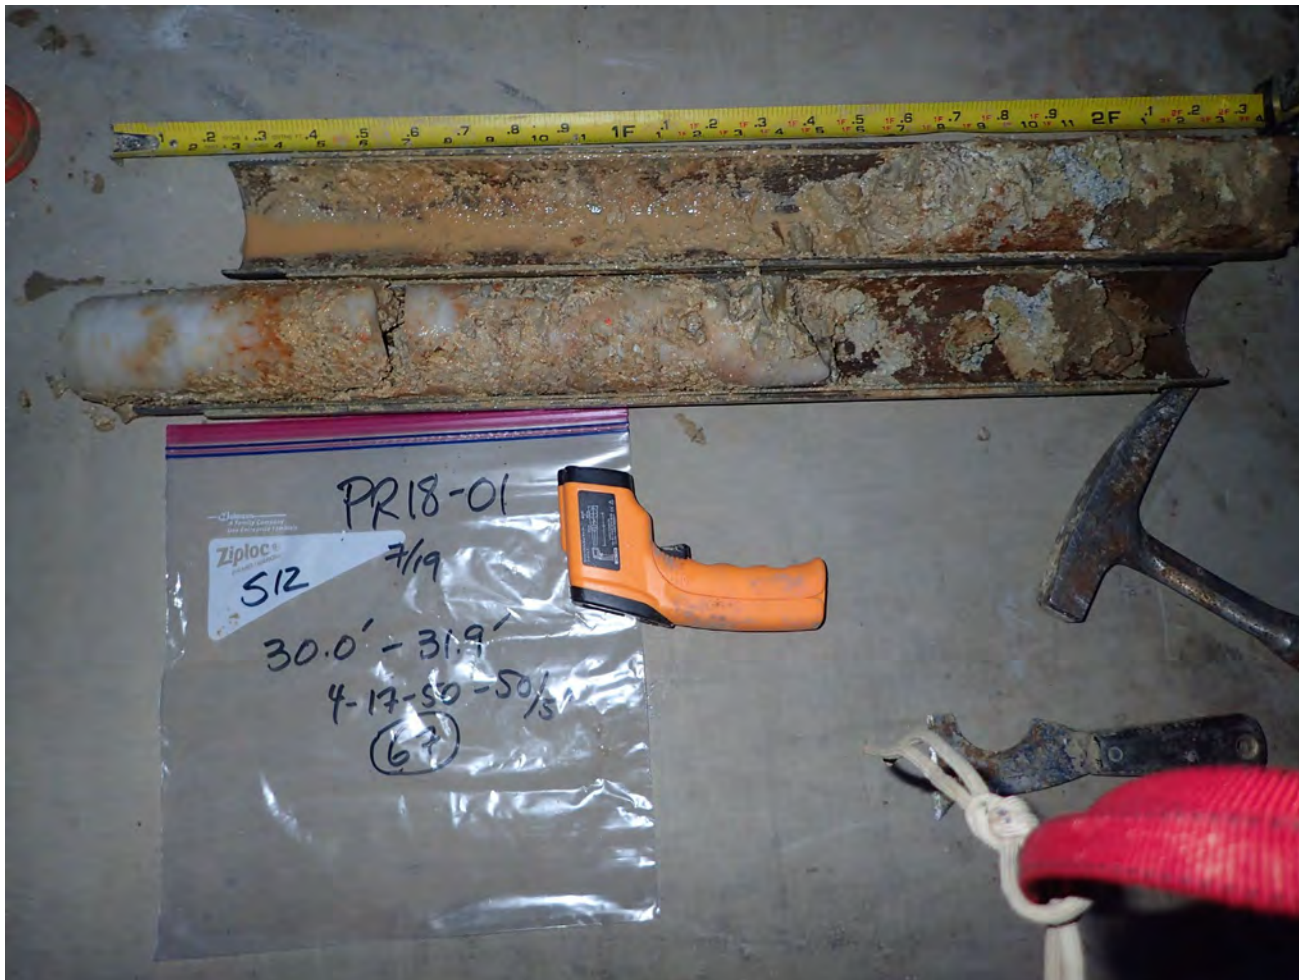
Figure 21. The drilling actions warmed up the “warm” permafrost, as can be seen in this thermistor string plot of PR19-02. Note that in the test boring, observations of massive to ice-rich soils was confined to 72.5 to 88.4 feet below the ground surface (BGS), but the thermistor readings indicate a restabilizing of the subsurface conditions following drilling, measuring freezing temperatures and potential ice rich soils between 36 and 88.4 feet bgs.

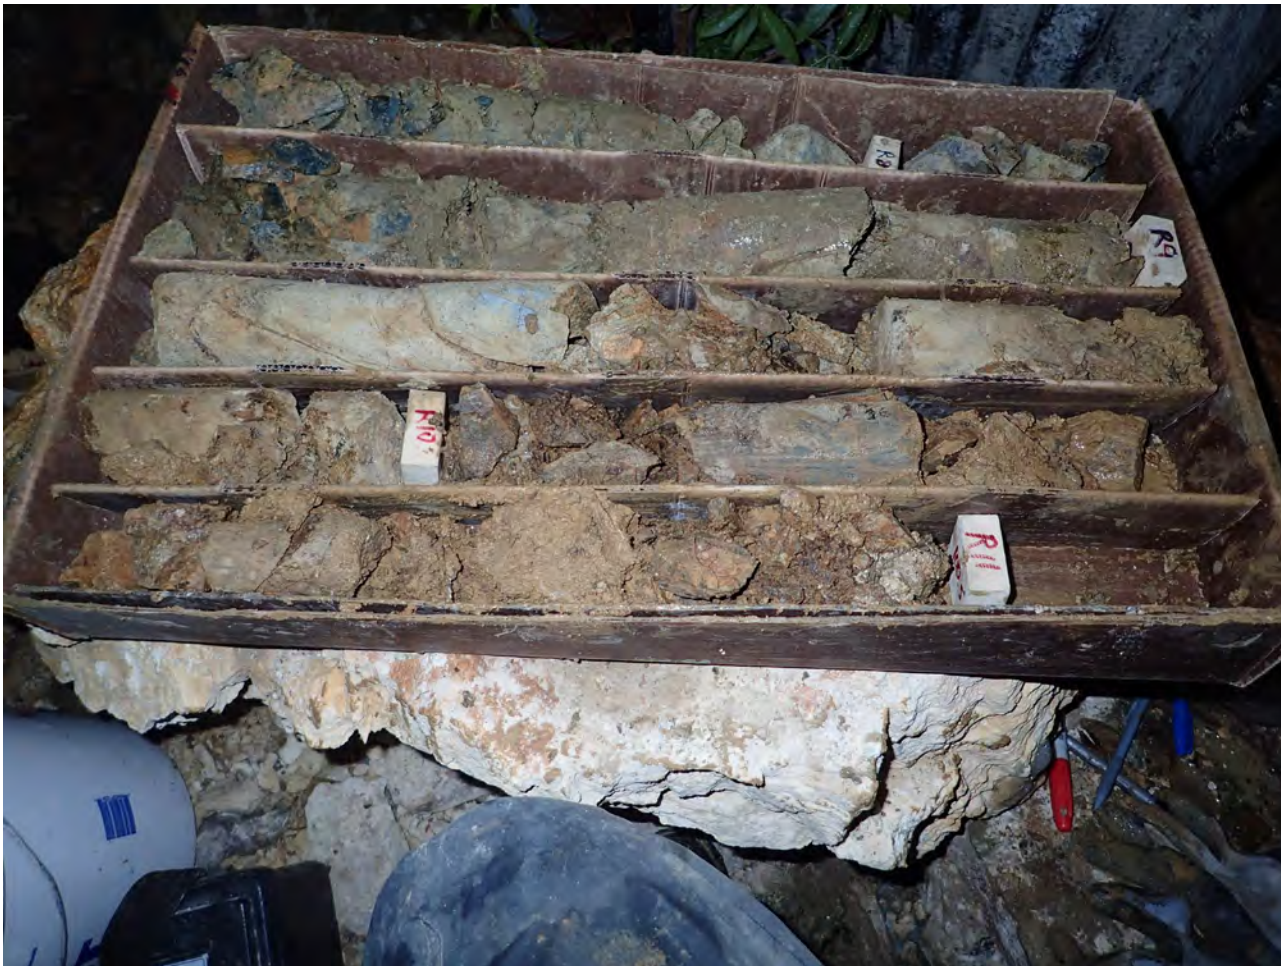
Figure 23. Test boring PR18-01 SAA reading and a photograph of the core recovered through the sharp failure plane at approximately 40.5 feet during drilling.

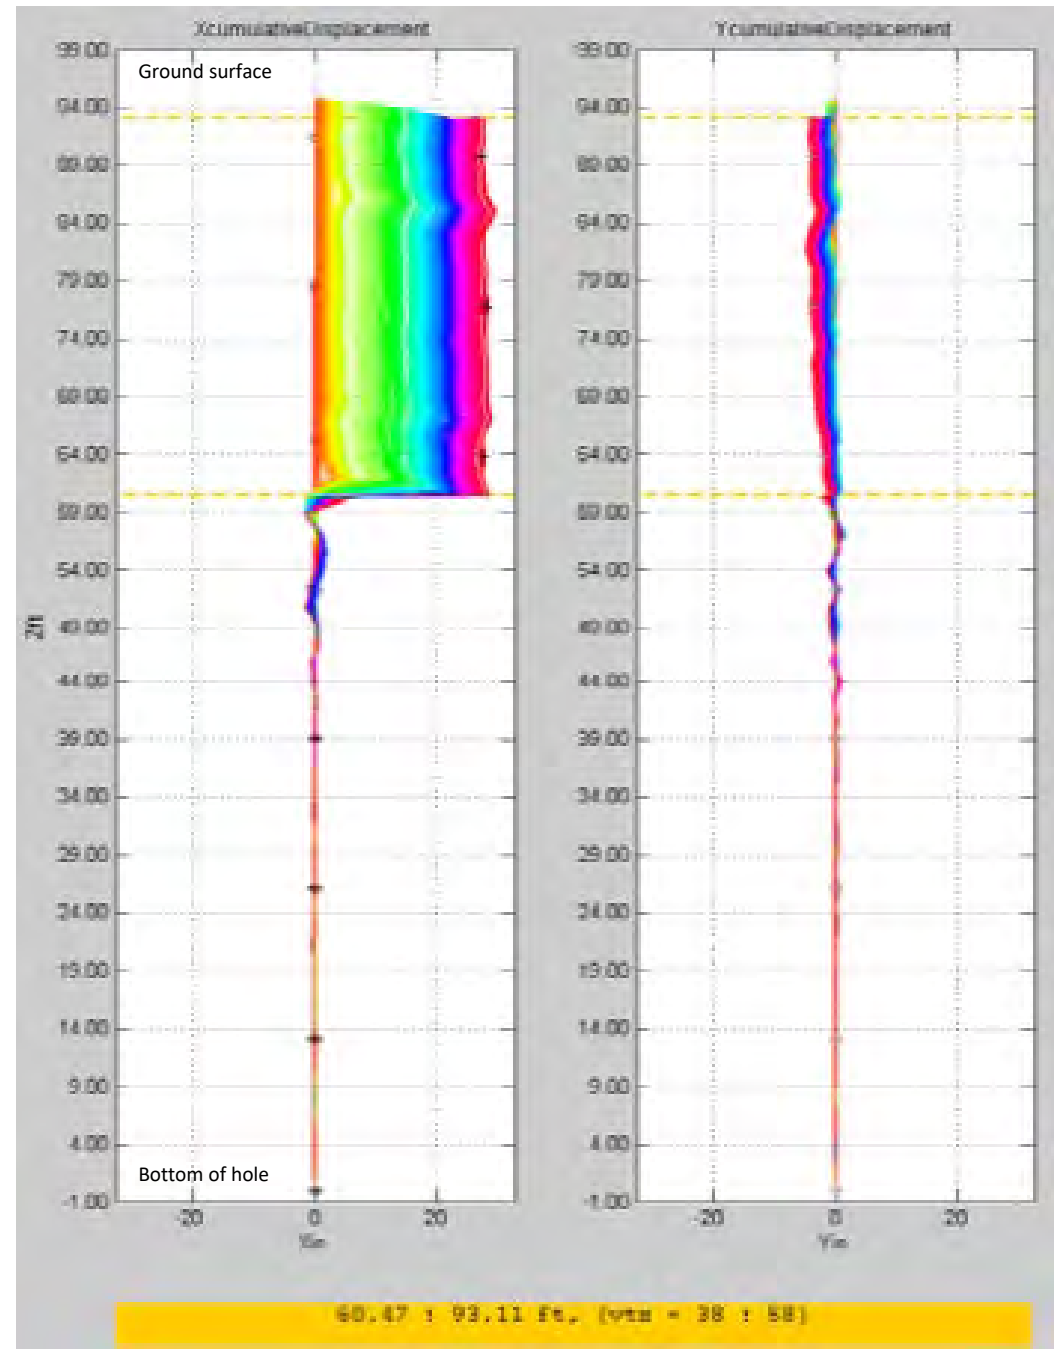
Figure 24. Slope inclinometer measurements in PR18-05 and a photograph of the core recovered that contains the abrupt failure plane and change in materials.

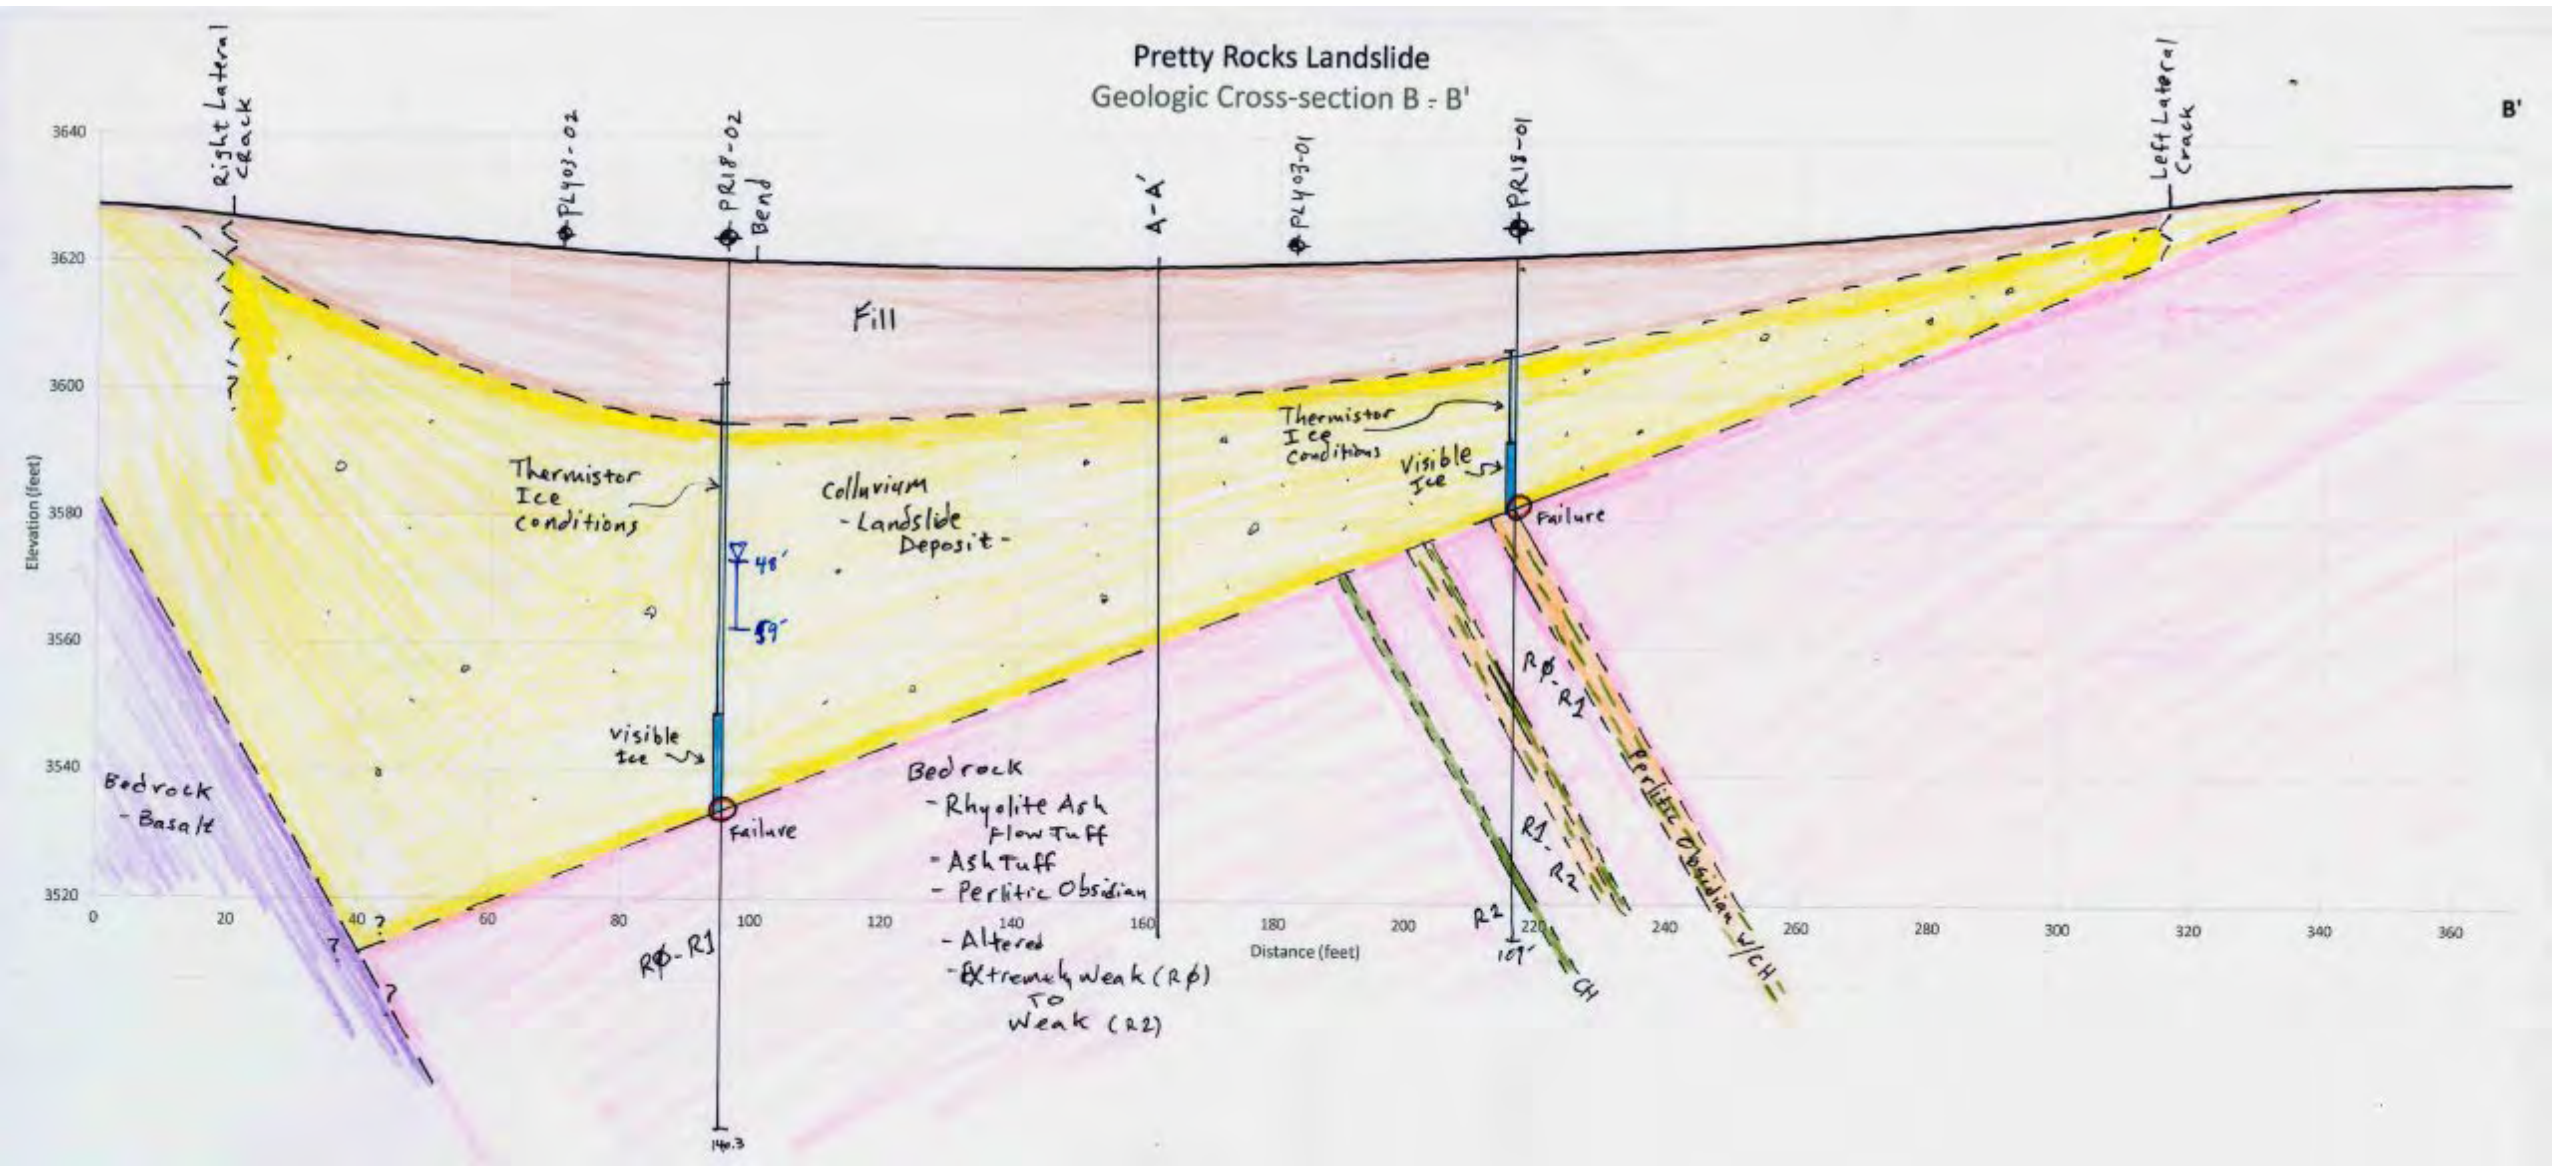
Figure 28. Preliminary slope stability model for geologic cross-section A to A' for the Pretty Rocks Landslide. A polyline was used to add the thin and sharp failure plane shear strength properties along the geologic contact between the underlying rhyolitic rock formation unit and the overlying ice rich landslide debris. Note that the preliminary landslide analysis does not select a possible failure down to the valley floor, as observed in the field.

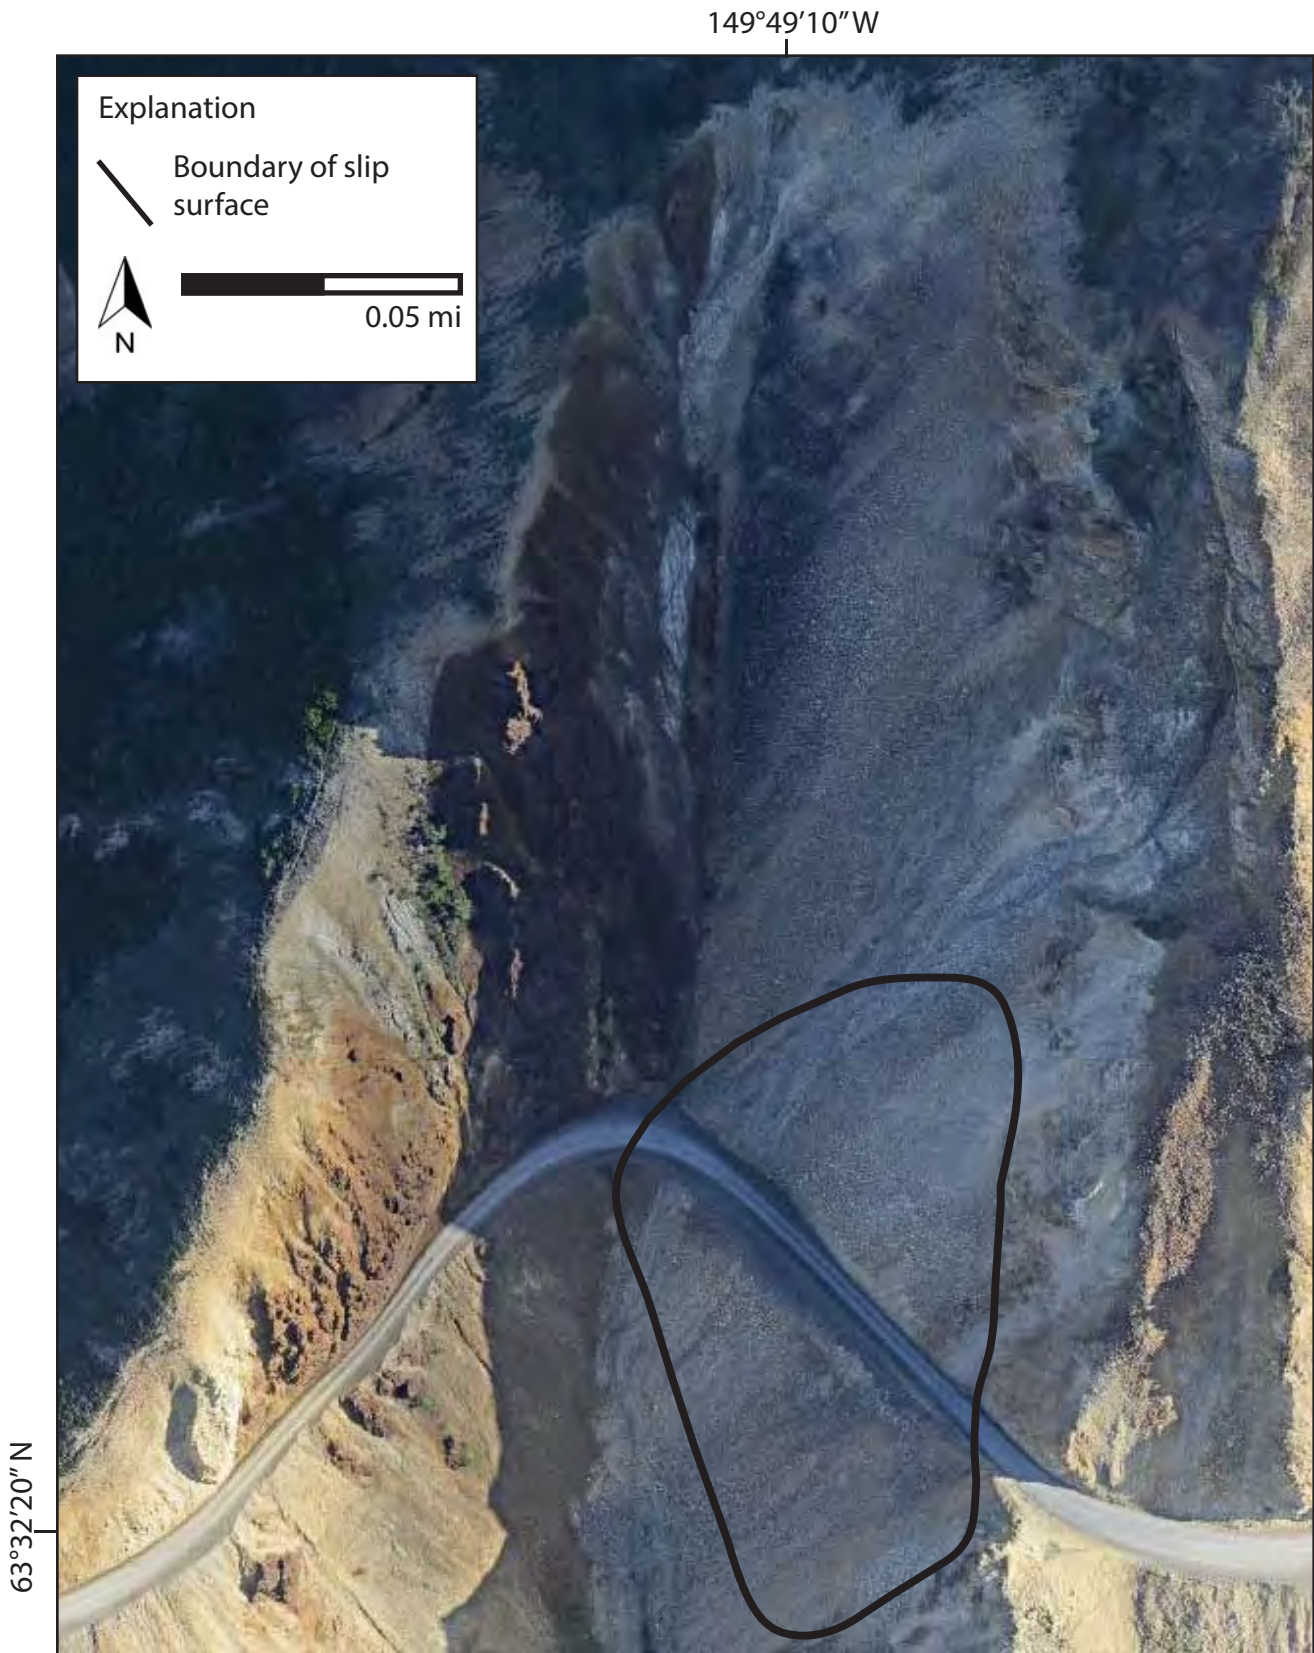
Figure 12: Proposed boundary of slip surface. Extent based on visual observations including cracks in talus slope, mapped locations of road cracks, crack dividing talus from rhyolitic bedrock to the east, and significant elevation changes seen in the Digital Elevation Model (Fig. 5).

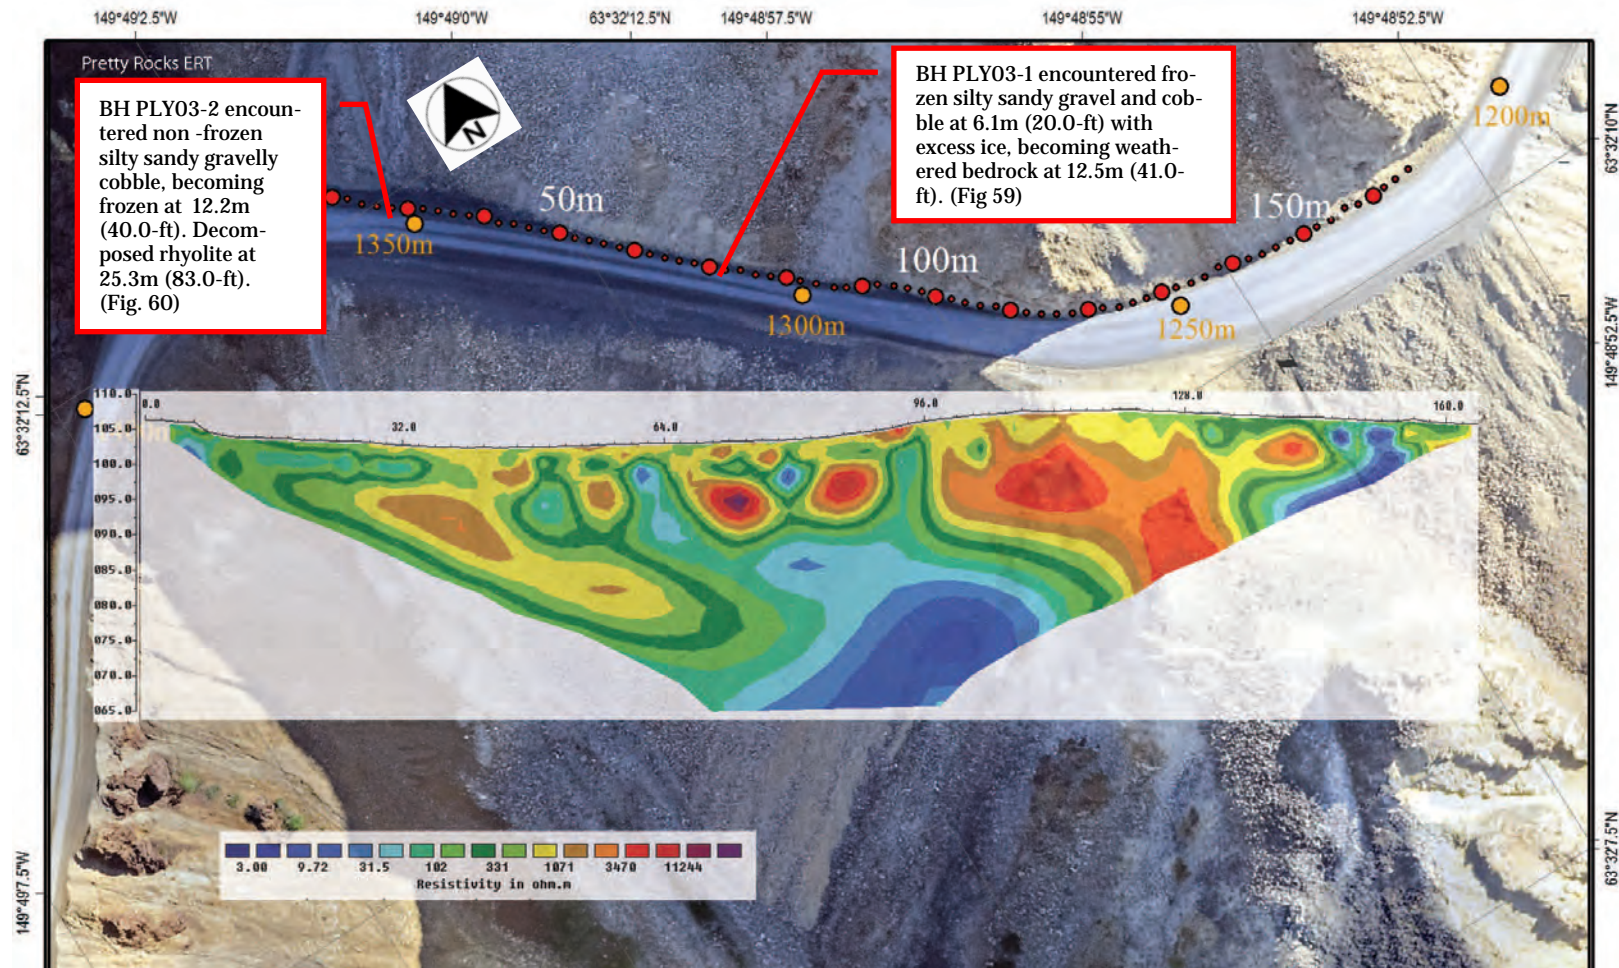
Figure 47. Pretty Rocks ERT. The total depth of the processed survey is approx. 40m (130 ft.). The electrical path is assumed to be parallel to the driven axis of the electrodes, which was at an angle nearly vertical in the road ditch. Very high ohm-m values are reported where the road passes through the rock cut at 120m to 130m, and this is interpreted as the natural resistivity of the felsic (rhyolite) strata in the dry condition. At either side of the cut in the debris slope, very low ohm-m values are reported, and we interpret this as moisture/water in the fine grained material of the debris, indicating a lubricated slip surface of the slope failure. The high ohm-m anomalies at 70m and 90m, and at 8m to 10m depth are inferred to be segregation ice that was logged in the two boreholes drilled in the area. The ERT line is oblique to the strike of the felsic strata, therefore we see an oblique cross-section of the slope and debris, and it appears the frozen zone is of limited thickness with a bottom of permafrost at approx. 15m (49 ft.). The ohm-m values are moderate from 20m to 60m, and this is interpreted as drier or moderate ice conditions.

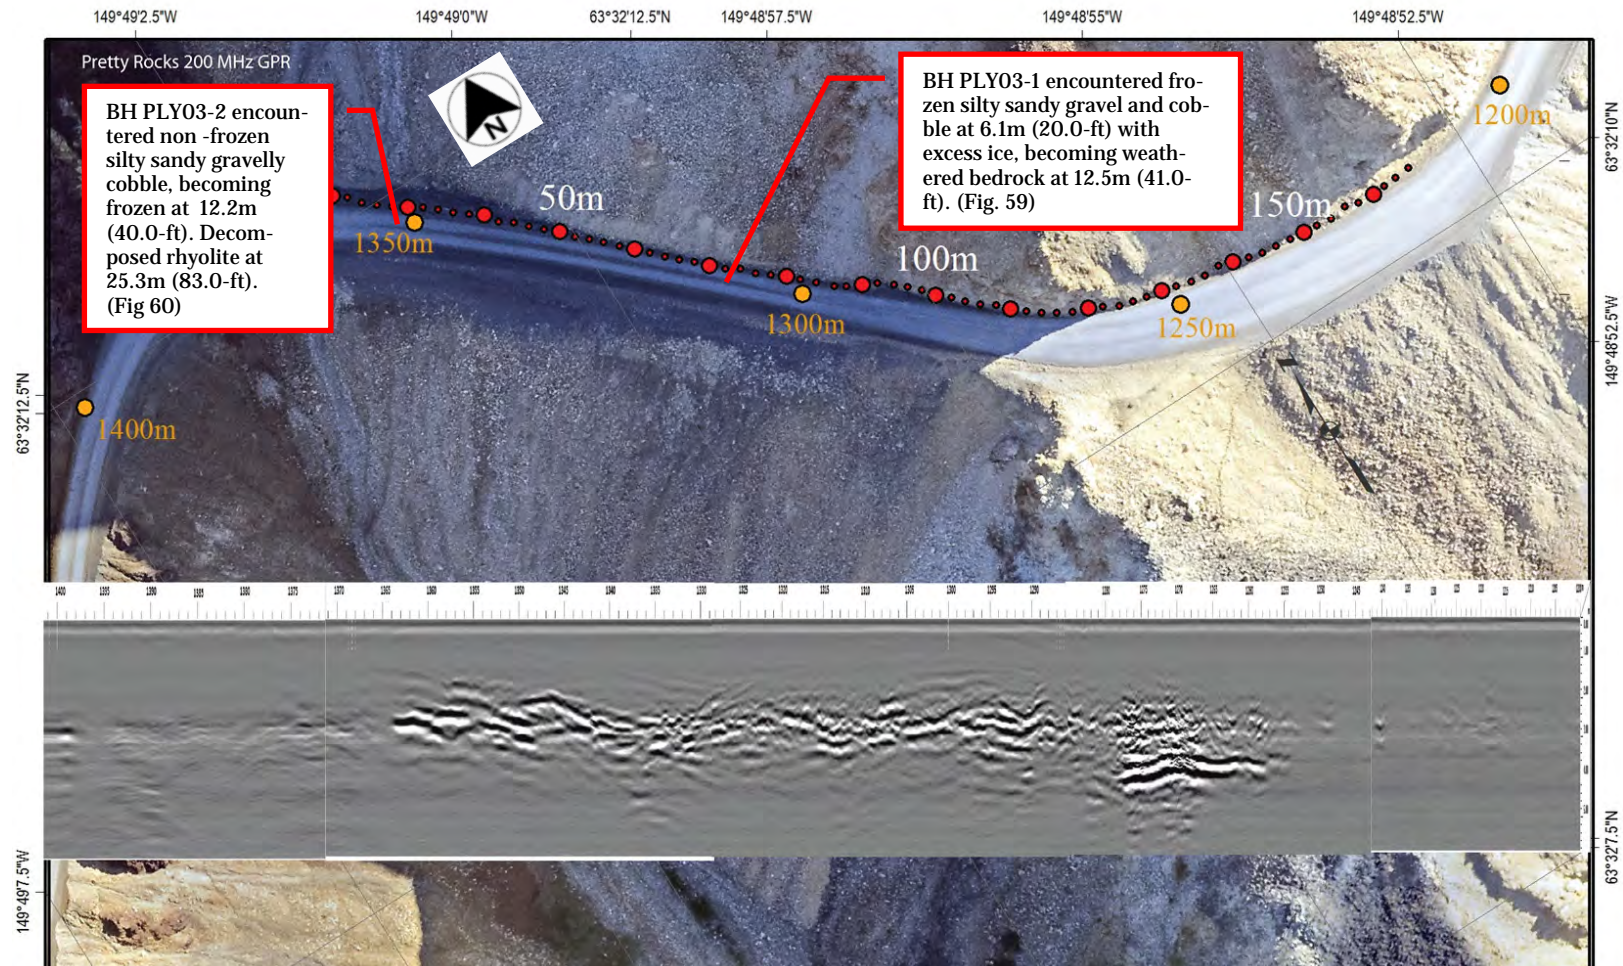
Figure 48. Pretty Rocks GPR. This survey was conducted with the 200MHz antenna system. Very distinctive chaotic reflected bands are imaged starting at approx. 35m continuing up to the rock cut at 120m, here they are approximately at 3.0m (9.8-ft) depth with a thickness of 1.5m to 2.0m (4.9-ft to 6.6-ft). At the road cut they increase in depth, down to 4.5m (14.8-ft), and increase in brightness through the cut to 140m. The primary polarity signature of the reflections is black to white to black (-, +, -), which indicates a lower dielectric material overlying a much higher dielectric material, for example thawed material over ground ice. The boreholes drilled at this location verify that ice exists through this area, therefore we interpret the ice to be multi-generational segregation ice. The segregated ice is created in the intermediate zone between the active layer and the permafrost table, moving downward due to the slope movement, and becoming captured (aggraded) in the permafrost table, out of the reach of subsequent summer thaw. We infer the lower reflector of this icy band at 4.5m to 5.0m (14.8-ft to 16.4-ft) represents the bottom of the permafrost, and this coincides with the ERT data from Figure 47. The much deeper reflector in the road cut at 120m to 130m is inferred to be permafrost protected from the movement of the slope and thawing from the inferred basal water of the slip plane.
