Accelerating Roundabout Implementation in the United States - Volume I of VII

Evaluation of Rectangular Rapid-Flashing Beacons (RRFB) at Multilane Roundabouts

PUBLICATION NO. FHWA-SA-15-069

SEPTEMBER 2015

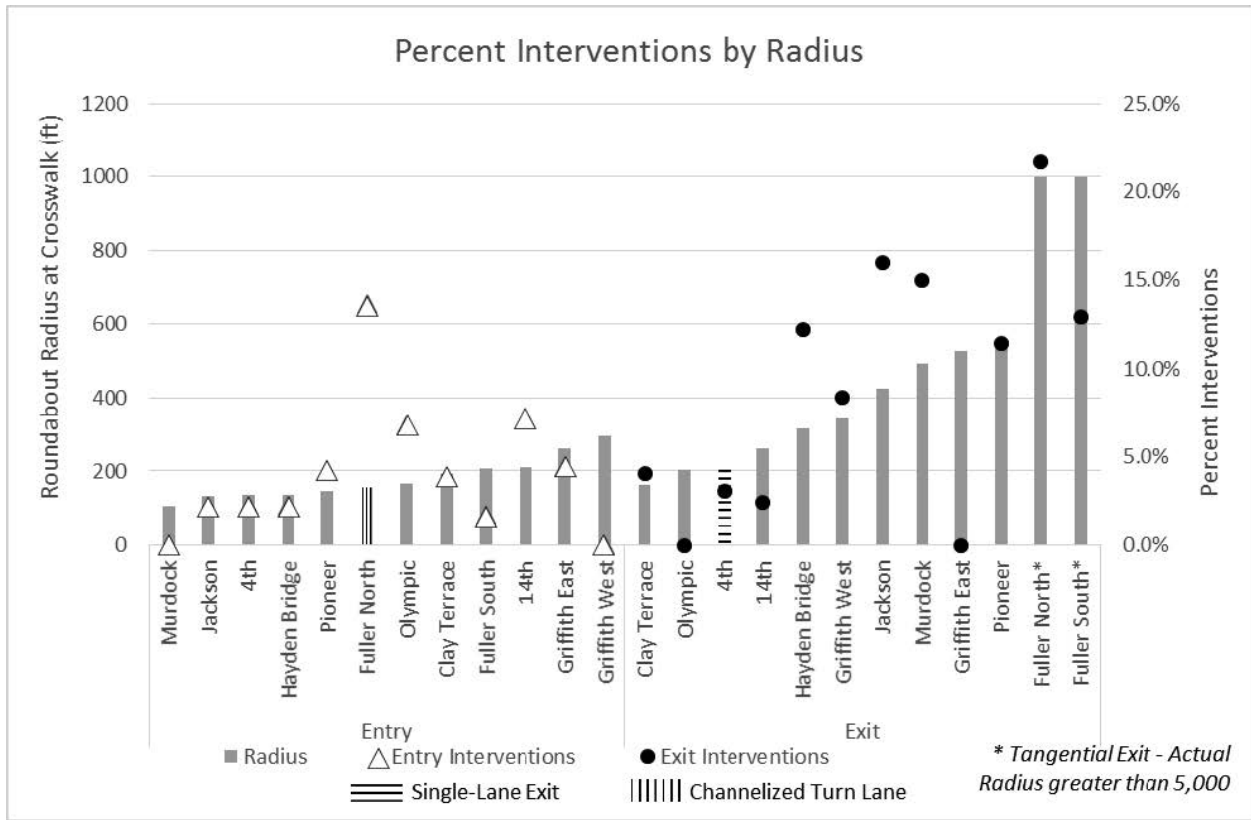
Figure 2. Chart. Percent of interventions as a function of radius of curvature at crosswalk.

Overall, it can be concluded from figure 2 that entry legs have generally smaller radii (tighter curves) than exit legs. There further appears to be a correlation between increasing percent interventions and increasing radii for both entry and exit. The highest percent interventions occurred at the very large exit radii, and even for entry legs, sites with larger radii appear to have higher percent interventions. Figure 3 shows the same data for degree of curvature with reversed trends as expected. A larger degree of curvature is evident for entry legs than exit legs. For each category, a larger degree of curvature appears to be correlated with a lower rate of interventions.

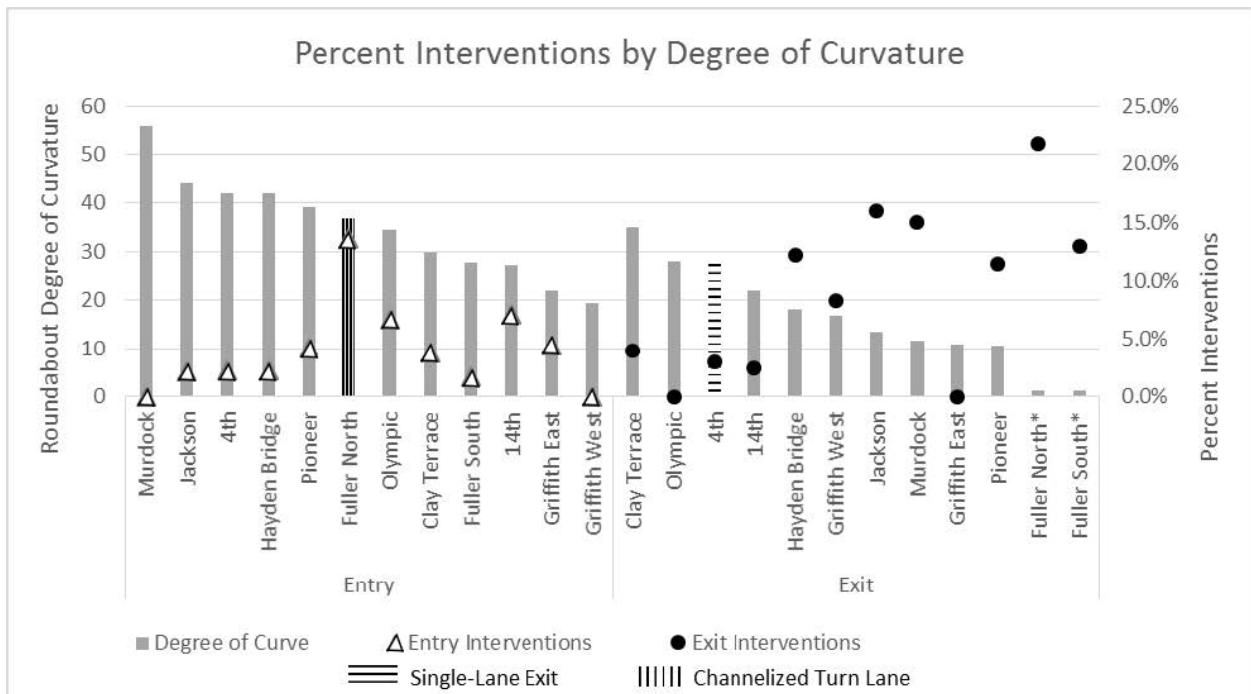
Figure 3. Chart. Percent of interventions as a function of degree of curvature at crosswalk.

A key exception to this trend appears to be the Davidson, North Carolina, roundabout. The site has a relatively large radius exit of more than 152 m (500 ft) at the Griffith East exit, which had zero interventions. Closer evaluation of the site showed relatively low vehicle speeds at that exit, despite the high radius, likely because drivers using this exit transition into a small town and pedestrian-focused environment, and because a second roundabout lies a few hundred feet downstream. In addition, drivers approaching from the west have a good view of the entire roundabout and the crosswalks (and RRFBs) on the east leg. The observation was similar for the west entry at this same roundabout, which also had zero interventions, despite having the largest entry radius studied. This entry is along the same travel path at the east exit. Interestingly, the reverse direction (east entry and west exit) had more interventions despite having smaller radii. Driver perception and expectation may again be a contributing factor here, with drivers leaving the small town community (and the expectation of pedestrian traffic), while accelerating toward a freeway interchange just west of the studied roundabout. This suggests that while geometric characteristics appear to show an effect, local context, driver culture, and visibility of the crossing appear to be equally (if not more) important for pedestrian safety and accessibility of a site.

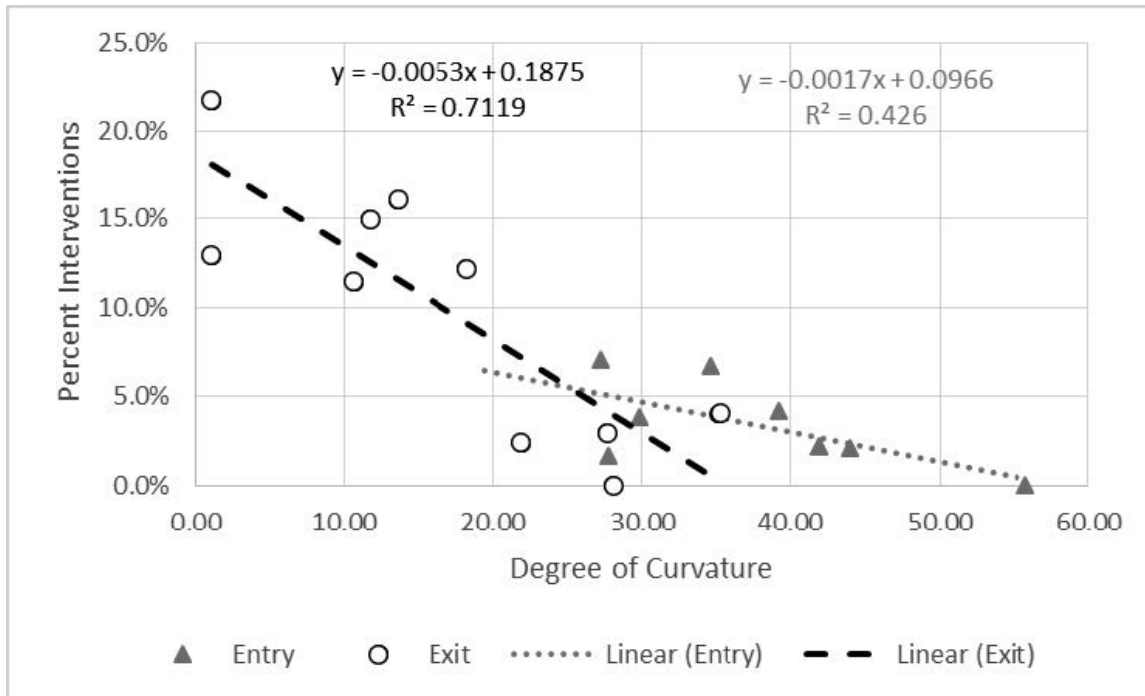
Figure 5. Graph. Percent intervention as a function of degree of curvature (Davidson, NC, site removed).

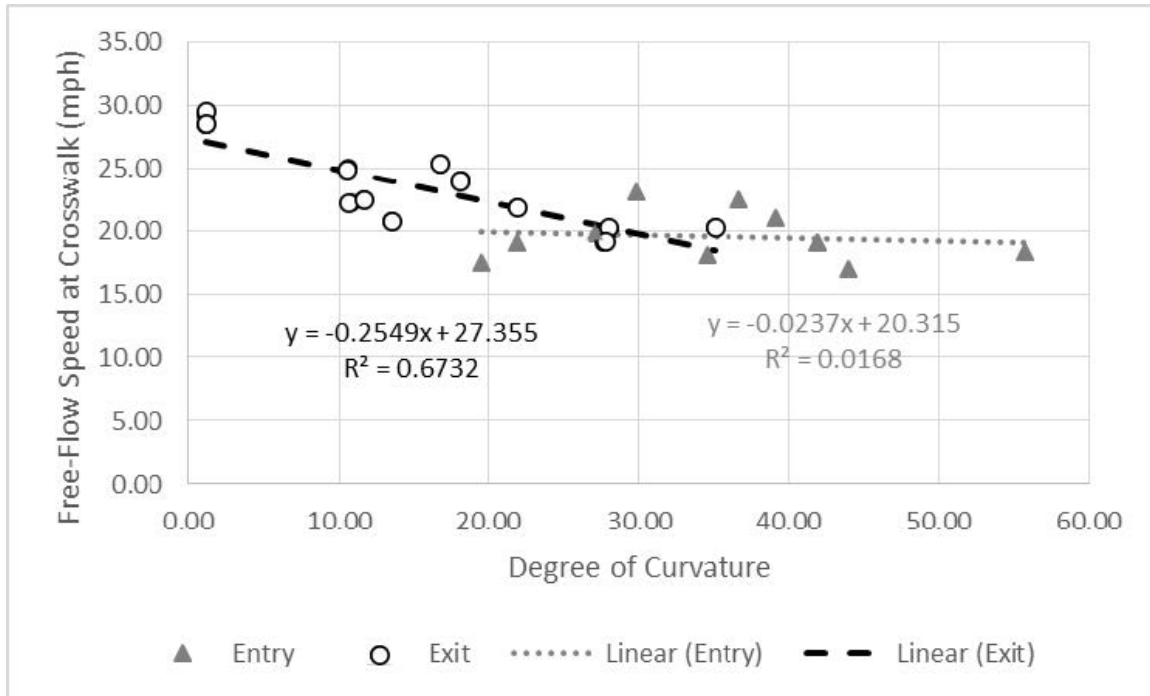
Figure 6 shows the field-measured free-flow speed at the crosswalk as a function of the degree of curvature at the crosswalk. The free-flow speed was determined from a sample of 30 free-flowing vehicles without pedestrians present. No circulating speeds were measured. The degree of curvature was estimated from the radius, which was measured from design drawings or aerial photographs. Figure 6 distinguishes entry leg (gray triangles) and exit leg (black circles) events.

Figure 6. Graph. Free-flow speed at crosswalk as a function of degree of curvature.

Figure 6 exhibits a decrease in free-flow speed as a function of degree of curvature at the exit crosswalks, but no relationship for the entry crosswalks was studied. Note that a larger degree of curvature denotes a smaller radius. The exit degree of curvature tends to be smaller than entry (indicating a larger radius), and the exit free-flow speeds tend to be higher than the speeds at entry. The slope and R-squared of 0.6732 for the exit leg suggests a correlation of free-flow speed to the degree of curvature at the exit leg. For the entry, the relationship is less pronounced, with speeds being relatively constant across the sites, suggesting that drivers may also anticipate the possibility of yielding to conflicting traffic and the need to negotiate geometry within the roundabout.

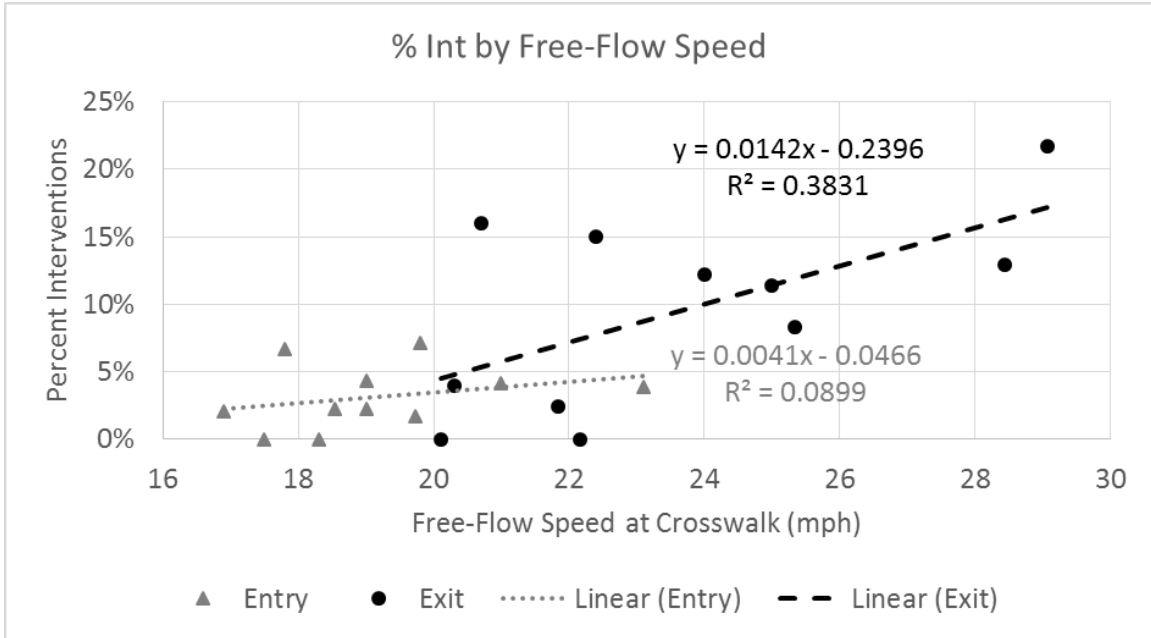
Figure 8 shows the percentage of interventions as a function of free-flow speed measured at the crosswalk (sample of 30 free-flowing vehicles without pedestrian presence). The chart shows entry legs in gray triangles and exit legs in black circles. The channelized turn lane at entry and the single-lane exit were excluded from this analysis.

Figure 8. Graph. Percent intervention as a function of free flow speed at crosswalk.

According to the data presented in figure 8, there is a positive correlation between percent intervention and speed for exits, and suggests a weak positive relationship for entries. Exit speeds and percent interventions are generally higher than entry speeds and percent interventions. Figure 8 also shows that the effect of speed (slope of the line) on percent intervention is more than three times as large for exits, suggesting that exit interventions are more sensitive to speed than entry interventions. The R-squared values for entry and exit are 0.0899 and 0.3831, respectively, indicating a stronger correlation at exit than entry.

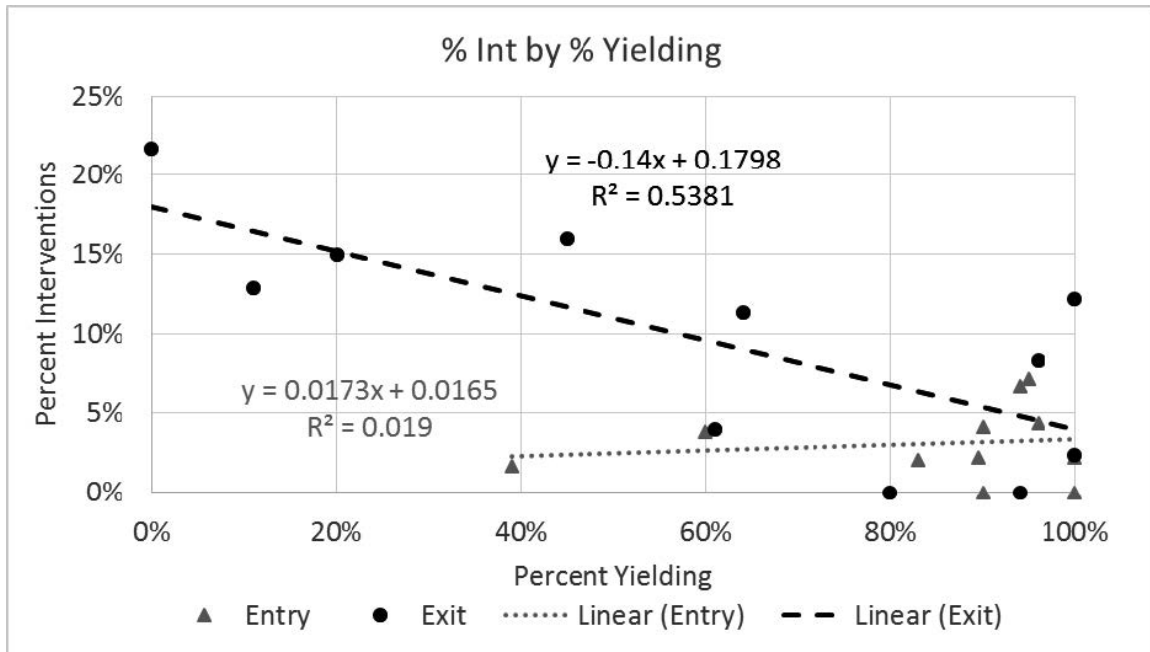
Figure 9. Graph. Relationship between percent interventions and percent yielding.

Figure 9 suggests an inverse correlation between percent interventions and yielding for exits. The R-squared value is 0.5381, showing a strong statistical correlation between the two values, with lower interventions rates observed at sites where drivers' yielding rate is higher.

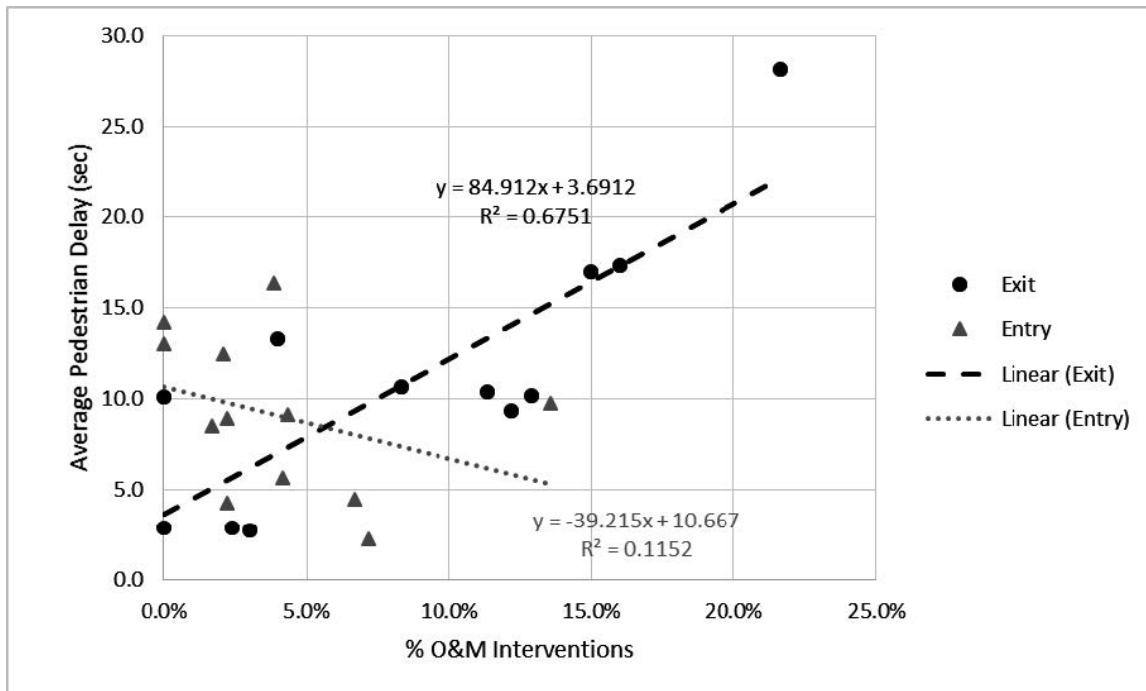
Figure 11 plots the relationship between interventions and delay for the various approaches. The relationship is very strong for exit legs (black dashed line) with an R-squared value of 0.6751. The relationship indicates increasing delay with increasing percent intervention; the exits with the highest rates of interventions were also those exit legs with the shortest delays. For entry legs, the trend is the opposite; exits with high percent interventions tended to also have the shortest delays, but that trend is weak, with an R-squared value of 0.1152. The differing trends show that blind participants experienced more challenges at exit legs compared to entry legs.

Figure 11. Graph. Percent interventions and delay correlation.

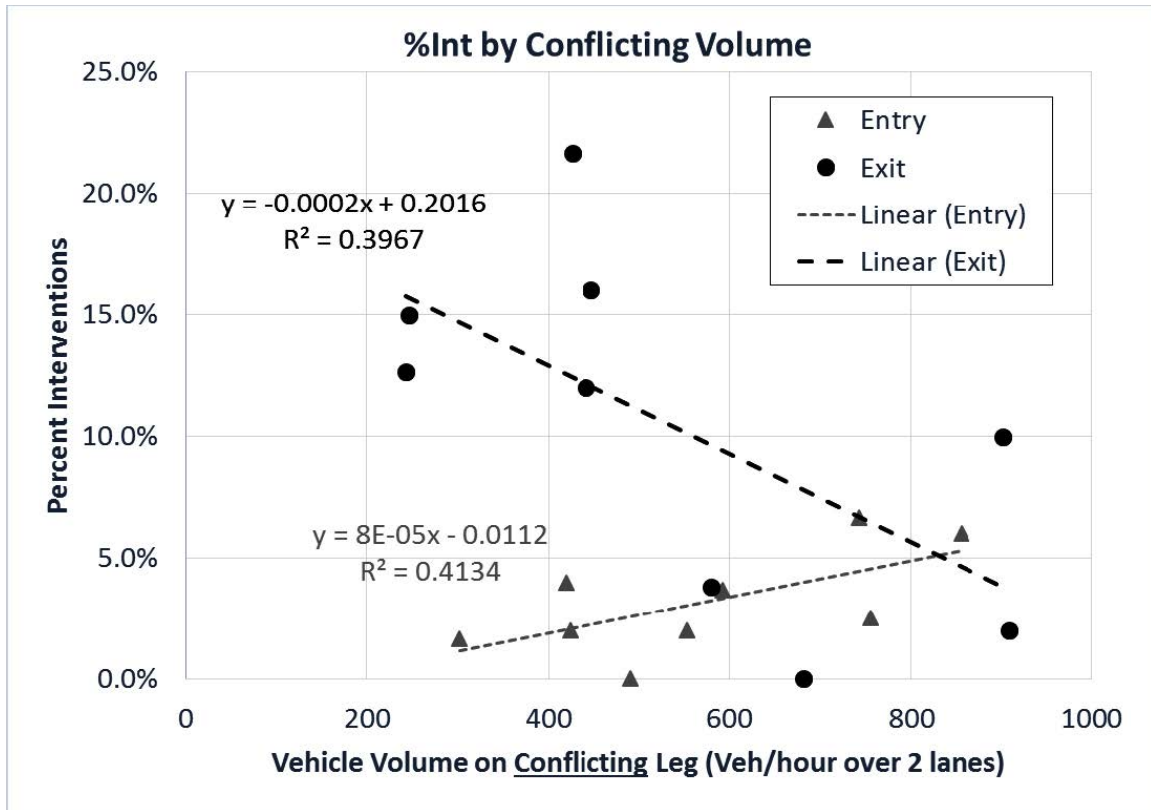
This section evaluates percent interventions as a function of traffic volume on the conflicting leg (lanes closest to the participant), as shown in figure 12. The graphs distinguish entry legs (gray triangles) and exit legs (black circles), and include a linear trend line fit to the data. The single-lane exit and channelized turn lane are excluded from this analysis. The Davidson site is also excluded, as no traffic volume data were available.

Figure 12. Graph. Percent intervention as a function of vehicle volume on conflicting leg.

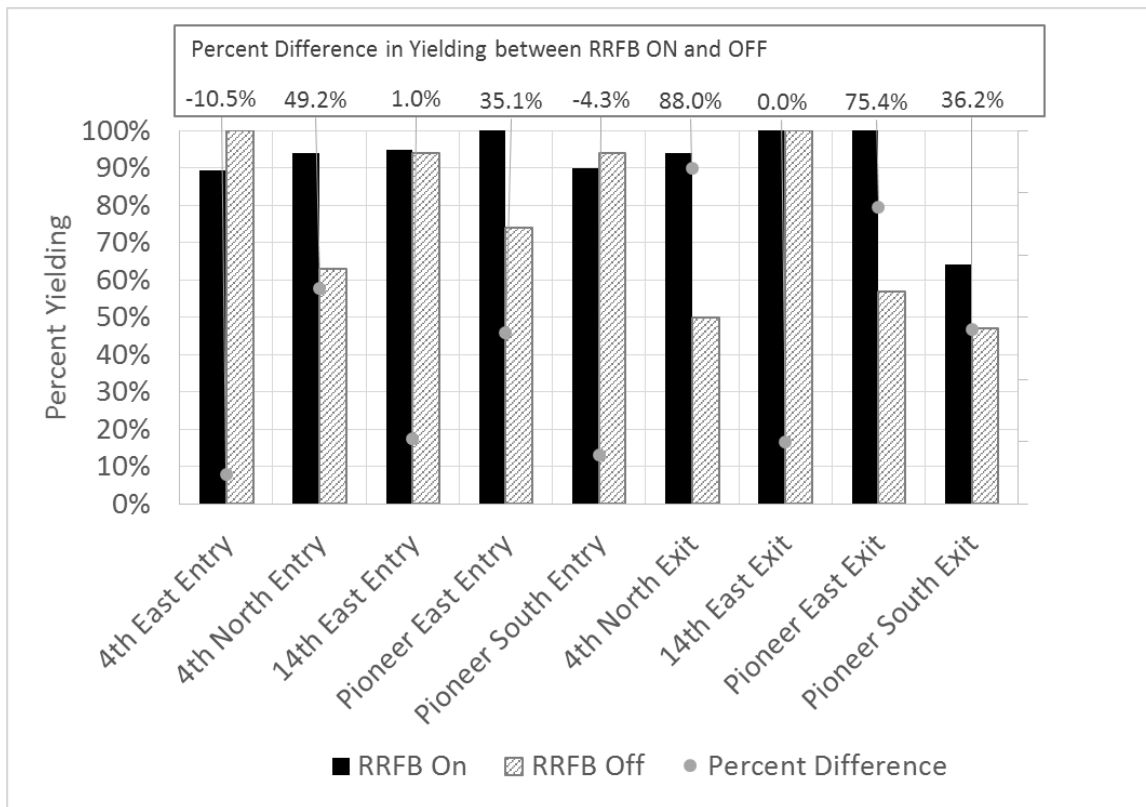
The RRFB was always activated in trials measuring percent intervention. However, at nine approaches, the team performed the naturalistic yielding study both with and without the RRFB devices activated to compare yielding behavior between those conditions. The results are shown in figure 13.

Figure 13. Chart. Effect of RRFB activation on yielding.

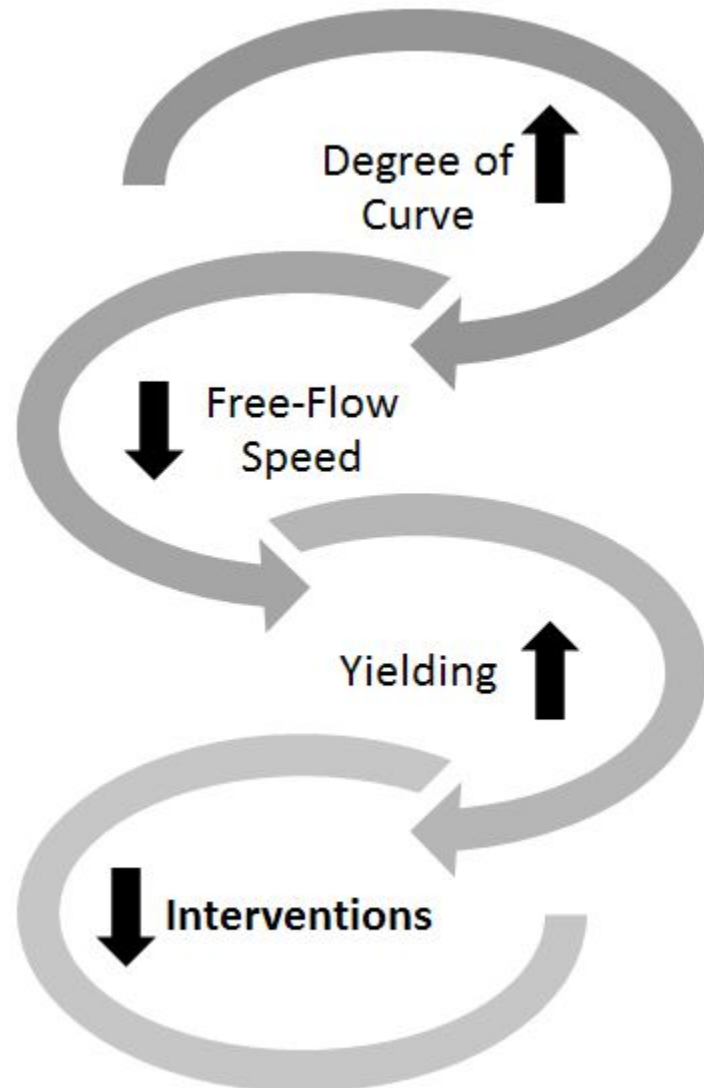
While none of the trends above should be interpreted as being a direct causal factor, the correlations paint a useful picture of the types of variables associated with increased percent interventions at the studied multilane roundabout approaches as shown in figure 14.

Figure 14. Diagram. Conceptual relationship between interventions and other factors.

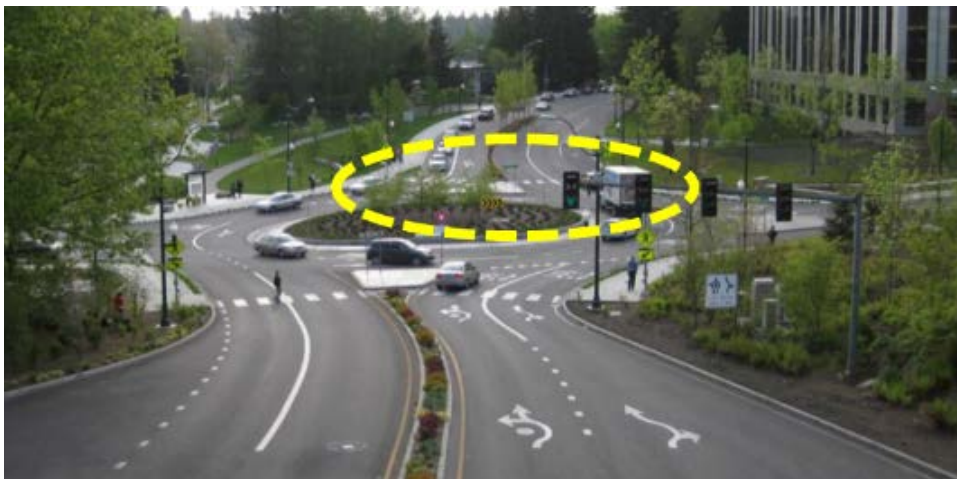
Figure 19: Photo. Phase I data collection site, Jefferson St. at 14th Ave. SE, Olympia WA.

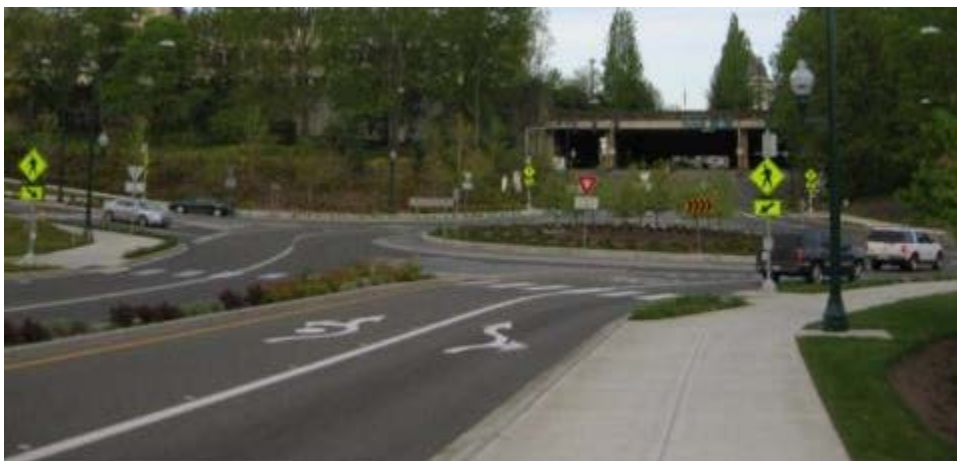
Figure 20. Photo. 14th Ave SE, east leg two-lane entry, two-lane exit, Olympia WA.

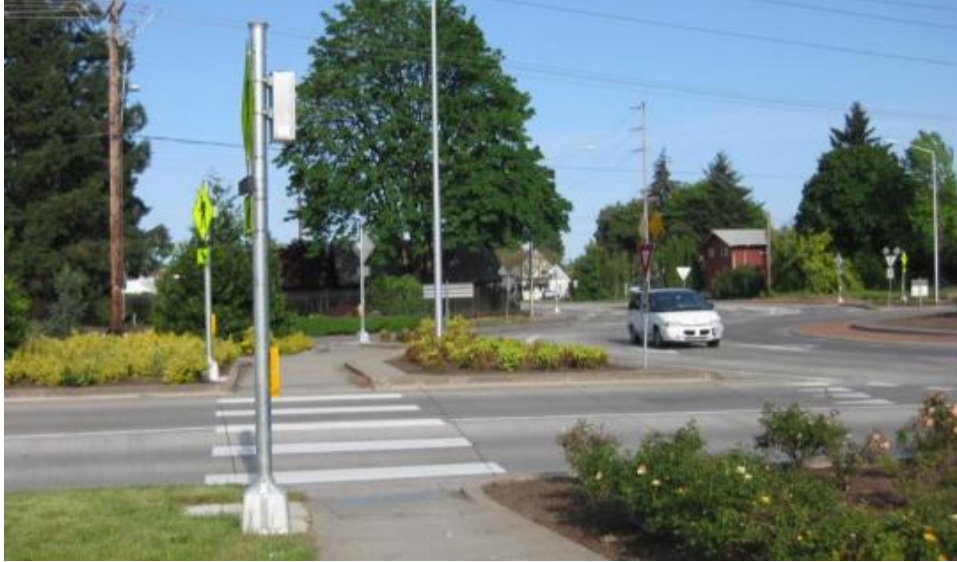
Figure 22. Photo. Pioneer Pkwy. south leg two-lane entry, two-lane exit, Springfield, OR.

The site had a high rate of exit-leg interventions at the south exit, which featured an upstream channelized right-turn lane to accommodate the eastbound to southbound right-turning movement. The team noted that a fairly large portion of interventions seemed to have been associated with right-turning vehicles from the west approach. Being faced with heavy conflicting flows, it appears that those upstream right-turn drivers would accelerate rapidly into the few available gaps in the circulating lane, with drivers' heads rotated to the left towards the conflicting traffic stream. The Pioneer Pkwy. exit-leg crosswalk is located relatively close to the

circulating lane, and driver reaction time at that exit leg is very short because they accelerate rapidly and are facing away from the crosswalk. This may at least partially explain the low yielding rate observed at the south exit. In addition, the rapid acceleration from a stopped position within a short distance also appeared to make it very difficult for blind participants to react to these vehicles. The roundabout geometry and landscaping appeared to contribute to some sight obstruction between the right-turning driver and the waiting pedestrian.

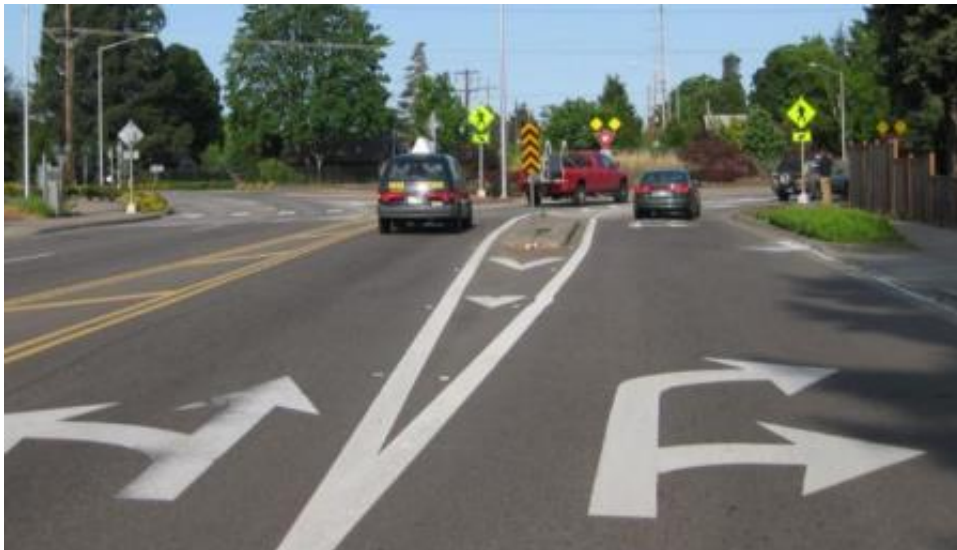
Figure 23. Photo. Hayden Bridge Rd. east leg two-lane entry, two-lane exit, Springfield, OR.

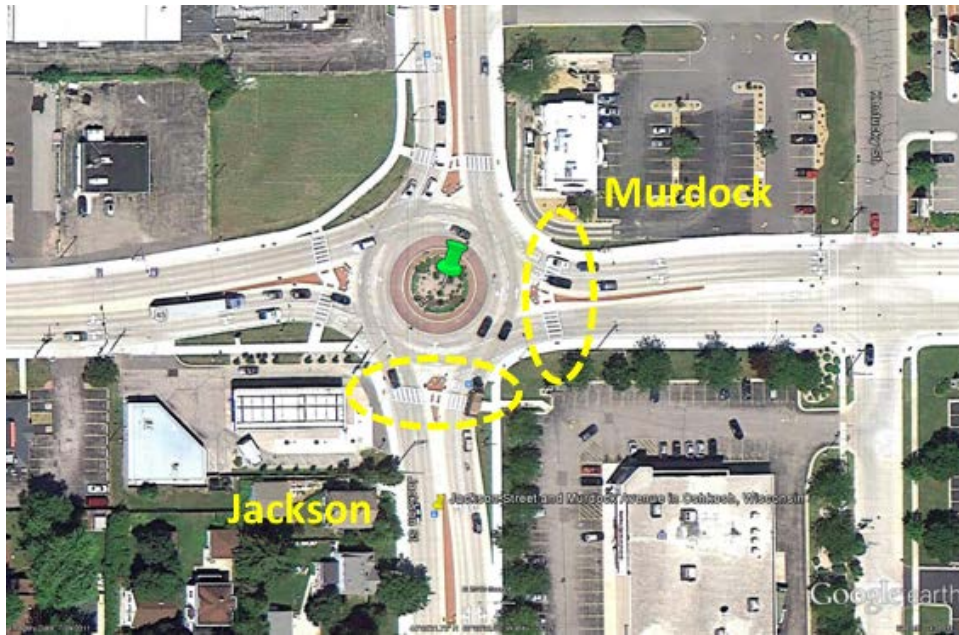
Figure 24 shows the Google aerial view of the roundabout located at the intersection of Jackson St. and Murdock Ave. in the city of Oshkosh, WI. The audit was applied to the east leg Murdock Ave. and south leg on Jackson St., both entry and exit. Figure 25 shows a street-level view of the southern approach on Jackson St.

Figure 24. Photo. Aerial view of Jackson St. and Murdock Ave., Oshkosh, WI.

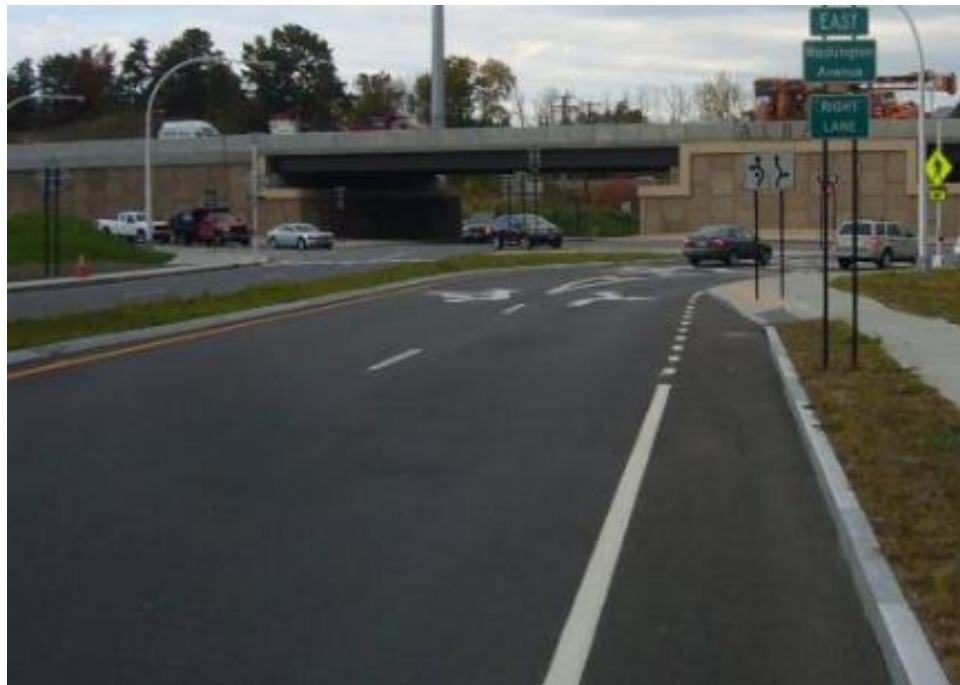
Figure 30. Photo. Street-level view of southern approach on Fuller Rd., Albany, NY.

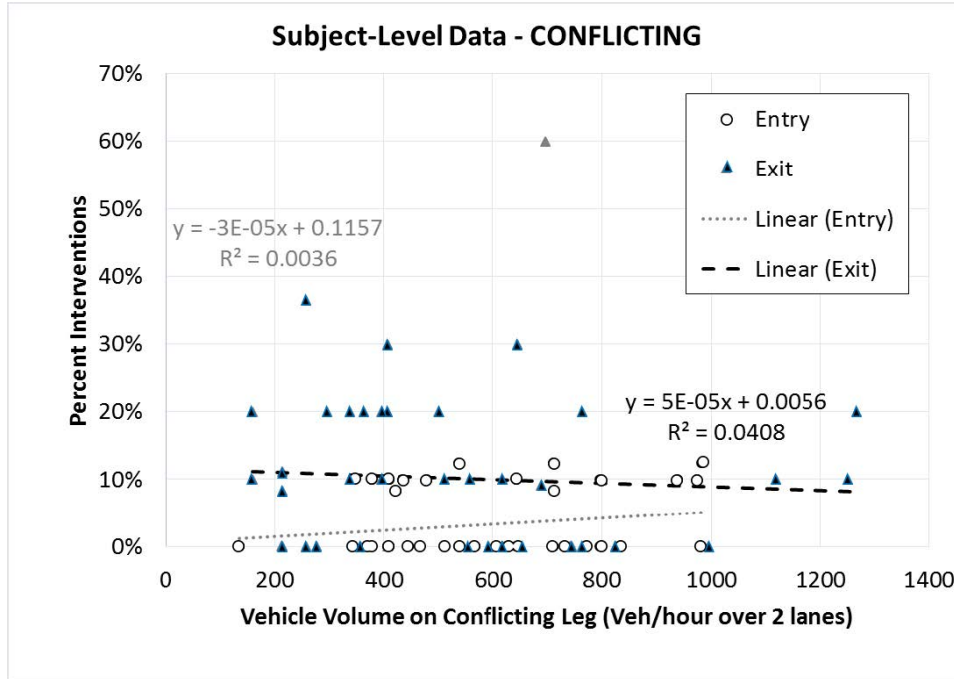
To further evaluate the effects of traffic volume, the volume vs. intervention analysis in the previous section was repeated using the individual subject-level data. This section evaluates percent interventions as a function of traffic volume on the conflicting lane, the lane closest to the participant attempting to cross. While volume on that lane is an important variable, other traffic in the roundabout could potentially mask the sound of traffic approaching in that lane. The graph in figure 36 distinguishes entry (gray triangles) and exit (black circles), and further show a linear trend line fit to the data. The single-lane exit and channelized turn lane trials were excluded from this analysis.

Figure 36. Graph. Percent intervention as a function of vehicle volume on conflicting leg at subject level.

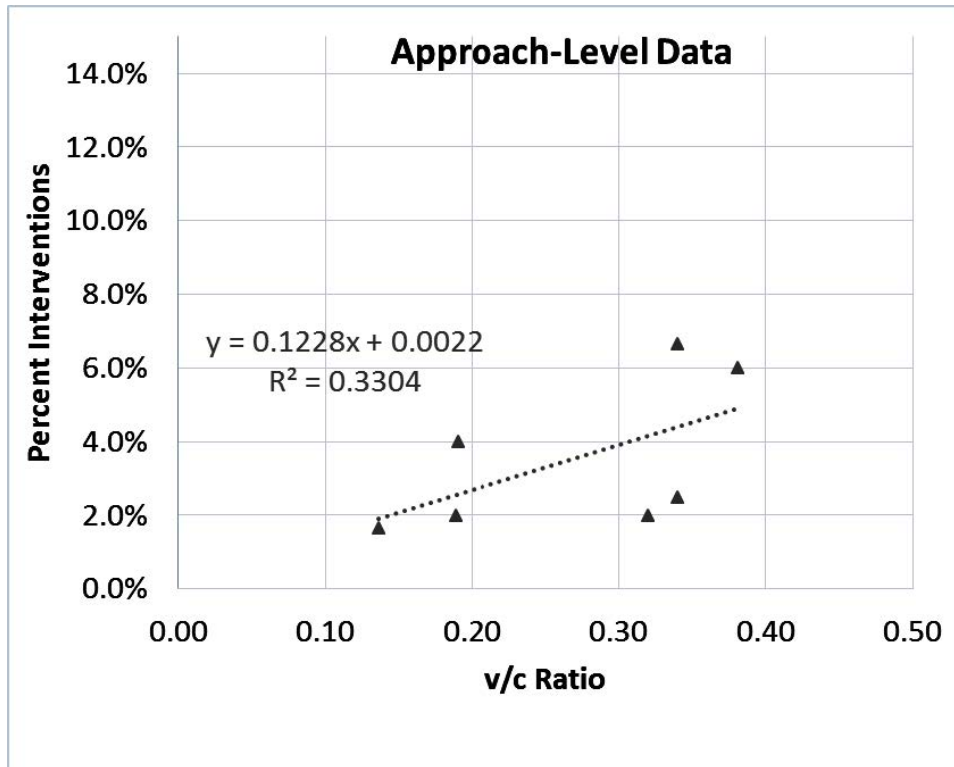
shown on a per-approach basis, with one data point corresponding to one approach, in figure 37, and on a per-subject basis, with one data point corresponding to one participant, figure 38.

Figure 37. Graph. Percent intervention as a function of volume-to-capacity ratio at entry - approach level data.

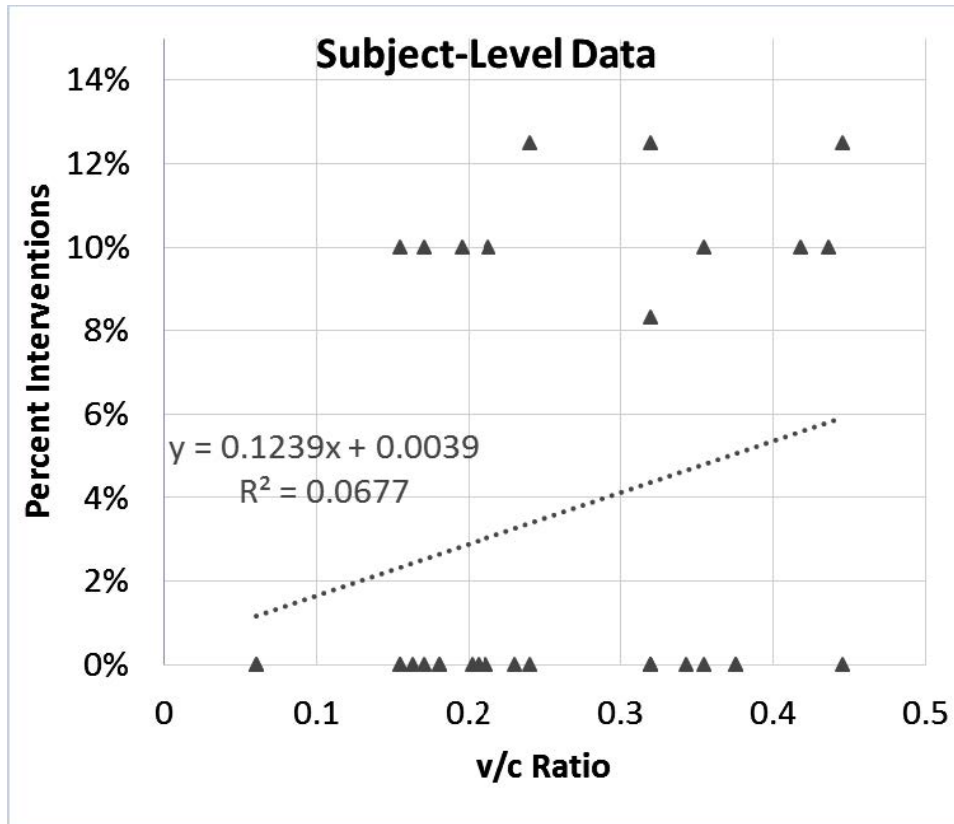
Figure 38. Graph. Percent intervention as a function of volume-to-capacity ratio at entry - subject level data.

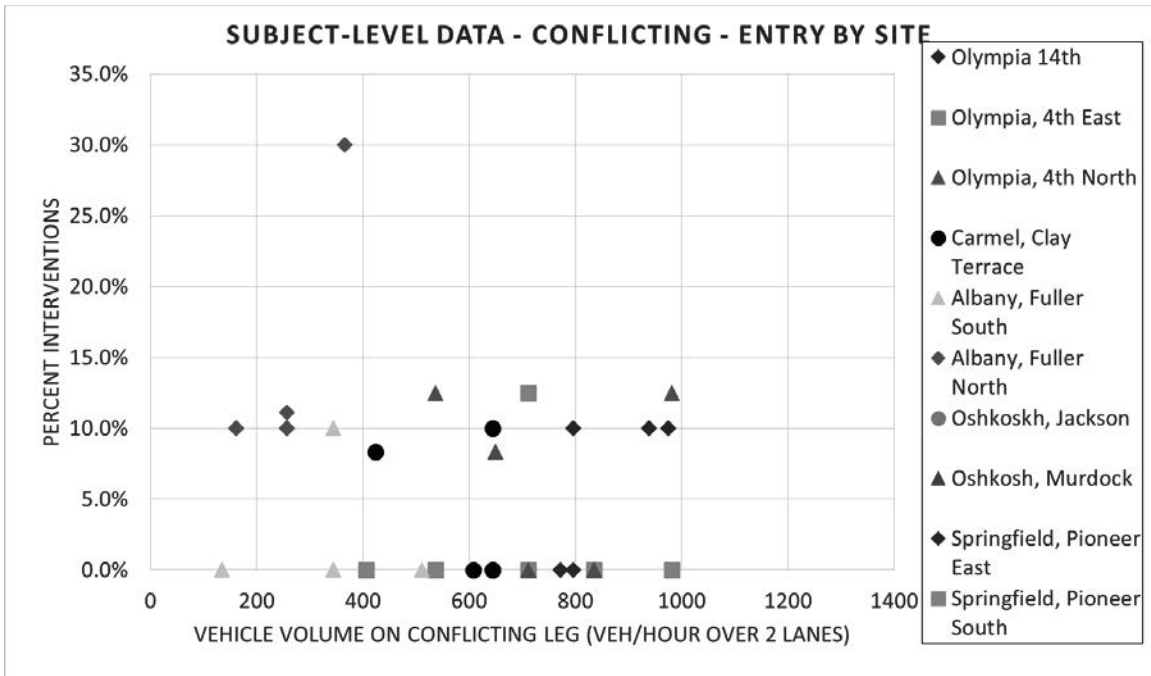
This section is an evaluation of percent interventions as a function of traffic volume on the lanes closest to the participant based on the individual subject-level data divided by site.

Figure 39. Plot. Percent intervention as a function of vehicle volume for individual sites- entry.

Figure 39 shows there are no clear patterns evident from the data. The following are the noteworthy observations for each site. 14th Ave. in Olympia, WA, generally had high volumes with a mix of interventions (0% to 10%). 4th St. East in Olympia, WA, had mid to high volume with generally zero interventions, except for one participant (13%). 4th St. North in Olympia, WA, had mid to high volumes with a mix of interventions (0% to 12%). Clay Terrace Blvd. in Carmel, IN, had mid to low volumes with a mix of interventions (0% to 10%). South Fuller St. in Albany, NY, had mid to low volumes with a mix of interventions (0% to 10%). North Fuller St. in Albany, NY (channelized turn lane) had relatively low volumes with high interventions (10% to 30%). Jackson St. in Oshkosh, WI, had mid-level volumes with mostly zero interventions, except for one participant (10%). Murdock Ave. in Oshkosh, WI, had mid-level volumes with all zero interventions. Hayden Bridge Rd. East in Springfield, OR, has mid to low volumes with generally zero interventions, except for one participant (10%). Pioneer Pkwy. South in Springfield, OR, has mid to low volumes with a mix of interventions (0% to 10%).

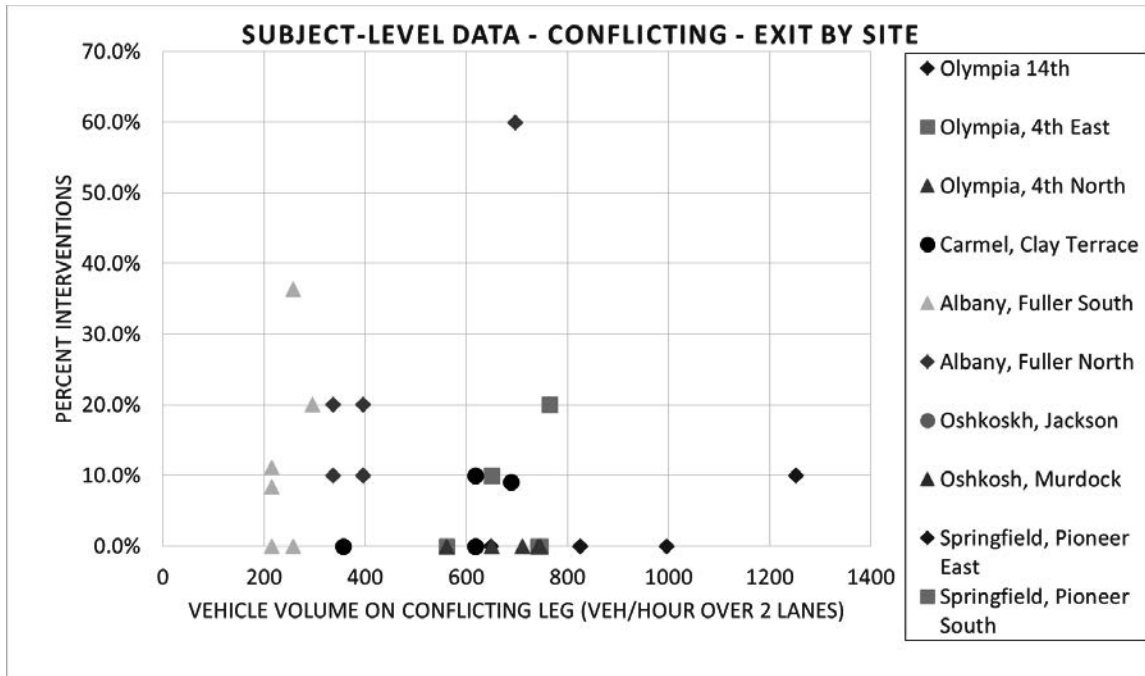
Figure 40. Plot. Percent intervention as a function of vehicle volume for individual sites- exit.
