Safety Edge_{SM}
PCC Demonstration Project
County Highway E34
Fairview, Iowa

Field Report
June 10, 2011

FIELD EVALUATION OF PCC OVERLAY WITH SAFETY EDGE_{SM}

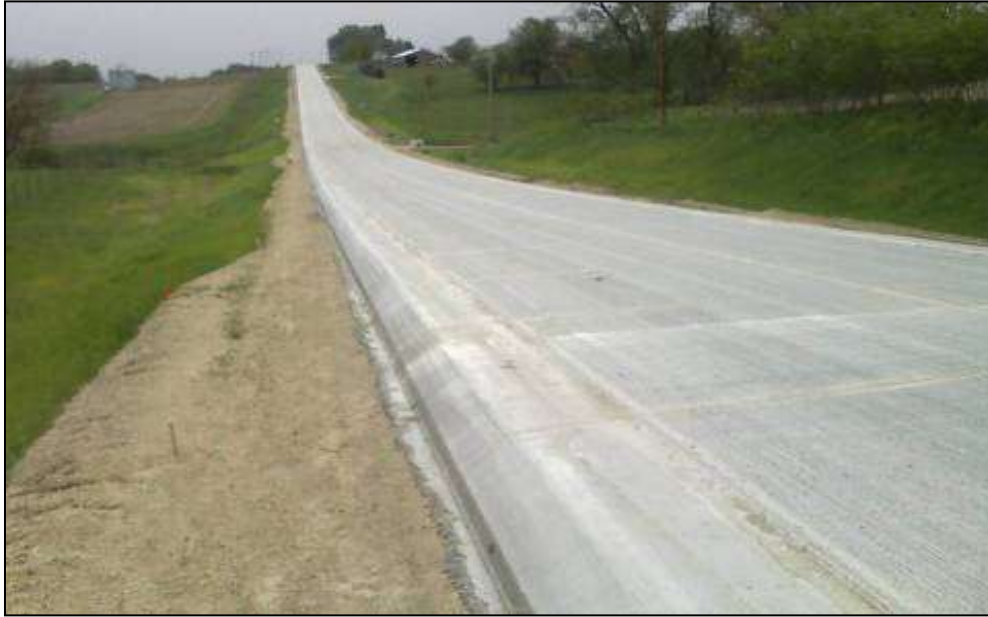
Figure 2. General view of the project showing the Safety Edge_{SM}.

Figure 2 presents a view of a completed section of the roadway. The construction included a 6 inch overlay of unbonded PCC over an existing 6 inch PCC pavement. The overlay included a tied 9-inch thick shoulder 2.75 ft wide, with a 30° sloped Safety Edge_{SM} in both the westbound and eastbound direction. A schematic of the cross section of the pavement is shown in Figure 3.

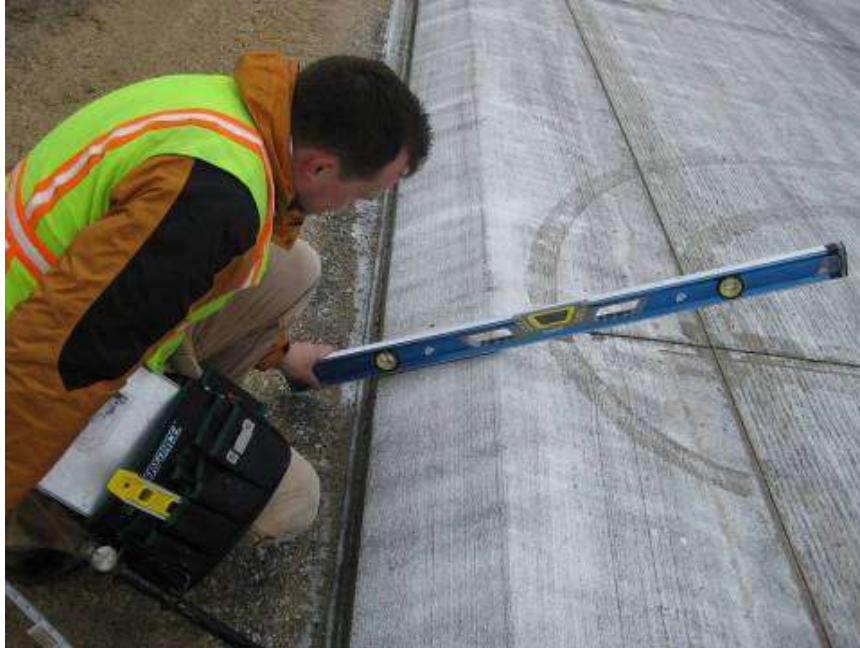
Figure 4. Measuring the slope and flatness of the Safety Edges_{SM}.

Some deviation in the flatness of the slope face was observed. The flatness was measured by placing a straightedge on the face as shown in Figure 4. The face was found to be concave in some cases and convex in other cases. This condition may be caused by either flexing of the device or issues during finishing. The deviation from flat is generally considered minor and is not expected to have a significant impact on the performance of the Safety Edge_{SM}.

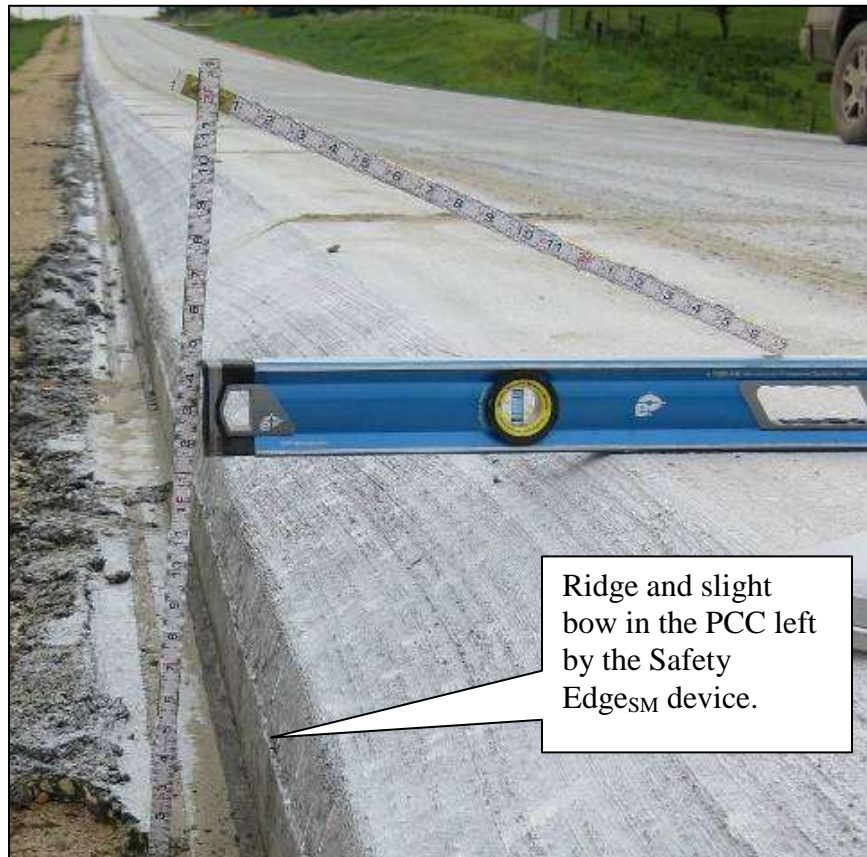
Figure 5. Slope face showing ridge and bow.

- The sloped face of the Safety Edge_{SM} was slightly concave or convex at some locations. This condition may be caused by either flex in the device during paving or due to issues during finishing. The deviation from flat surface is generally considered to be minor and is not expected to have a significant impact on the performance of the Safety Edge_{SM}.

Similarly, the vertical edge face of the pavement was found to have defects from forming. The Safety Edge_{SM} device did not always seal tightly against the end gate, leaving a ridge in the face. Figure 5, shows an example of this. The vertical face is bowed and the marks created by the end of the device and the end gate can be clearly observed.

- The slope was generally found to be appropriate. The average slope was 31.5° with a maximum value of 34.0° and a minimum value of 28.5°.
- A slight hump or bow in the slope face was produced by the Safety Edge_{SM} device. Modifications to the device and a more robust design should be considered to prevent this problem on future projects. Unlike the Safety Edge_{SM} attachments for asphalt pavers, the PCC device on the concrete paver requires more time and effort to install or modify once paving begins.

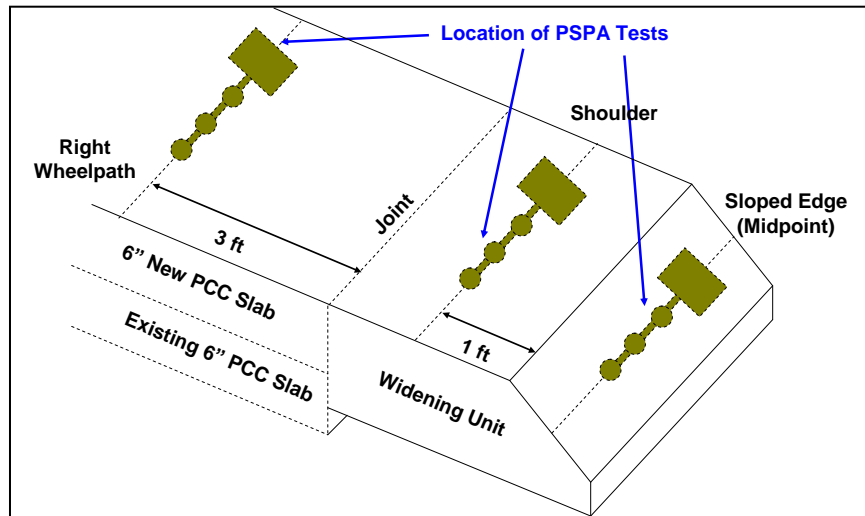
Figure 6. Location of PSPA test points.

The PSPA was utilized to provide a measure of quality by determining the variation in modulus with depth of the concrete in the field. Details of this nondestructive test procedure are explained in Appendix A. PSPA testing was conducted on the sloped edge, at 1 ft from the edge, and on the right wheelpath as illustrated in Figure 6. This was done to compare the quality of the concrete within the edge and at points gradually moving towards the interior of the pavement.

PSPA tests were conducted on the westbound and eastbound lanes from Stations 19+00 to 53+00 of Linn County and from Stations 11+00 to 19+00 of Jones County. Spacing between stations was 100 ft. This portion of the project was paved over two days. The first section that was tested was paved on May 5 and tested on May 10 (Day 1 of testing) and included stations 19+00 to 36+00. The second section that was tested was paved on May 6 and tested on May 11 (Day 2 of testing) and included station from 11+00 to 19+00 and from 37+00 to 53+00. In total, tests were conducted at 44 stations. In addition to the PSPA tests, nine cores were obtained at three different locations for laboratory analysis of the concrete's modulus for comparison with the PSPA results.

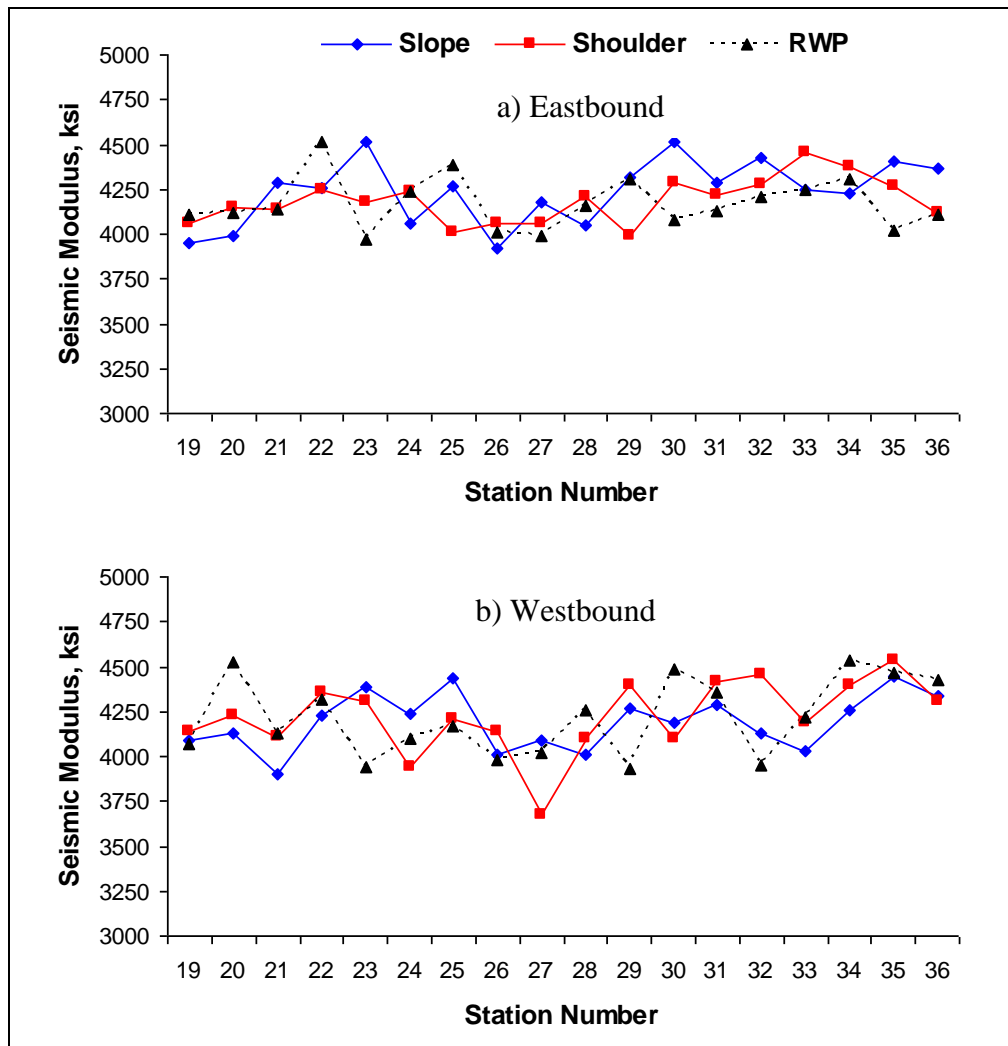
Figure 7. Variations of the moduli for the sections tested on Day 1.

Moduli for the 44 stations investigated in each direction and representative statistics are summarized in Table 1. The full set of data are presented in Appendix A. The section that was paved on Day 1 exhibited an average modulus of 4,200 k/in², slightly higher than the section constructed on Day 2 (4,050 ksi). Coefficients of variation (COV) of the modulus for all stations were small and between 3 and 6 percent. Figure 7 and Figure 8 graphically present the variation of moduli at the three lateral points tested along the project.

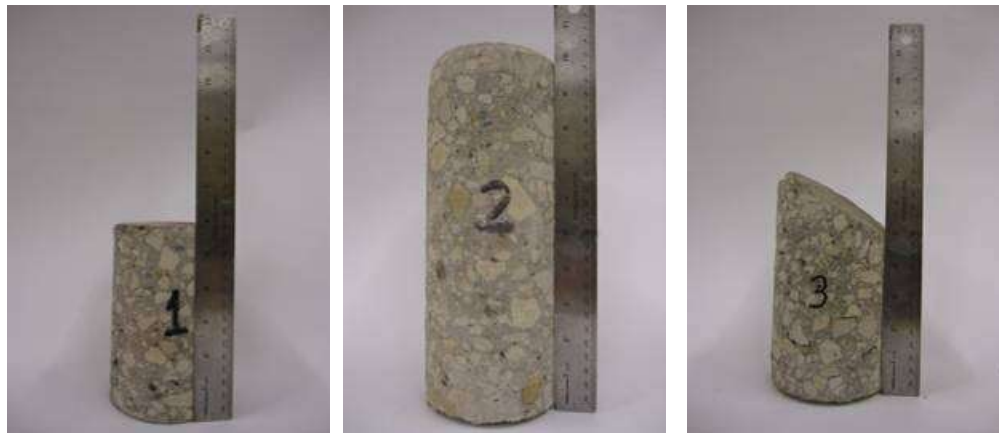
Figure 9. Cores retrieved from station 21+00.

As an example, the cores from station 21+00 are shown in Figure 9. The cores were first trimmed to remove either the rough ends (if needed) or the sloped portions.

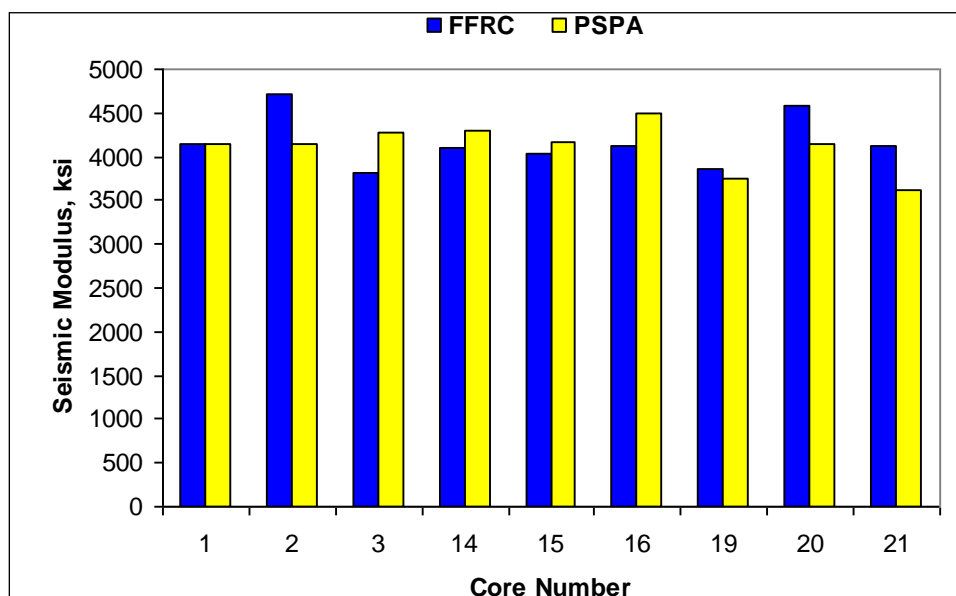
Figure 10. Comparison of the moduli obtained with PSPA and FFRC.

The seismic moduli of the cores were determined by measuring the resonant frequency of vibration (standing waves) according to the FFRC test for comparison with the moduli measured in the field with the PSPA. Details of the FFRC test procedure are included in Appendix A. At the time of FFRC testing, the specimens had cured for approximately seven days. The comparisons of the lab and field moduli for the nine cores are presented in Figure 10. The results of the PSPA and FFRC testing were similar with the average difference of 7 percent and a range of 1 to 13 percent.

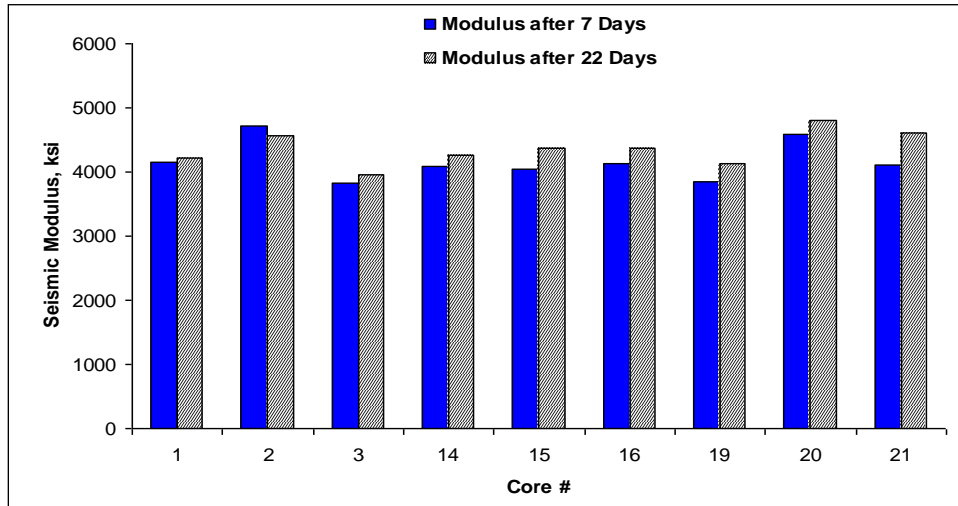
Figure 11. Comparison of the FFRC Moduli.

Before conducting strength tests, the cores longer than 8 inches were further trimmed to 8 inches and all cores were tested again with the FFRC. The comparisons of the FFRC moduli at ages of 7 and 22 days are shown in Figure 11. On average, the moduli increased by 5 percent in that time frame.

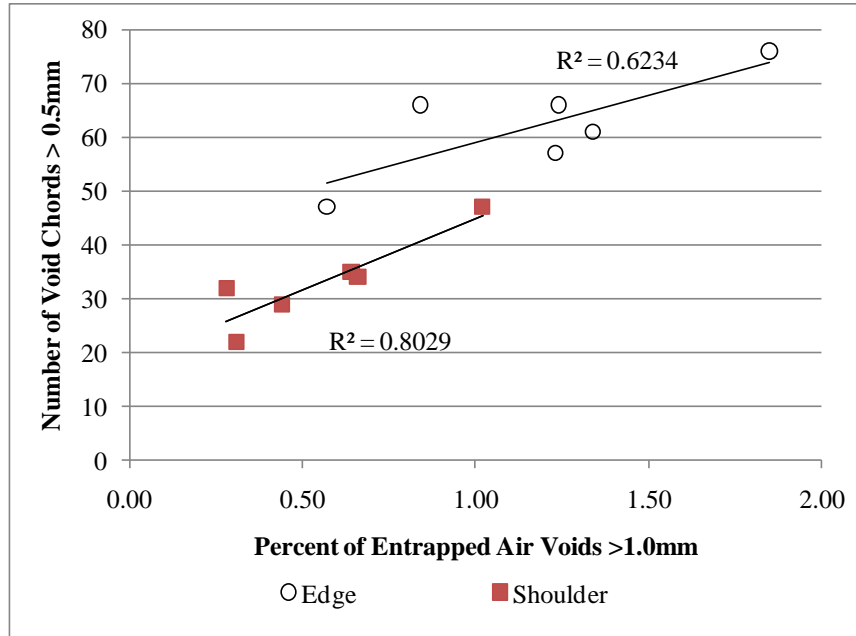
Figure 12. Comparison of the percentage of entrapped air and the number of void chords greater than 0.5mm.

Generally, laboratory testing revealed that the air void systems in the edge cores had both a greater percentage of entrapped air voids greater than 1.0 mm and more air void chords greater than 0.5mm in comparison to the shoulder cores (Figure 12).

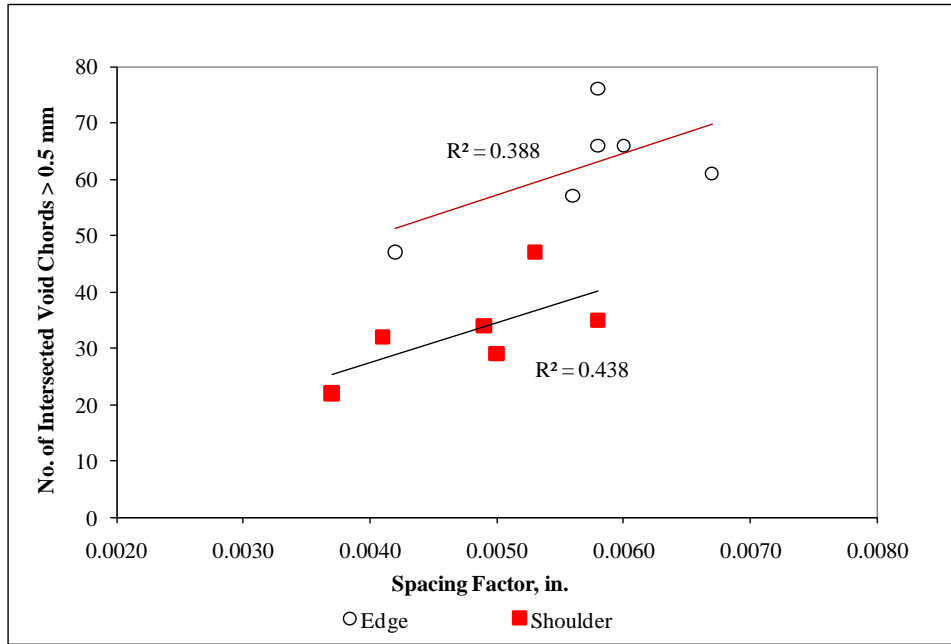
Figure 13. Comparison of the number of large air voids (> 0.5 mm) and the spacing factors.

On average, the edge cores had a lower unit weight, a higher air content, a slightly higher spacing factor, and more air voids over 0.5mm. Despite the differences, however, the spacing factors and other parameters were reasonable and the concrete at the edge as well as from the shoulder appears to be durable. Table 6 summarizes these results.

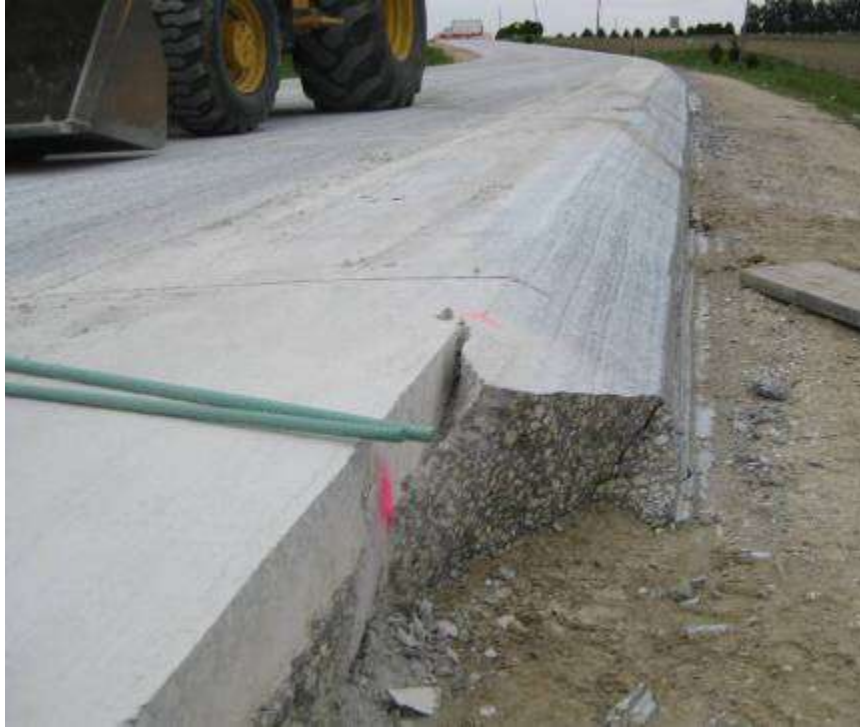
Figure 16. Saw cut edge at an intersection.

An example of saw cutting and removing the Safety Edge_{SM} at an intersection is shown in Figure 16. The alternative was to build up the Safety Edge_{SM} by hand (see Figure 17) in order to tie into pavement intersections.

- Additional labor was required to cut and remove the Safety Edge_{SM} or form the Safety Edge_{SM} to tie into connecting pavements.
- The results of field and laboratory test results indicate the quality, as indicated by PCC modulus and compressive strength testing, is reasonably uniform throughout the pavement.
- Laboratory test results of cores taken at the Safety Edge_{SM} show, on average, a lower unit weight, a higher air content, a slightly higher spacing factor, and more 0.5 mm air voids in comparison to cores taken from the shoulder. Despite the differences, however, the concrete within the edge appears to be as durable as that in the mainline pavement.

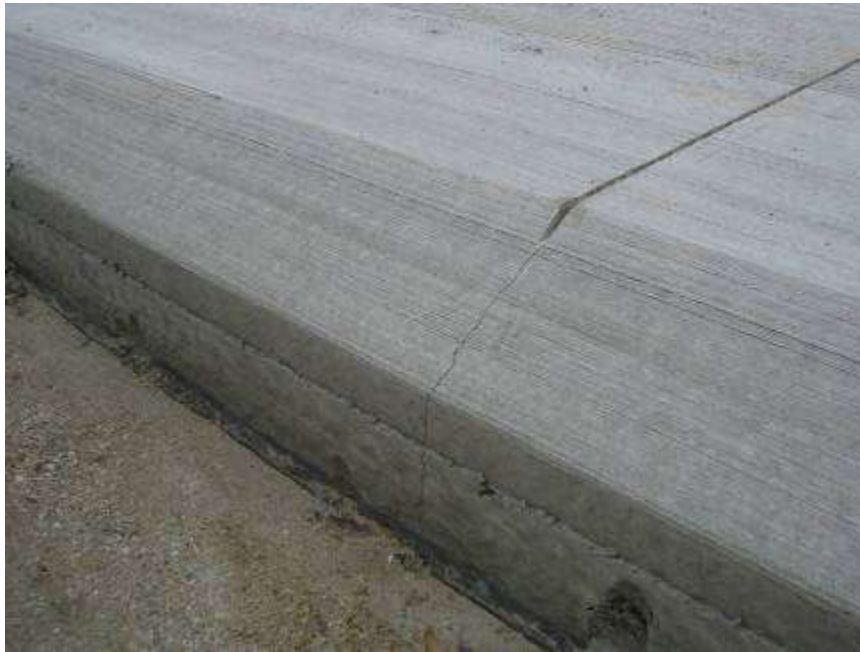
Figure 18: Photo of saw cut and formed joint.

A decision was made to saw cut only the top of the pavement and not saw cut the slope of the Safety Edge_{SM} as shown in Figure 18. The reason for not saw cutting the slope was that it would be easier to retain the joint sealant with only the sawcut on top. Another reason was the joint would crack straight down which was what was observed. Figure 18 also shows that the joint formed properly at this location.

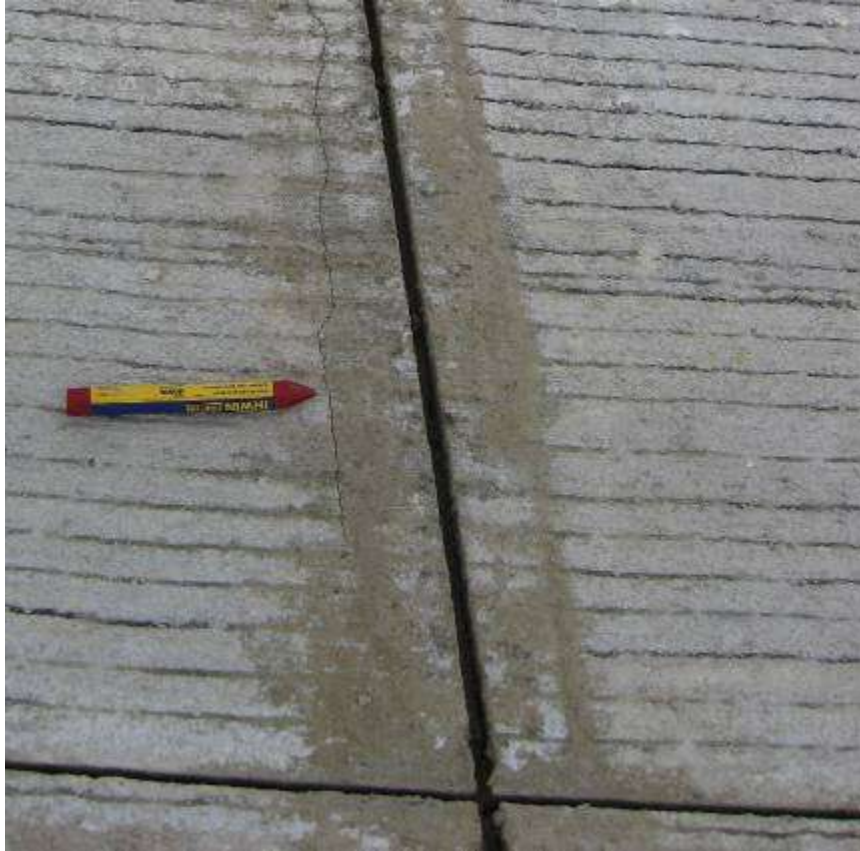
Figure 19. Random crack formed near joint.

Figure 19 shows one of two locations along the project where random cracking was observed parallel to the sawed joint. It is unknown if the Safety Edge_{SM} contributed to the formation of these cracks, however, given the location and orientation it appears unlikely that the Safety Edge_{SM} contributed to these cracks.

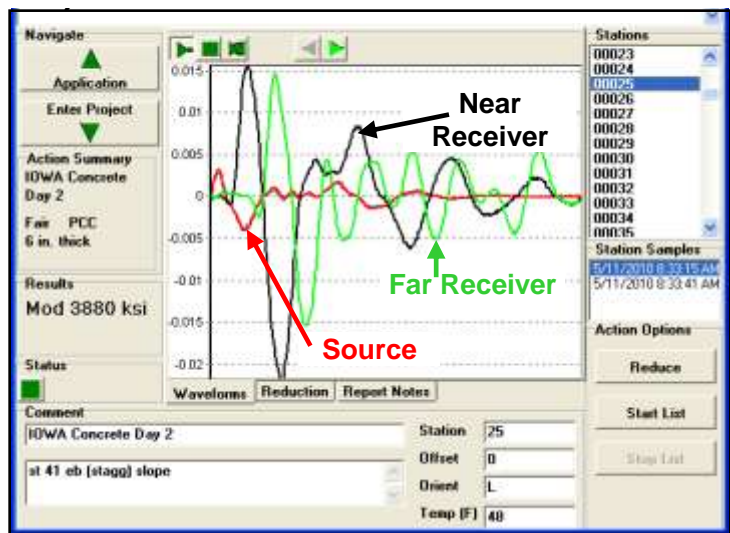
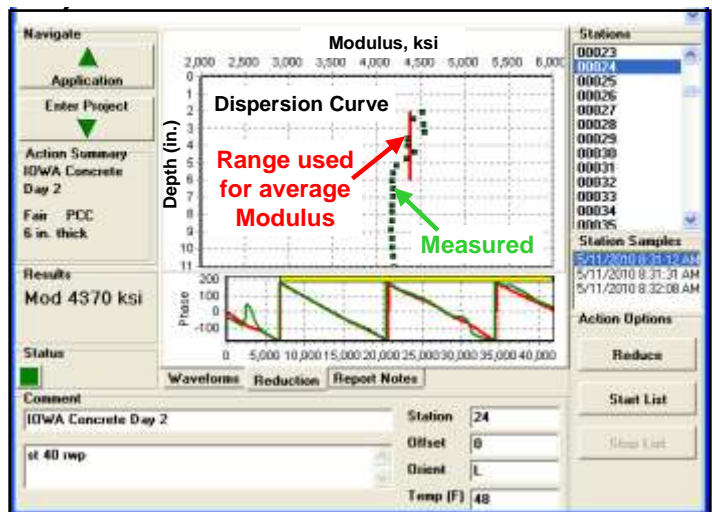
Figure A-3. Reduced data shown on the PSPA interface screen.

Typical time records of the receivers are shown in Figure A-3. These records are analyzed to obtain a dispersion curve, a plot of the modulus vs. wavelength (or depth), as shown in Figure A-3. At wavelengths less than or equal to the thickness of the uppermost layer, the travel time and velocity of surface waves is independent of wavelength, as long as the modulus of the layer is constant. If the pavement structure is composed of several layers, voids are present or poorly-constructed layers exist, the velocity will vary with wavelength in the dispersion curve. In that manner, the operator of the PSPA can get a qualitative feel for the variation in modulus with depth. In Figure A-3 the modulus remains constant for the top 5 inches, and slightly decreases below that depth and remains constant below 6 inches. To obtain the average modulus, the moduli from a wavelength of about 2 to 6 inches (nominal thickness of the overlay) is used. The results of the PSPA testing are in Table A-1.
