Federal Highway Administration
Every Day Counts
Innovation Initiative

Safety Edge_{SM}
Demonstration Project
Turner, Maine

Field Report
June 15, 2011

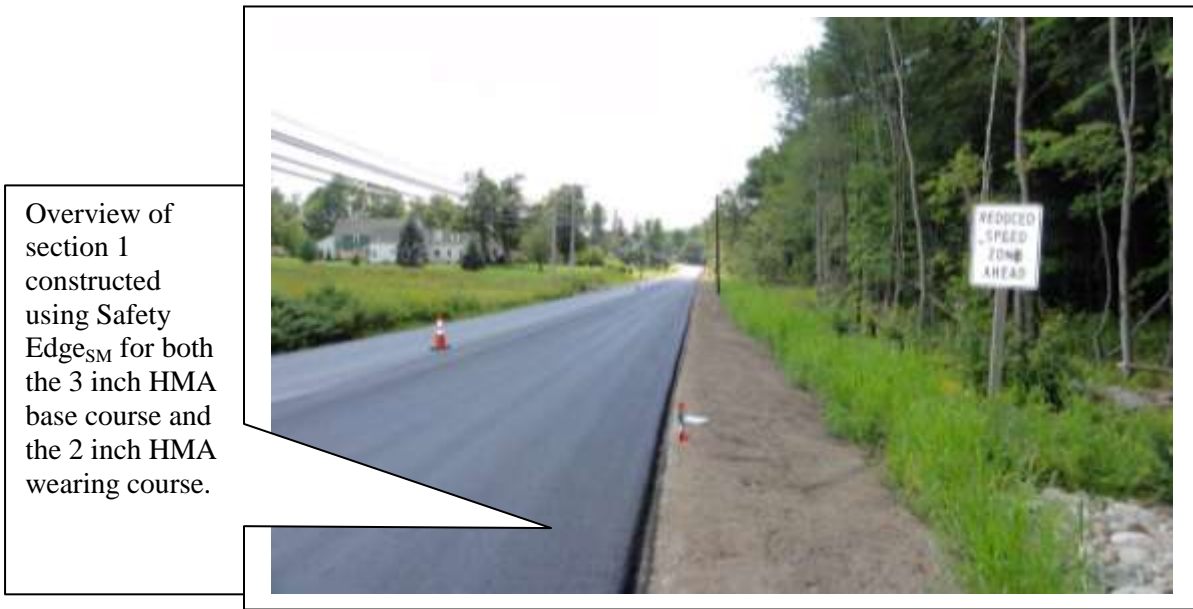
Figure 4. General overview showing the wearing course with Safety Edge_{SM}. Image taken facing the southbound direction around station 374+53, the end of section 1.

1. Section #1 (Refer to Figure 4), Safety Edge_{SM} placed using Advant-Edger, southbound lane, tangent section, 700 ft section starting at Sta 367+53 going north (opposite to the direction of traffic). The section starting point is 16 ft north of posted speed limit sign, 32 ft north of a telephone pole, and 62 ft north of a driveway. 200 ft north of the section start is the center of a driveway to "Long Meadow Estates." The section ends at Sta 374+53 just before a posted sign indicating "Reduced Speed Zone Ahead." At around the 300 ft and 500 ft marks of the section are mailboxes with posts. The mailbox at the 500 ft mark is marked as "105."

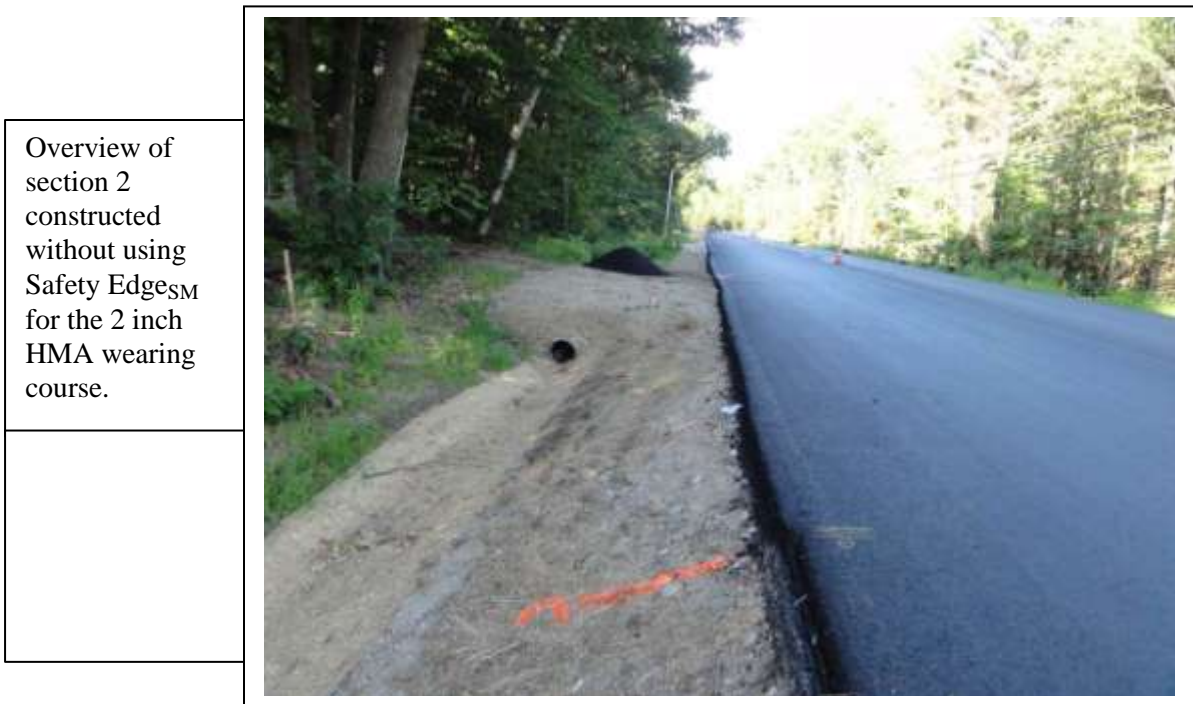
Figure 5. General overview showing the wearing course without Safety Edge_{SM}. Image taken facing the northbound direction around station 385+38, the beginning of section 2.

2. Section #2 (Refer to Figure 5), no Safety Edge_{SM} (control section), southbound lane, tangent section north of section #1, 500 ft section starting at Sta 385+38 going north (opposite to the direction of traffic). The section starting point is 40 ft south of a driveway with a culvert. Around 135 ft north of the section starting point is another driveway and a mailbox with a wooden post. The mailbox is marked as "166." Another mailbox marked as "177" is around 410 ft north of the starting point. The section ends 500 ft north of the starting point at Sta 390+38, 20 ft south of another driveway with a culvert.

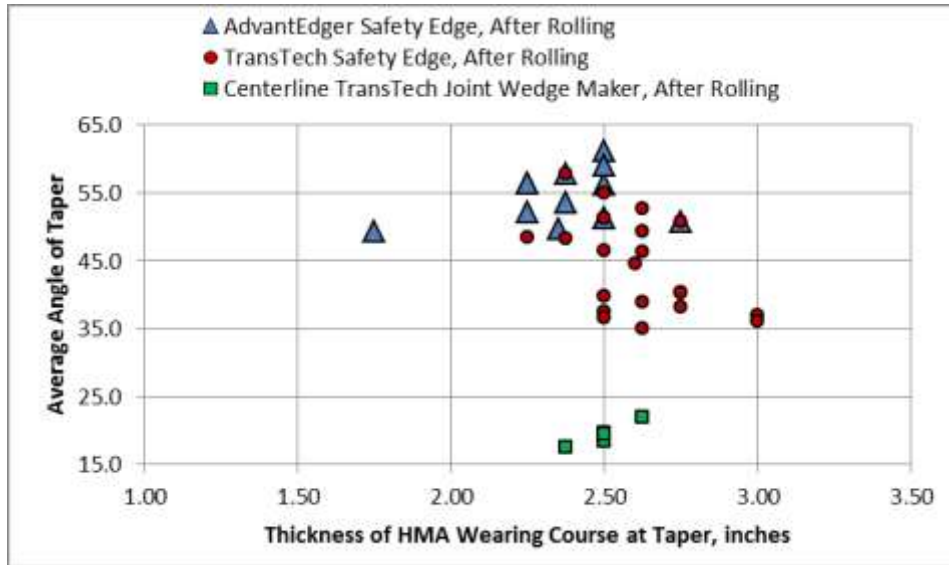
Figure 8. Comparison of the Safety Edge_{SM} slope and thickness of the HMA adjacent to edge of HMA wearing course.

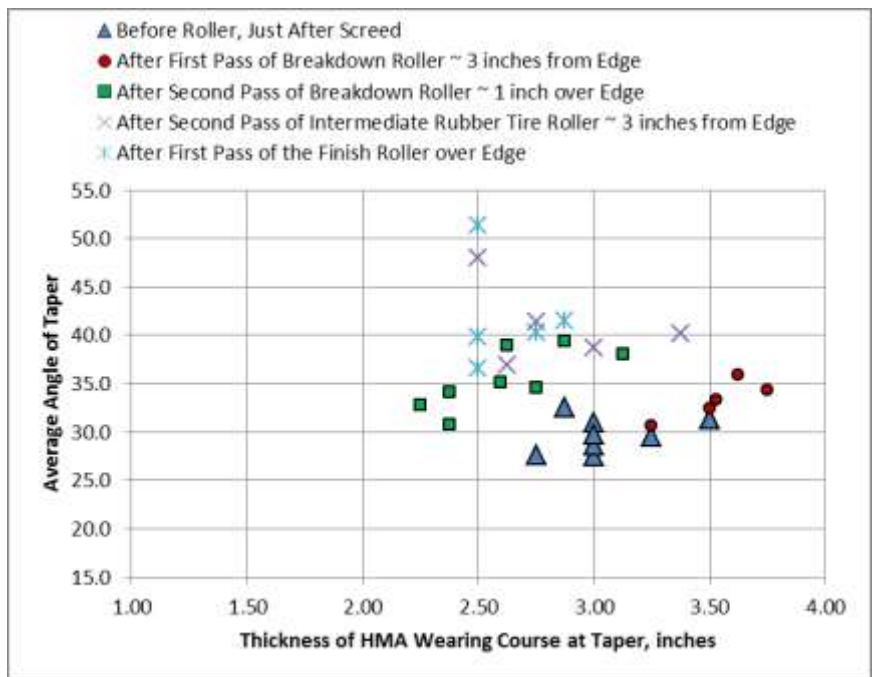
The change in the slopes of the Safety Edge_{SM} and thickness at the Safety Edge_{SM} was also evaluated as a function of the passes of the individual rollers for the section pavement using the TransTech Shoulder Wedge Maker (Refer to Figure 9).

Immediately behind the screed, and prior to the rolling of the HMA mat, the average slope was 30°. After the first pass of the breakdown roller, the average slope increased to 33°. There was a corresponding increase in average thickness (by about 0.5 inches) at the edge since the first pass of the breakdown roller was approximately 3 inches from the edge, resulting in some HMA wearing course material being shoved up near the edges. Following the second pass of the breakdown roller the average slope increased to 35°. The HMA thickness near the Safety Edge_{SM} was now reduced to an average value of 2.6 inches (from 3.5 inches) due to the fact that the second pass of the breakdown roller was 1 to 2 inches over the edge.

After two passes of the intermediate rubber tire roller (which did not go over the edge in either of the two passes but was approximately 3 inches from the edge), the average slope of the Safety Edge_{SM} increase to 41°. There was a slight increase in thickness of the HMA mat near the Safety Edge_{SM} from 2.6 inches to 2.9 inches. Following the first pass of the finish roller (over the edge) the HMA mat thickness was reduced to an average value of 2.6 inches. The average slope of the Safety Edge_{SM} was 42°.

Figure 9. Effect of rolling on the angle of taper and the thickness of HMA wearing course at the taper.

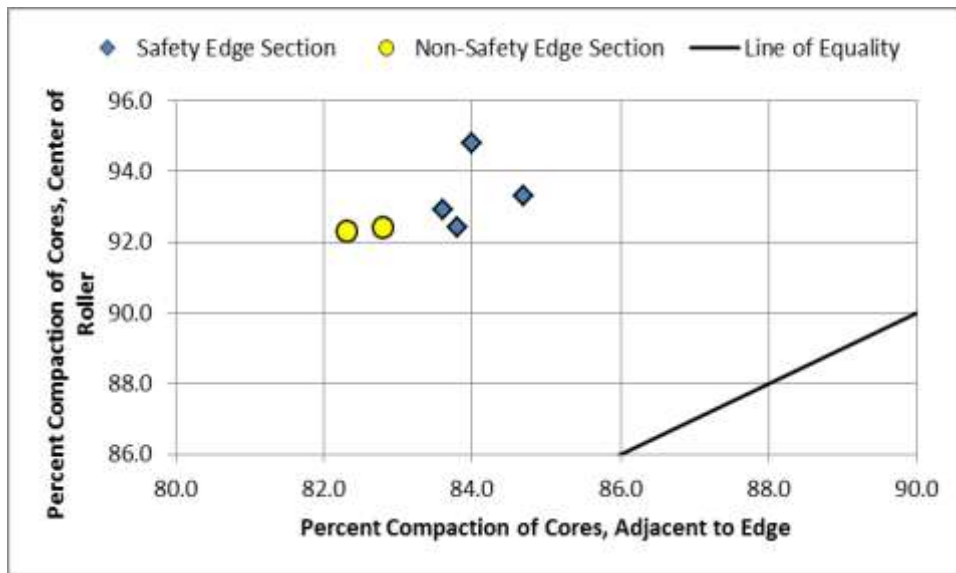
Table A-2 in Appendix A includes a summary of these test results and bulk specific gravities (saturated surface dry) converted to percent compactions. Figure 10 compares the core percent compactions taken along the edge and near the center of the steel drum roller for the Safety Edge_{SM} and non-Safety Edge_{SM} sections. As expected the compactions (and densities) near the center of roller are significantly higher than along the edge of the mat (unconfined edge). More importantly, the core percent compactions (and densities) taken along the pavement’s edge are consistently higher for the Safety Edge_{SM} section than for the non-Safety Edge_{SM}. These results suggest that the Safety Edge_{SM} is providing better confinement for rolling an unconfined edge of the mat.

Figure 10. Comparison of core percent compactions (densities) adjacent to the edge of pavement and the near center of the roller.

- The core percent compaction of the HMA mixture adjacent to the Safety Edge_{SM} was found to be slightly higher than along the unconfined edge in the areas placed without the Safety Edge_{SM} – a positive benefit from the Safety Edge_{SM} device. However, there was no statistical difference in the PQI percent compaction measurements between the HMA mixture adjacent to the Safety Edge_{SM} and the unconfined edge in the control areas placed without the Safety Edge_{SM}.

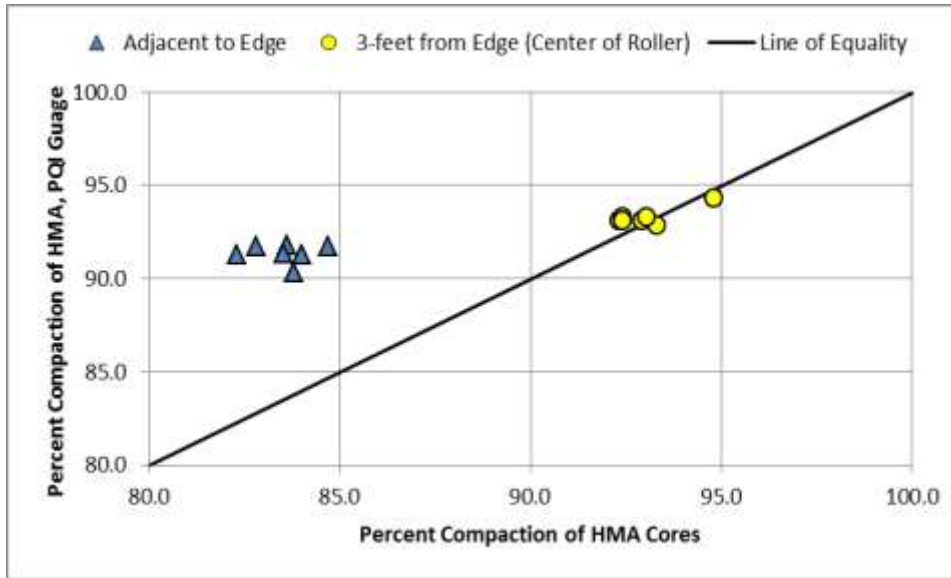
PQI readings were taken at the locations of each core. Figure 11 shows a comparison of the PQI percent compaction measurements and percent compactions measured on the cores. As shown, there is close correspondence between the PQI and core percent compactions for locations away from the Safety Edge_{SM}. However, for locations close to the Safety Edge_{SM}, the lab percent compactions (and densities) were substantially lower than that measured using the PQI. This could be due to the fact that the PQI was calibrated for the higher mat densities and not for the lower densities at the edges. Adjustment factors were determined for the PQI percent compaction readings taken at the Safety Edge_{SM} and near the center of the steel drum roller being used to compact the HMA mat. The adjustment factors are included in

Figure 11. Comparison of the PQI percent compaction readings and percent compactions measured on cores recovered from the HMA wearing course.

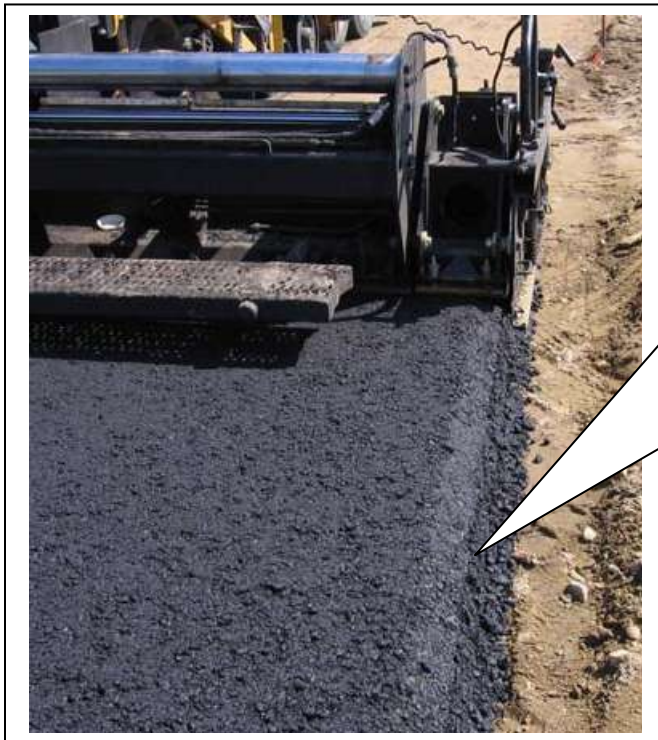
While paving the 3 inch HMA base course a line in the middle of the angled edge was made by the Advant-Edger. The material to the right of this line is loose. It would seem that the 3 inch mat thickness was too much for the Safety Edges_{SM} device. A slight adjustment to the angle was made by spot welding a shim to the back of the Advant-Edger.

Figure 13. Paving the lower 3 inch HMA 19 mm base course with the Advant-Edger on the compacted Type D aggregate subbase.

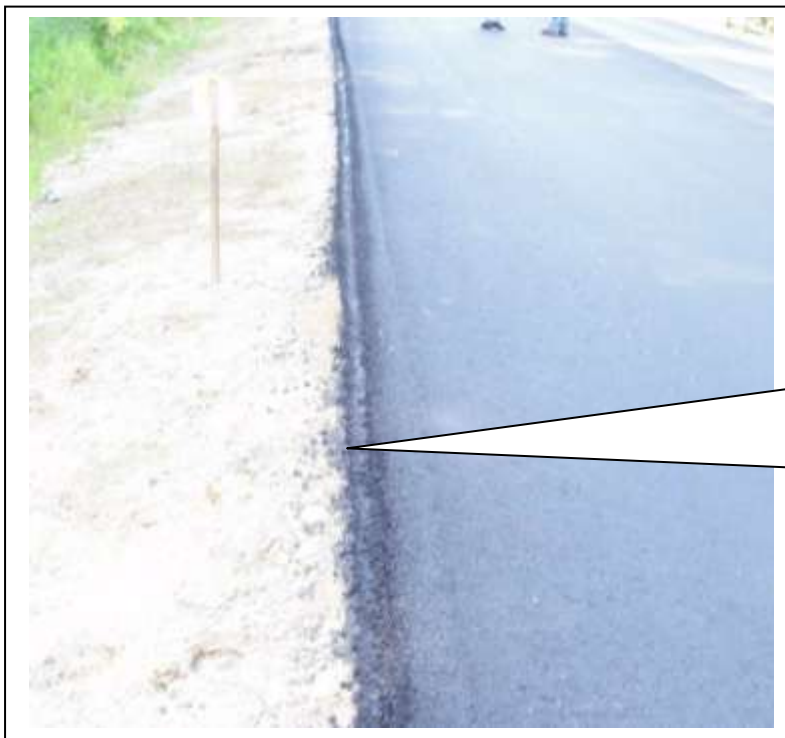
Both the 3 inch HMA 19 mm base course and the 2 inch HMA 12.5 mm wearing course were paved using a Safety Edges_{SM}. However, the Safety Edges_{SM} for the lower lift at many locations did not appear to have a distinct slope.

Figure 14. Both HMA lifts were paved using a Safety Edges_{SM} device.

The Advant-Edger was used to pave the first 3 inch HMA 19 mm base course on the compacted variable thickness (nominal thickness of 18 inches for grade improvement) Type D aggregate subbase. Figure 13 shows the HMA placed on top of the Type D aggregate subbase. Both the Advant-Edger and the TransTech Safety Edge_{SM} devices were used to pave the second 2 inch HMA 12.5 mm wearing course. Each side of the road had to be widened by about 8 inches to accommodate the Safety Edge_{SM} without reducing pavement width. Figure 14 shows the edge of both lifts.

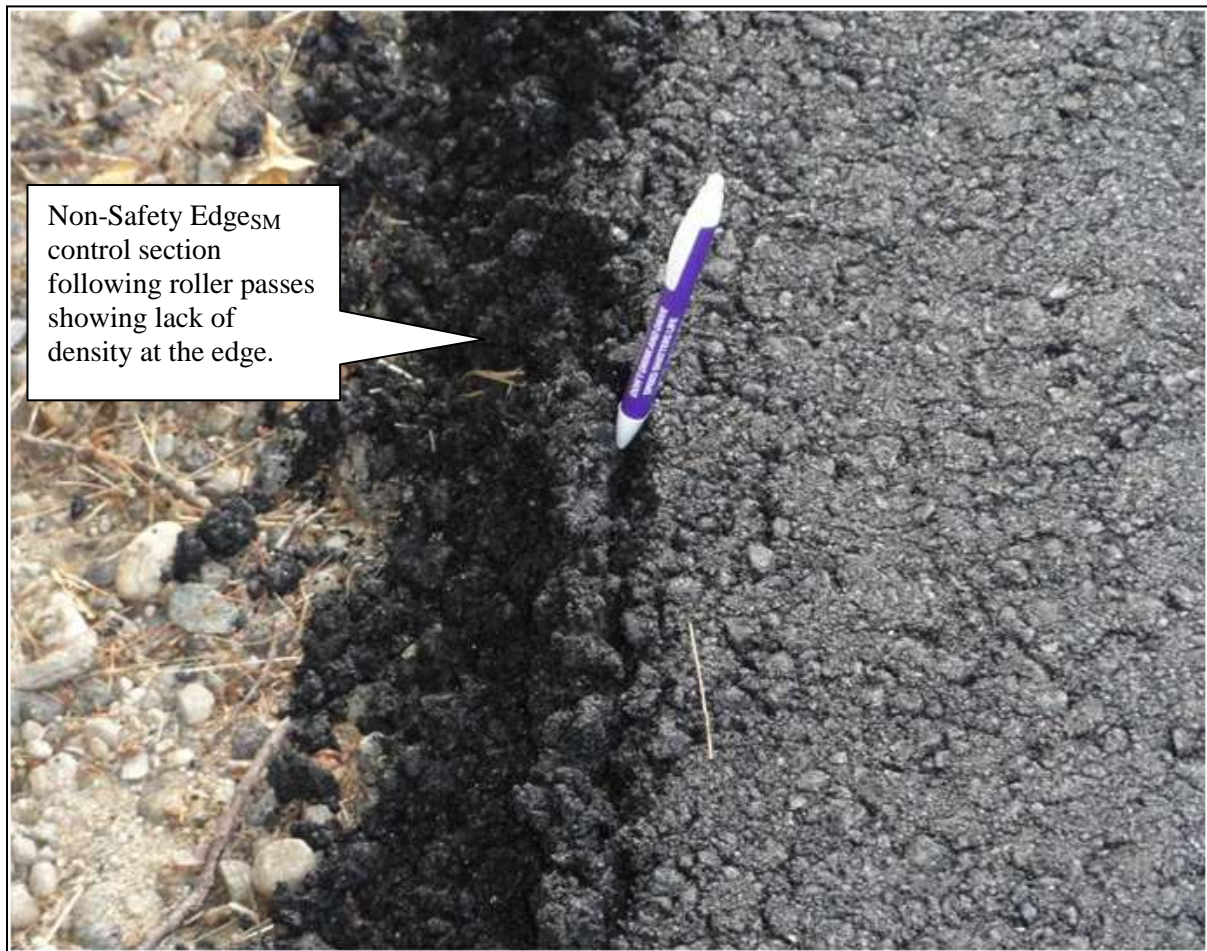
Figure 16. Non-Safety Edge_{SM} control section showing the lack of density at edges even after roller passes.

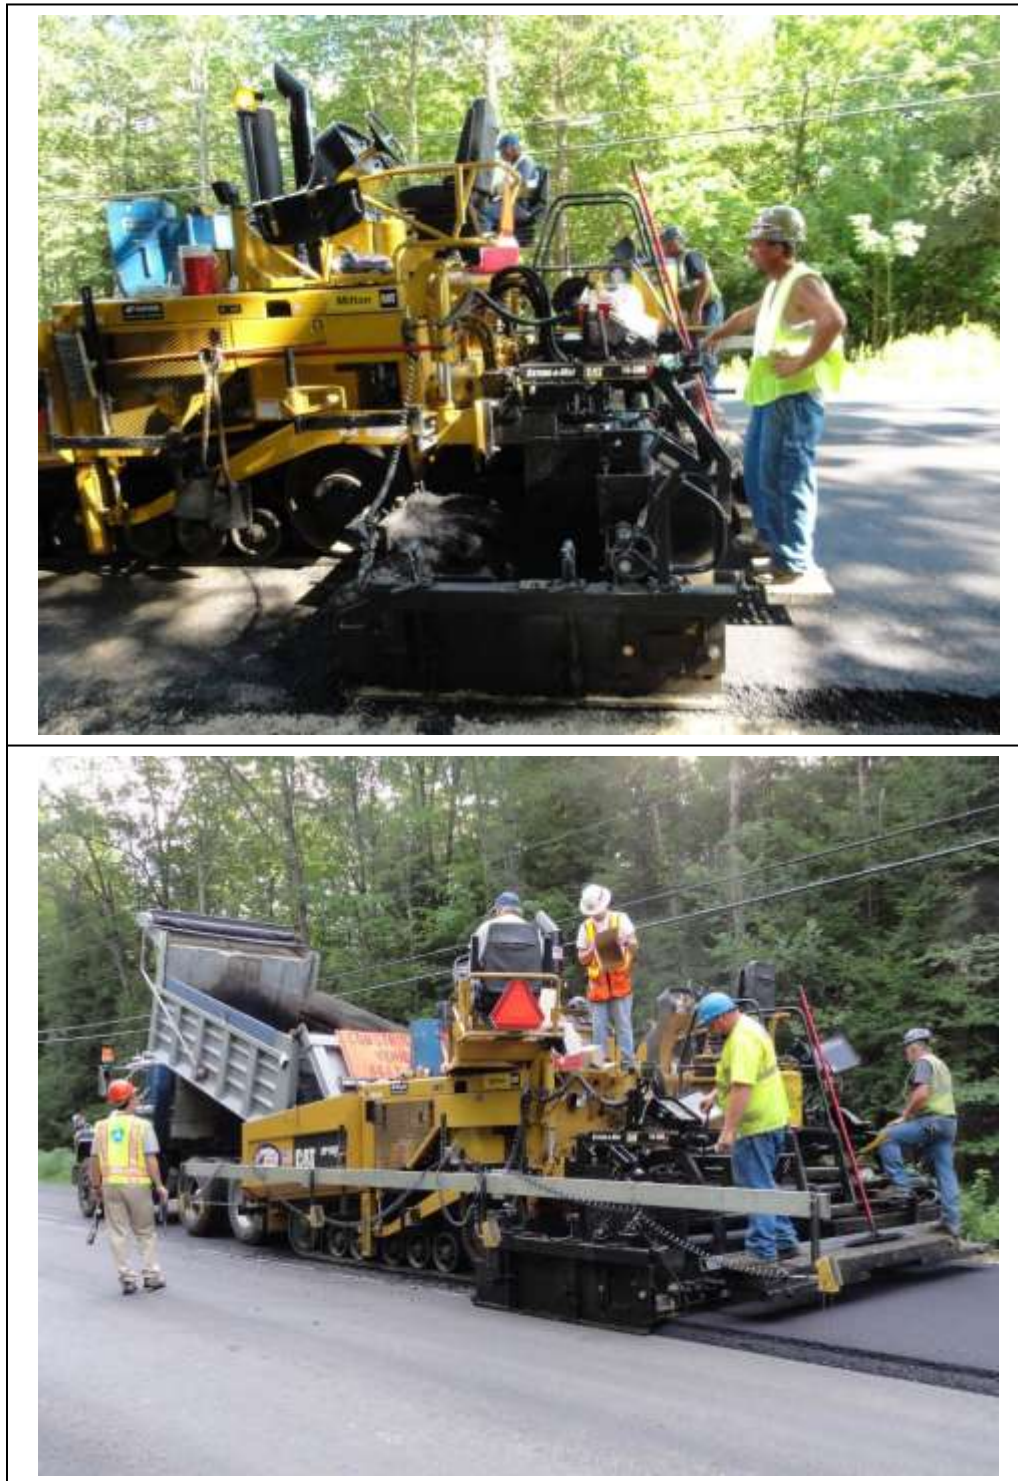
End of paver material feed auger was about 2.5 feet from end gate on the Safety Edges_{SM} side. Paver equipment manufacturers recommend that the auger be no more than 18 inches from end gate.

Figure 18. Paving operations showing the Safety Edges_{SM} paved using the Advant-Edger and the centerline joint paved using the TransTech Notched Wedge Joint Maker.

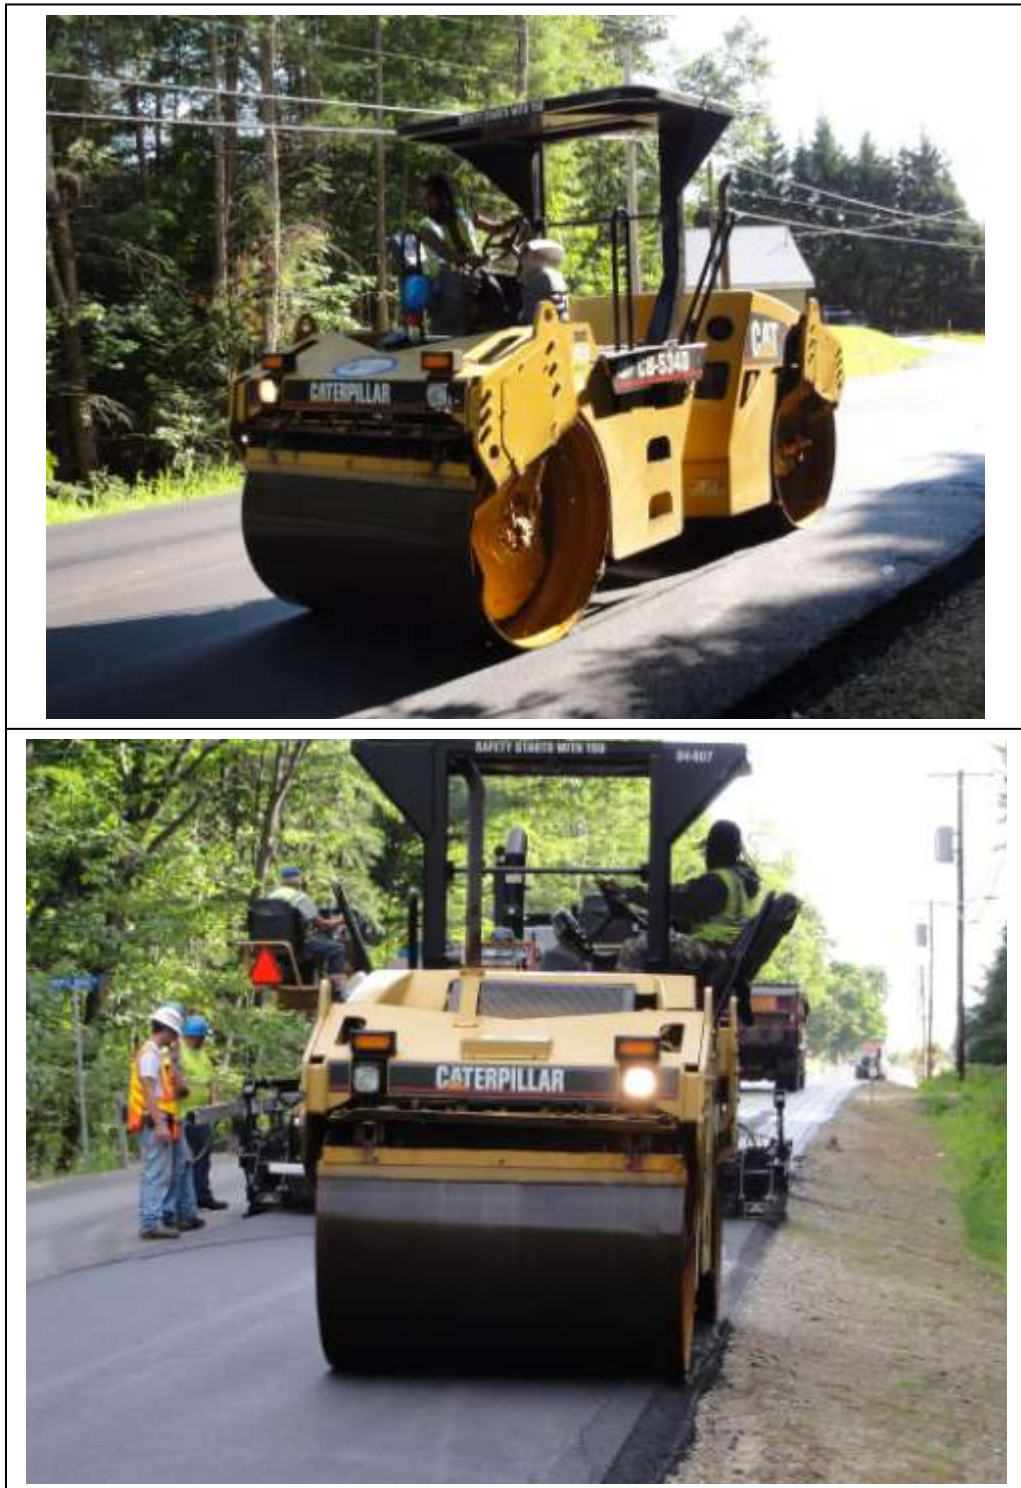
- Caterpillar steel wheel roller; high frequency, low amplitude (only 1 drum vibrating); primary or breakdown roller:
 - First pass (forward) with vibrations and 2 to 6 inches off centerline edge joint.
 - Second pass (reverse) with vibrations and extended over the centerline edge joint by about 2 to 6 inches.
 - Third pass (forward) with vibrations in the middle of the lane.
 - Fourth pass (reverse) with vibrations in the middle of the lane.
 - Fifth pass (forward) with vibrations and 2 to 6 inches off edge joint.
 - Sixth pass (reverse) with vibrations and extended over the edge joint by about 2 to 6 inches.

Figure 20. Steel wheel roller used in the breakdown position to compact the 12.5 mm HMA mix.

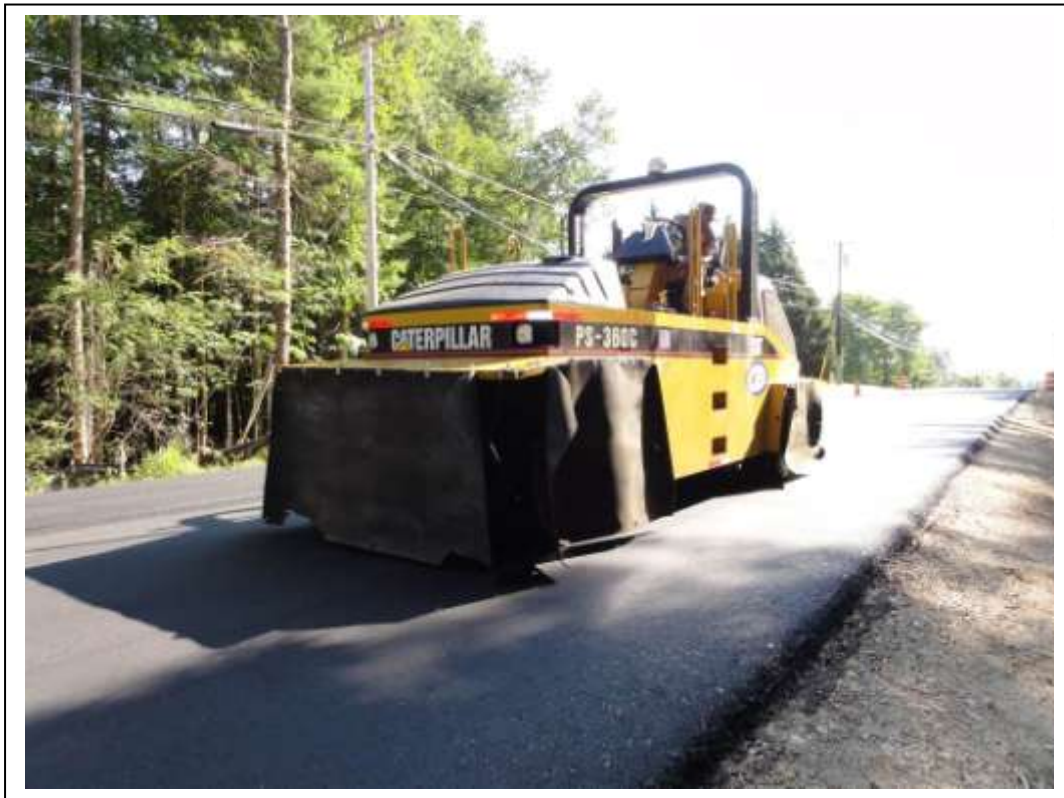
The Caterpillar intermediate rubber tire pneumatic roller shown in Figure 21 was operated right behind the breakdown roller along most of the areas. The roller had 4 tires (15 inch footprint with 9.5 inch gap between tires) in front and 3 tires (15 inch footprint with 9.5 inch gap between tires) in back to cover the gaps between the front tires. The roller was operated without water ballast; the operator indicated that the tire pressure was about 85 psi (pressure set to give good compaction and still allow the finish roller to remove the intermediate roller tire marks).

- Caterpillar intermediate rubber tire pneumatic roller:
 - First pass is on the centerline hanging over about 2 inches.
 - 6 passes to traverse across the pavement such that with each pass the roller moves over about 12 inches.
 - Another 6 passes to traverse back across the pavement.
 - Roller does not get any closer to outside edge than 6 inches (so pneumatic roller does not roll the outside edge where the Safety Edge_{SM} is located).

Figure 21. Rubber tire pneumatic roller used in the intermediate position.

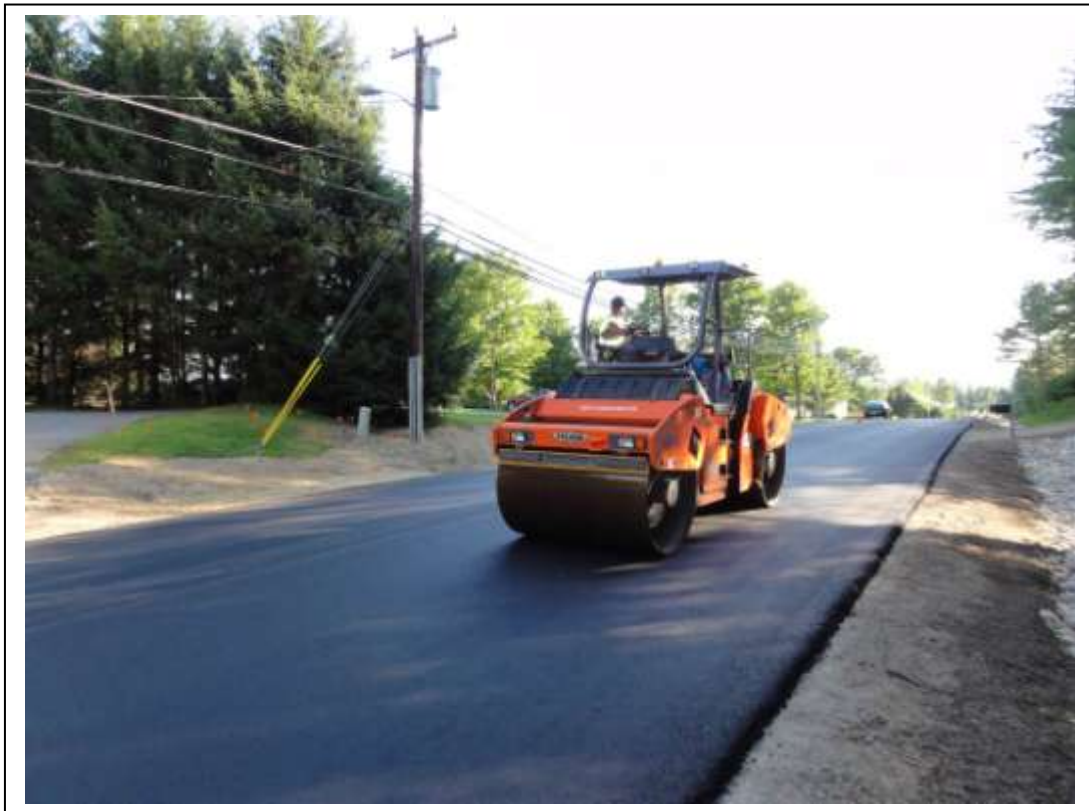
The Hamm finish roller shown in Figure 22 was operated in the static mode. The finish roller operator waited to roll the mat until the temperature was less than 130° at the edges of the mat. The following summarizes the number of passes and coverage used by the finish roller:

- Hamm steel wheel roller; static mode; finish roller:
 - First pass (forward) without vibrations and extended over the centerline edge joint by about 2 to 6 inches.
 - Second pass (reverse) without vibrations and extended over the centerline edge joint by about 2 to 6 inches.
 - Third pass (forward) without vibrations in the middle of the lane.
 - Fourth pass (reverse) without vibrations in the middle of the lane.
 - Fifth pass (forward) without vibrations and extended over the edge joint by about 2 to 6 inches.
 - Sixth pass (reverse) without vibrations and extended over the edge joint by about 2 to 6 inches.

Figure 22. Steel wheel roller used in the finish position.
