Safety Edge_{SM}
Demonstration Project
Brogden Road in
Johnston County,
North Carolina

Field Report
June 1, 2011

The purpose of this field report is to provide a summary of observations made during the warm mix asphalt (WMA) Safety Edge_{SM} project on Brogden Road (State Route 1007) in Johnston County, North Carolina. These observations and data are to be used with similar information from other Safety Edge_{SM} projects to facilitate the development of standards and guidance for Safety Edge_{SM} construction and long-term performance.

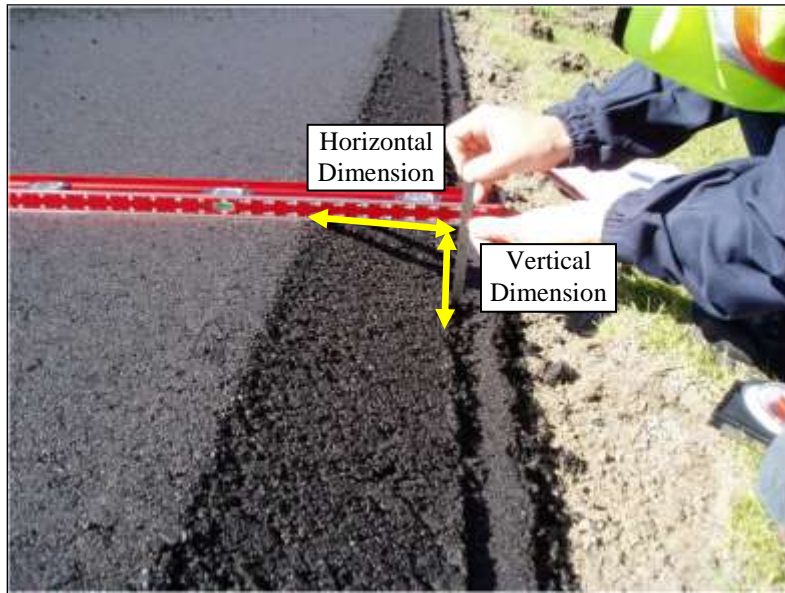
Figure 2. Slope measurement technique.

Slope measurements were recorded on test sections #1 and #2 at 25-foot intervals using a straight-edge and ruler to measure the horizontal and vertical dimensions of the edge (see Figure 2). The following summarizes the average slope measurements:

<u>Pavement Section</u>	<u>Slope</u>
Test Section #1, Troxler Device	28°
Test Section #2, NCDOT Device	26°
Section #3, Control	NA

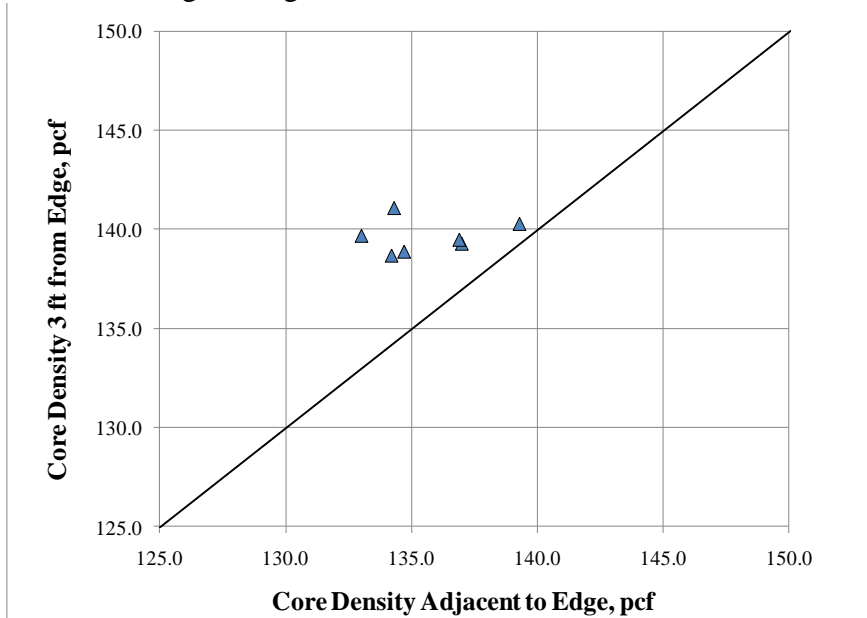
Figure 3. Comparison of core densities adjacent to the edge and 3 feet from the edge.

Several pairs of cores were cut from each test section. Each pair of cores had a core taken 3-feet from the edge of the mat (where the maximum number of roller passes were made) and a corresponding core taken adjacent to the edge (where fewer roller passes were made). Table A-2 in Appendix A lists the stations from where these cores were taken and the respective core thicknesses measured. The laboratory-determined densities from these cores serve to calibrate the nuclear density measurements. Laboratory density was determined from the bulk specific gravity at saturated surface dry test condition. Tables A-3 in Appendix A includes a summary of the laboratory density test results. Figure 3 compares the laboratory

core density readings for the test sections. As expected, the densities 3 feet from the edge were higher than those along the edge of the mat.

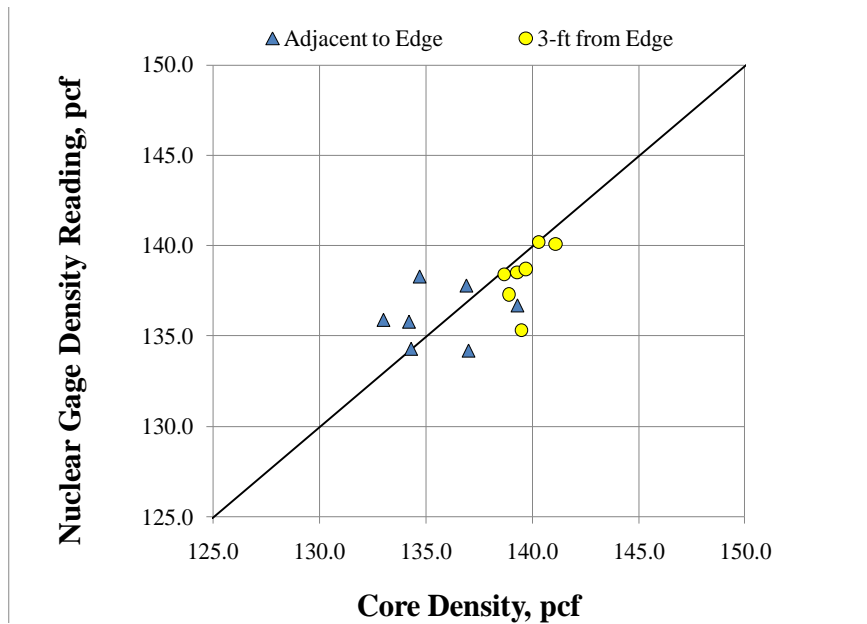
Figure 4. Comparison of the nuclear densities and core densities.

Density tests were conducted using a nuclear density gauge in backscatter mode for 60-second test durations. The tests were conducted at 50-foot intervals at 3-feet from the edge and adjacent to the edge. Table A-3 in Appendix A presents the results of the nuclear density testing along with the laboratory density results from these locations. Figure 4 compares the nuclear density readings to the densities measured on the cores. As shown, there is close correlation between the nuclear gage and core densities.

Adjustment factors were determined from correlating the nuclear density readings and the core laboratory density results shown in Table A-3 in Appendix A. The factors were close to unity and were used to adjust the nuclear density gauge readings to be consistent with the densities that were measured in the laboratory. The adjusted or corrected densities using the correction factors are listed in Table A-4 in Appendix A and are summarized as follows:

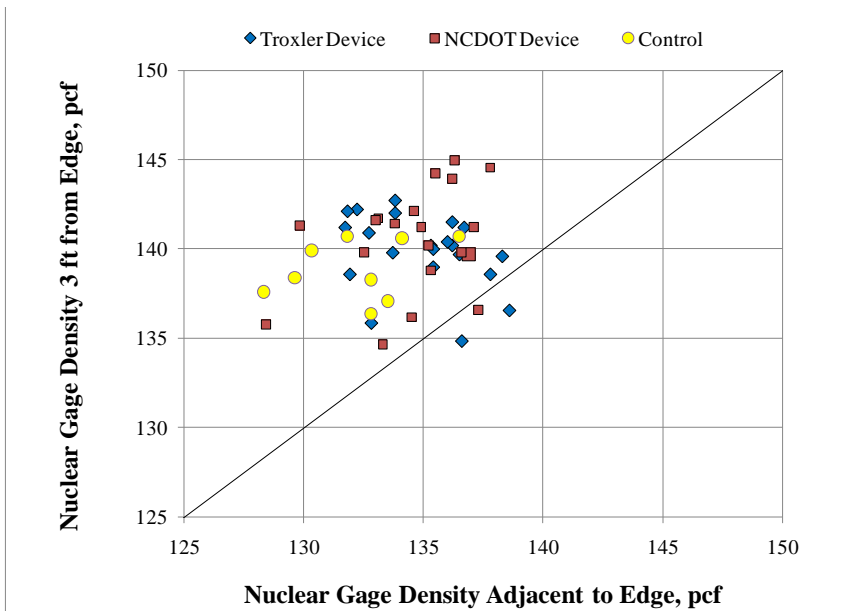
Figure 5. Comparison of the nuclear densities adjacent to the edge and 3 feet from the edge.

The control section had a lower average density value (132.2 pcf) adjacent to the edge compared to section #1 (134.9 pcf) or section #2 (134.8 pcf), suggesting the confining effect of the edge devices helped to increase densification near the edge. The rolling pattern was the same for all three sections and is discussed later in this report.

Figure 5 compares the nuclear densities taken adjacent to the edge and 3 feet from the edge. Generally, the densities were higher 3 feet from the edge in all sections.

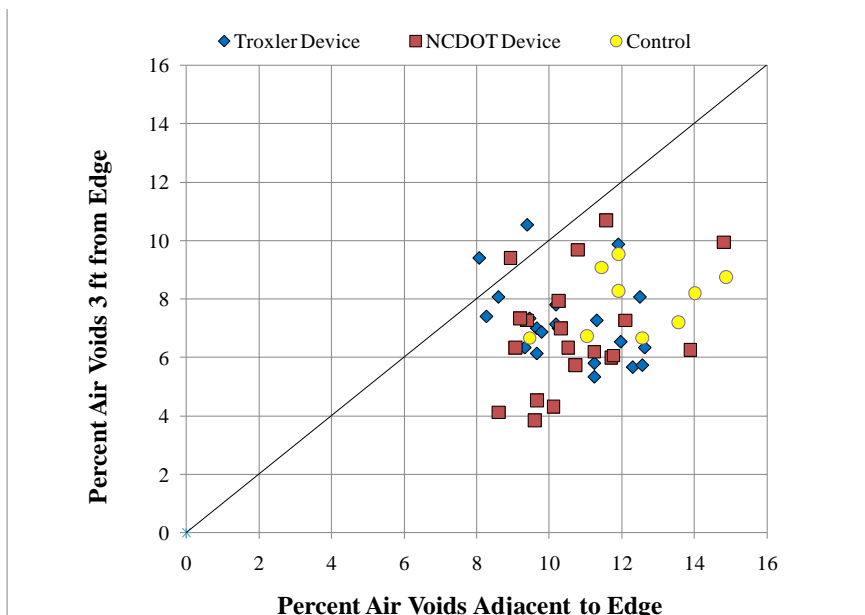
Figure 6. Comparison of the air voids adjacent to the edge and 3 feet from the edge.

Figure 6 compares the air voids (as calculated from the density test results and the maximum theoretical mix density). As shown, the percentages of air voids in the mix usually were higher adjacent to the edge.

Average air voids are summarized in Table 1. This table shows higher air voids in the control section near the edge, underscoring the favorable impact of edge devices on

increasing the quality of the mat near the edge. It is theorized that the confining pressure the edge devices exert on the edge adds to the compaction at the edge.

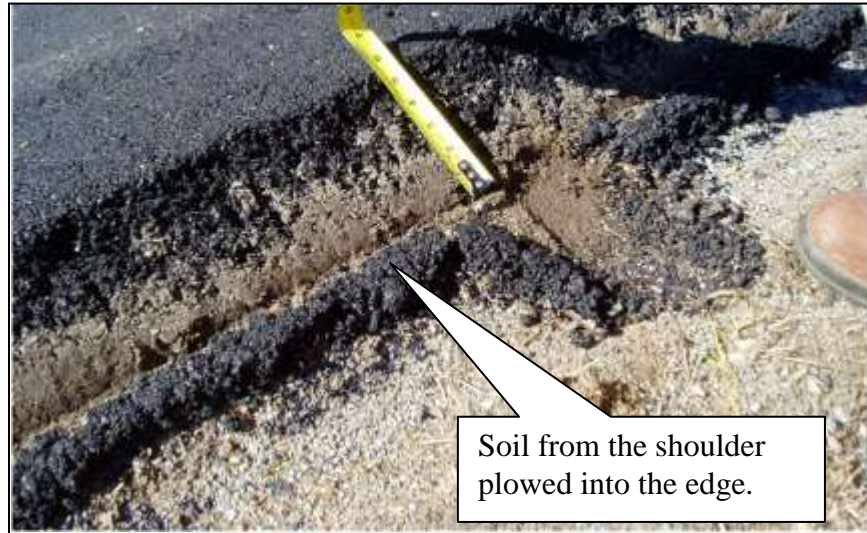
Figure 9. Example of the Safety Edge_{SM} device plowing up soil into the Safety Edge_{SM}.

The contractor clipped the shoulder which is standard practice for this scope of project. The conventional shoulder clipping operation was used, which did not take into account the extra width needed for the Safety Edge_{SM}. Figure 8 shows there was enough room at this particular location, but that was not always the case. At some isolated locations the shoulder was not clipped wide enough. Although equipment was used to prepare the shoulders, labor was needed occasionally to rake or shovel clumps of soil from the shoulder ahead of the paver. Figure 9 shows an isolated instance in which the Troxler SafeTSlope Edge Smoother was running on soft soil, resulting in the device plowing soil into the Safety Edge_{SM}.

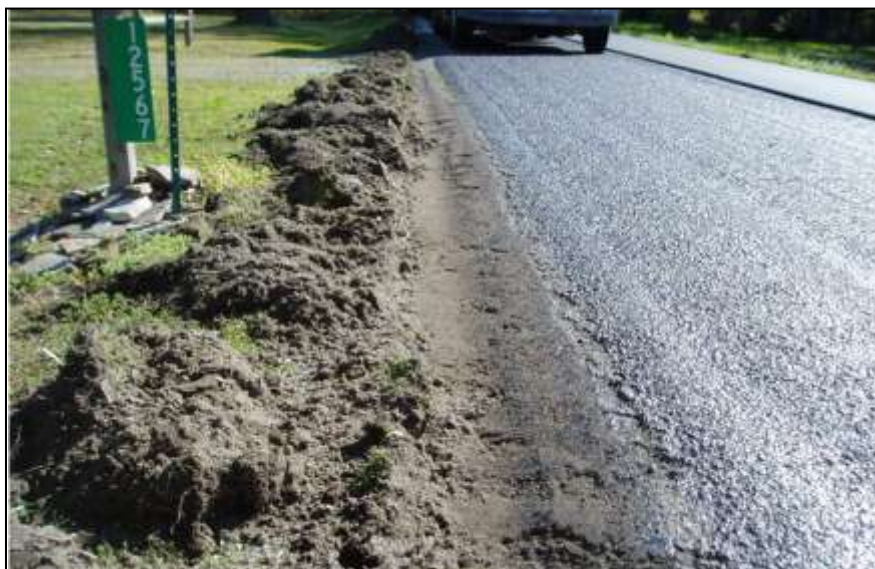
Figure 10. Soil/vegetation piled up from edge preparation work.

At some locations the clipping removed a large amount of buildup from the edge of the road. Figure 10 shows mounds of soil/vegetation piled up from the edge preparation work.

Given the extent of shoulder clipping and preparations needed for the Safety Edge_{SM}, it is expected that more asphalt material would be placed than with conventional overlays. However, this will depend heavily on the existing site conditions. On this project, a reliable account of the extra tonnage of WMA was not available, and the contractor stated that all projects overrun the estimated amount of material regardless of a conventional edge or Safety Edge_{SM}.

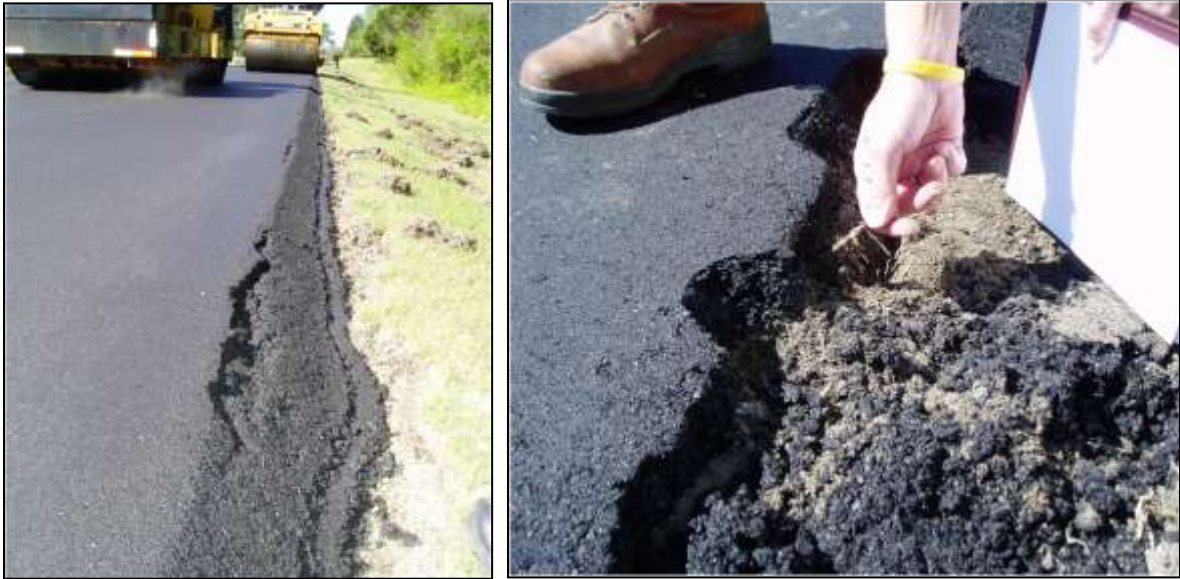
Figure 14. Isolated longitudinal edge cracking (left) and investigation revealed soil/vegetation under the pavement edge (right).

At a few isolated locations, longitudinal cracks quickly developed near the breakpoint of the slope face after the breakdown roller finished making passes (Figure 14). The asphalt mix was removed with hand tools to reveal that the reason for the cracking was the pavement edge was placed over soil/vegetation and not on top of the existing pavement. This resulted in paving on top of differential structural support which resulted in the longitudinal crack. The longitudinal crack would happen regardless of the presence of the Safety Edge_{SM}.

- Preparing the edge of the existing pavement for this project was important to create room and remove vegetation for the Safety Edge_{SM}.
- The edge of pavement separated from the mat at an isolated location where the edge of pavement was placed over soft soil/vegetation. This would have occurred

- regardless of the use of the Safety Edge_{SM}; nevertheless, this underscores the importance of preparing the edge of the pavement.
- The contractor was able to attach and operate both devices successfully.

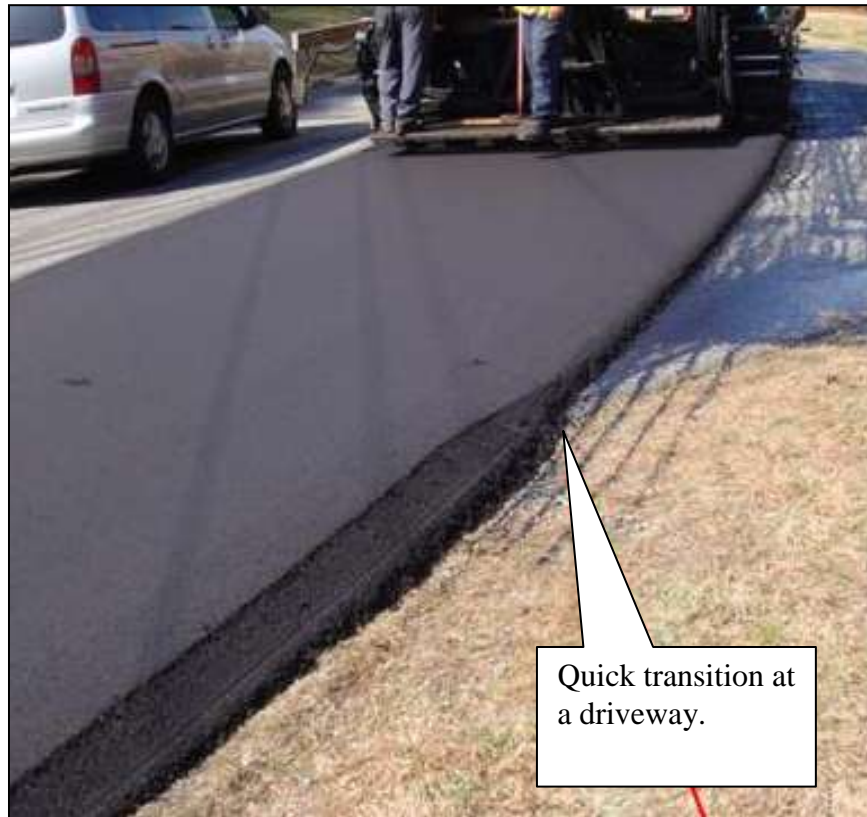
Figure 22. Transition at a driveway.

The second prototype was used successfully on the fifth route under the contract prior to Brogden Road. The contractor used an electric drill with a 15/16 inch bit to raise and lower the device at driveways in a matter of seconds. Figure 22 shows an example of the short transition length created by the ability to raise the shoe quickly for an approaching driveway. The shoe did not have to be removed; however, the cotter pin holding the shoe up had a tendency to come loose as the device was being raised and lowered.
