**Safety Edge<sub>SM</sub>**  
**Demonstration Project**  
**Little Divine Road in**  
**Johnston County,**  
**North Carolina**

Draft Field Report  
July 1, 2011

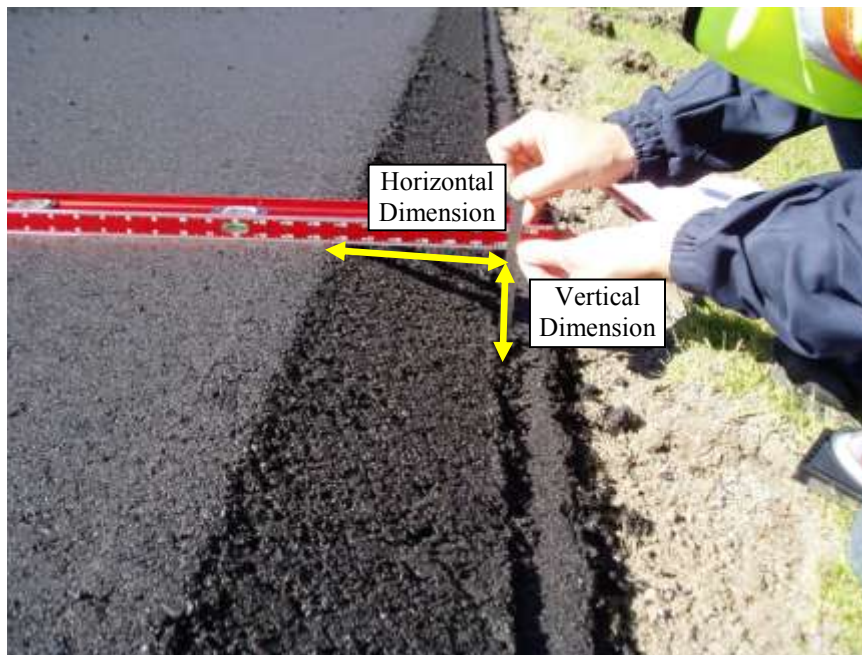
Figure 2. Slope measurement technique.

Slope measurements were recorded at 25-foot intervals using a straight-edge and ruler to measure the horizontal and vertical dimensions of the edge (see Figure 2). The Carlson device was set at a 25° angle and produced an average slope of 29° after compaction.

Table A-1 in Appendix A contains slope measurements recorded at each individual measurement location. Accurate edge thickness measurements were not possible due to the slope of the Safety Edge<sub>SM</sub> extending over the edge of the existing pavement, thereby exaggerating and confounding the edge thickness measurements.

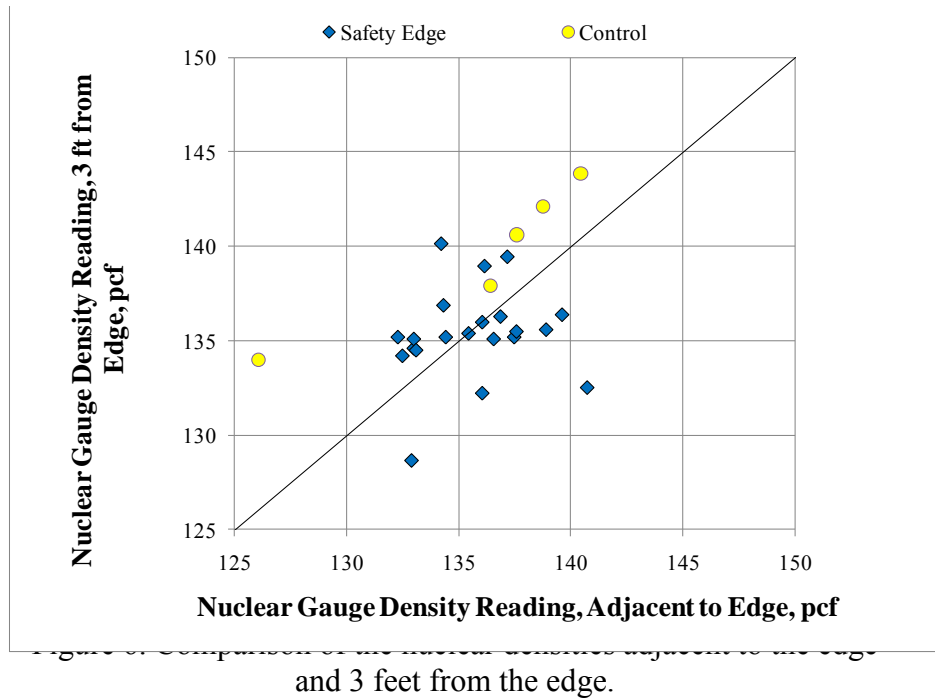
Figure 6 compares the density values taken adjacent to the edge and 3 feet from the edge. Generally, the Safety Edge<sub>SM</sub> section shows no distinct trend in the relationship between data adjacent to the edge and 3 feet from the edge whereas, the values for the control section tend to be higher 3 feet from the edge.

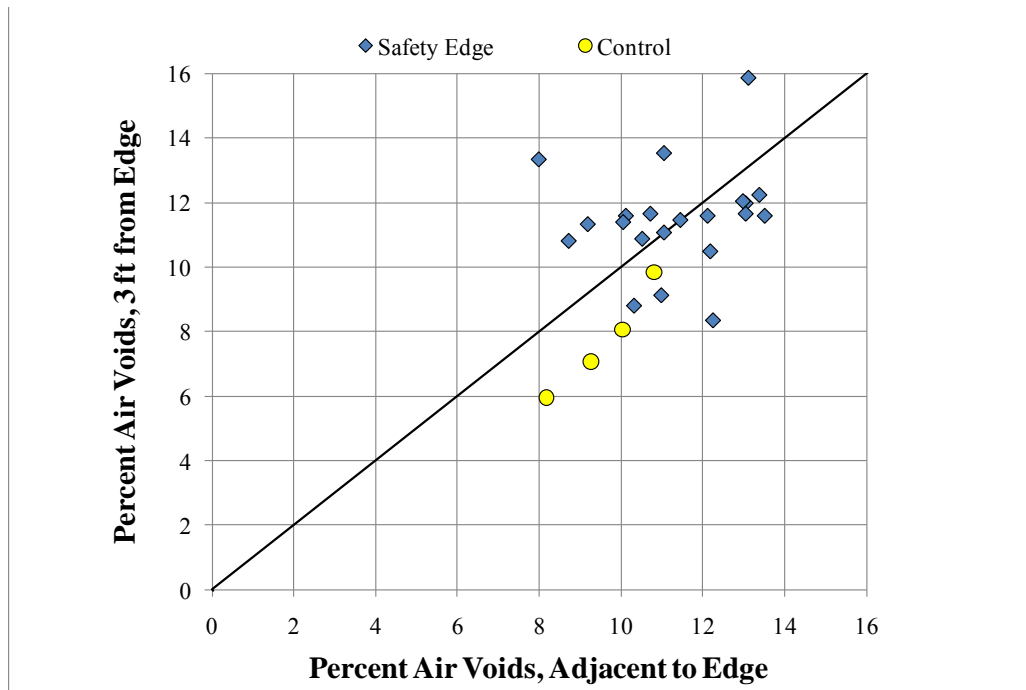
Figure 7 compares the percent air voids (as calculated from the density test results and the maximum theoretical mix density). The percent air voids shows no clear trend for the Safety Edge<sub>SM</sub> section whereas, the values for the control section were higher adjacent to the edge.

Figure 7. Comparison of the air voids adjacent to the edge and 3 feet from the edge.

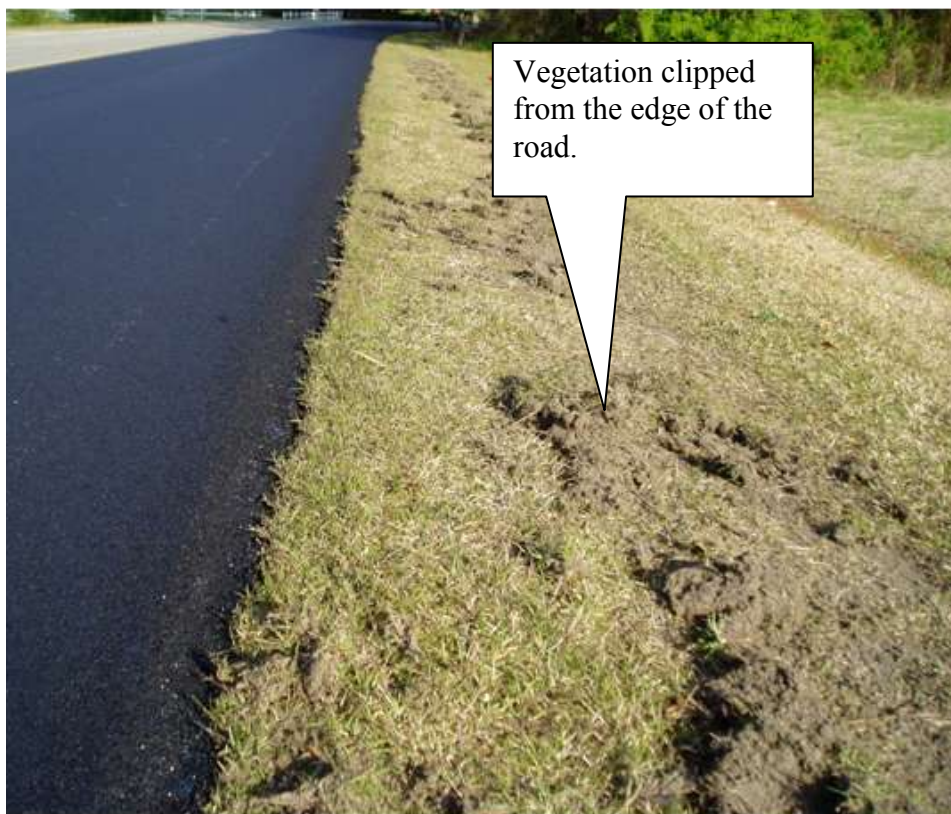
Isolated HMA patching and continuous brooming was conducted prior to paving. In limited locations the contractor used a small tractor equipped with a blade to clip soil/vegetation from the edge of the road, exposing the existing edge of pavement. Figure 8 shows some of the vegetation removed by the preparatory work. There were a few isolated areas where the soil/vegetation was slightly higher than the existing pavement and should have been clipped back farther to make room for the Safety Edge<sub>SM</sub>. It is important to clip the shoulders far enough back so the soil/vegetation does not become mix with the asphalt during paving.

Figure 8. Vegetation removed by clipping the edge of the existing pavement.

- It is important to clip the shoulders far enough back so soil/vegetation does not become mixed with the edge of the asphalt during paving. Clipping should be extended farther into the existing shoulder than with conventional overlays to allow extra width for the Safety Edge<sub>SM</sub>.

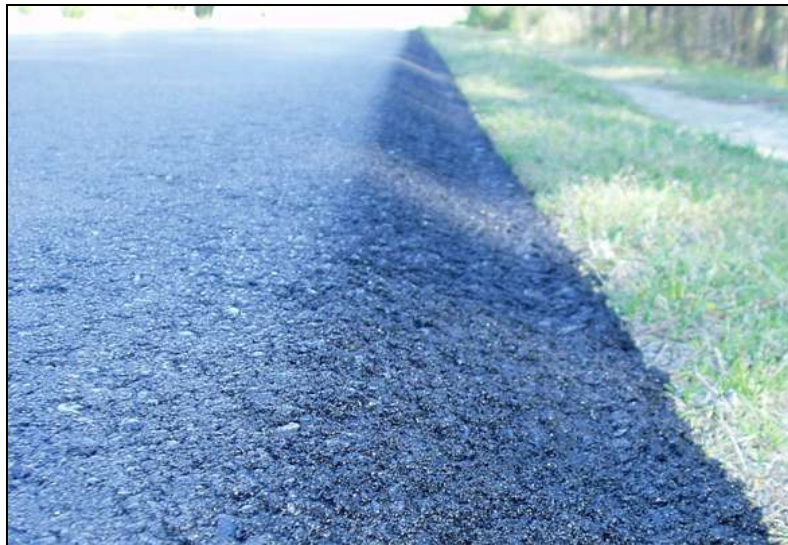
The Carlson device created a 0.25-inch vertical lip at the breakpoint of the edge as shown in Figure 9. The lip was compacted flat by the rolling operation. The texture of the finished slope face of the Safety Edge<sub>SM</sub> edge as shown in Figure 10 was nearly as smooth and sealed as the rest of the mat.

Figure 10. Texture of the Safety Edge<sub>SM</sub> slope face was nearly as smooth and sealed as the rest of the mat.

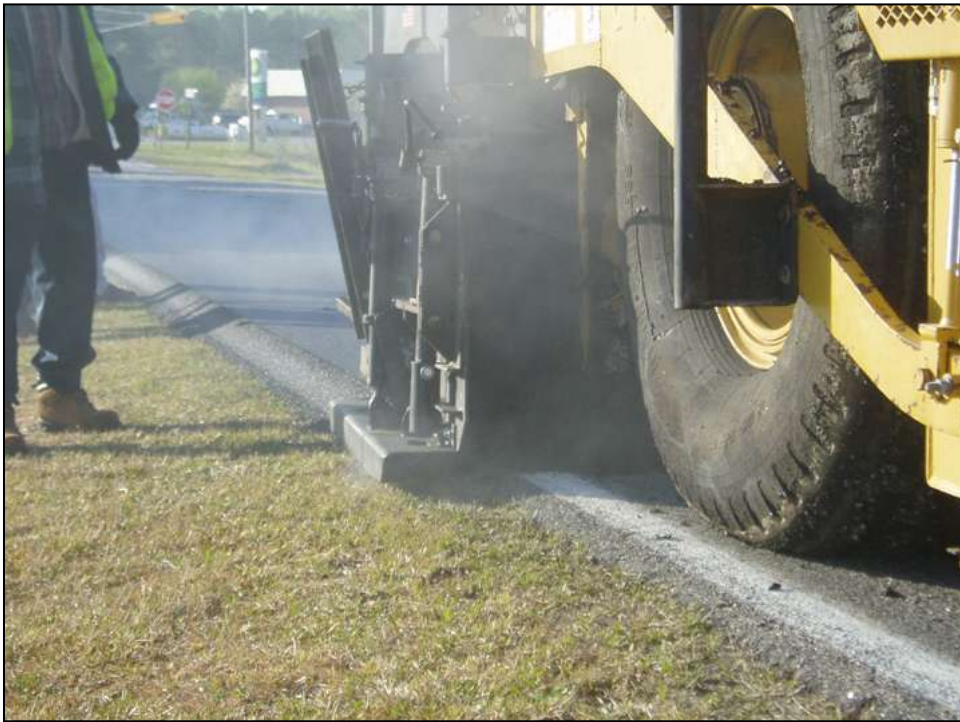
The Carlson device was set at a horizontal angle to the mat as shown in Figure 11 to add confining pressure to the edge as the paver moved forward. Figure 12 shows the Safety Edge<sub>SM</sub> directly behind the Carlson device.

Figure 11. Angled approach of the Carlson device.

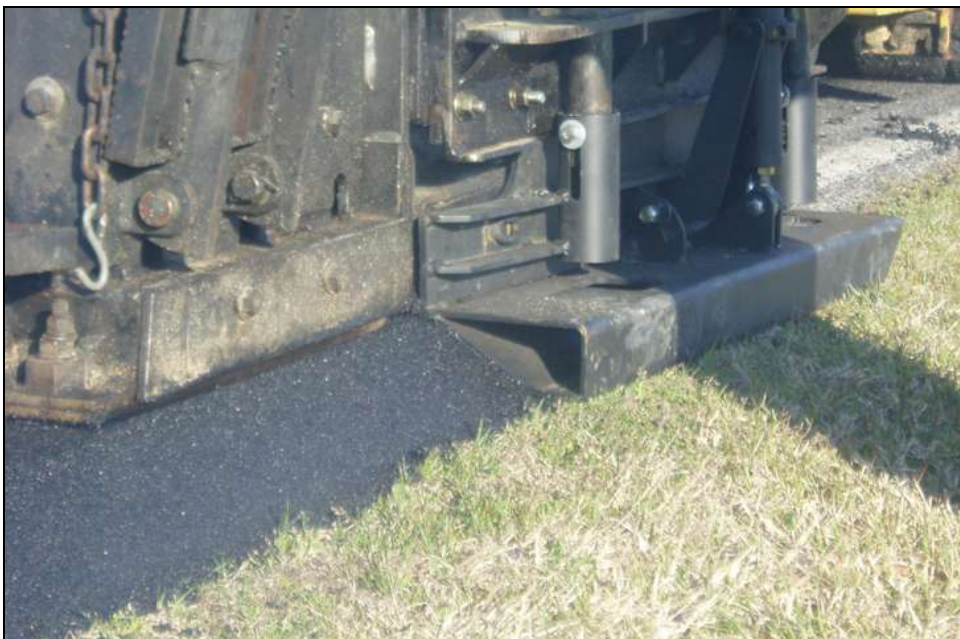
Figure 12. Safety Edges<sub>SM</sub> directly behind the Carlson device.
