CASE STUDY

HIGH FRICTION SURFACE TREATMENT (HFST)

High Friction Surface Treatments: Not Just for Rural Curves

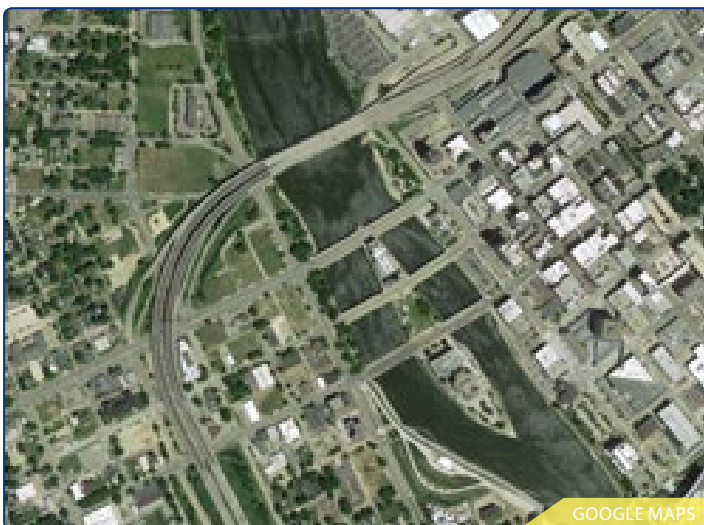
Figure 1. 5-in-1 Cedar Rapids Bridge

Iowa Department of Transportation (IDOT) chose to install their introductory HFST application on a bridge over the Cedar River. The 5-in-1 structure comprises four bridges: north and southbound I-380, eastbound “A” Avenue, westbound “F” Avenue, and a dam. Located just west of the river, the curve is a part of the six-lane urban I-380 that runs through Cedar Rapids and carries approximately 85,000 vehicles per day. Several large corporations surround this area and ship supplies nationwide, contributing to the approximately 7,800 heavy trucks that use the bridge daily.

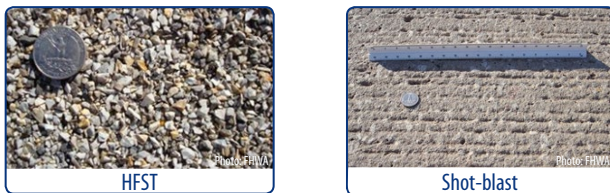
Figure 2. HFST Treatment Texture Compared to Shot-blasting Texture

IDOT staff considered and compared multiple pavement friction restoration technique solutions that would reduce crashes significantly and quickly. One potential solution was shot-blasting, which may temporarily increase friction values into the low 60s. IDOT also considered repaving this portion of I-380, but the expense was greater than available funding. Further, the new surface could have polished quickly due to the high traffic volumes, volumes of heavy trucks, and frequent lane changes just as the existing pavement had experienced.

In June 2012, IDOT installed a single layer of HFST at this location after existing pavement was shot-blasted to provide better HFST adhesion. Additional work included deck patching, pavement marking removal, joint covering, shot-blasting, and automated HFST application.

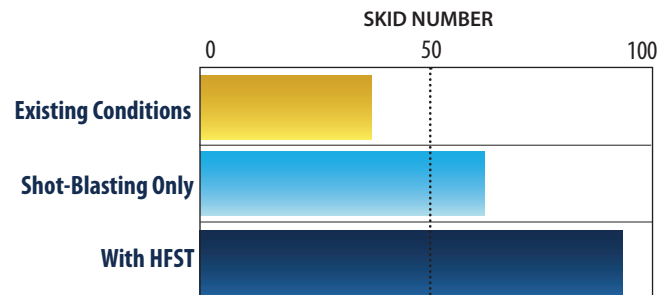
Figure 3. Pavement Friction Levels on 5-in-1 Bridge I-380, Cedar Rapids, Iowa

Immediately after installation, IDOT measured friction values in the 90s and low 100s and found that they stayed approximately the same several months later. When tested again over a year later, they found that values ranged from the 80s to low 100s. Figure 3 displays comparative pavement friction levels taken at this location for:

- Existing pavement conditions prior to HFST installation,
- Short-term friction increases provided by shot-blasting, and
- Long-lasting friction increases after HFST installation.
