August 25, 2008
Miami-Dade Pedestrian Safety Project: Phase II
FINAL IMPLEMENTATION REPORT AND EXECUTIVE SUMMARY

Pedestrian Safety Engineering and Intelligent Transportation
System-Based Countermeasures Program for Reduced Pedestrian Fatalities,
Injuries, Conflicts and Other Surrogate Measures: Miami-Dade Site

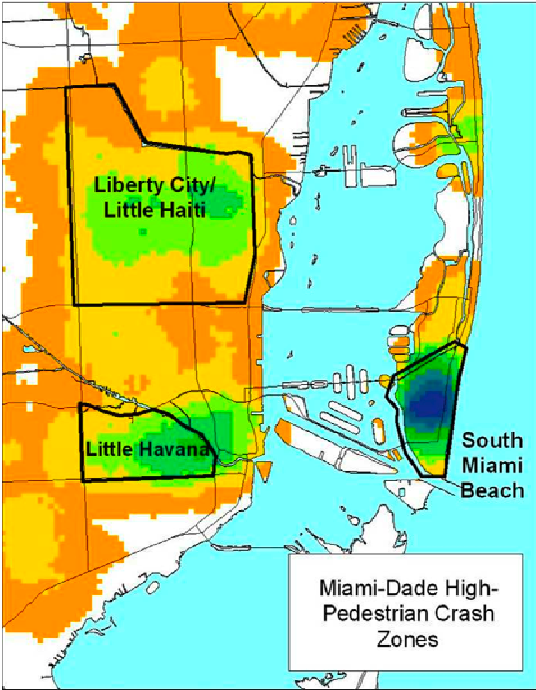
Figure 1.1 Miami-Dade High Pedestrian Crash Zones

Miami-Dade County has the highest incidence of pedestrian injuries and fatalities in the State of Florida, which ranked within the top two states in number of pedestrian crashes as well as per capita pedestrian crashes during the baseline period. In recent years the pedestrian crash rate had remained relatively steady prior to the implementation of the NHTSA and FHWA Pedestrian projects. During the nine years prior to the FHWA project there were a total of 15,472 pedestrian crashes in the DHSMV Miami-Dade County, which included 670 fatal crashes (4.2 percent). Figure 1.1 shows the geographic distribution of pedestrian crashes during the baseline period as a crash density map. High crash zones are represented by darker colors. Figure 1.2 shows the Crash map for South Miami Beach. South Miami Beach has the highest crash density in Miami-Dade County.

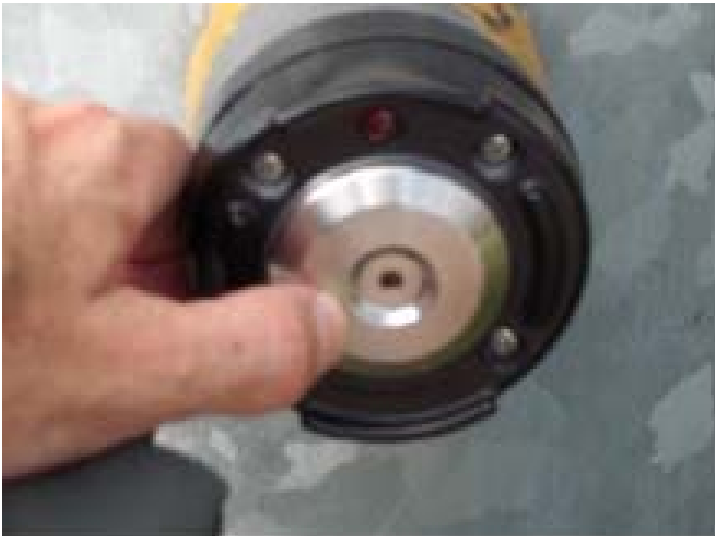
Figure 3.1 Picture of Pedestrian Push Button That Confirms Press

This treatment consists of a pedestrian stainless steel push button with a piezo driven solid state switch that provides two types of feedback when the push button is pressed. First, the button is illuminated with a 1200 mcd red light emitting diodes (LED) for 0.1 s (Momentary LED Model) and second, a 2.6 kHz tone is sounded simultaneously with the LED flash when the button was pressed and a 2.3kHz tone was sounded when the button was released. The device could also be modified so the light remained on until the onset of the “WALK” indication. These buttons were installed at 17 intersections, typically with 2 buttons per intersection.

Notes: It was difficult to see the LED light in bright Florida sunlight. It appeared that the auditory feedback was more critical to the efficacy of the device. In areas with less bright sunlight the pilot light might be more salient. These buttons might also be of useful to visually impaired pedestrians because they confirm the button press. However, accessible call buttons with a locator tone would be preferred when taking into account the needs of visually impaired pedestrians.

These devices seem reliable and durable and are associated with minimal maintenance needs. Because these push buttons provide feedback when they are pressed we observed fewer multiple presses, which could extend the life of the buttons, reducing maintenance costs over conventional buttons.

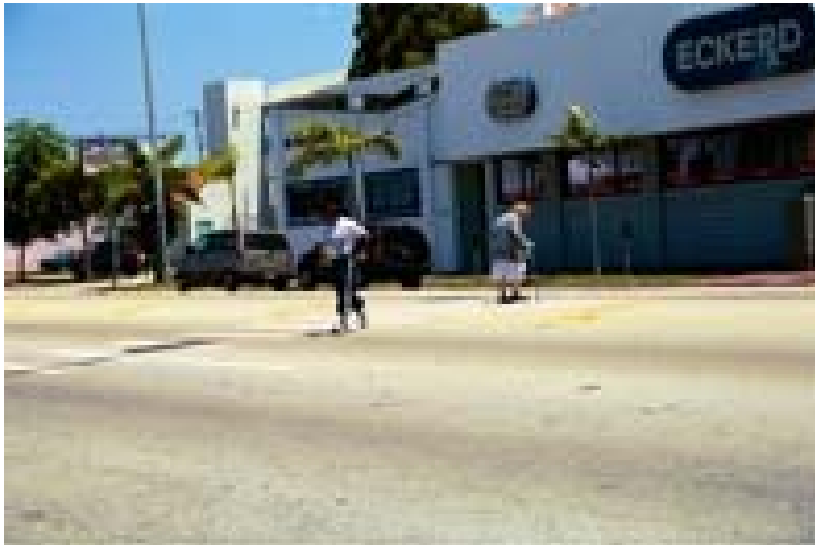
Figure 3.2 Picture of Midblock Crossing with Reduced Minimum Green Time

This treatment was installed at mid-block traffic signals. It required the signal to be operated in isolation mode (non synchronous timing). The minimum green time was reduced to decrease pedestrian wait time and increase compliance with the signal. Three of these treatments were installed as indicated in table nine. Prior to the start of the study both signals were run in synchronous mode, and the cycle length was 130 s between 8 am and 8 pm at the Alton Road crosswalk and varied from 90 s to 120 s at the crosswalk on SW 8th Street. Minimum green time was evaluated at 30 s, 1 minute and 2 minutes at both crosswalks. The speed limits at these locations were 35 mph on Alton Rd. and 30 mph on SW 8th St.

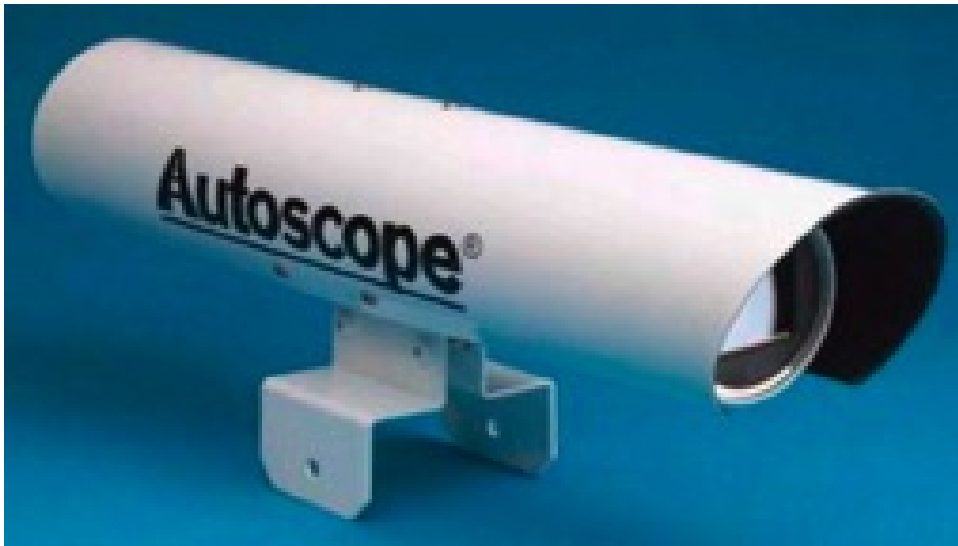
Figure 3.3 Picture of Device Used For Pedestrian Detection

This device uses video detection technology to detect the pedestrian and put in a call for a mid-block traffic signal. An Autoscope Solo Pro was used for pedestrian detection in this study. The processor was included in the camera. The camera sent compressed video via twisted pair. Two rectangular zones were set up on the sidewalk approaching the curb; the pedestrian had to cross both zones to trigger the device. The device could determine direction of movement by the order in which the zones were crossed. With this method the pedestrian only put in a call when entering the crosswalk. This system was installed at one midblock traffic signal on Alton Road.

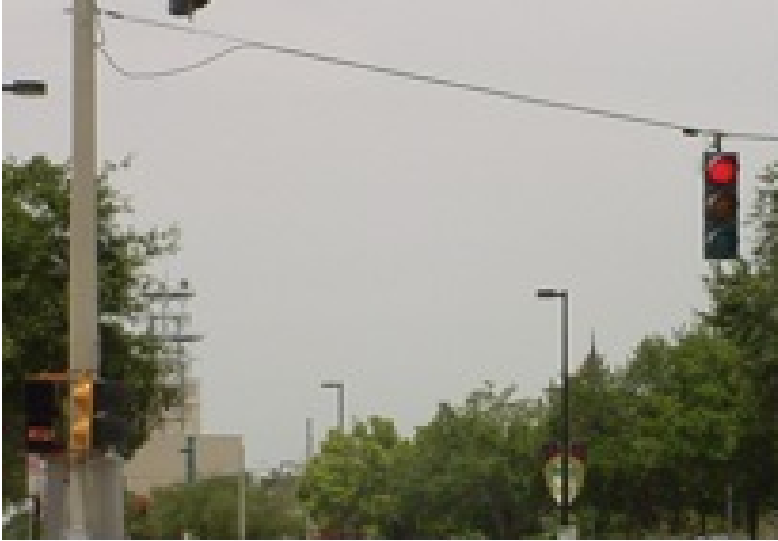
Figure 3.4 Picture of Leading Pedestrian Phase

The purpose of this device was to give a head start for pedestrians over left and right turning vehicles at the start of the WALK. Pedestrians crossing the main line receive a 4 second exclusive pedestrian phase while all vehicle signals remained in the all red phase. These vehicles lost 4 seconds of green time in order to give the pedestrians a 4 second exclusive pedestrian phase. This treatment provides the best protection from vehicles turning left and provides less protection from vehicles turning right because they may still turn right on red.

Notes: This treatment was effective at increasing yielding by drivers turning left but was not effective at improving the behavior of drivers turning right. Prohibiting right turn on red at the start of the WALK when a pedestrian pushed the call button should greatly improve the efficacy of this countermeasure.

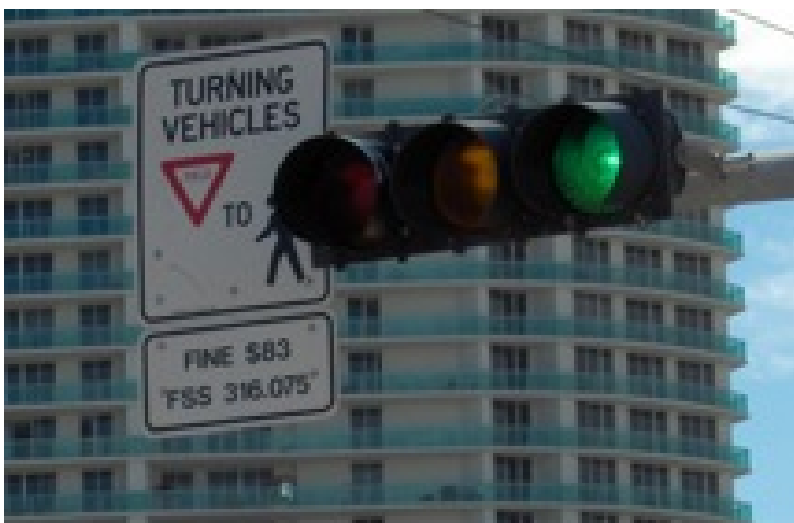
Figure 3.5 Picture of “Turning Vehicles Yield to Pedestrians” Symbol Sign

This treatment was a symbol version of the “Turning vehicles must yield to pedestrians” text sign. This sign retained the text message “Turning vehicles” and “to” and substituted the yield symbol for the word “yield” and the pedestrian symbol for the word “pedestrian”. The purpose of using this sign in place of the text message sign was to make the sign more comprehensible to tourists that were not native speakers of English and to increase recognition distance.

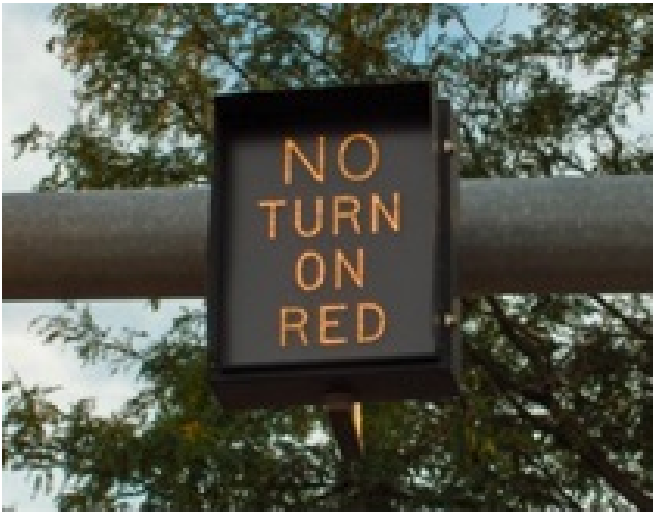
Figure 3.6 Picture of Electronic No Turn on Red Sign

This sign was illuminated when right turn on red was not permitted. The sign was installed on the mast arm in the same location that the static “No turn on red when pedestrians in crosswalk” sign and the “No turn on red” sign were installed. This allowed a direct comparison of all three signs.

Notes: The electronic NRTOR sign reduced the percentage of motorists turning right-on-red when a pedestrian was present over that produced by the two static signs and reduced the percentage of conflicts between vehicles turning right on red and pedestrians crossing within the crosswalk over the other two signs. However there were many violators during all conditions. The electronic sign had an even larger effect on increasing the percentage of violators coming to a complete stop

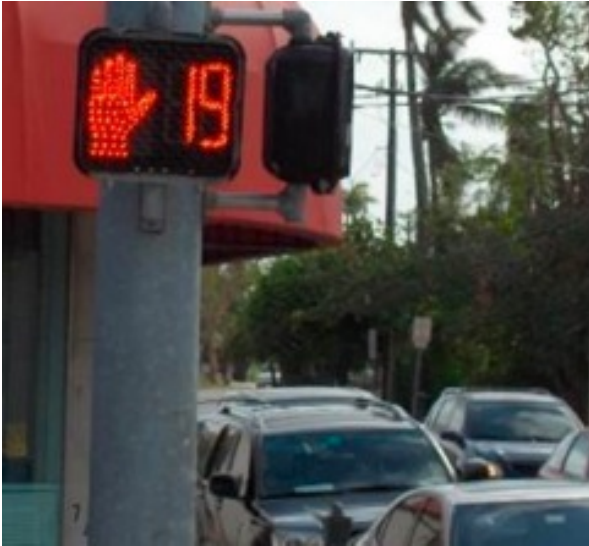
Figure 3.7 Picture of a Pedestrian Countdown Signal

This treatment was a countdown pedestrian signal that displayed a walking person symbol during the "WALK" indication, counted down the seconds in the clearance phase along with the flashing hand display, and displayed the solid hand during The "DON'T WALK" indication which began during the all red phase. These signals were

programmed to begin the countdown at the start of the pedestrian clearance (flashing hand) phase and counted down to 0 at the end of the yellow phase.

Notes: The countdown displays decreased the percentage of pedestrian in the crosswalk during the all red phase and were associated with an increase in the percentage of pedestrians that pressed the call button as well as the percentage of pedestrians that pressed the call button that then waited for the WALK indication.

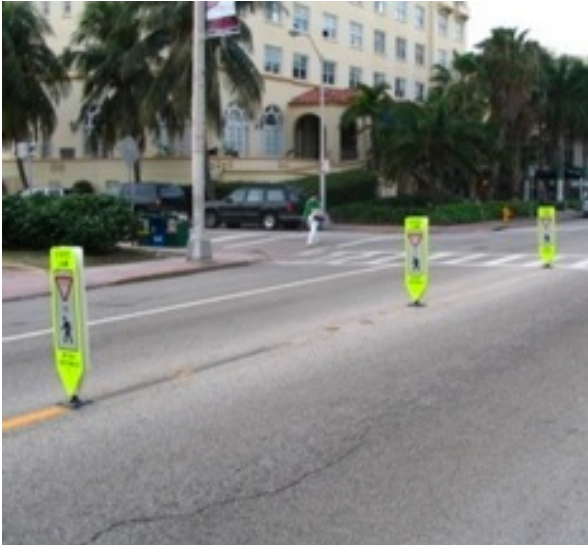
Figure 3.8 Picture of In-street “Yield to Pedestrians” Signs

In-Street Pedestrian Signs are intended for use at uncontrolled (not signalized) crosswalks to remind drivers of laws regarding pedestrians’ right-of-way. They are more noticeable than roadside signs and may also exert a minor traffic-calming effect by effectively narrowing the inside lanes slightly. Dimensions and color: 12” x 44”, fluorescent yellow green diamond sheeting with 10” x 24” white high intensity sheeting inserts. Overall height is 47 inches. The signs can be installed with either a portable or fixed base.

Notes: These signs were effective but had a very short lifespan. The streets were narrow and did not have a median island to protect the signs. We found that using three signs on each approach was no more effective than using one.

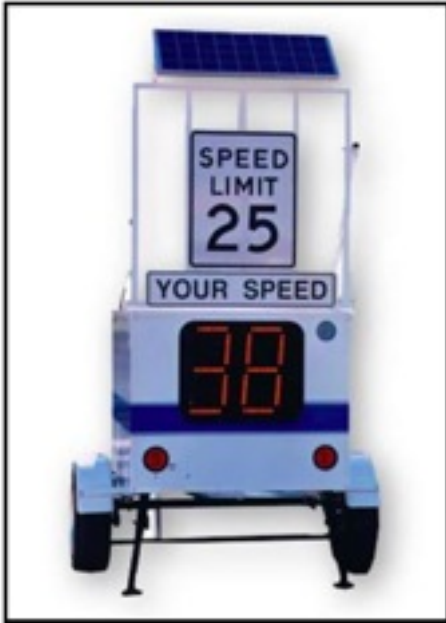
Figure 3.9 Picture of a Speed Trailer

Portable Changeable Message Speed Limit Signs, also known as “radar speed trailers,” are used to deter speeding. These devices can be installed along the side of the road; typically in parking areas, and display the speed of each approaching vehicle and can flash LEDs when the approaching vehicle is speeding. A speed limit sign is included on the trailer. Above a user-selected maximum, the sign “blanks out” to avoid enticing drivers into exhibitions of speed. A computer within the device recorded speed data.

Notes: These signs reduced braking for pedestrians but had little effect on vehicle speed. One reason why the sign was ineffective in reducing vehicle speed was most vehicles were already driving within the speed limit.

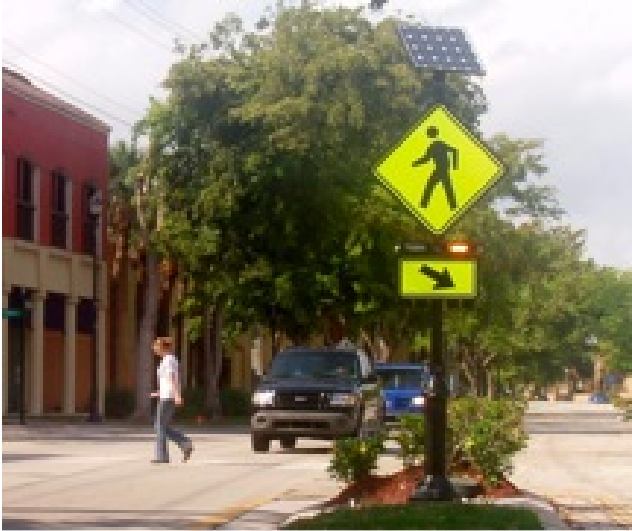
Figure 3.10 Picture of Rectangular LED Rapid Flashing Beacons

This treatment was the standard pedestrian warning sign with two LED flashers attached (see Figure 1). The LED flashers were each 6 inches wide and 2.5 inches high placed 9 inches apart. Each unit was dual indicated (LED's on front and back). Each side of the LED beacon flashed in a wig-wag flashing sequence (left, then right) the 2 large LED's in combination flashed 76 times in the wig-wag flashing sequence during a 30 second cycle. Of the 2 large LED's, the Left LED, flashed 2 times (in a slower type of a rapid flash) each time it was energized followed by the Right LED, which flashed in a very fast rapid 3 flash volley when energized. The total number of flashes in this combination was 190 total flashes per 30 second cycle. Four signs along with beacons were installed at each crosswalk. The devices were linked by radio frequency transponders so a depression of any of the pedestrian call buttons immediately activated the flashers on all four signs. At the South Bayshore Drive crosswalk a sign was placed on the left side of each approach and on the right side of each approach at the median island. At the NW 67th Street site a sign along with beacons was placed on the left side of each approach and on the right side at a median just after the crosswalk on the northbound approach and before the

crosswalk on the southbound approach. A LED facing the pedestrian flashed to indicate to pedestrians that the system was operating. The system also presented an audible message instructing pedestrians that the light flashing across the street indicates that the device was operating, and instructing them to wait for cars to stop before crossing. Signal duration was timed assuming a crossing speed of 3.5 feet per second.

These devices seem very reliable. The primary maintenance issue would be the repair or replacement of a unit if a vehicle strikes it.

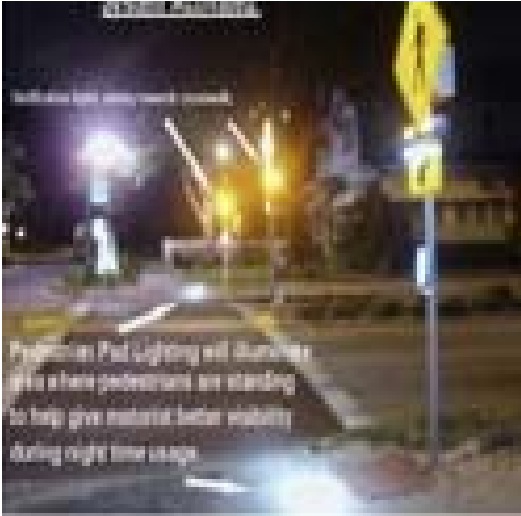
Figure 3.11 Picture of Dynamic Lighting

This treatment was used in conjunction with the rectangular LED rapid flashing beacons treatment described above. When a pedestrian pressed the call button to activate the beacon at night, the device was activated and LED white lighting illuminated the departure portion of the curb face and the first 4 feet of the crosswalk. This dynamic pad lighting consisted of four 2.5 by 1.25 inch housings each containing 3 LEDs.

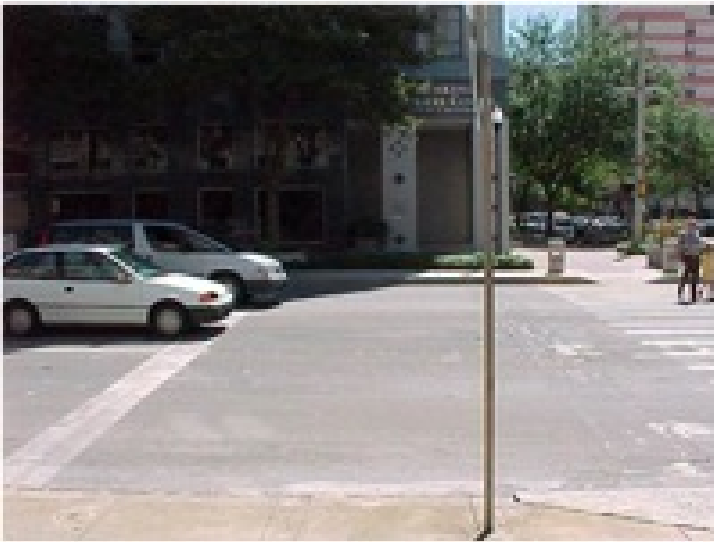
Figure 3.12 Picture of Offset Yield Lines

This treatment involved installing stop bars 20 feet in advance of the crosswalk rather than the minimum distance of 4 feet in advance of the crosswalk. Studies have shown that offset and setback stop bars can reduce vehicle/pedestrian conflicts. Setting back stop bars has also been shown to add .75 s to intersection clearance time and can reduce turning vehicle threats by increasing intersection visibility.

Notes: This treatment is easier to install on fresh pavement.

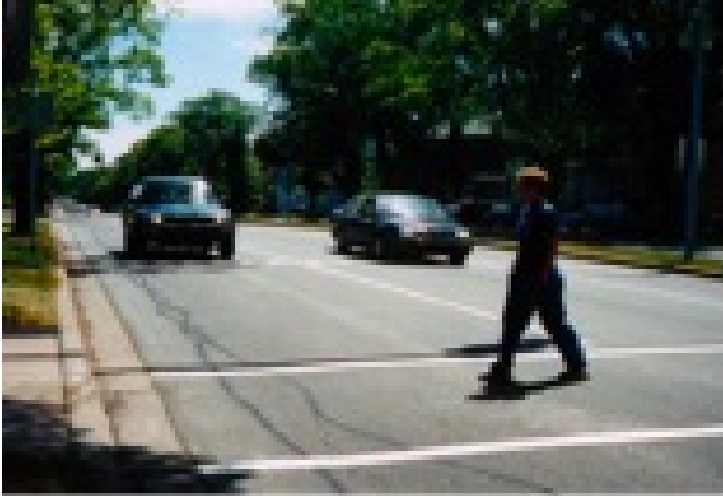
Figure 3.13 Picture of Advance Yield Markings

Advance yielding markings may be installed in advance of crosswalks at uncontrolled locations. Previous work has shown that advance yield markings placed 30 feet in advance of the crosswalk increases the distance that drivers yield in advance of the crosswalk. Advance yield markings were only installed at one site because the sign size specified in the 2003 manual was much smaller than the sign used in the research that supported the introduction of this marking into the manual.

Notes: This treatment is designed to reduce multiple threat conflicts and therefore has been installed at the two multilane locations with the rectangular LED rapid flash beacon.

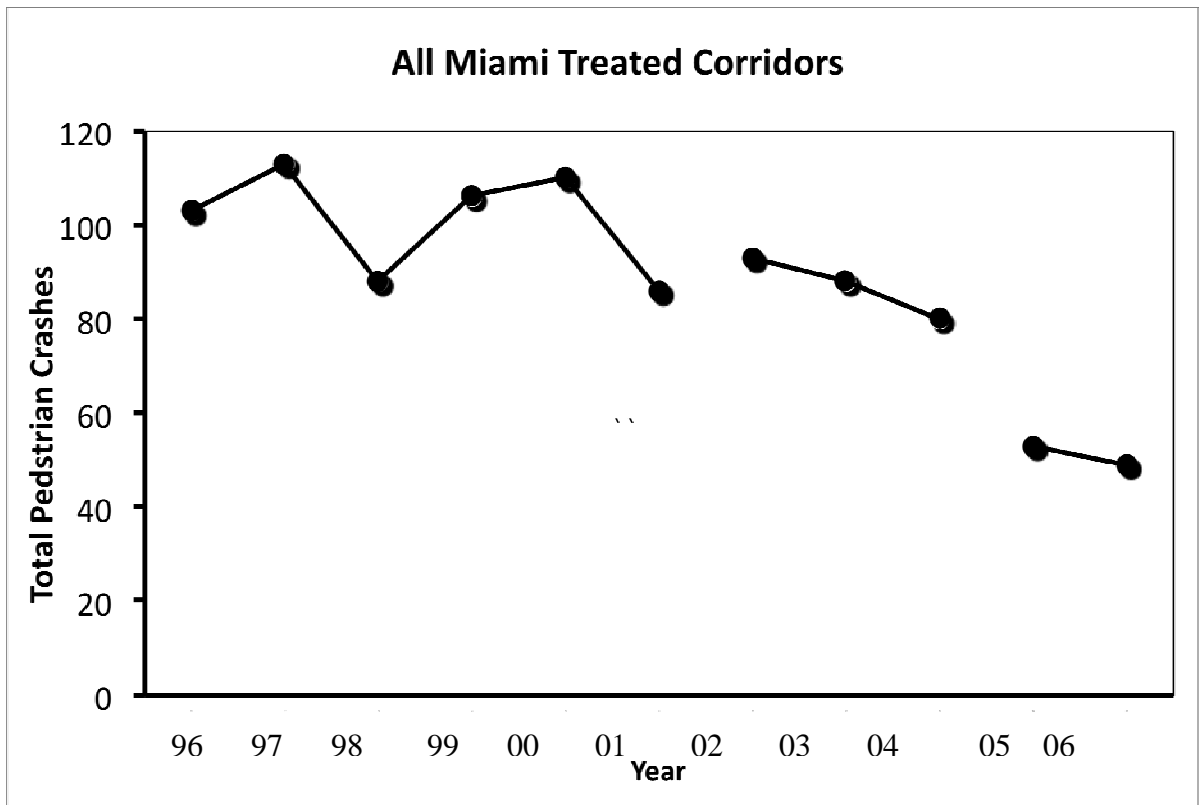
Figure 4.2 Crashes per Year for All Eight Crash Corridors from 1996-2006

Data were collected for each corridor for 6 years prior to the introduction of the NHTSA project, for the 3 years that the NHTSA project was implemented, and for an additional 2 years that the FHWA project was implemented. This provides a total of 11 years of crash data along these high crash corridors. Figure 4.2.1 shows the crash rate for all eight treated corridors remained reasonably stable with a slight downward trend during the 6 years prior to the introduction of the NHTSA project. The introduction of the NHTSA project appeared to lead to a small decrease in pedestrian crashes from a mean of 101 during the baseline period to a mean of 87 (a decrease of 11.5%) during the three years that the NHTSA project was in effect. The installation of the engineering countermeasures on top of the NHTSA education and enforcement efforts lead to a further reduction to an average of 51 crashes per year. This represents a 50% reduction over the baseline level and a 41% reduction from the NHTSA project levels. It is interesting to note that during the 9 years prior to the FHWA project there were 15,472 pedestrian crashes in Miami-Dade County. Of these 46% occurred on State and County Roads for a total of 7,117 crashes or 791 crashes per year. Around 100 per year or nearly 13% of these crashes occurred along the treated corridors.

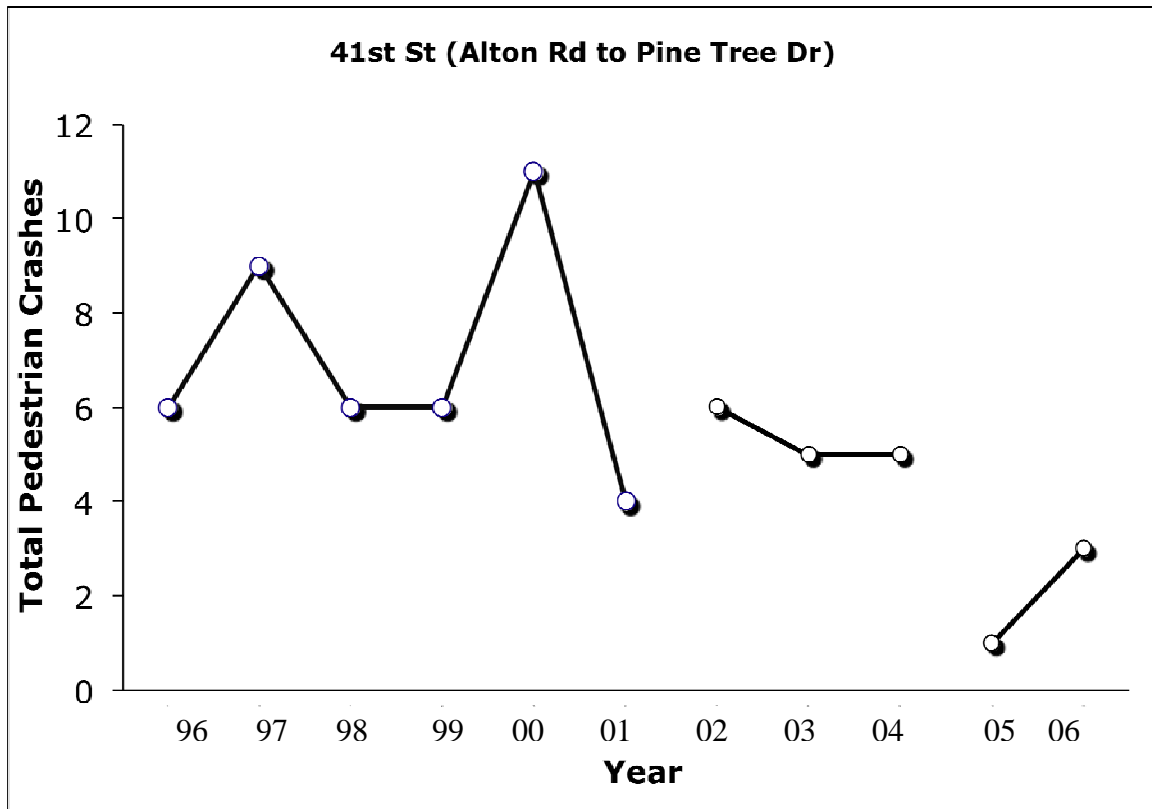
Figure 4.3 Crashes per Year for 41st St.; Alton Rd. to Pine Tree Dr. 1996-2006

It is interesting to note that crashes declined in each of the eight crash corridors. Data from each corridor is presented below. One corridor that was not particularly responsive to the NHTSA treatment but very responsive to the FHWA engineering treatments was 41st Street; Alton Road to Pine Tree Drive. This corridor had the highest percentage of daytime pedestrian crashes of all eight corridors (81%). The results for this location are presented in Figure 4.2.2. Crashes averaged 7 per year during baseline, 5.3 per year during the NHTSA program, and 2 per year during the FHWA program. This corridor received a large number of countdown timers, push buttons that confirmed the press, the no right turn on red electronic sign, and the prohibited permissive left turn treatment. Data for this corridor are presented in Figure 4.3.

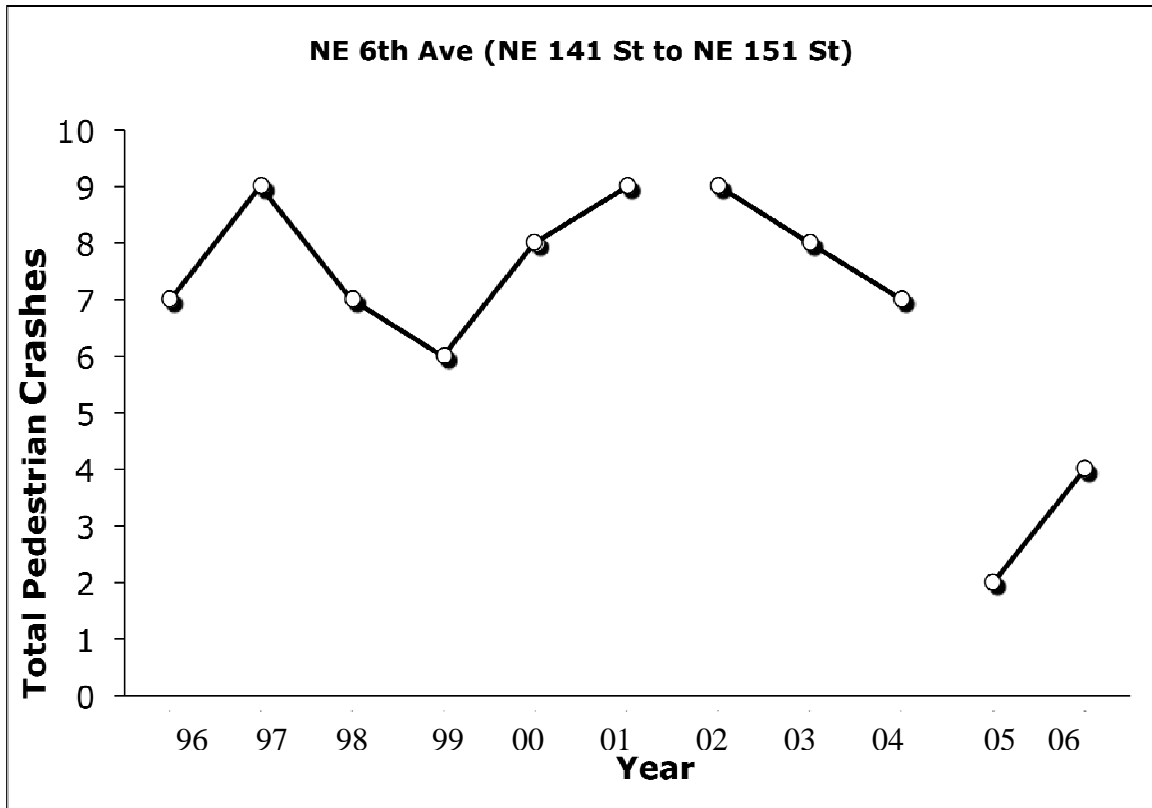
Figure 4.4 Crashes per Year Along NE 6th St. (NE 141st St. to NE 151st St.) from 1996 to 2006

Another corridor that responded well to the engineering treatments was NE 6th St. (NE 141st St. to NE 151st St.). Many of the pedestrians struck in this corridor were children who were hit in crosswalks near the school. This corridor

had the highest percentage of crashes involving children and youth (34%) and the highest percentage of crashes involving African American pedestrians (73%). During baseline crashes averaged 7.7 per year at this site and maintained at 8.0 during the three years of the NHTSA project. The FHWA project was associated with a reduction in crashes to 3 per year. This site also received countdown timers and push buttons that confirmed the press at high crash intersections and a large number of pedestrian zone signs. Data from this site are presented in Figure 4.4.

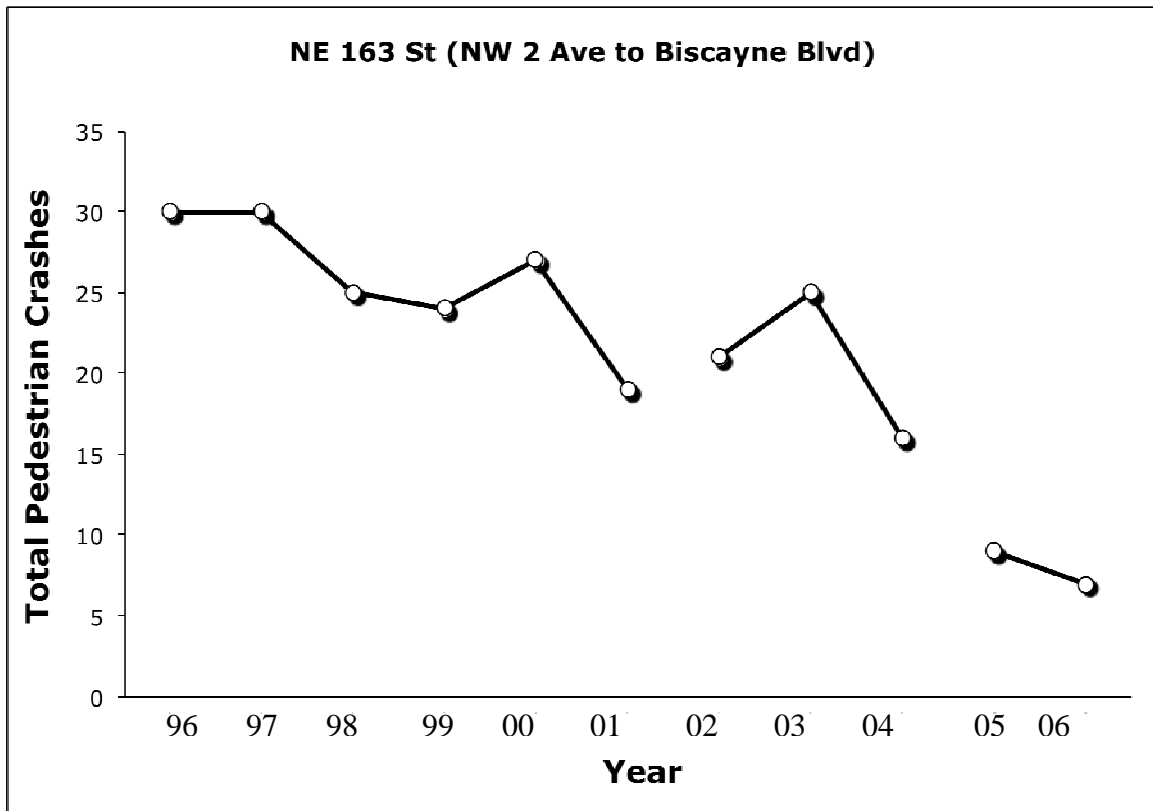
Figure 4.5 Crashes per Year NE 163rd St. (NE 2nd Ave to Biscayne Blvd.) from 1996 to 2006

The corridor that showed the largest improvement also had the highest number of crashes per year during baseline, the second highest percentage of African American pedestrians struck during baseline (41%), and the second highest percentage of senior pedestrians struck during baseline (28%). Baseline data show a downward trend during the baseline period. This corridor had the second highest percentage of pedestrian crashes involving turning vehicles (60%). This large corridor along NE 163rd St. had 25.8 crashes per year during baseline, crashes declined to 20.7 crashes per year during the NHTSA project and declined further to 8 per year during the FHWA project. This corridor also received the largest number of countermeasures. This corridor had a large number of countdown pedestrian signals and push buttons that confirmed the press installed. This site also received "Turning Vehicles Yield To

Pedestrians” symbol signs, and a large number of offset stop lines. Data for this corridor are presented in Figure 4.5.

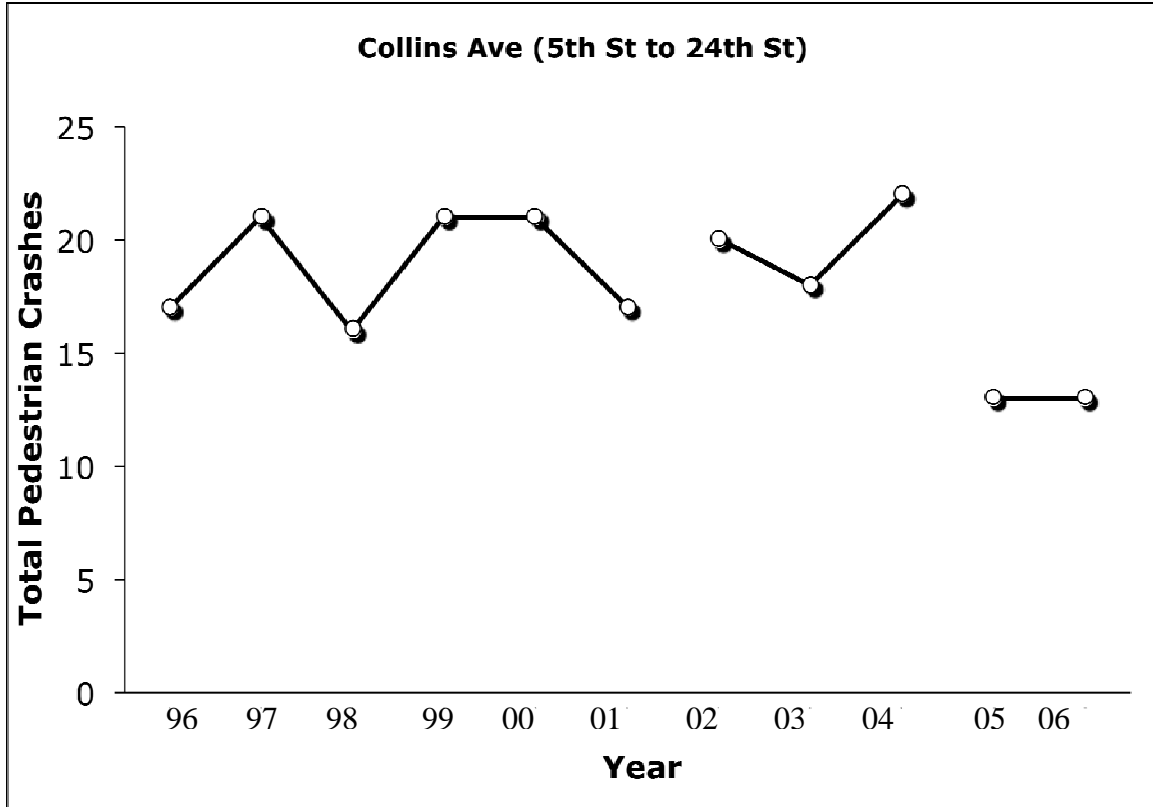
Figure 4.6 Crashes per Year Collins Ave. (5th Street to 24th St.) from 1996 to 2006

This corridor on Collins Ave. between 5th St. and 24th St. was in the middle of the South Beach recreational area. Therefore it is not surprising that this corridor had the highest percentage of nighttime crashes of all eight corridors (55%). During baseline there were 18.8 pedestrian crashes per year along this corridor. During the NHTSA project there were 20 crashes per year. The introduction of the FHWA project was associated with a decline in crashes to 13 per year. One of the treatments that was effective along this corridor was the in street pedestrian signs. Unfortunately these signs did not stand the test of time and were only in effect for a relatively short period of time. This corridor also received a couple of lead pedestrian intervals, a large number of “Turning vehicles yield to pedestrians” symbol signs, some pedestrian zone signs, and one advance yield marking. Crash data are presented in Figure 4.6.

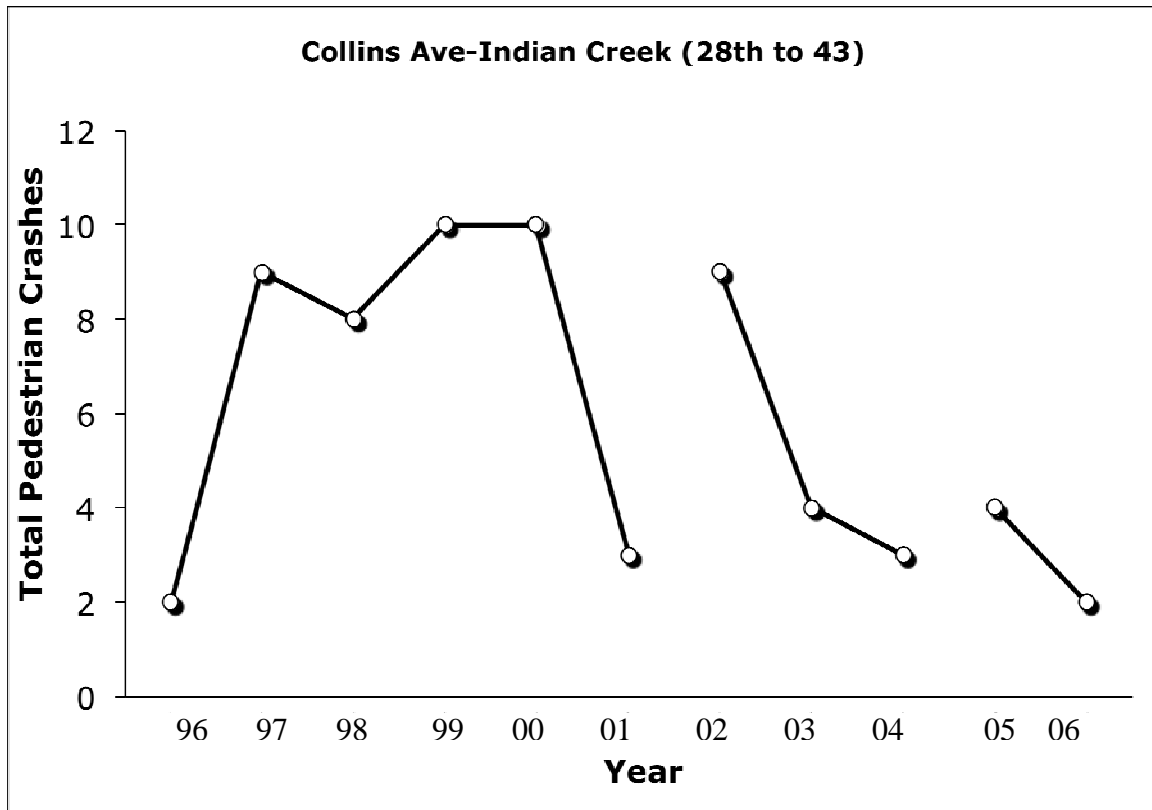
Figure 4.7 Crashes per Year Collins Ave. (Indian Creek 28th St. to 43rd St.) from 1996 to 2006

This corridor is immediately adjacent to the Collins Ave (5th to 24th St.) corridor. Treatments installed along this corridor included “TURNING VEHICLES YIELD TO PEDESTRIANS” symbol signs, and the use of the speed trailer. Crashes averaged 7 per year during the baseline period along this corridor, 5.3 per year during the NHTSA project and 3 per year during the FHWA project. The graph of the yearly crash data is shown in Figure 4.6. Although the average number of crashes is lower during the FHWA study there are too few crashes and too much overlap to conclude much about the efficacy of the treatment at this location.

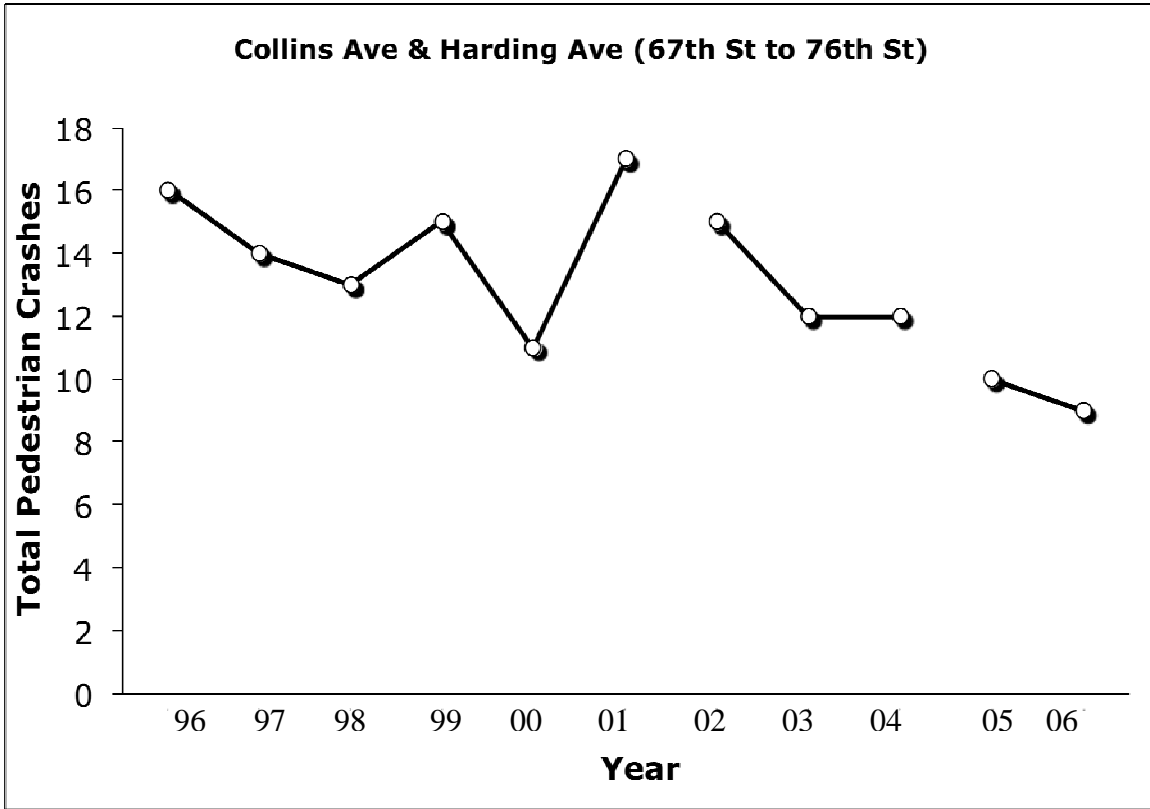
Figure 4.8 Crashes per Year Collins Ave. and Harding Ave. (67th St. to 76th St.) from 1996 to 2006

This crash corridor had the highest percentage of crashes involving turning vehicles during baseline of all of the selected corridors averaging 80% and the highest percentage of pedestrians struck over the age of 65 years (49%). Treatments installed along this corridor included “Turning vehicles yield to pedestrians” symbol signs, pedestrian zone signs, and the speed trailer. During the baseline condition the number of crashes per year averaged 14.3, during the NHTSA project crashes averaged 13 per year and during the FHWA project they averaged 9.5 per year. Overall it appeared the treatments were only moderately effective at this site. A graph of the yearly crash data is shown in Figure 4.8.

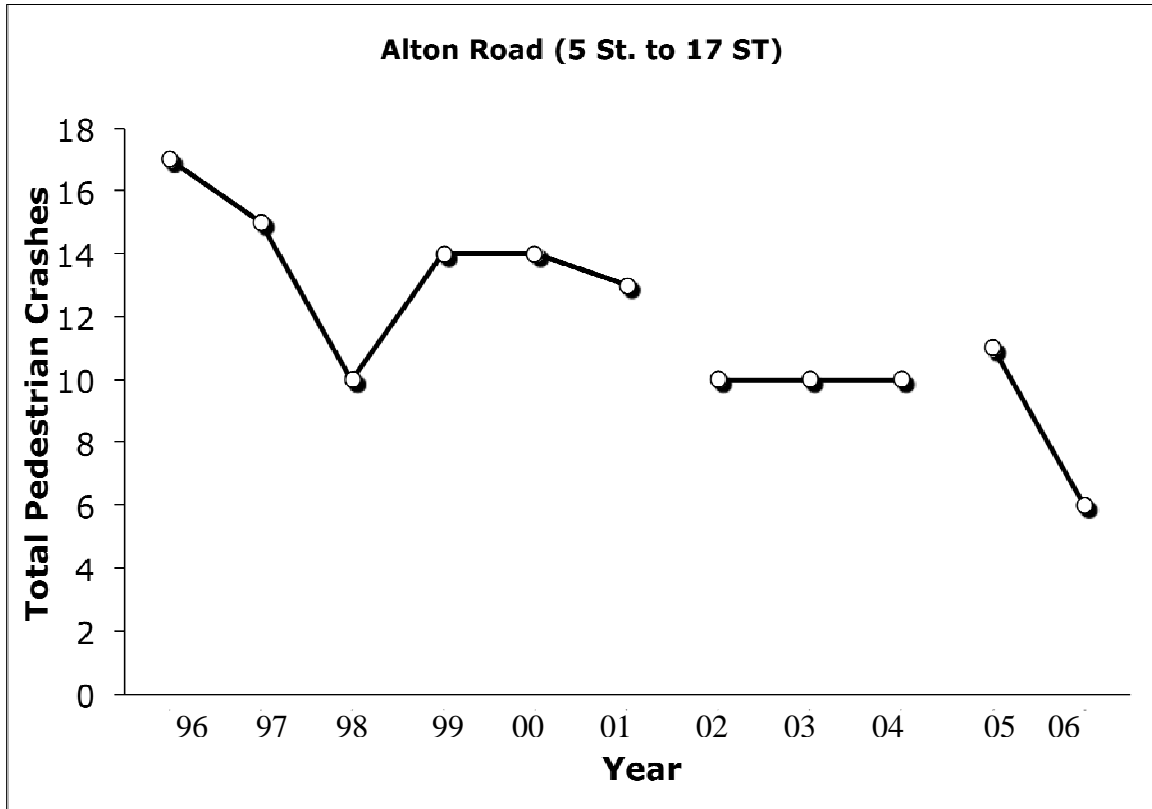
Figure 4.9 Crashes per Year on Alton Rd. 5th St. to 17th St.) from 1996 to 2006

The corridor along Alton Road between 5th St. and 17th St. averaged 13.8 crashes per week during baseline. This corridor had the second highest percentage of daytime crashes (74%) and 42% of crashes occurred at intersections. Alton Rd. received a number of treatments. A large number of push buttons that confirmed the press and countdown pedestrian signals were installed along this corridor. The video detection system was installed at a midblock signalized crosswalk. Three intersections received a leading pedestrian interval, and one intersection received the “Turning vehicles yield to pedestrians” symbol sign treatment. The introduction of the NHTSA project was associated with a decline in crashes to 10 per year and the FHWA project was associated with a further small decline to 8.5% crashes per year. A graph of these data is shown in Figure 4.9.

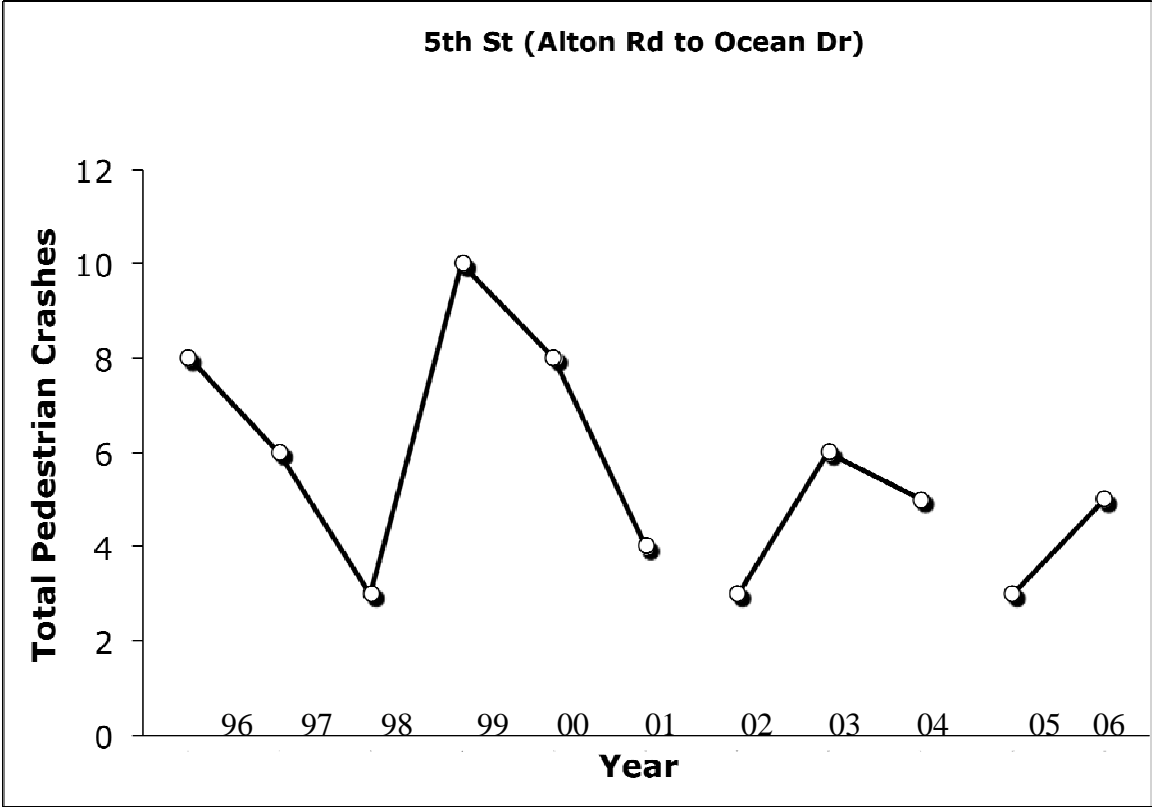
Figure 4.10 Crashes per Year on 5th St. Between Alton Rd. and Ocean Dr.) from 1996 to 2006

The final graph shows the number of crashes occurring on 5th St. between Alton Rd. and Ocean Drive. More than half the crashes along this corridor occurred at night and only 23% involved turning vehicles. Treatments installed along this corridor included push buttons that confirmed the button press, and “Turning vehicles yield to pedestrians” symbol signs. During the baseline condition pedestrian crashes averaged 6.5 per year. After the NHTSA program was introduced these crashes declined to 4.7 per year and following the introduction of the FHWA project crashes declined to 4 per year. Figure 4.10 shows crashes at this site. Overall there were not a large number of crashes along this corridor and it is difficult to determine whether the treatments had an effect.
