# **Wetland and Stream Report**

**MT FLAP BOR 2980(1)**

**Sun River Bridge Replacement**

**Lewis and Clark and Teton Counties,  
Montana**

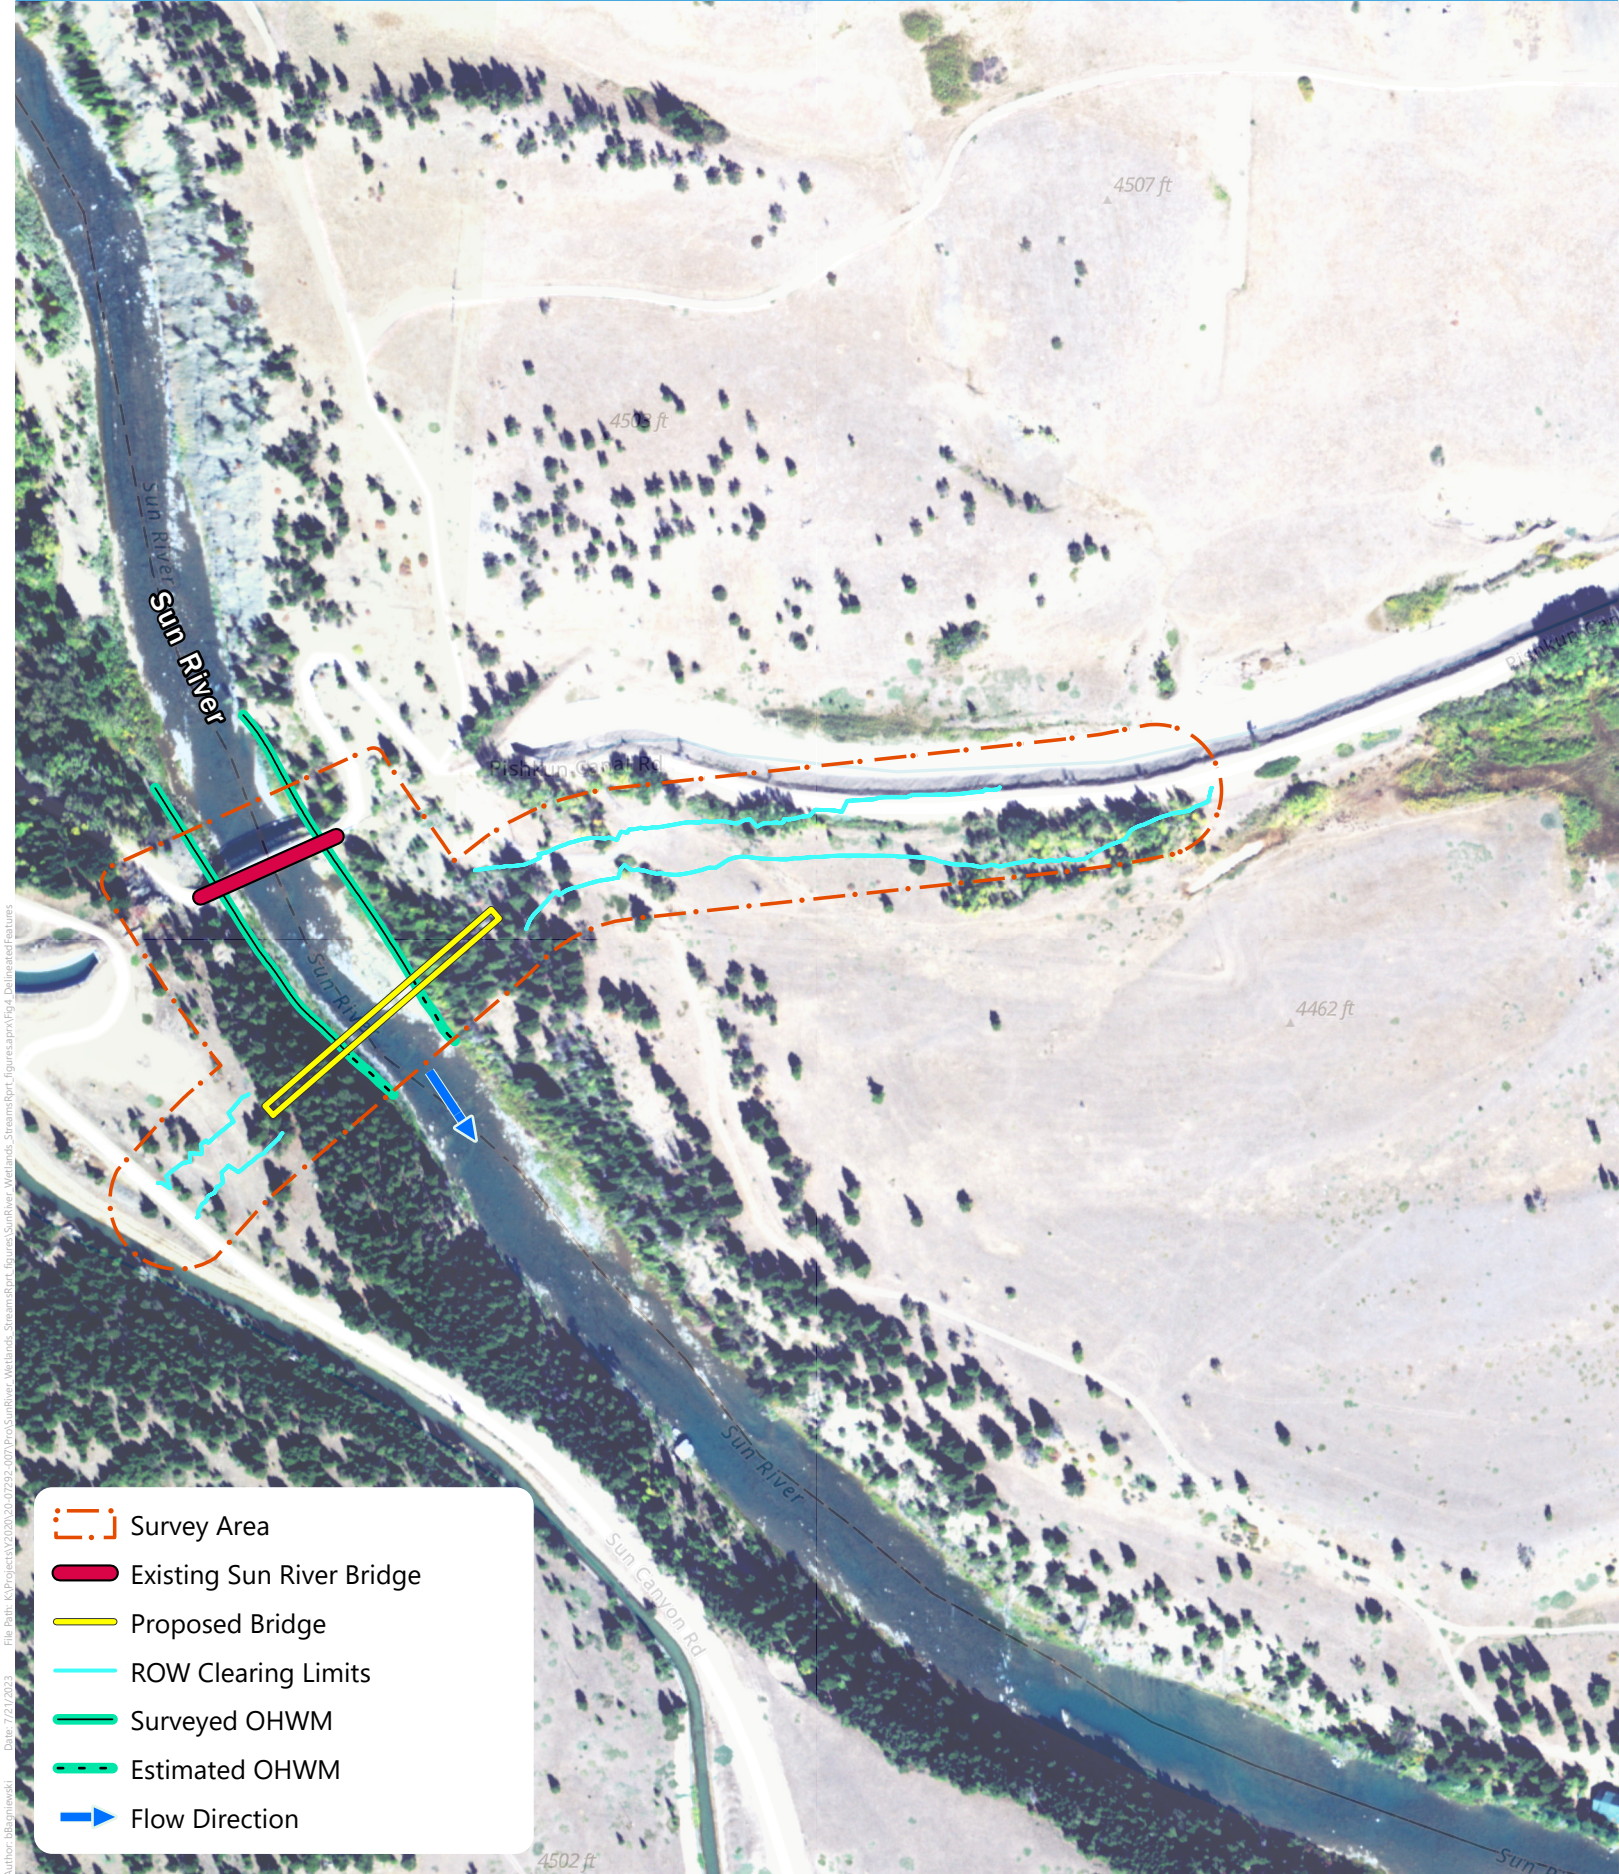
Surveyed OHHW
-

Estimated OHHW
-

Herrera staff walked the length of the survey area along the right and left banks of the Sun River. The river was at a relatively high stage (1,850 cfs) on the morning of the site visit, which is above the median for that date (USGS 2023). They observed the low flow channel of the Sun River, indicated by a break in slope that was below the water surface on the day of the site visit. This low flow channel was marked by a distinct drop-off to the channel bed. The observed water level during the site visit was between the edge of the low flow channel and the OHWM. The delineated OHWM is shown on Figure 4 and a field data sheet and photographs for the OHWM delineation is provided in Appendix A. The elevation of the OHWM at the new bridge crossing is 4,371.5 feet.

Permanent impacts on the Sun River will be avoided by spanning the canyon and placing bridge piers above the 4,371.5-foot elevation of the OHWM. Temporary impacts during construction would be minimized by implementing the following measures:

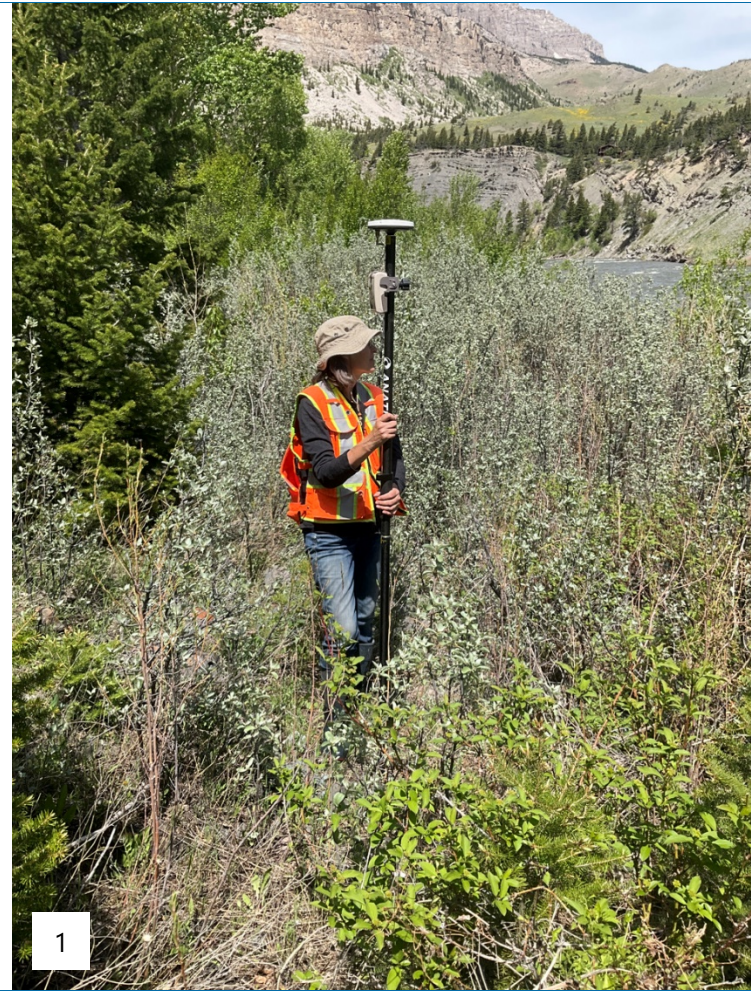
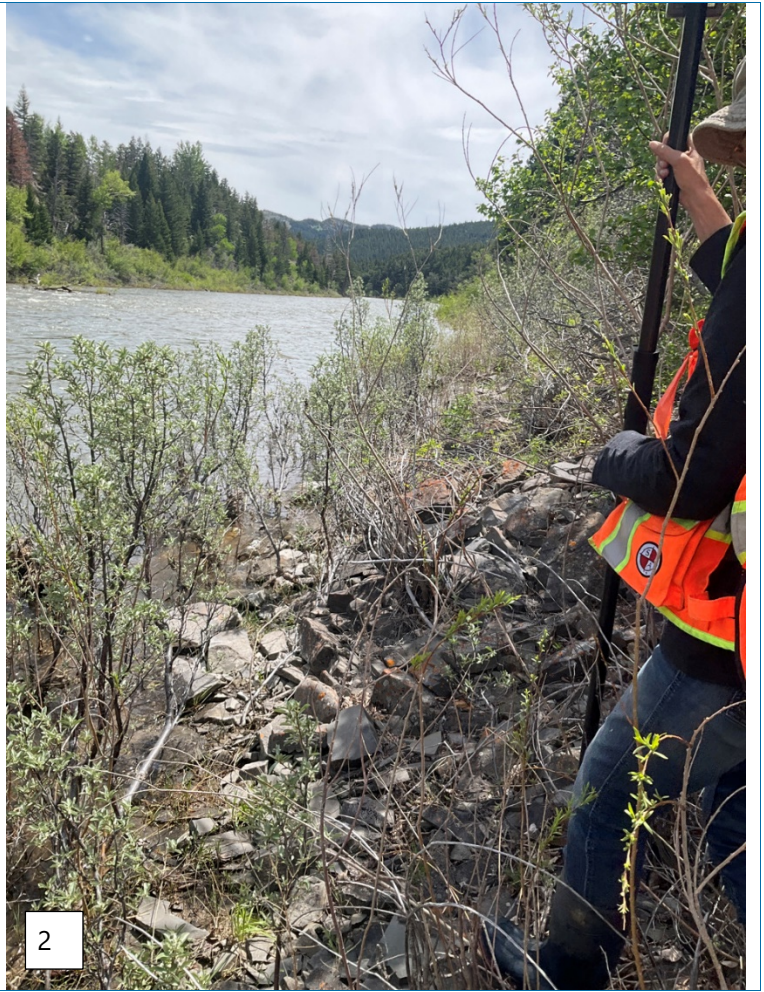
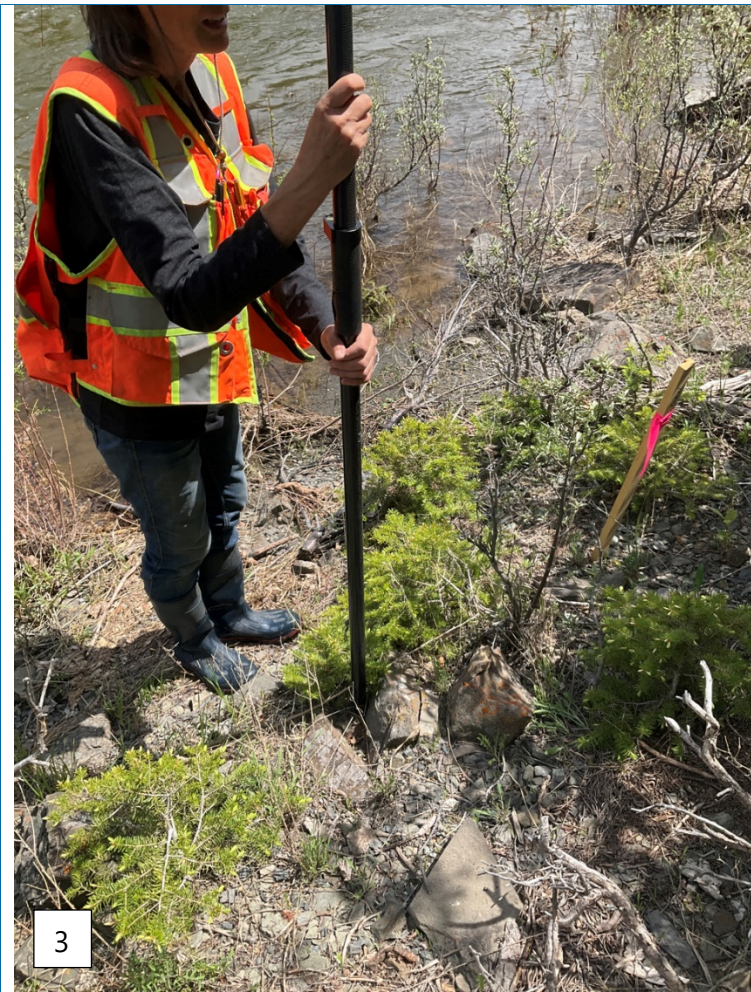
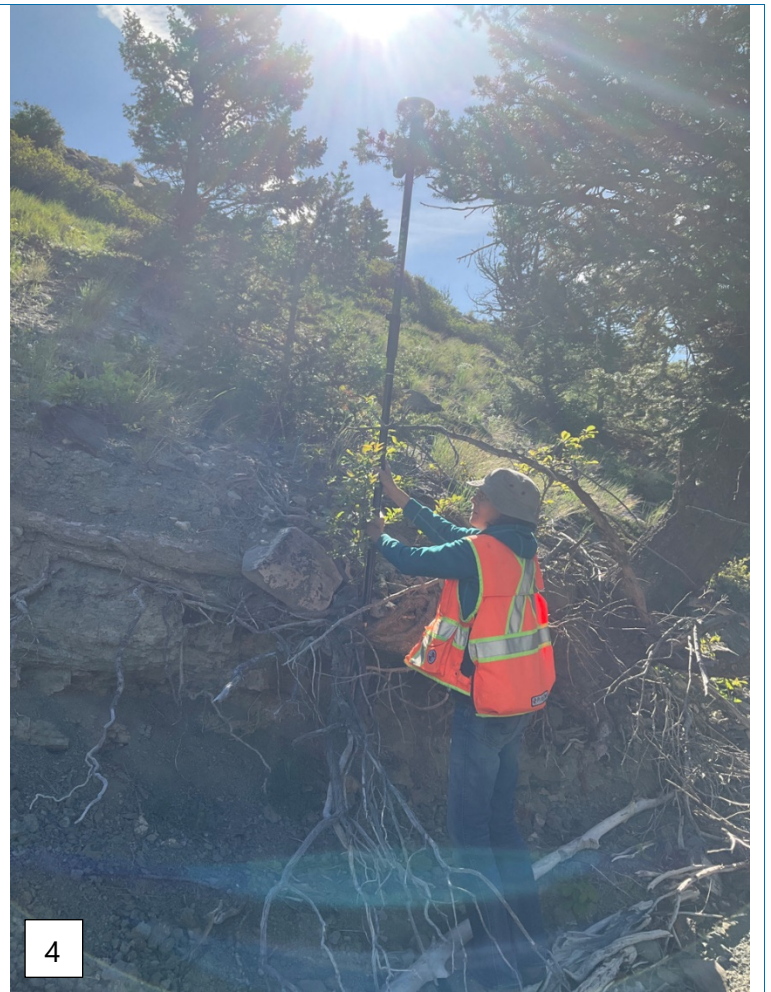
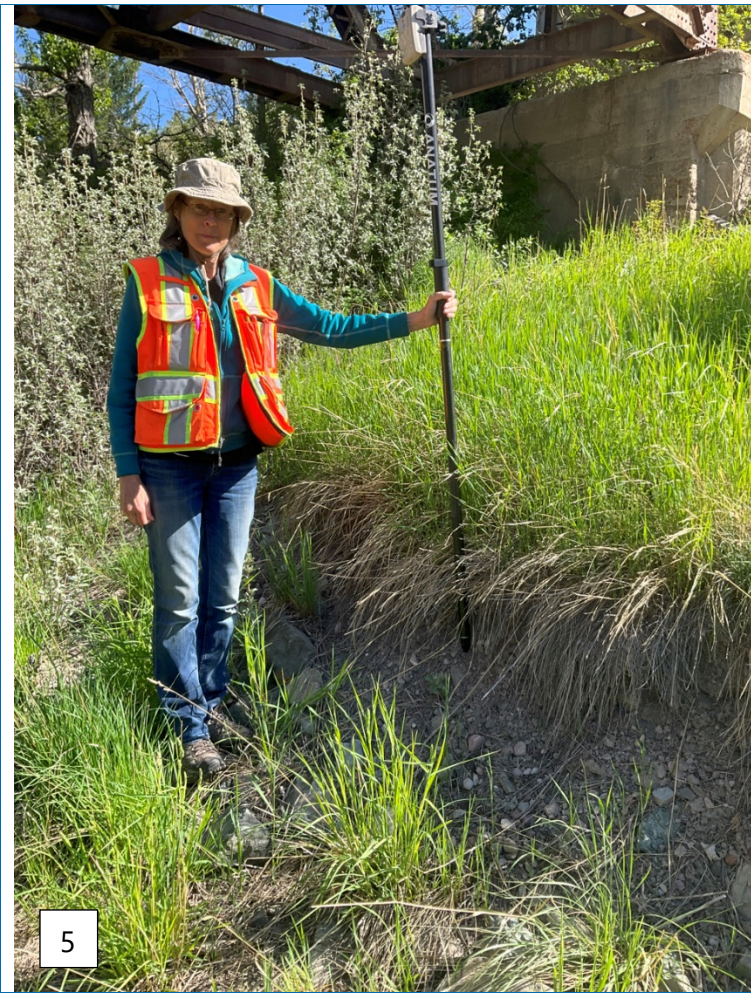
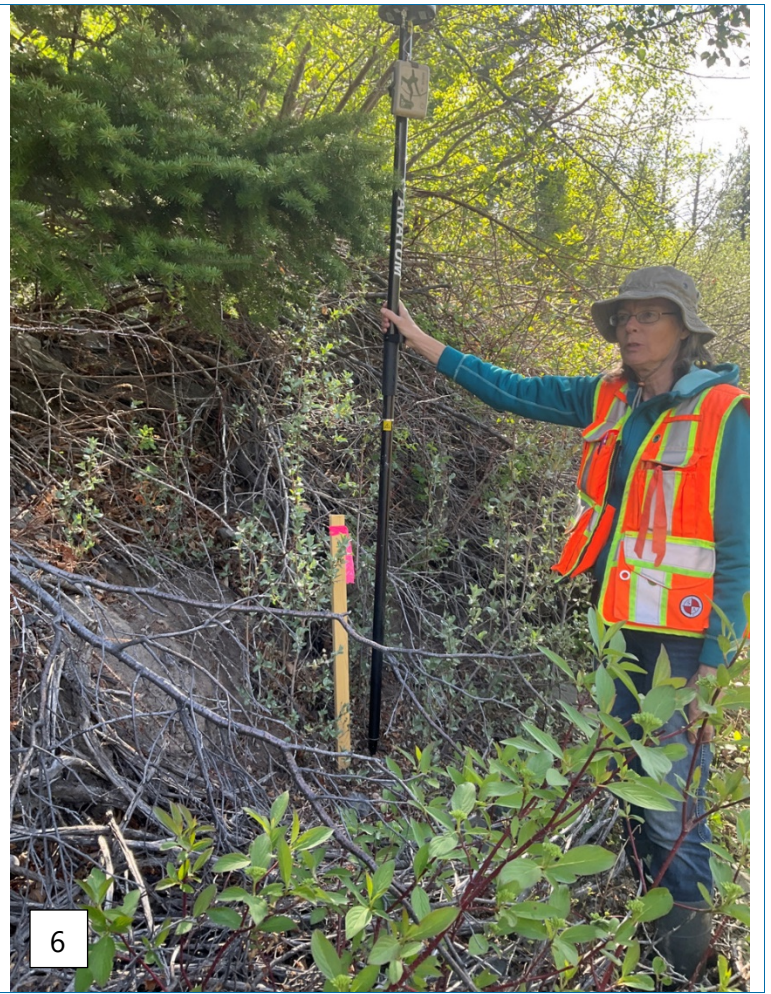
Photo Number	Photo Description
1	Right bank OHWM upstream of bridge, facing upstream. Silverberry, cottonwood saplings, and willow below OHWM, Douglas-fir and mature cottonwoods above OHWM. Break in slope at OHWM.
2	Right bank OHWM downstream of bridge, facing downstream. Break in slope at OHWM, silverberry below OHWM, Douglas-fir and lodgepole pine above OHWM.,
3	Right bank OHWM downstream of bridge. Silverberry below OHWM, Douglas-fir saplings below OHWM.
4	Left bank OHWM upstream of bridge. Break in slope and exposed roots at OHWM. Bare substrate below OHWM, upland grass and scattered conifers above OHWM.
5	Left bank at the bridge facing upstream. Shelving and change from scattered patches of grass below OHWM to dense grass and shrubs above OHWM.
6	Left bank downstream of the bridge. Break in slope at OHWM. Silverberry and red-osier dogwood below OHWM, Douglas-fir and mature cottonwoods above OHWM.

7	Right bank from bridge facing downstream showing break in vegetation from bare substrate with scattered shrubs below OHWM to conifer forest dominated by Douglas-fir and lodgepole pine above OHWM
8	Left bank from bridge facing downstream showing break in vegetation from willow, red-osier dogwood and silverberry below OHWM to cottonwood and Douglas-fir above OHWM
9	Left bank from bridge facing upstream showing break in vegetation from silverberry below OHWM to rocky slope above OHWM
10	Left bank upstream of bridge looking down showing line of silverberry at edge of low flow channel below the water surface

At the upstream end of the survey area, the OHWM on the right bank (facing downstream) was located at a break in slope at the landward edge of a gravel bar. The dominant plant species on the gravel bar were silverberry (*Elaeagnus commutata*) and willows (*Salix* spp.), species that can tolerate periods of inundation and have flexible stems that can bend during river flooding. The plant community on the slope above the OHWM was dominated by an overstory of trees including Douglas-fir (*Pseudotsuga menziesii*) and black cottonwood (*Populus balsamifera* spp. *trichocarpa*), with Rocky Mountain maple (*Acer glabrum*), and serviceberry (*Amelanchier alnifolia*) in the understory.

The OHWM on the right bank downstream of the bridge was identified based on a break in slope and a change in vegetation from primarily grasses and forbs to forest dominated by Douglas-fir with an understory of creeping juniper (*Juniperus horizontalis*), buffaloberry (*Shepherdia canadensis*), chokecherry (*Prunus virginiana*), bristly gooseberry (*Ribes oxycanthoides*), wax currant (*Ribes cereum*), and Wood's rose (*Rosa woodsii*).

The left bank OHWM upstream of the bridge was located at the edge of a steep bank with exposed tree roots. A clear, continuous break in slope could be seen upstream and downstream at this location.

Downstream of the bridge there was a gravel bar on the left bank vegetated with silverberry, willows and red-osier dogwood (*Cornus sericea*). The OHWM was located landward of the vegetated gravel bar, at a transition between these species and a vegetation community dominated by Douglas-fir, black cottonwood and creeping juniper.
