Emerging ISTD technology uses an innovative erosion head that more accurately measures soil erosion resistance, resulting in more cost-effective foundation designs and greater reliability and resiliency in bridge performance.

INTRODUCTION

The North Carolina Department of Transportation (NCDOT) hosted the eighth ISTD field demonstration on State Route 11 at the bridge over Contentnea Creek, located 1 mi west of the town of Grifton, NC. The demonstration was held in the median, north of the creek. The bridge was not scheduled for replacement, but NCDOT was interested in the technology, and the site was easily accessible.

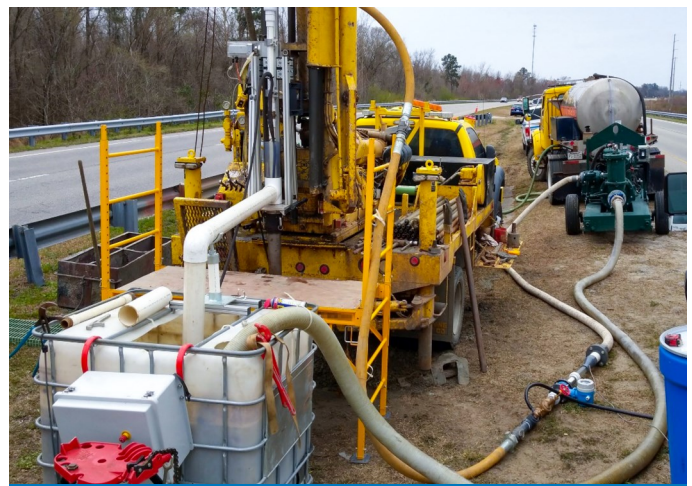
The ISTD equipment assembled in front of the drill rig.

The demonstration took place on March 20, 2019, but the drill crew and the hydraulics team arrived a day in advance to perform the SPTs and conduct as much ISTD field testing as possible in the two-day span. Unfortunately, unforeseen events, including equipment malfunctioning on the drill rig and issues with the commercial pump delivery, caused lengthy delays on the first day. The drill team was able to pull some samples to return to the laboratory, but most of the day was lost. After an early start on the second day, the drillers were quickly able to auger to a depth of 25 ft, then lowered in the casing and Shelby tube. Despite the stiff clay, the drillers successfully pushed the Shelby tube 14 inches with full recovery. The hydraulics team then assembled the remaining equipment, including the linear drive, water tank, piping, hoses, and laptop, and began the first test.
