# **WESTERN FEDERAL LANDS HIGHWAY DIVISION**

## **POLYCHROME AREA IMPROVEMENTS**

### **GEOTECHNICAL MODELING REPORT**

PROJECT NO.: 2000004  
DOCUMENT NO.: GR 06-22

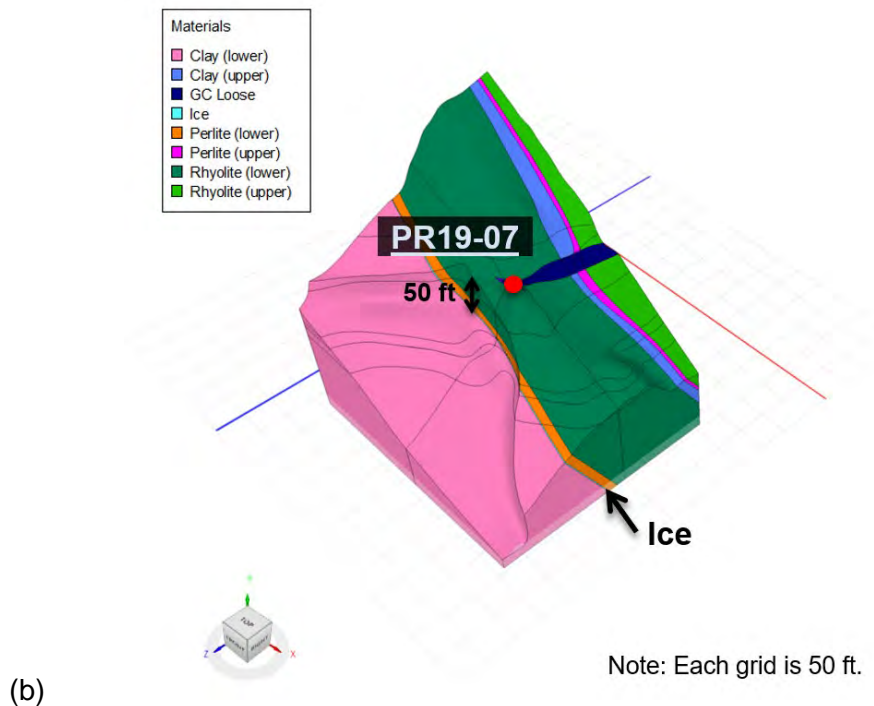
**Schematic 2-6. East abutment 3D section in TEMP3D: (a) Original section using the 2021 DEM model and (b) removal of landslide material based on January 31, 2022 conditions.**

Site photos (Photograph 2-1) were provided to BGC on January 31, 2022 (Capps, 2022) which show additional drop in elevation from the original road alignment near the planned east bridge abutment location. This was accounted for in TEMP3D by removing 50 ft of material from the topography used from the original analysis as shown in Schematic 2-6b. The material removed from the model was assumed to be completely mobilized and deposited outside the domain of the model. This material removal exposes the soil and rock units closer to PR19-07, which changes the thermal regime at the east abutment.

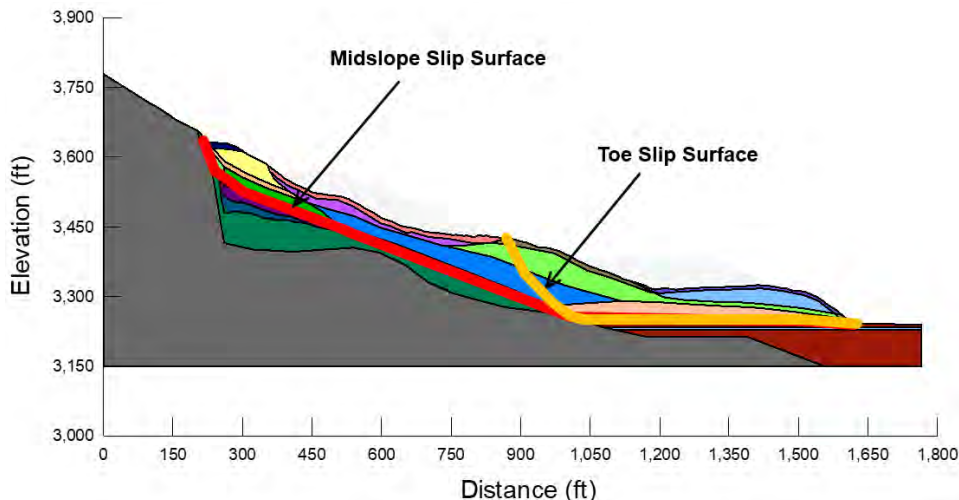
**Schematic 5-2. Typical slip surfaces at Section C-C prior to any spoil placement.**

The typical slip surfaces at these locations are shown in Schematic 5-2. As the spoil is added, it is expected that the minimum FoS will change, along with the corresponding slip surface. The slip surface obtained from the NS case is used as an additional check as to how the spoil placement may influence the stability and deformation process of the landslide prior to any changes. Similarly to the deformation models, the cross-section was modified to correspond to the frozen and unfrozen layer boundary from the temperature models at year 2100, as in Section 4.1.
