# NCHRP

## REPORT 553

### **Crashworthy Work-Zone Traffic Control Devices**

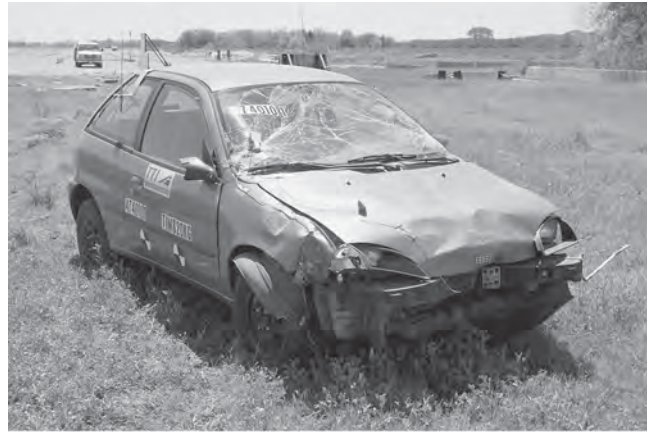
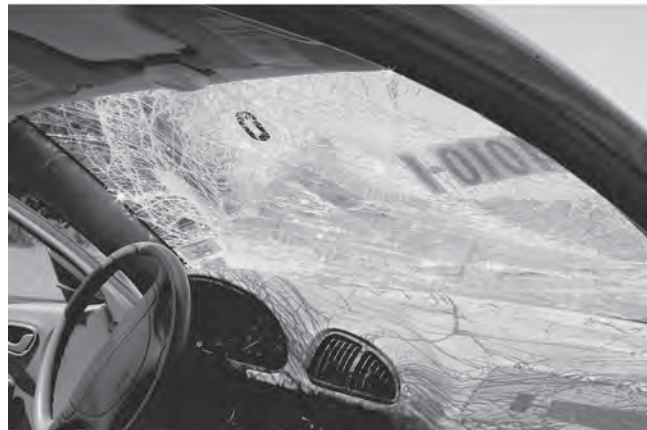
Figure 6.10. Damage to vehicle after Test 1.

The vehicle remained upright throughout and after the crash period. Damage to the vehicle is shown in Figure 6.10. The front bumper, hood, radiator, and radiator support were damaged, and the right side A-post was dented. Maximum exterior crush was 250 mm (9.8 in) in the center front of the vehicle. The windshield was shattered and deformed inward 50 mm (2.0 in) (a combination of Case 5 and Case 6 of the FHWA windshield damage classification criteria). There were

A summary of the test evaluation is presented in Table 6.2. The 50-mm (2.0-in) deformation of the windshield is considered to be marginally acceptable in terms of the FHWA windshield damage classification criteria. Therefore, since the barricade met all other relevant evaluation criteria of *NCHRP Report 350*, the perforated steel-tube barricade with wooden rails and 1.2-m  $\times$  1.2-m  $\times$  13-mm (4-ft  $\times$  4-ft  $\times$  1/2-in)

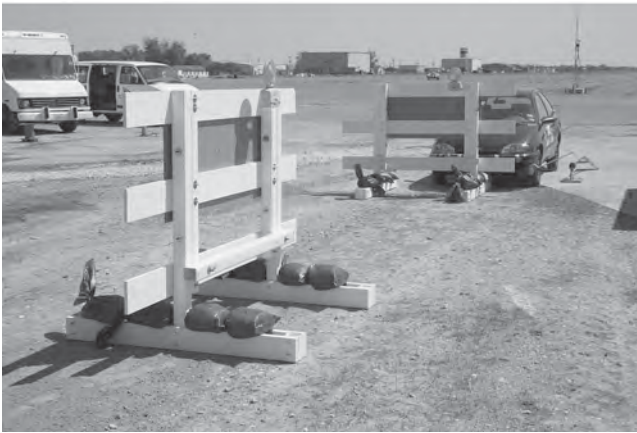
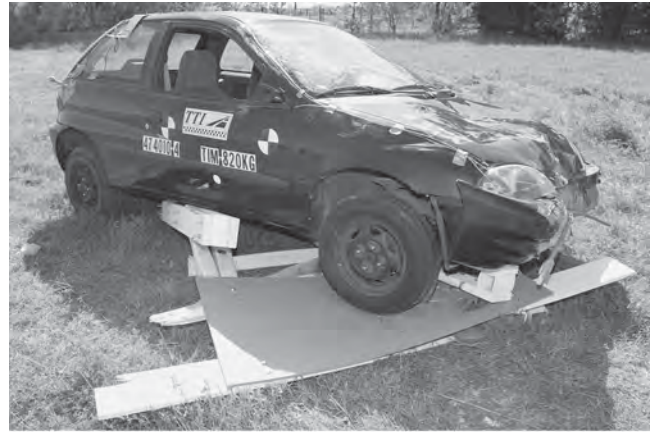
Figure 6.25. Damage to vehicle after Test 4.

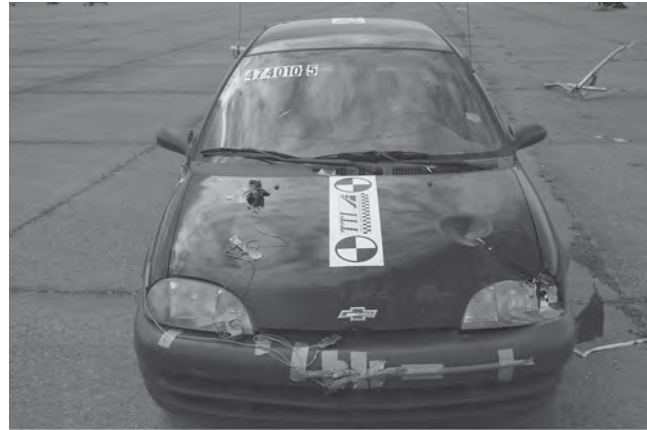
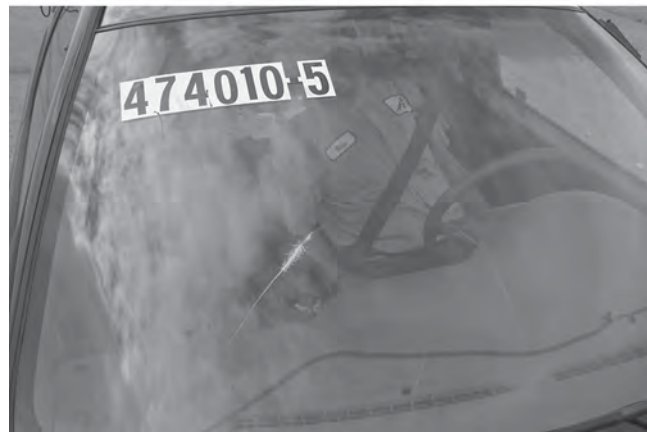
Figure 7.12. Vehicle after Test 5.

The vehicle remained upright during and after the collision event. Damage to the vehicle is shown in Figure 7.12. The front bumper, left headlight, hood, and roof were deformed. Maximum crush to the exterior of the vehicle was 30 mm (1.2 inches) at the left front at bumper height. The windshield

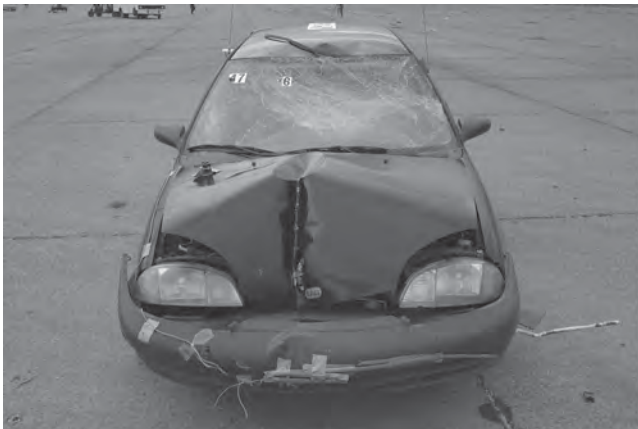
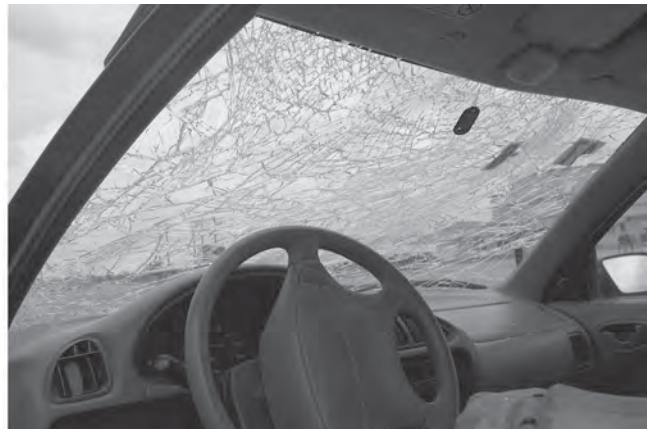
Figure 7.17. Vehicle after Test 6.

windshield damage classification scheme. Therefore, since the short dual-leg, perforated steel-tube sign support met all other relevant evaluation criteria of *NCHRP Report 350* (see Table 7.2), the sign support system with dual pivoting uprights and  $1.2\text{-m} \times 1.2\text{-m} \times 13\text{-mm}$  ( $4\text{-ft} \times 4\text{-ft} \times \frac{1}{2}\text{-in}$ ) plywood sign panel mounted 0.3 m (1 ft) above ground is considered marginally acceptable.

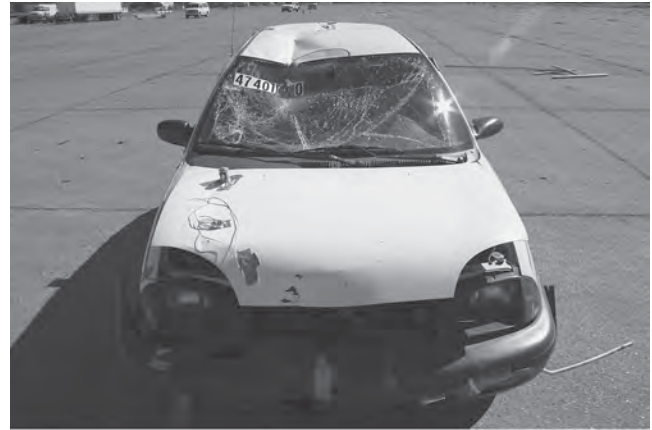
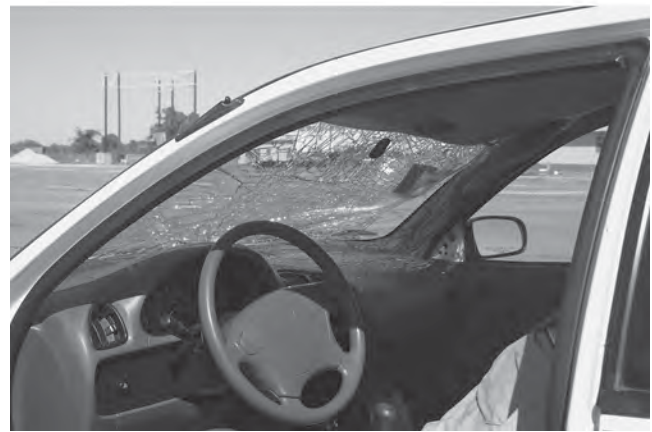
Figure 8.25. Vehicle after Test 10.
