Development of *MASH* TL-2 Crashworthy W-Beam Terminals For Low-Speed/Volume Roads

Publication No. FHWA-FLH-23-004

Test Report No. 615181-01

Sponsored by
**Federal Highway Administration
Office of Federal Lands Highway**

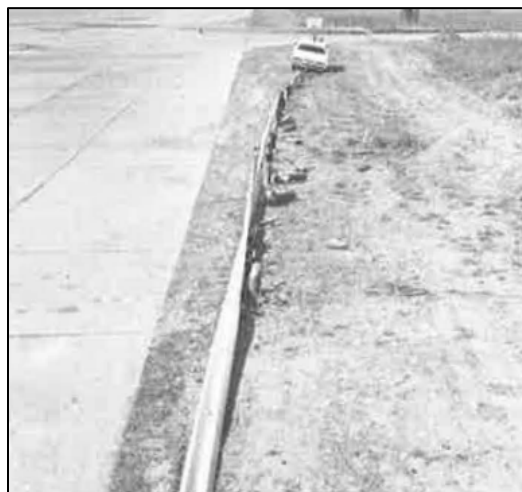
Five crash tests were conducted to evaluate the crashworthy performance of the Texas turndown terminal. The terminal system was considered satisfactory for the NCHRP Report 153 evaluation criteria. The turndown system allowed the vehicle to ride over the twisted section without rolling over. In the head-on crash test, the vehicle depressed the rail and rode along the length of the guardrail installation. Figure 1.5 shows the vehicle after the crash test.

Figure 1.5. Test Vehicle after Head-On Crash Test (3).

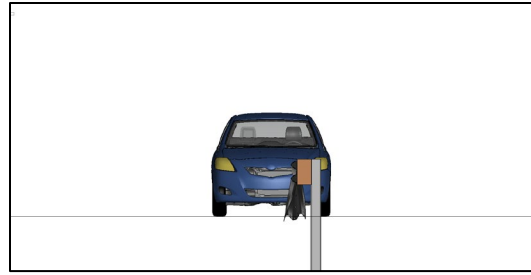
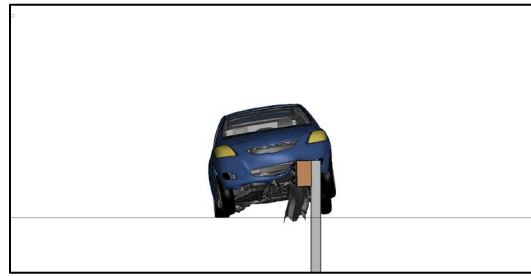
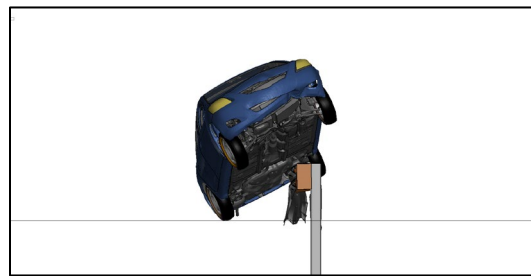
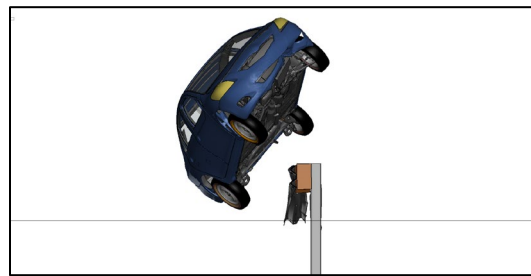
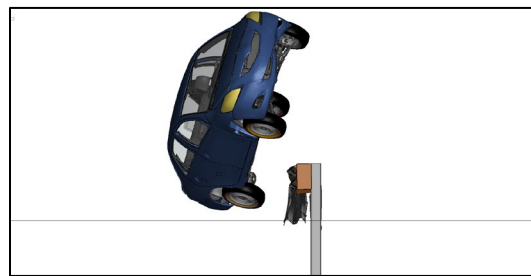
The first impact simulation for this system was *MASH* Test 2-30, which is a head-on impact. This test involved impacting the end terminal with the 1100C vehicle model at a speed of 44 mi/h and an angle of 0 degrees. The 1100C vehicle model impacted the terminal system with the quarter point of the vehicle bumper aligned with the tangent guardrail. Figure 2.3 shows sequential images for the *MASH* Test 2-30 simulation impact. The small car vehicle model climbed the rail during impact and rolled over. Thus, the system would be considered unsatisfactory according to *MASH*. Additional simulations were not conducted on this system based on the unsatisfactory performance.

Figure 2.3. Texas Twist Test 2-30 Simulation Sequential Images (Downstream View).

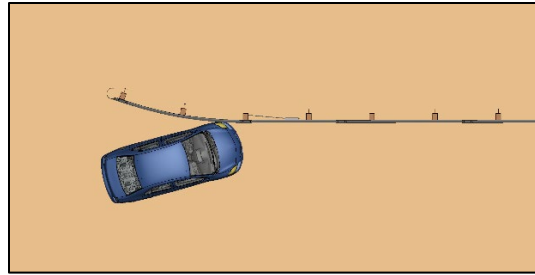
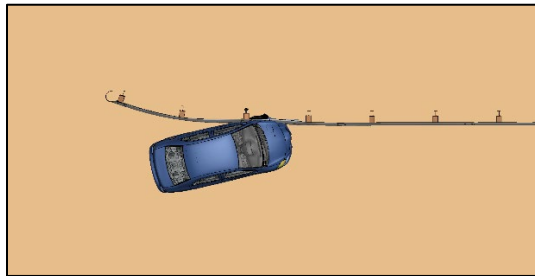
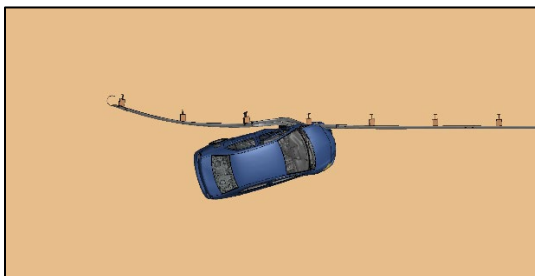
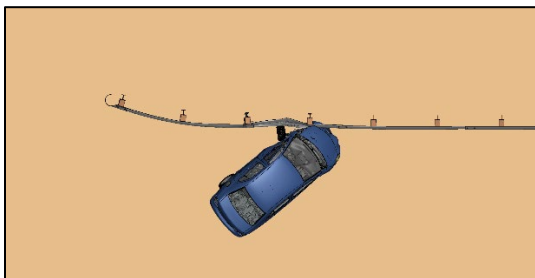
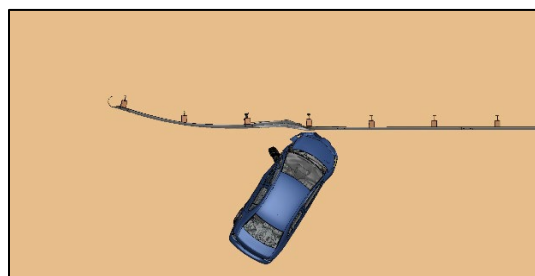
MASH Test 2-34 involved impacting the end terminal with the 1100C vehicle model at a speed of 44 mi/h and an angle of 15 degrees. The 1100C vehicle model impacted the terminal system 30 inches upstream of the third steel post. Figure 2.5 shows sequential images for the *MASH* Test 2-34 simulation impact. The impact side front wheel of the car model snagged on the cable anchor during impact. This resulted in a longitudinal occupant ridedown acceleration (ORA) of 25.6 g, which was above the *MASH* limit. Thus, the system would be considered unsatisfactory according to *MASH*. Additional simulations were not conducted on this system based on the unsatisfactory performance.

Figure 2.5. Vermont Terminal Test 2-34 Simulation Sequential Images (Overhead View).

The Vermont terminal design did perform acceptably for most of the *MASH* TL-2 crash tests. However, the small car wheel snagged on the cable anchor during the Test 2-34 impact simulation. This snagging phenomenon led to ridedown accelerations exceeding the *MASH* limit. The failure of the vehicle suspension is a complex phenomenon to be accurately modeled and simulated. Thus, having a simulated higher ridedown acceleration value is not necessarily going to be reflected in the physical tests given that small car suspension fails easily from an overall anecdotal observation of recent testing.

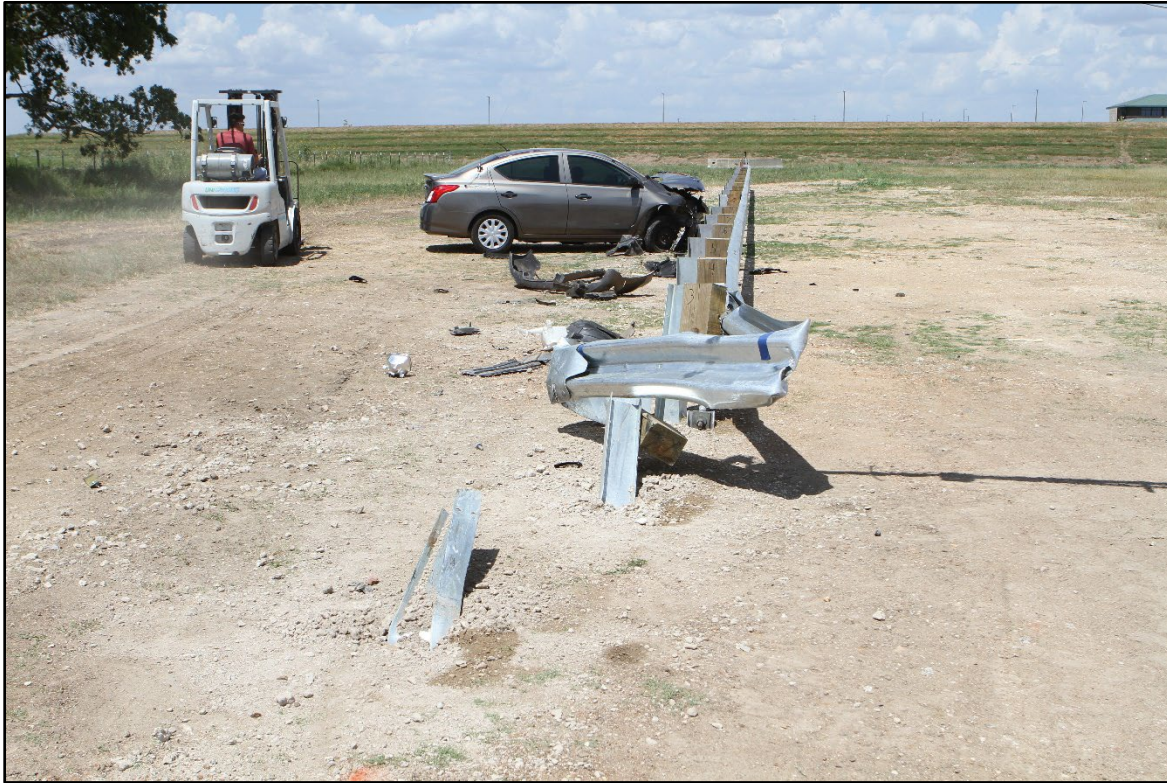
The TL-2 Terminal for crash test 615181-01-1 met the performance criteria for *MASH* TL-2 Test 2-32 for Gating Terminals. Thus, crash test 615181-01-2 for *MASH* Test 2-30 was performed next. Its details follow in section 3.2.

Figure 3.5. TL-2 Terminal on MGS Post Impact for Crash Test 615181-01-1.

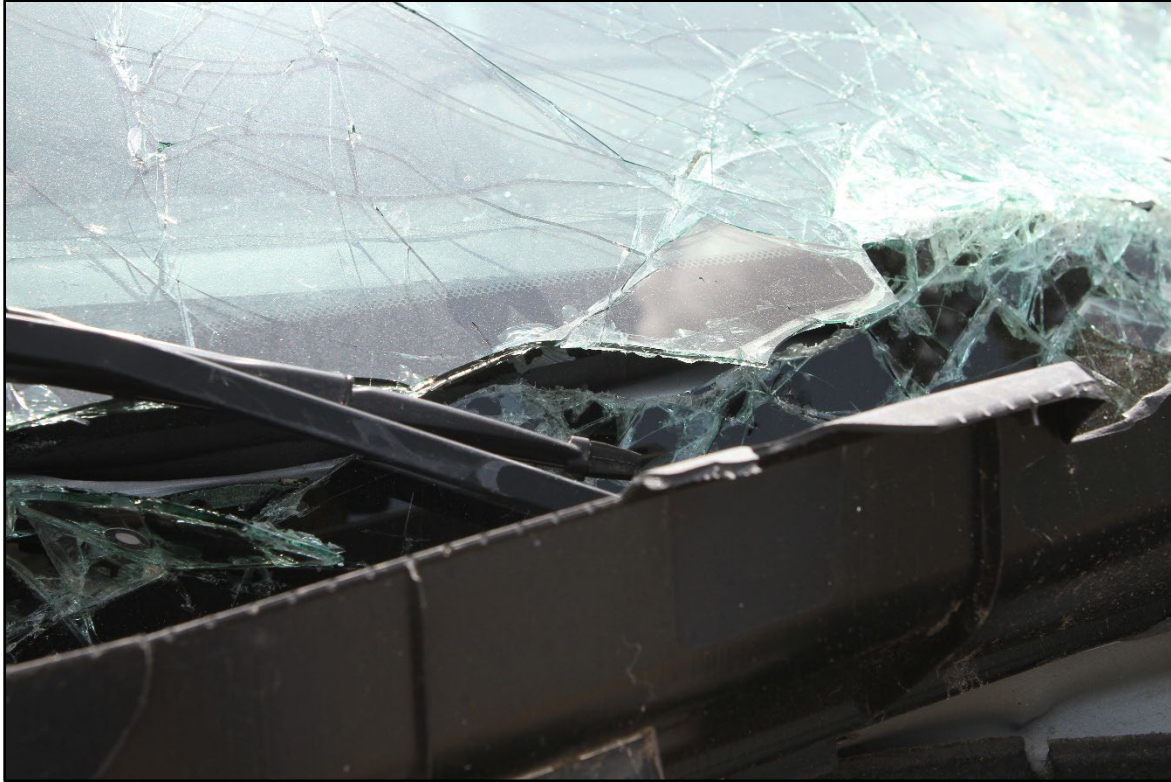
The TL-2 Terminal for *MASH* Test 2-30 crash test 615181-01-2 did not meet the performance criteria for *MASH* TL-2 Gating Terminals. The rail impacted and tore the windshield, thus showing potential for penetration of the occupant compartment, which is considered a failure under *MASH* Evaluation Criteria D, as detailed in Chapter 6. The installation was redesigned, and the details of the 615181-01-10 installation for *MASH* Test 2-30 are presented in section 3.3.

Figure 3.11. Detailed View of the Windshield after Crash Test 615181-01-2.

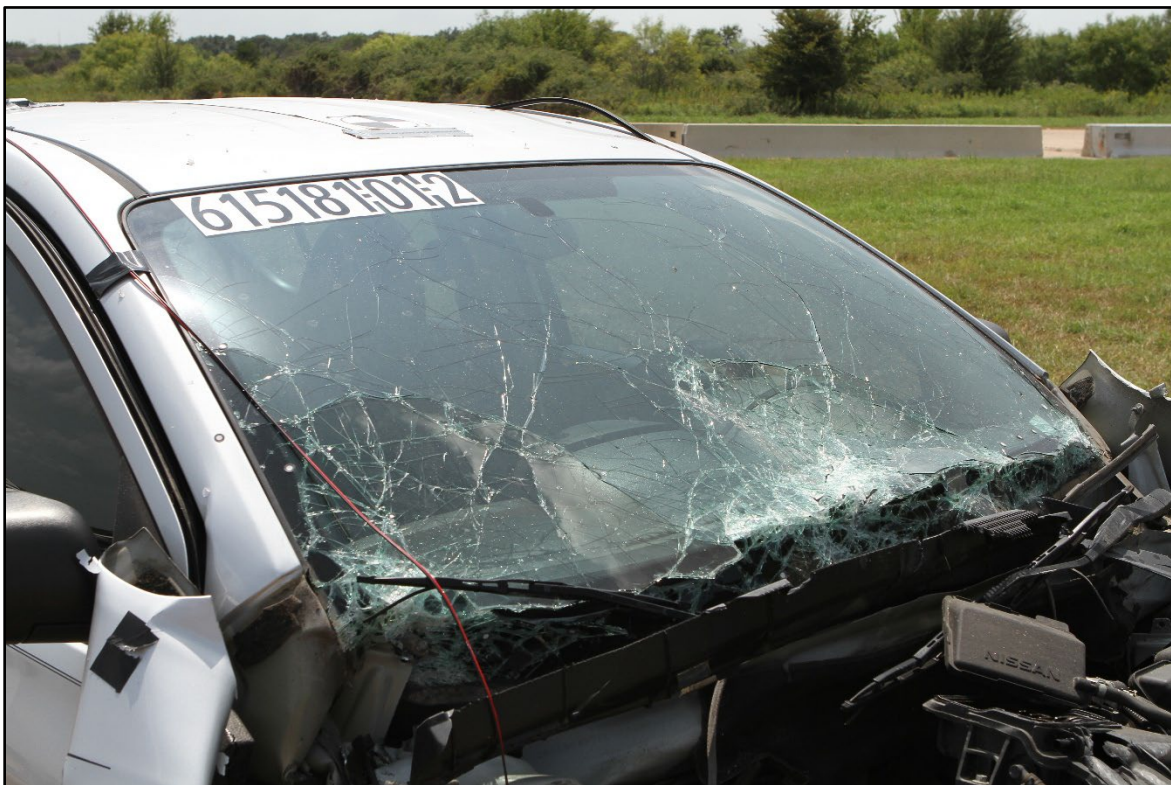
Figure 3.12. Overall View of the Windshield after Crash Test 615181-01-2.

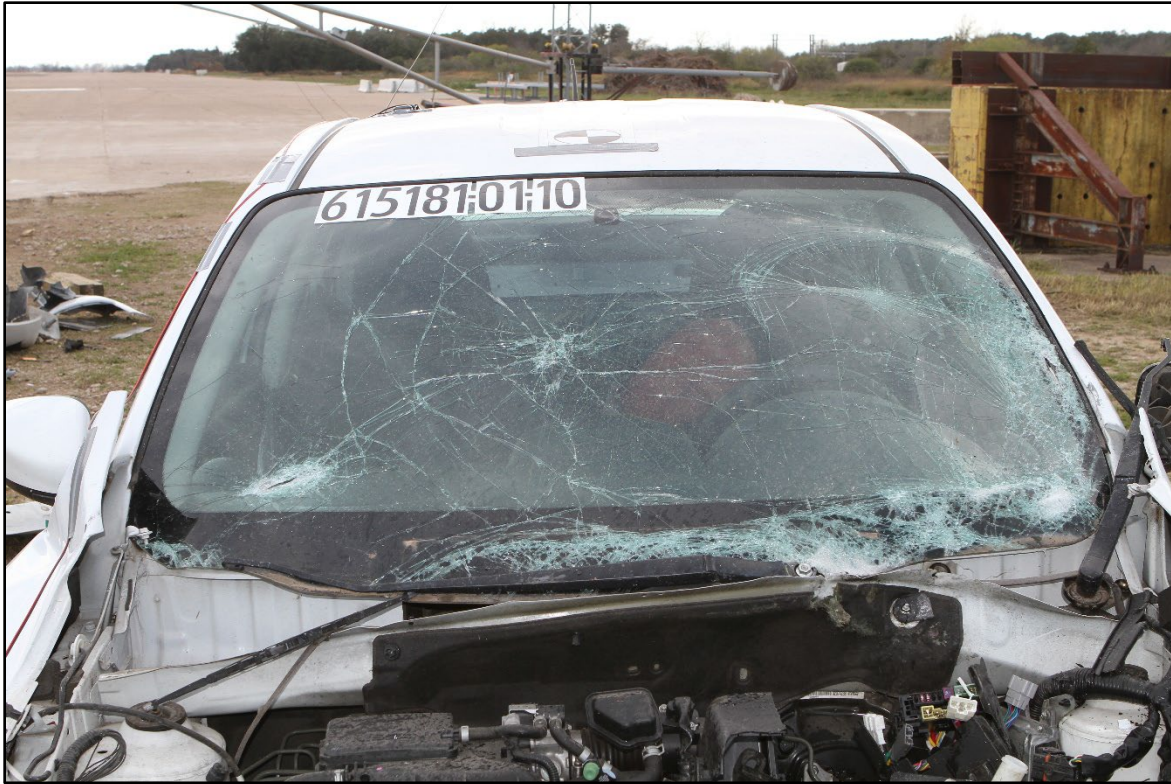
Figure 3.18. TL-2 Terminal on MGS Post Impact Crash Test 615181-01-10.

The TL-2 Terminal for crash test 615181-01-10 did not meet the performance criteria for *MASH* TL-2 Gating Terminals. The rail impacted and tore the windshield thus showing potential for penetration of the occupant compartment, which is considered a failure under *MASH* Evaluation Criteria D as detailed in Chapter 6. The installation was redesigned, and the details of the 615181-01-9 installation and crash test are presented in section 3.3.

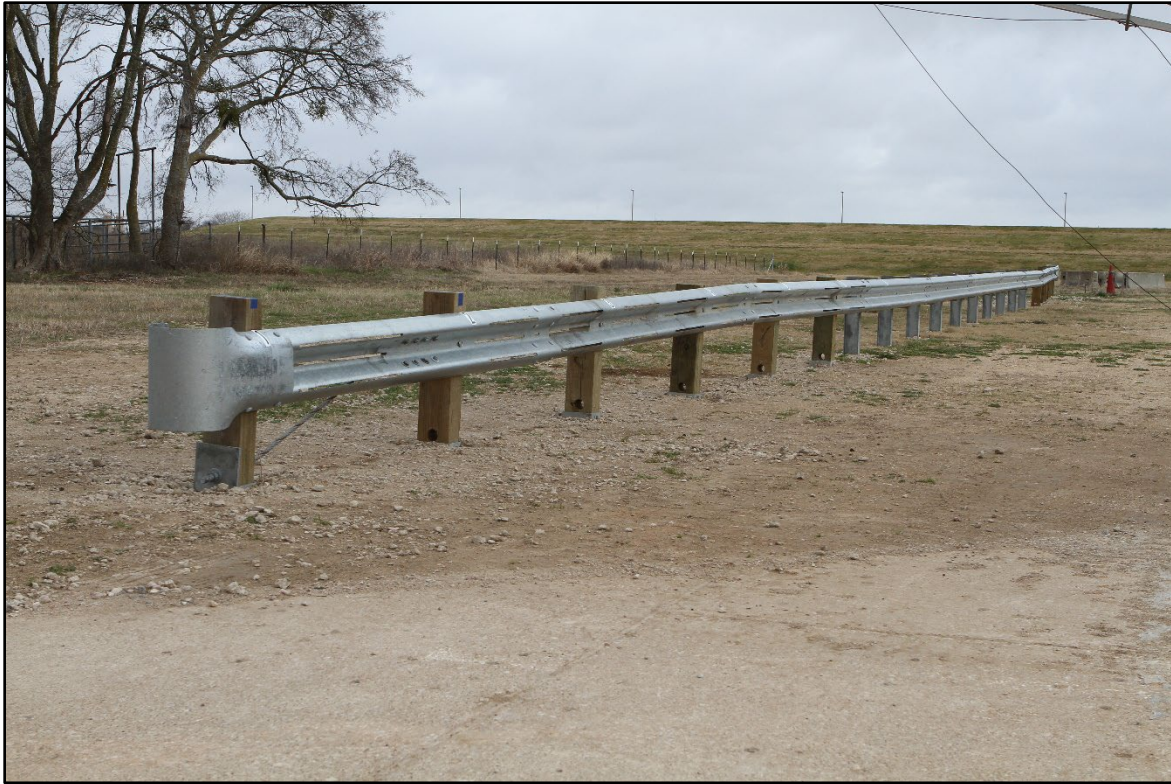
Figure 3.22. TL-2 Terminal on MGS prior to Crash Test 615181-01-9.

The 615181-01-9 test installation differed from the 615181-01-10 installation in that the rail height was lowered upstream of post 7 and downstream of post 16 from 31 inches to a height of 25 inches at the end posts.

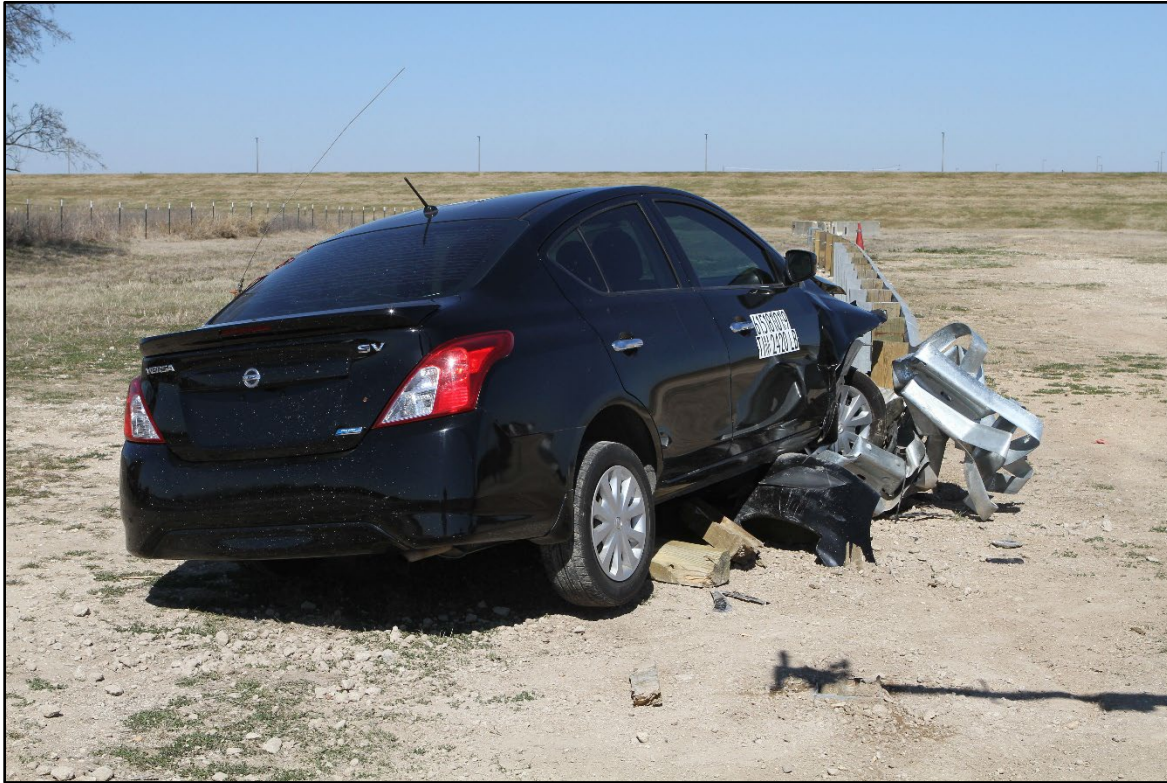
Figure 3.24. TL-2 Terminal on MGS Post Impact for Crash Test 615181-01-9.

The TL-2 Terminal for crash test 615181-01-9 met the performance criteria for *MASH* TL-2 Test 2-30 for Gating Terminals. Therefore, testing continued with *MASH* Test 2-31 as Test 615181-01-3. Its details are in section 3.5.

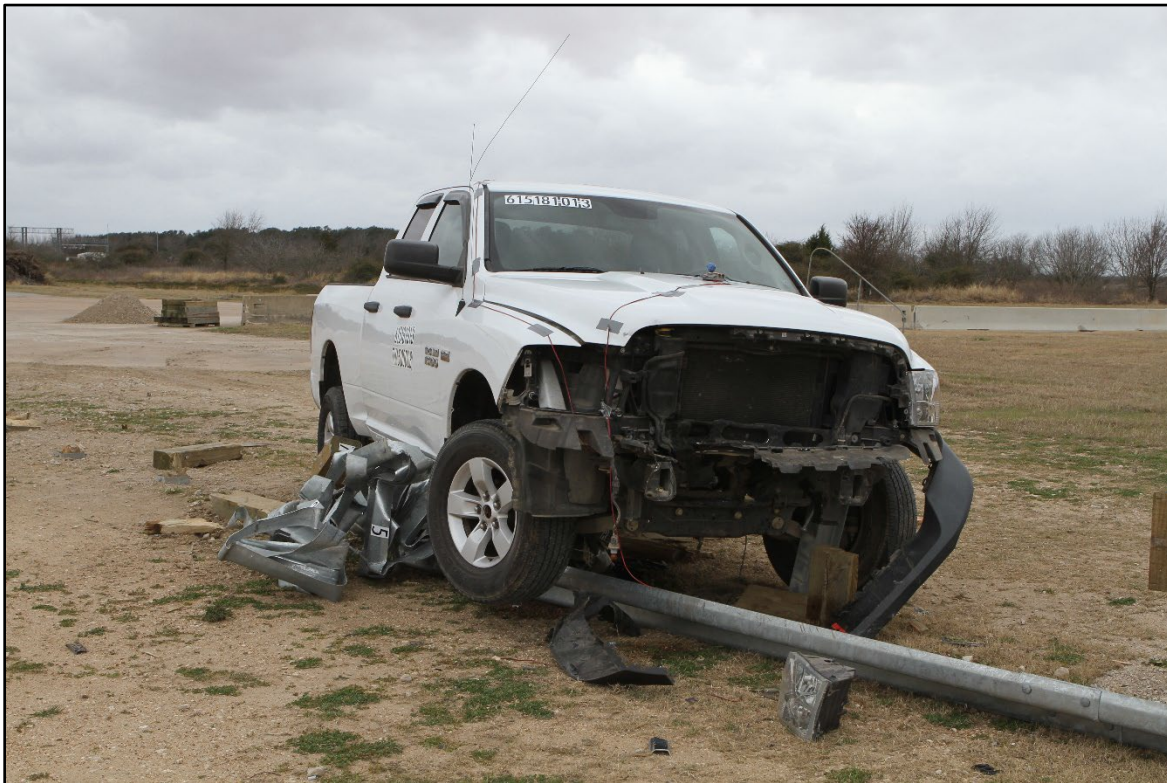
Figure 3.25. TL-2 Terminal on MGS Post Impact for Crash Test 615181-01-3.

The TL-2 Terminal for *MASH* Test 2-31 crash test 615181-01-3 met the performance criteria for *MASH* TL-2 Gating Terminals. Therefore, testing continued with *MASH* Test 2-35 as Test 615181-01-8, which is detailed in section 3.6.

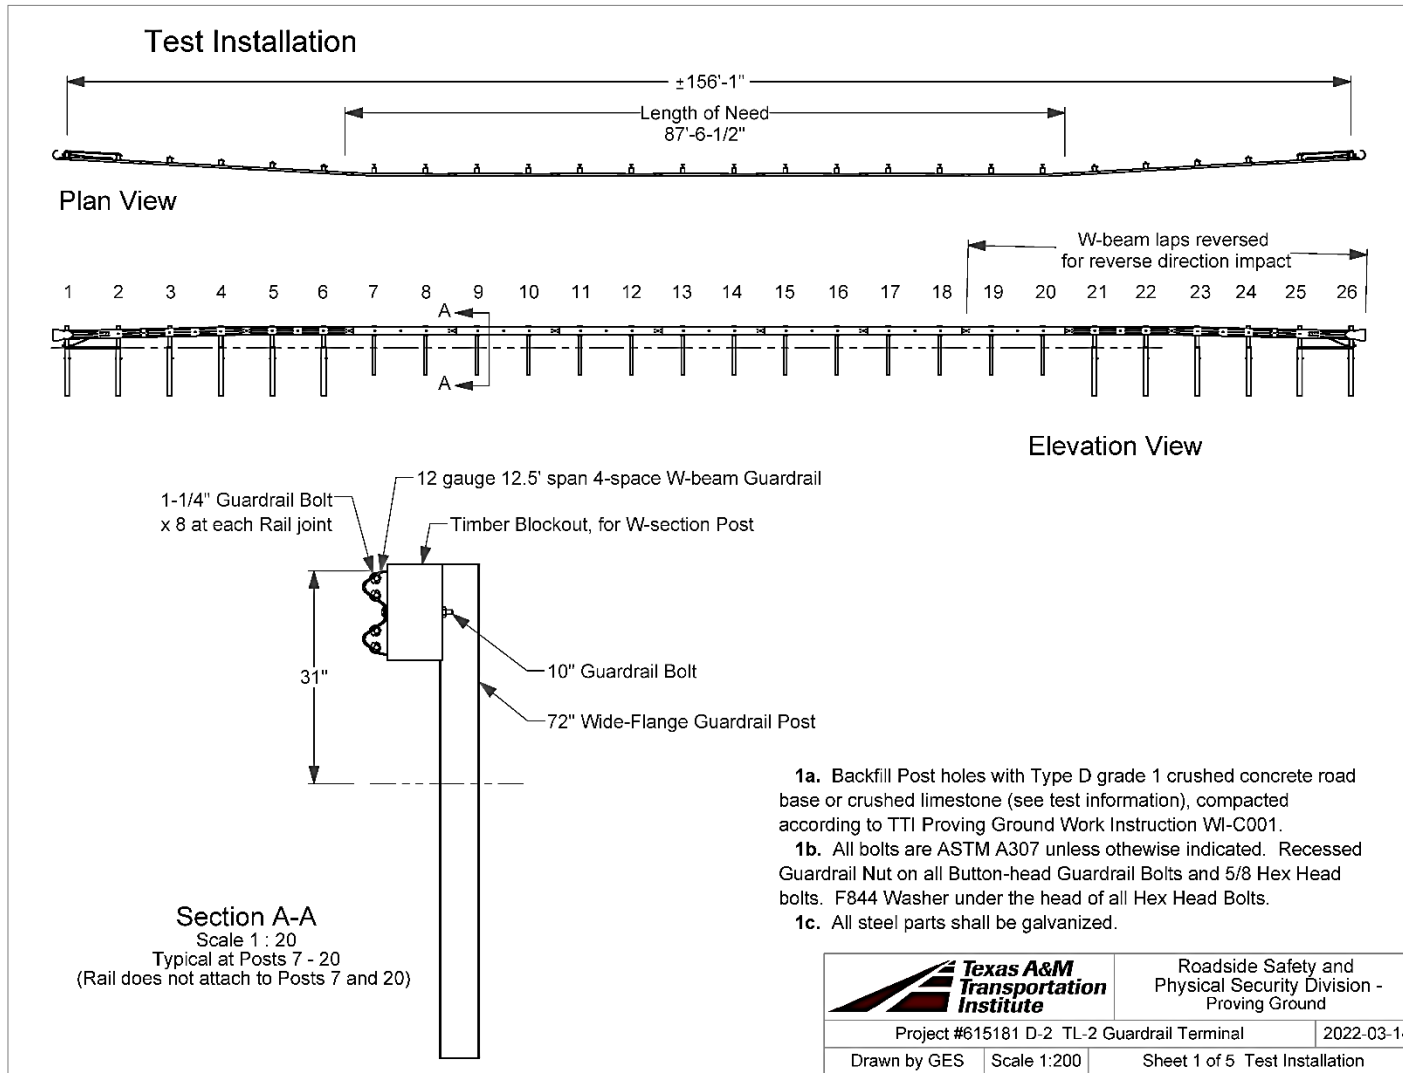
Figure 3.26. Details of TL-2 Terminal on MGS for Crash Test 615181-01-8.

A crash test simulation showed that the 2270P vehicle could override the system as tested in 615181-01-3 when tested to *MASH* Test 2-35 criteria, therefore a strut was added between posts 1 and 2, and then again at posts 25 and 26. The length of need was also increased, which led to an overall length of 156 ft- 1 inch. All other details remained the same as the installations for crash tests 615181-01-09 and 615181-01-3.

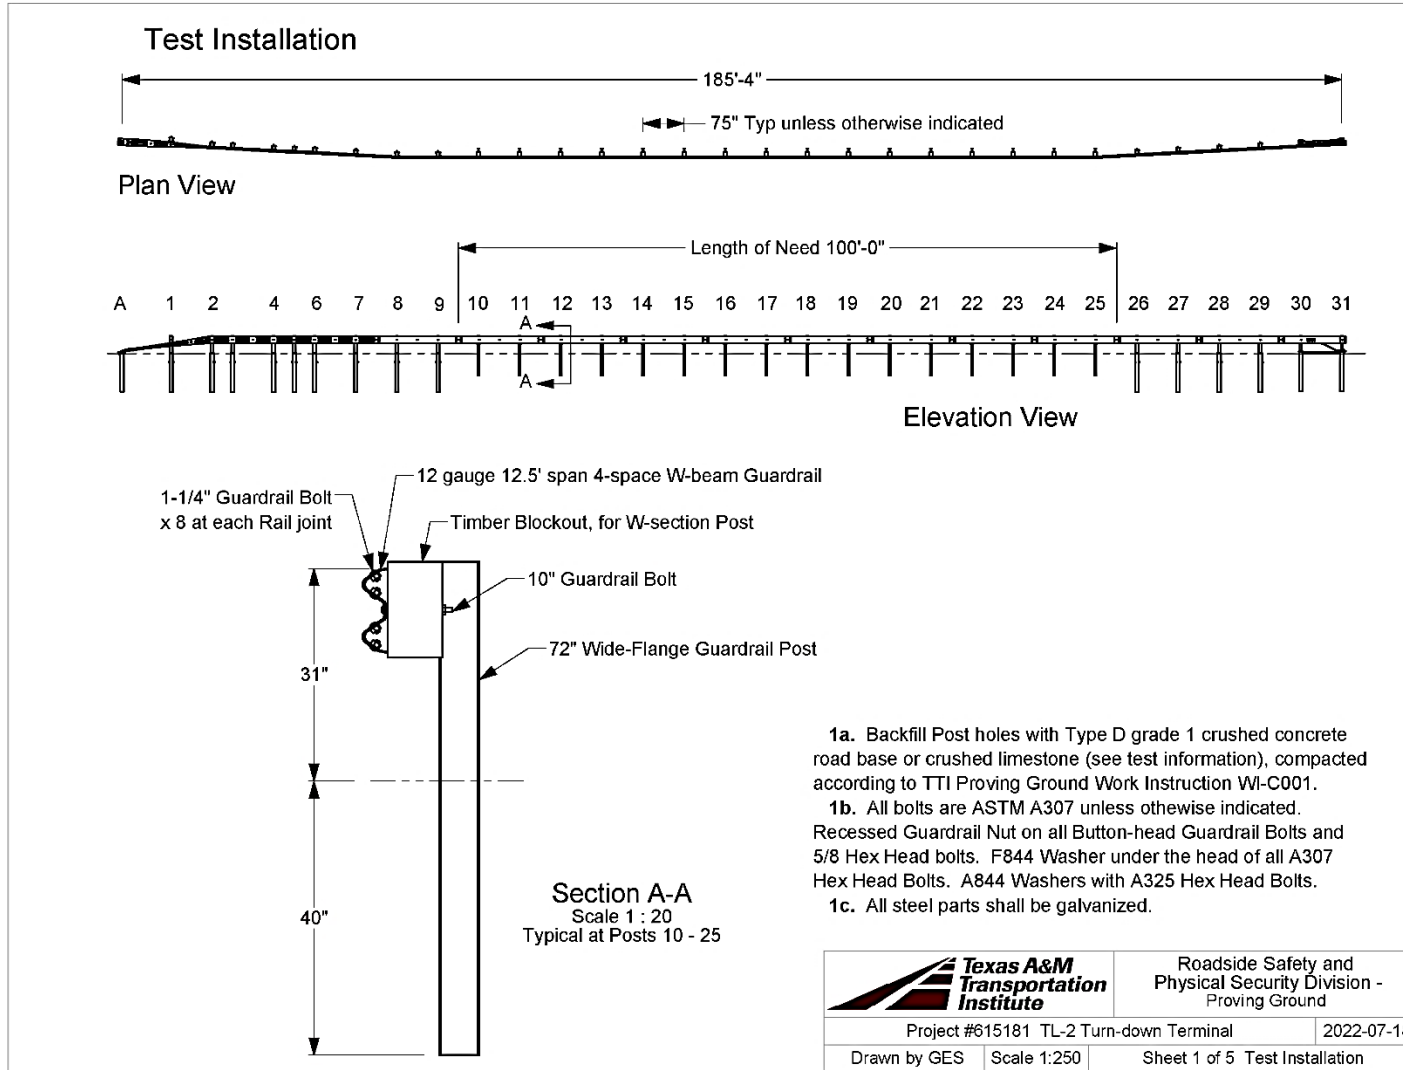
Figure 3.30. Details of TL-2 Terminal on MGS for Crash Test 615181-01-3.

The 615181-01-4 test installation differed from the 615181-01-8 installation in that an anchor post was added upstream of post 1 and the rail began to turn down starting at post 2 and connected to the anchor post at grade. The downstream terminal remained unchanged. The spacing on the posts between posts 2 and 6 also changed.

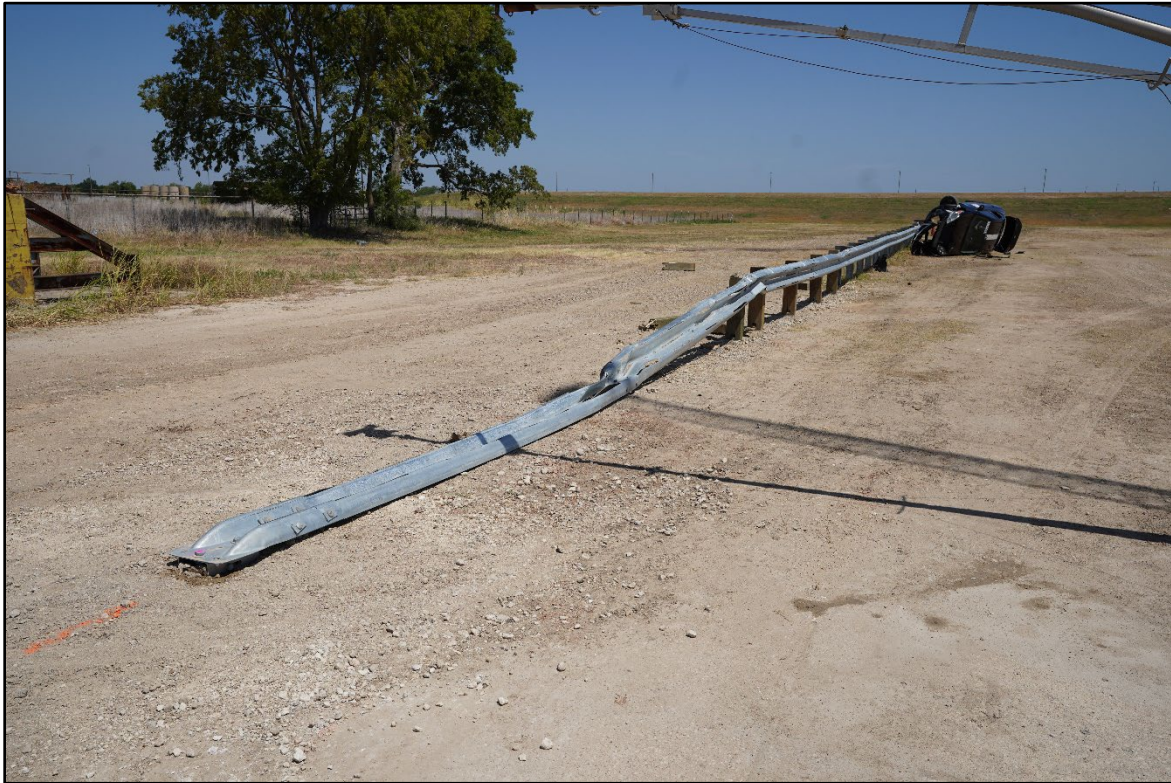
Figure 3.33. TL-2 Terminal on MGS Post Impact for Crash Test 615181-01-3.

The TL-2 Terminal for crash test 615181-01-4 did not meet the performance criteria for *MASH* TL-2 Gating Terminals. The vehicle rolled 103°, which exceeds the 75° maximum specified in *MASH* Evaluation Criteria F as detailed in Chapter 6. The installation was redesigned, and the details of the final designs are presented in the remainder of this report.

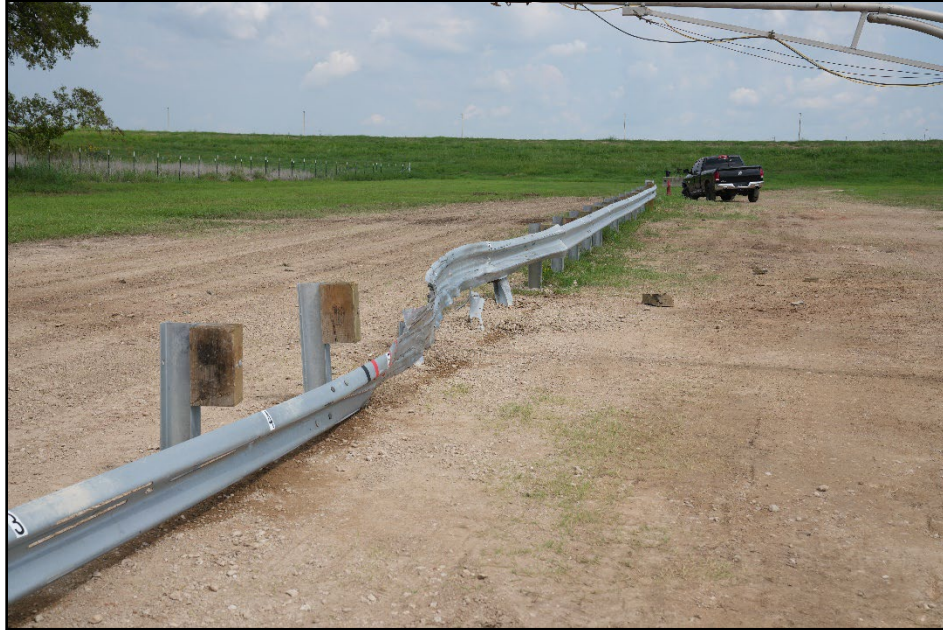
The rail released from posts 2 through 9, and the blockouts were missing from posts 6 and 7. Posts 6 through 8 were twisted 90° clockwise. Table 8.6 describes the damage to the TL-2 W-beam End Terminal. u/s = upstream d/s = downstream f/s = field side t/s = traffic side

Test Parameter	Measured
Permanent Deflection/Location	29.0 inches toward field side, 12 inches downstream of post 7
Dynamic Deflection	38.2 inches toward field side
Working Width ^a and Height	46.5 inches, at a height of 62.3 inches at the left side mirror

Figure 8.5. TL-2 W-beam End Terminal after Test at Impact Location 615181-01-5.

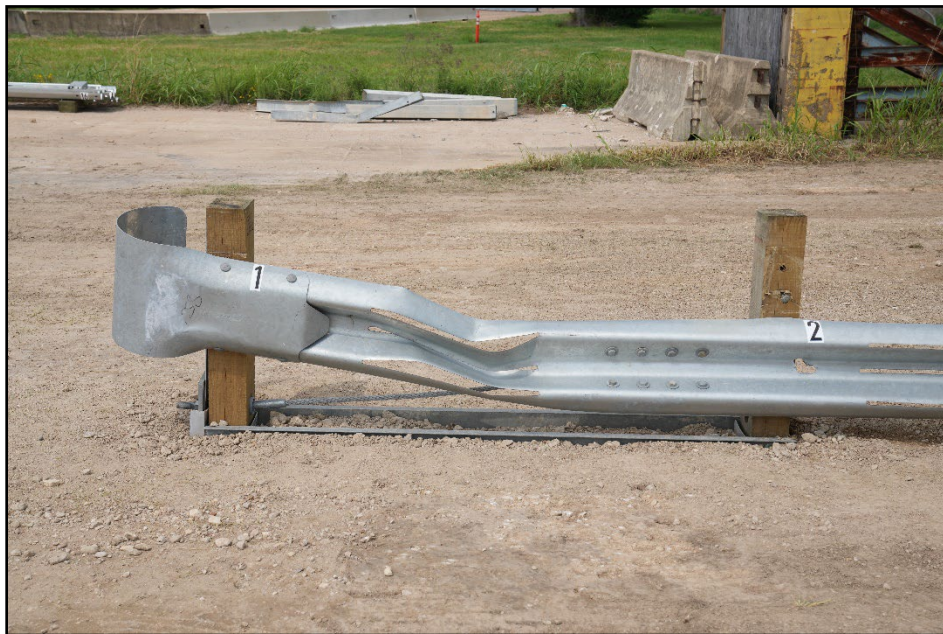
Figure 8.6. TL-2 W-beam End Terminal after Test at the Upstream End Terminal 615181-01-5.

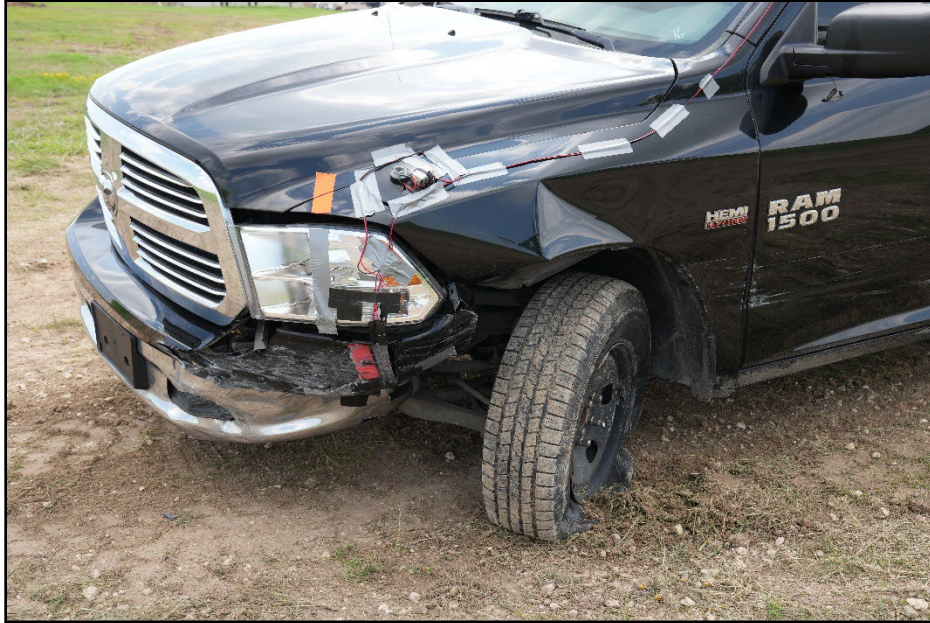
Figure 8.7. Impact Side of Test Vehicle after Test 615181-01-5.

Side Windows	The side windows remained intact
Maximum Exterior Deformation	10 inches in the front plane at the right front corner at bumper height
VDS	11FLQ2
CDC	11FLEW2
Fuel Tank Damage	None
Description of Damage to Vehicle:	The front bumper, left front headlight, left front quarter fender, left front tire and rim, left front door, left rear door, left cab corner, left rear quarter fender, and rear bumper were damaged.

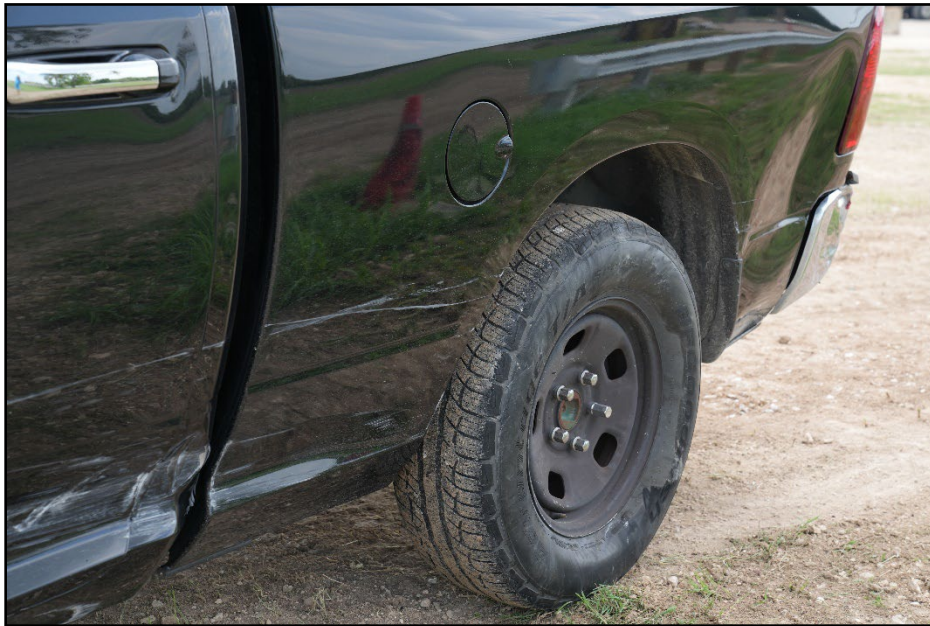
Figure 8.8. Rear Impact Side of Test Vehicle after Test 615181-01-5.

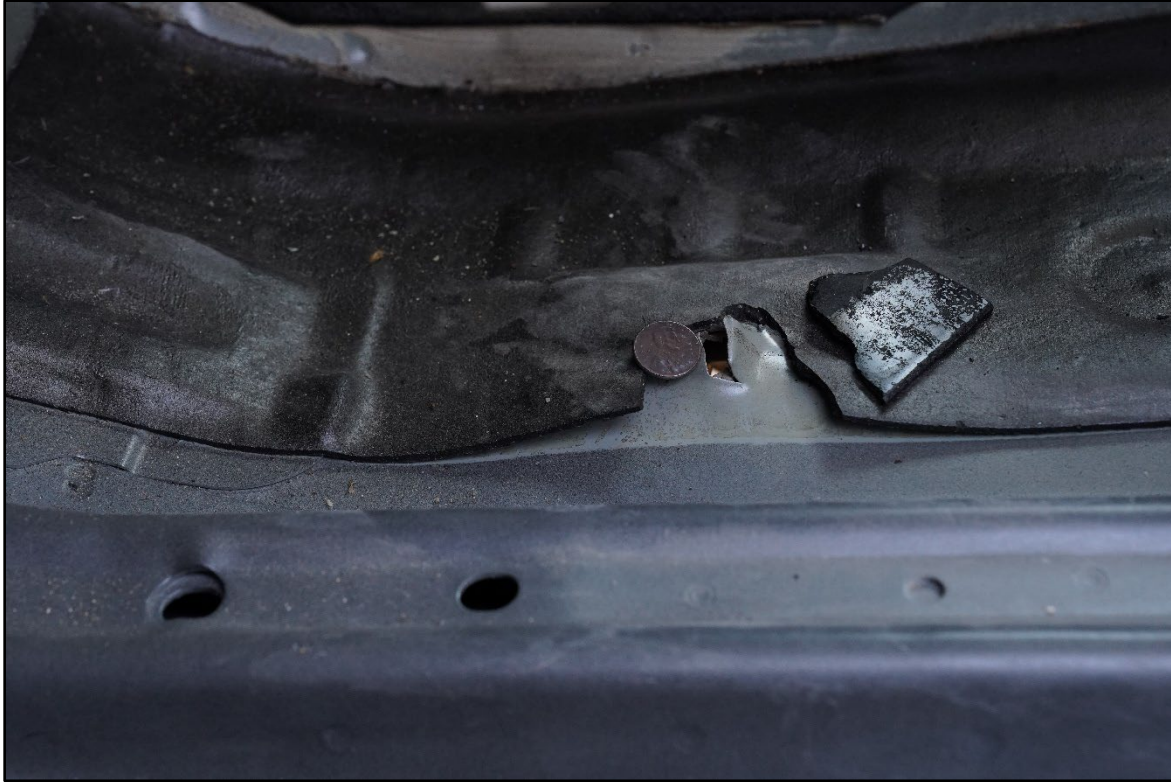
The TL-2 Terminal for crash test 615181-01-6 did not meet the performance criteria for *MASH* TL-2 Gating Terminals. The threaded rod on the anchor cable punctured the floor board of the vehicle, penetrating into the occupant compartment, which is considered a failure under *MASH* Evaluation Criteria D, which is detailed in Chapter 6. Changes were made to the installation and the details of the 615181-01-7 installation and crash test are presented in section 9.2.

Figure 9.2. Occupant Compartment Penetration after Crash Test 615181-01-6.

The installation differed from crash test 615181-01-6 in that a crown cap nut was added to the threaded rod of the anchor cable, and the pull plate thickness was changed to 1/8-inch.

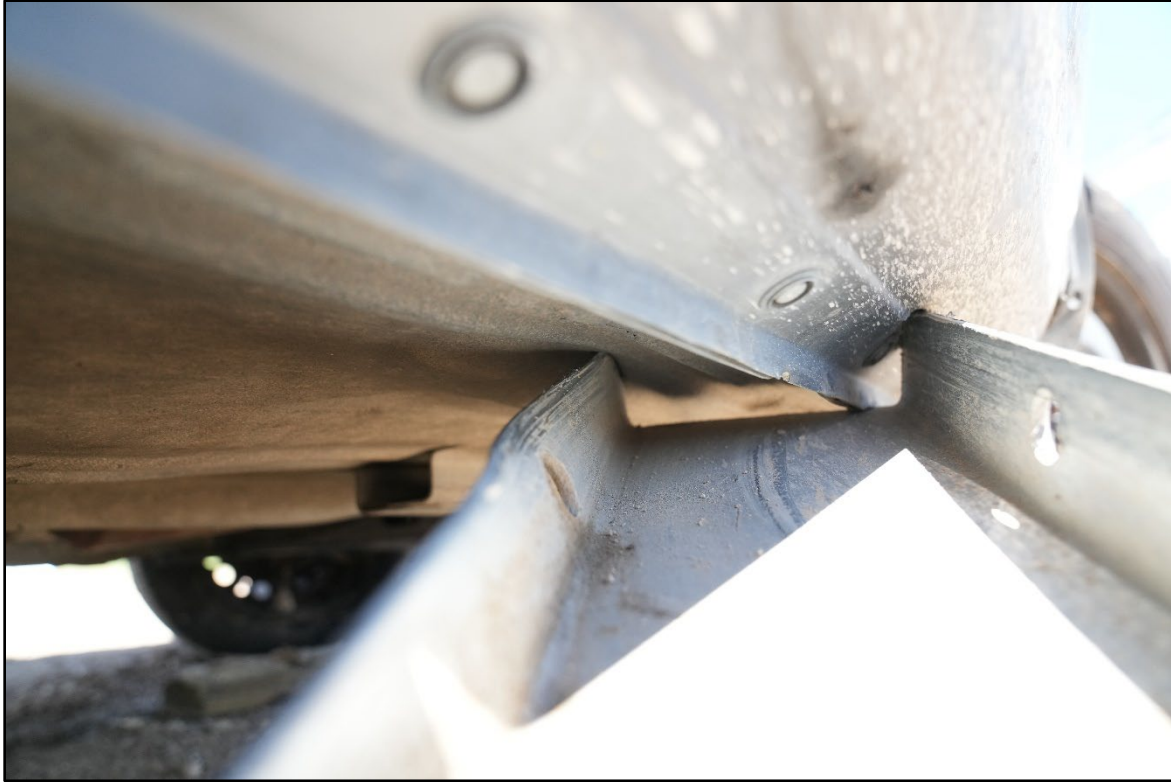
The TL-2 Terminal for crash test 615181-01-7 did not meet the performance criteria for *MASH* TL-2 gating terminals. An upstream corner of a steel guardrail post punctured the floor board of the vehicle, penetrating into the occupant compartment, which is considered a failure under *MASH* Evaluation Criteria D as detailed in Chapter 6. Additional changes were made (as described in chapter 7) to the installation and the crash tests are presented in the remainder of this report.

Figure 9.8. Post Engaged with Undercarriage of Vehicle after Crash Test 615181-01-7.
