Safety Edge_{SM}
HMA Demonstration Project
Jasper County, Iowa

Field Report
June 6, 2011

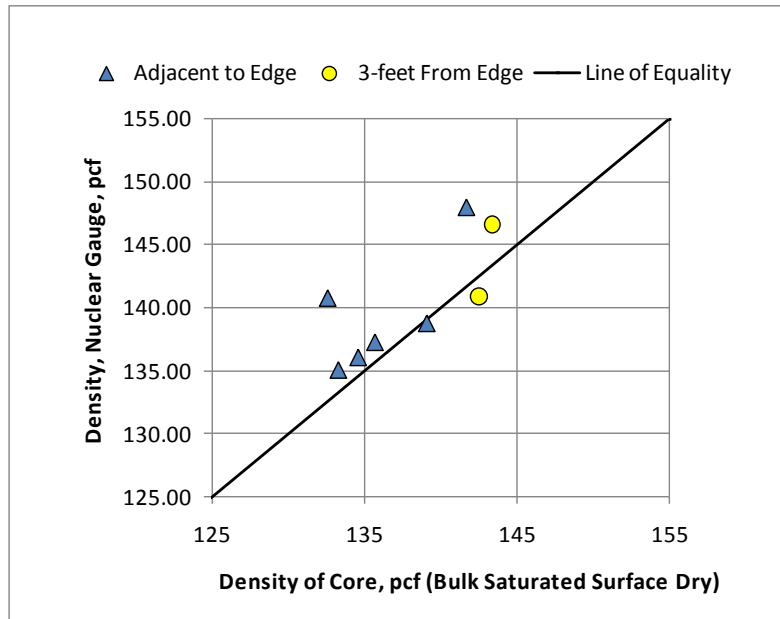
Figure 7. Comparison of the nuclear density readings and core densities.

Figure 7 shows a comparison of the nuclear densities and densities measured from the cores. As shown, the value at 3 ft. from the edge was close to unity and the value adjacent to the edge is not as close to unity. The adjusted densities using the adjustment factors are also listed in Table A-4 in Appendix A. The factors were used to adjust the nuclear density gauge readings to be consistent with the densities that were measured in the laboratory. The nuclear density test results are listed in Table A-5 and A-6 in Appendix A.

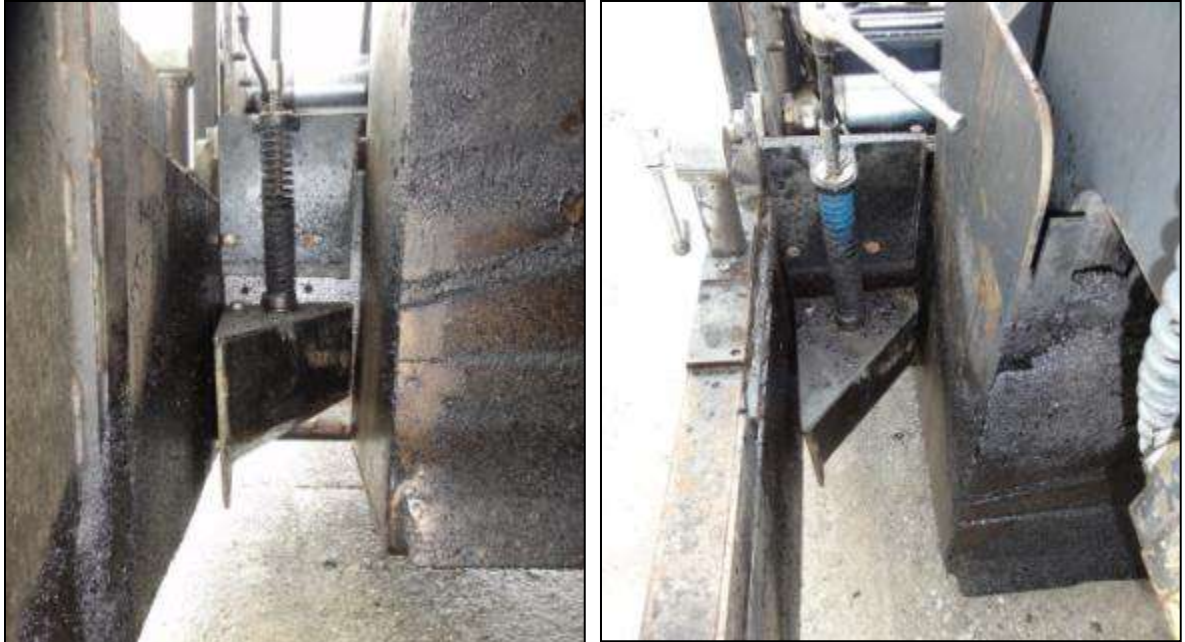
Figure 12. TransTech Shoulder Wedge Maker bolted to the paver screed.

The contractor utilized a windrow material transfer vehicle (MTV) together with a Blaw-Knox rubber tire paver equipped a Caterpillar Extend-A-Mat 10-20B screed (Figure 10). Figure 11 and Figure 12 are images of the paving screed and the Safety Edge_{SM} device bolted to the screed. Vertical control of the Safety Edge_{SM} device was accomplished by hand cracking the device by the screed operator walking beside the paver.
