FINAL REPORT

Oregon Route 224 Corridor Study: Phase 1 – Existing Conditions Assessment

October 2021

Prepared by:
Federal Highway Administration
Western Federal Lands Highway Division

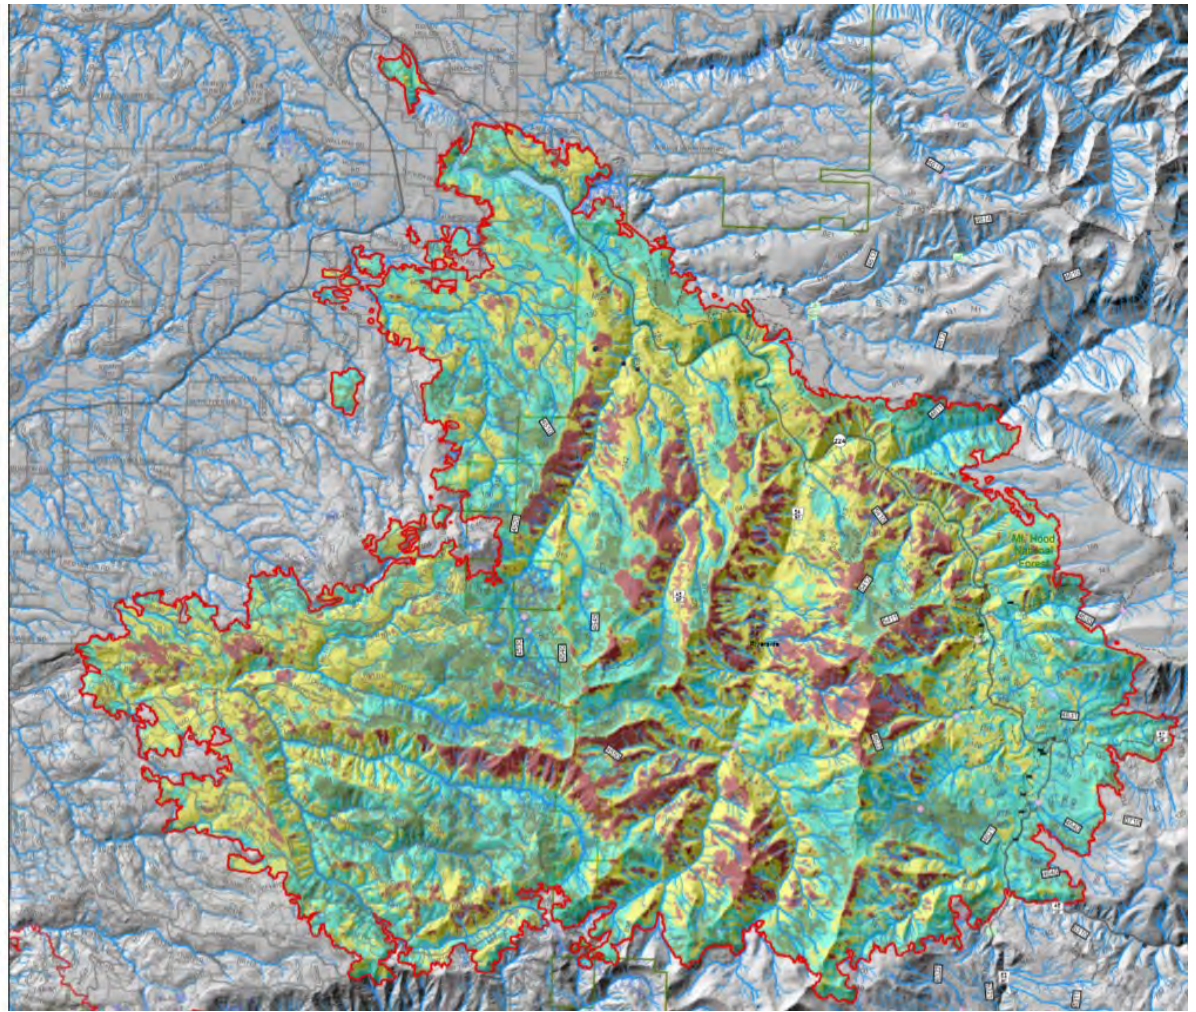
Riverside Fire – Soil Burn Severity Map

Burned Area Reflectance Classification (BARC), aerial reconnaissance data, and on-the-ground surveys were conducted to develop a Soil Burn Severity (SBS) map which was used to estimate the soils post-fire hydrologic responses and resulting flows for the Clackamas River subwatersheds. Risk of upland erosion, sedimentation delivery rates, and increased flood flows were then estimated for 27 subwatersheds using the Water Erosion Prediction Project (WEPP) Post-Fire Erosion Predictor (PEP). This was compared to pre-fire 5-year recurrence interval flood conditions to identify levels of risks at road/stream crossings. The BAER report provides analysis results of crossing points along OR 224 listed in Table 1. Significant increase in flow are predicted for a majority of the analyzed crossings.
