SUBJECT: **REVISED Geotechnical Memorandum 03-20**
Preliminary Pretty Rocks Landslide Bridge Feasibility and Constructability
Pretty Rocks Landslide Investigation
AK NPS DENA 10(45)

Denali National Park Unstable Slope Corridor Assessment

**GEOTECHNICAL SUMMARY REPORT OF EXISTING
CONDITIONS**

Re: Geotechnical Report 05-20, AK NPS DENA 10(49), Geotechnical Summary Report of Existing Conditions

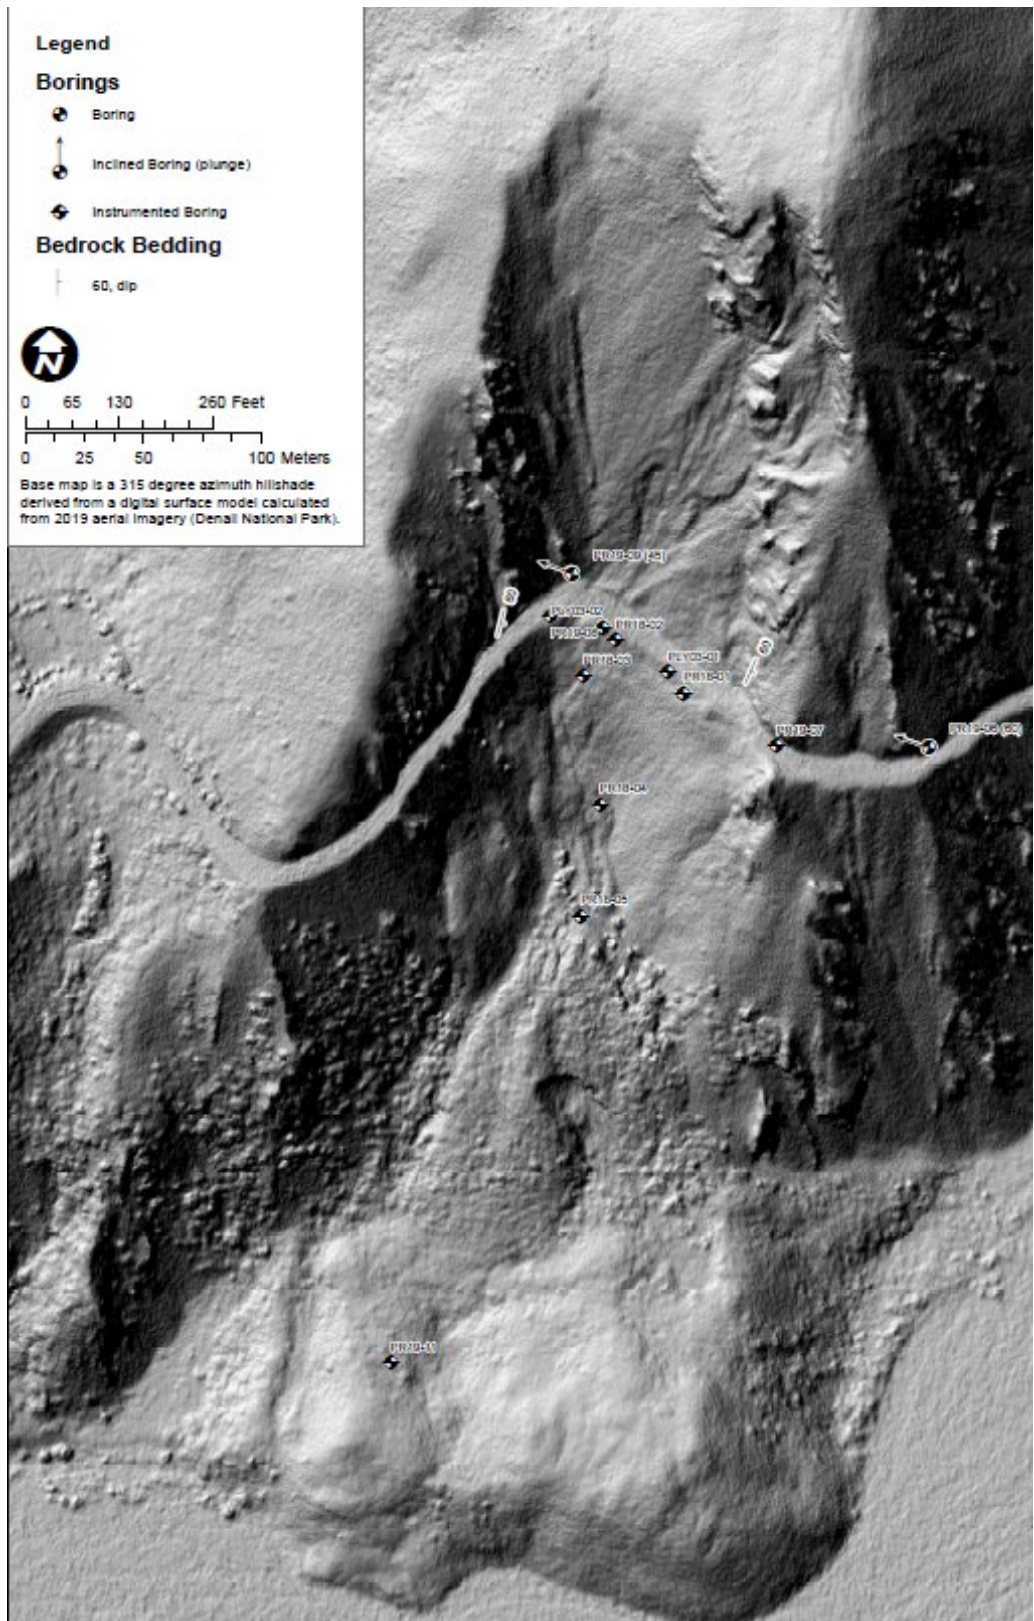
Figure 1. Test boring locations for Pretty Rocks Landslide Investigation.

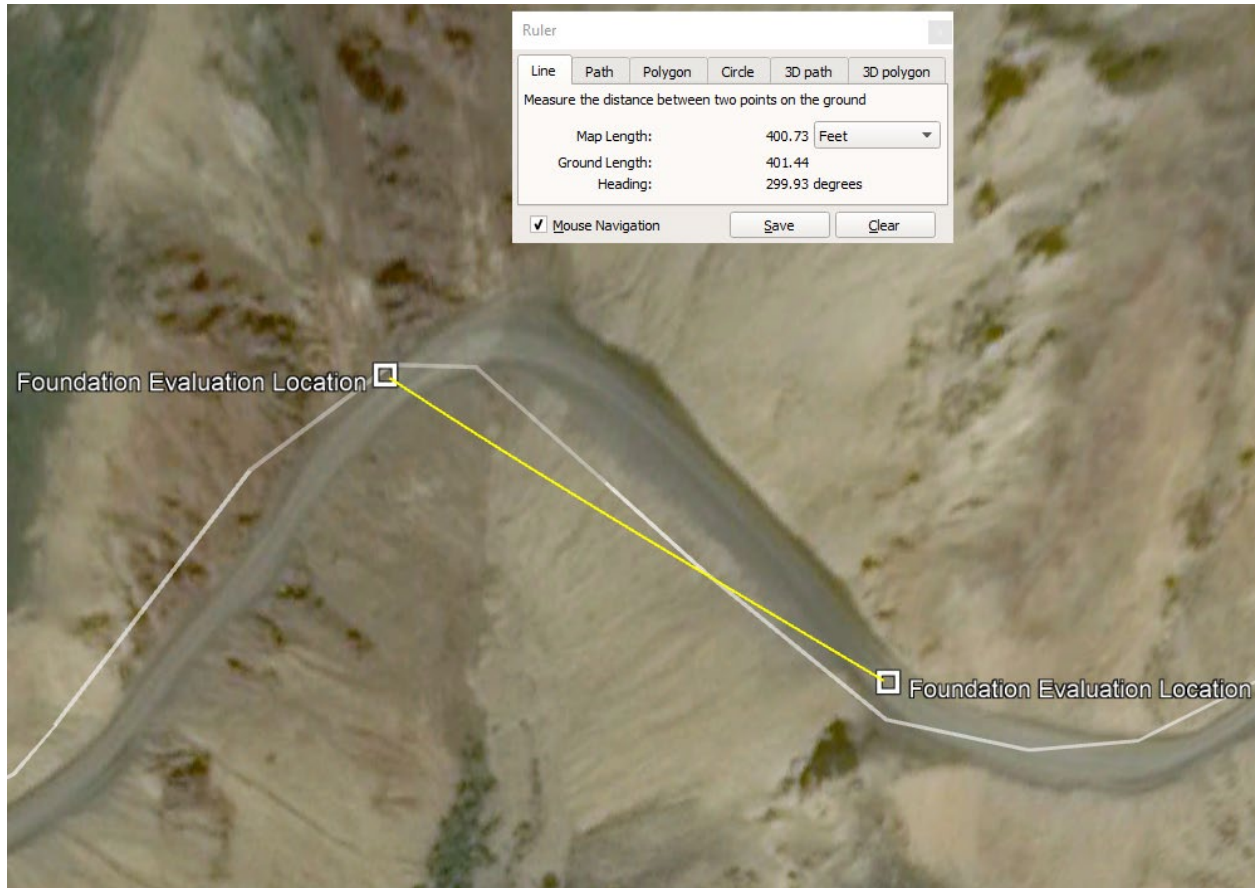
Figure 2. Approximate location of bridge foundations evaluated for feasibility of bridging the landslide.

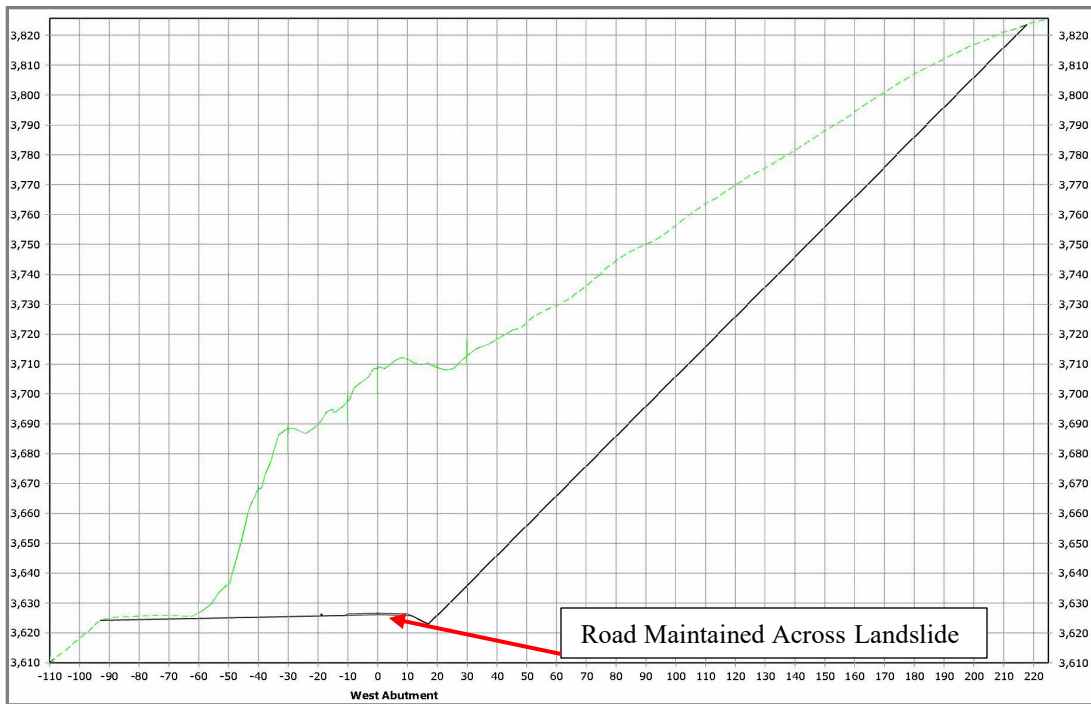
The most feasible bridge type, as discussed above, is the steel truss modular design. In order for it to be constructed, it will require rock cut excavation adjacent to the west and east abutments to allow for assembly of the bridge, staging of equipment and material, and to accommodate the bridge approach road alignment on the west side (Figure 11). The anticipated quantity of rock excavation is estimated at 150,000 to 200,000 cubic yards (CY) and extends about 100 feet above the road at the east abutment and 200 feet above the road at the west abutment (Figure 12 and 13, respectively).

Figure 12. Cross section near the west abutment. Existing ground is represented by the green dashed line.

As discussed above in the preliminary foundation section, the bridge abutments will require additional rock excavation and a combination of deep foundations and rock reinforcement to meet design standards for bridge foundation stability. The modular steel truss bridge design is typically assembled behind the abutment and launched into place, limiting the space requirements for assembly. However, because of the road curvature at the east and west abutments, there is not sufficient space behind either abutment to assemble in this manner, so the bridge would likely be assembled on the existing road alignment across the landslide and lifted into place, as discussed in the bridge structure options section.

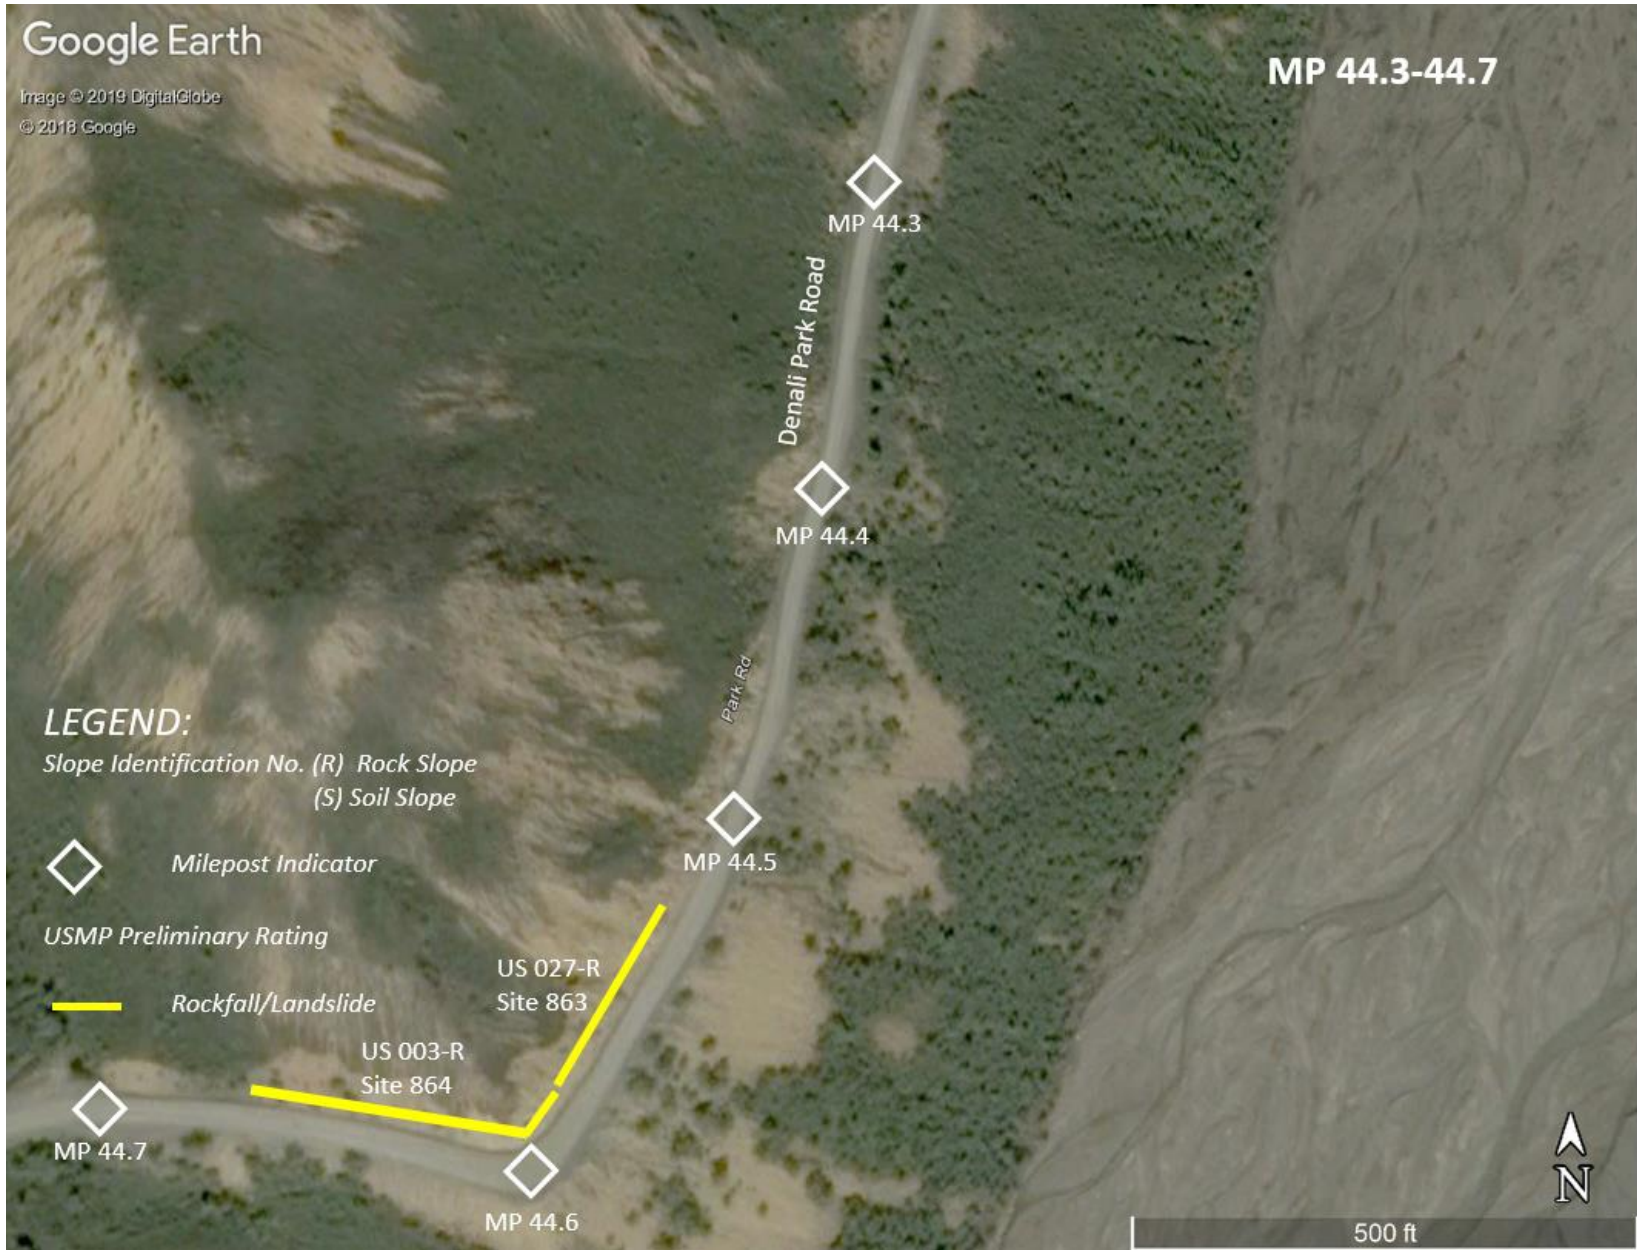
Site 863 (DENA USMP 027)

This unstable slope has a maximum slope height of approximately 95 feet and is approximately 180 feet long. The slope is composed of decomposing rhyolitic (igneous) rock that is producing both, structurally controlled planar and wedge failures and differential erosion failures consisting of boulders with a maximum block size of two feet.

At a minimum, rock scaling should be performed as a temporary risk reduction measure along the slope to remove loose, precariously positioned rocks. The rock scaling would need to be repeated every five to ten years to maintain the same level of risk reduction. For a higher level of risk reduction (Option 2), rock scaling should be completed and large, unsupported rock features would require rock reinforcement with rock bolts and dowels. Cleaning and maintaining the existing ditch will also be required to preserve its effectiveness to contain future rockfall.

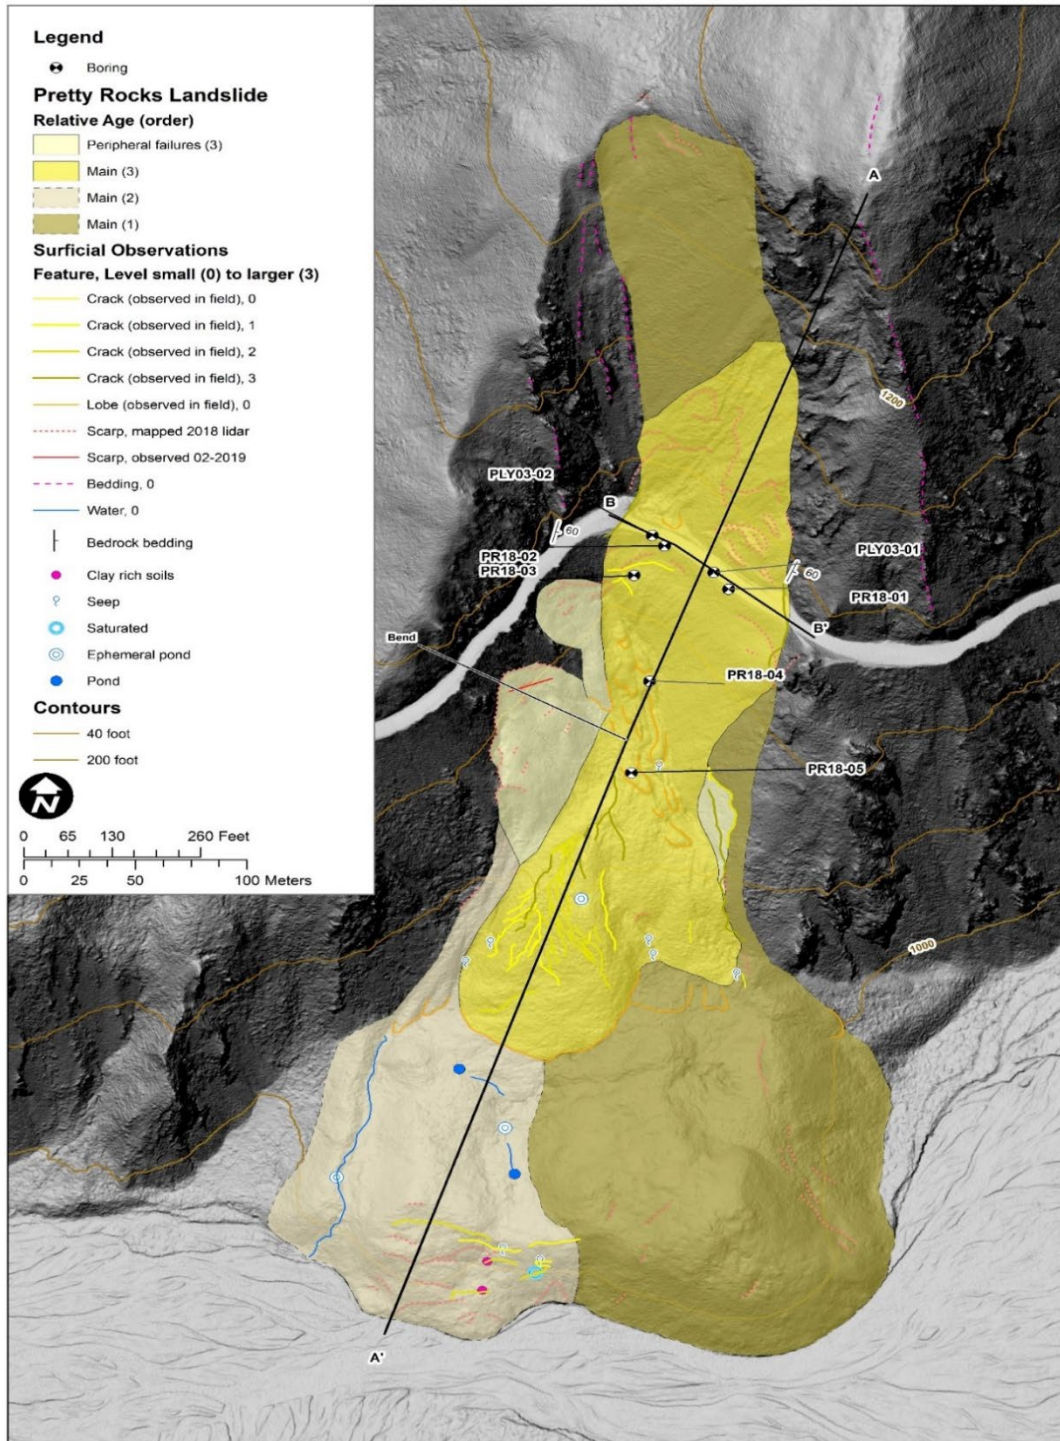
Figure 1-1. Pretty Rocks Landslide mapping and 2003 and 2018 test boring locations (Source: Task Order No. 69056720F000025).

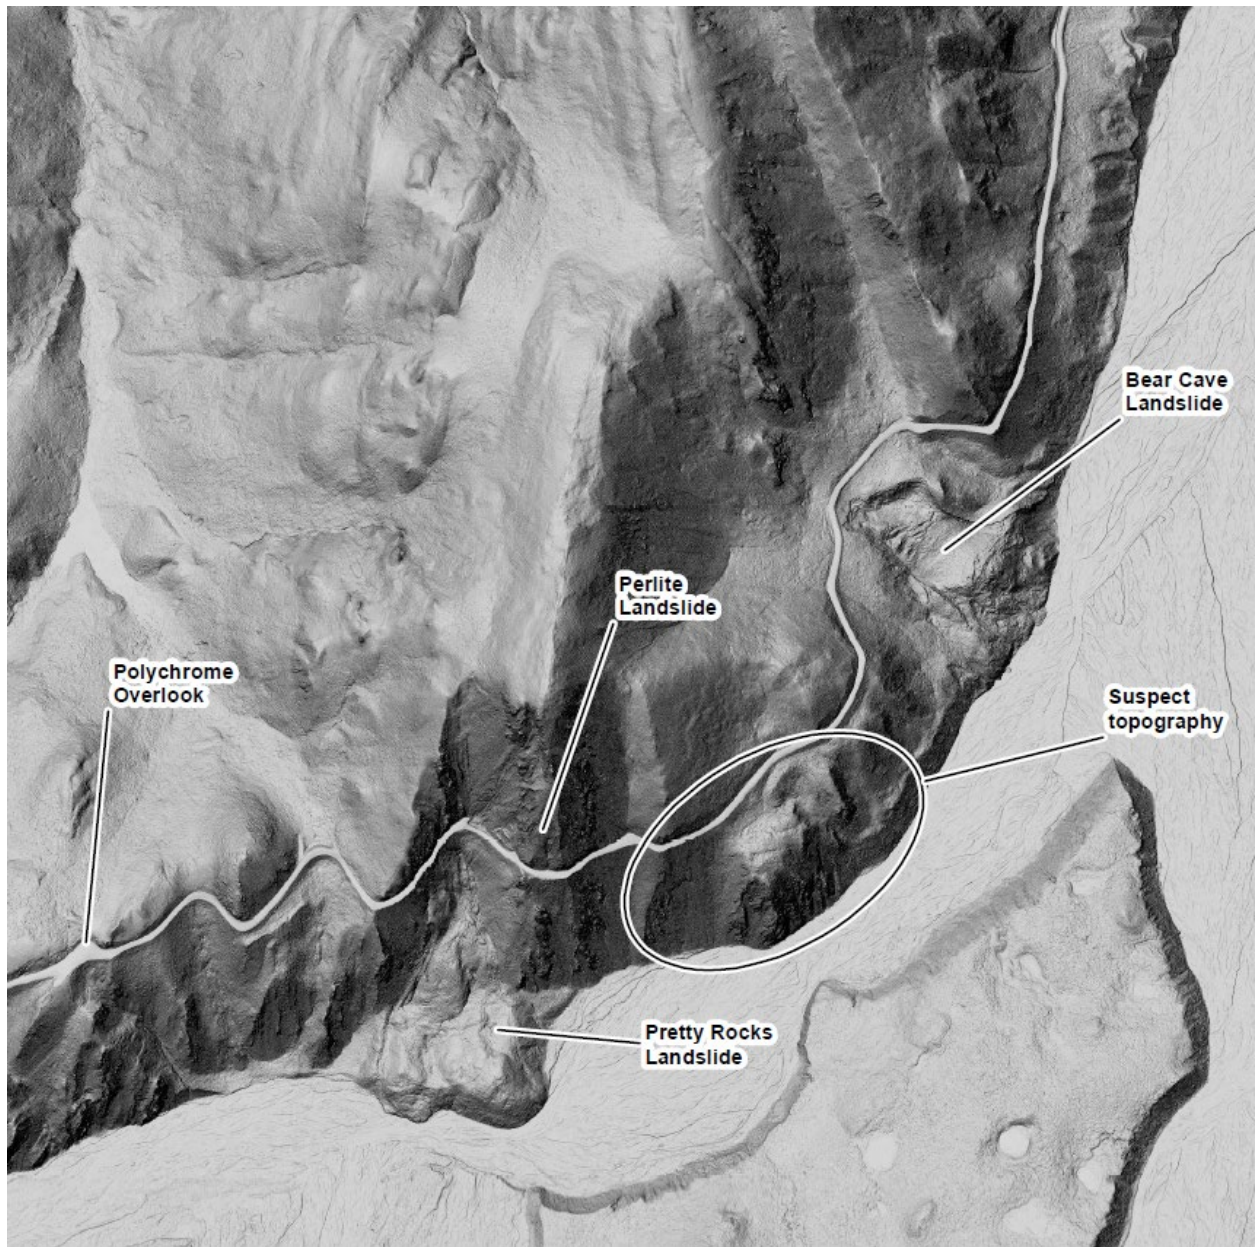
Figure 1-2. Other known landslides on Polychrome Pass (Source: Task Order No. 69056720F000025).

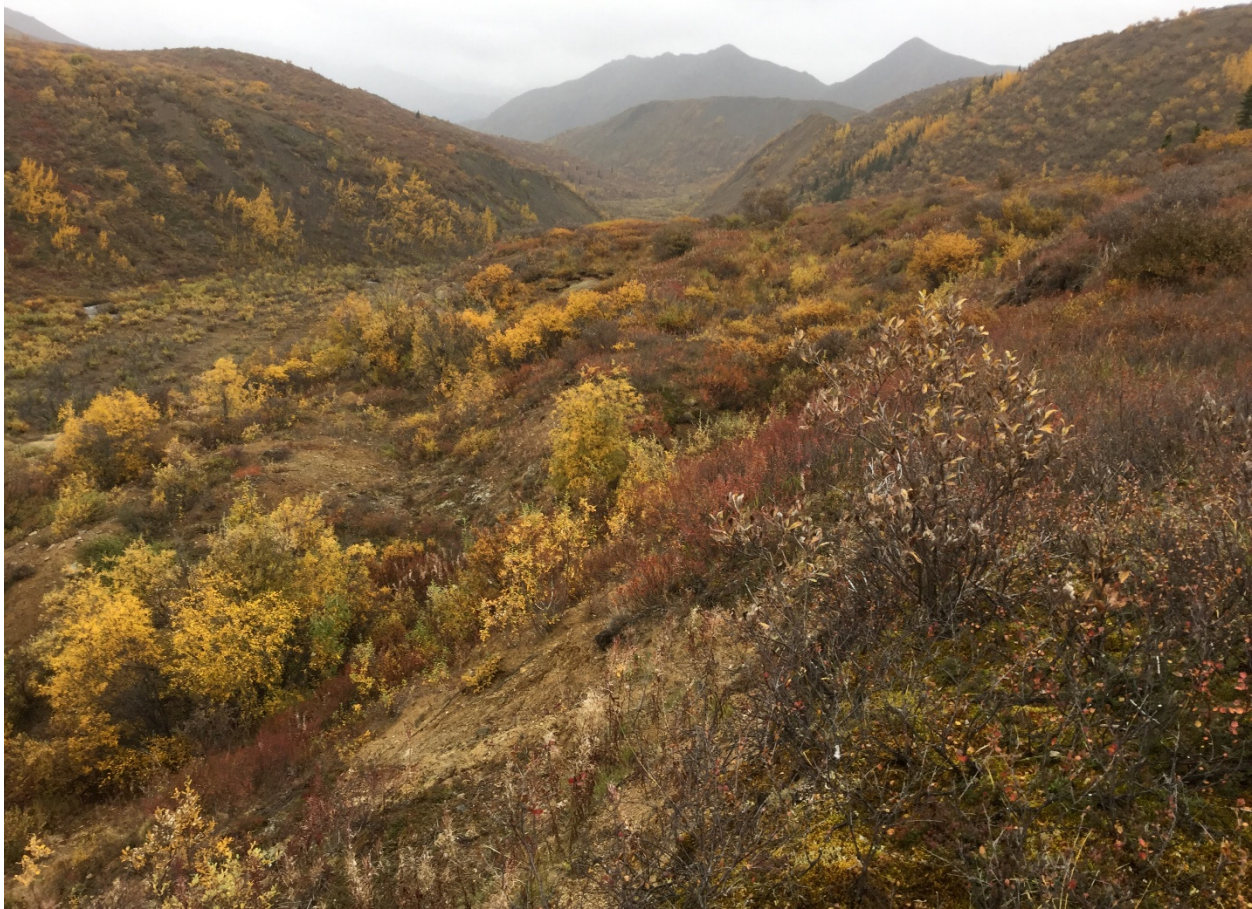
Figure 3-3. The north alignment traverses a valley. Photo location shown as #106 in Figure 3-7. FHWA photo (2019).

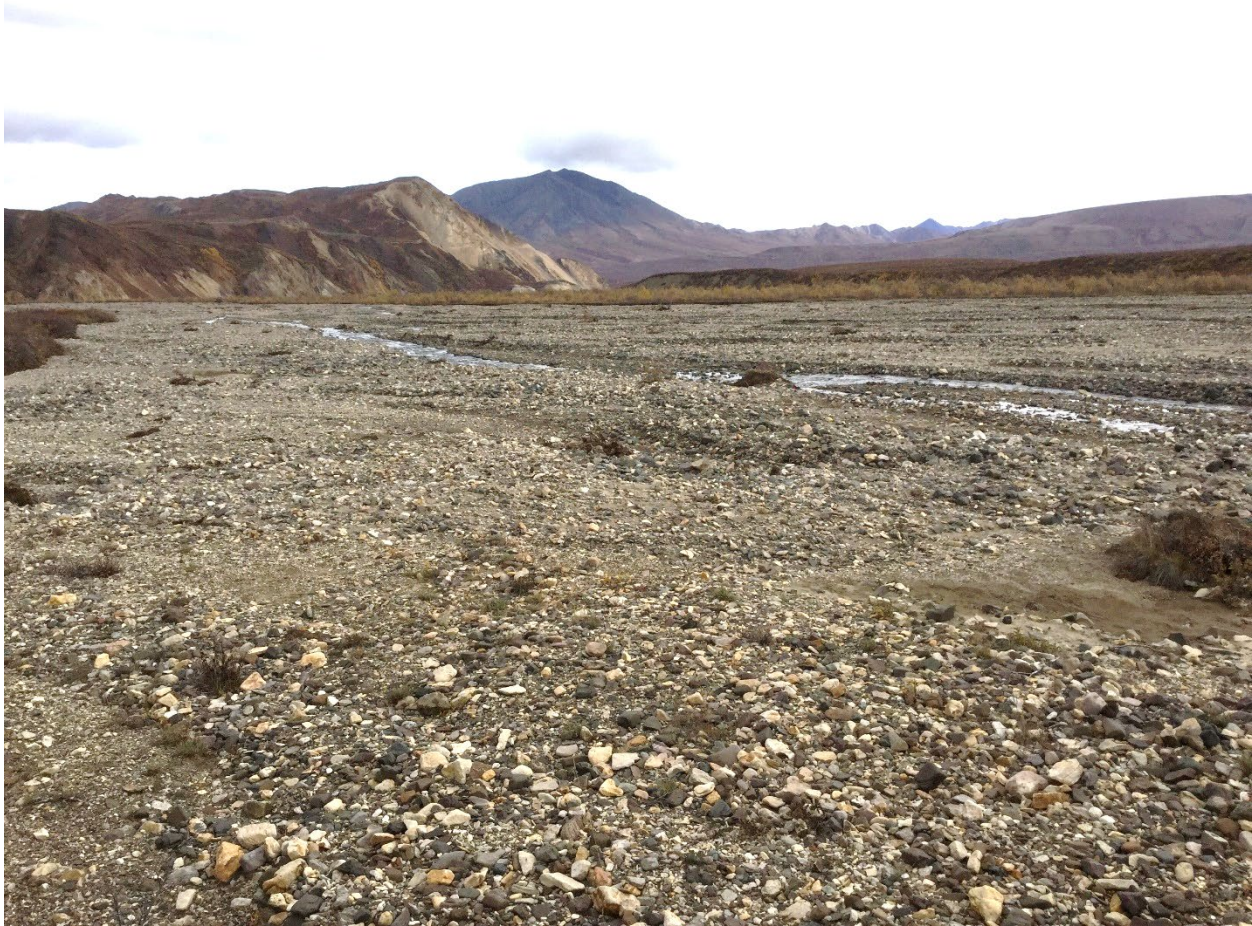
Figure 3-5. Braided channel characteristic of the south alignment. Photo location shown as #014 in Figure 3-7 FHWA photo (2019).

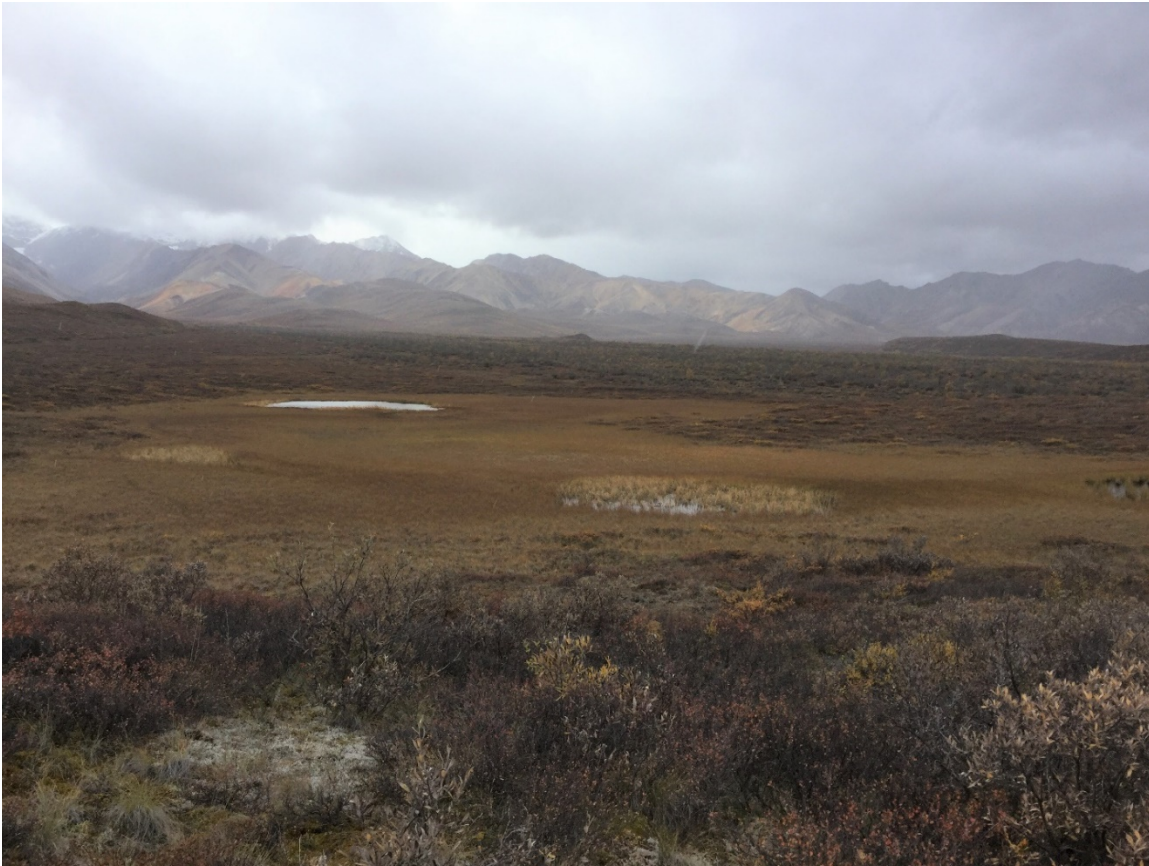
Figure 3-6. Tundra characteristic of the south alignment. Photo location shown as #029 in Figure 3-7 FHWA photo (2019).

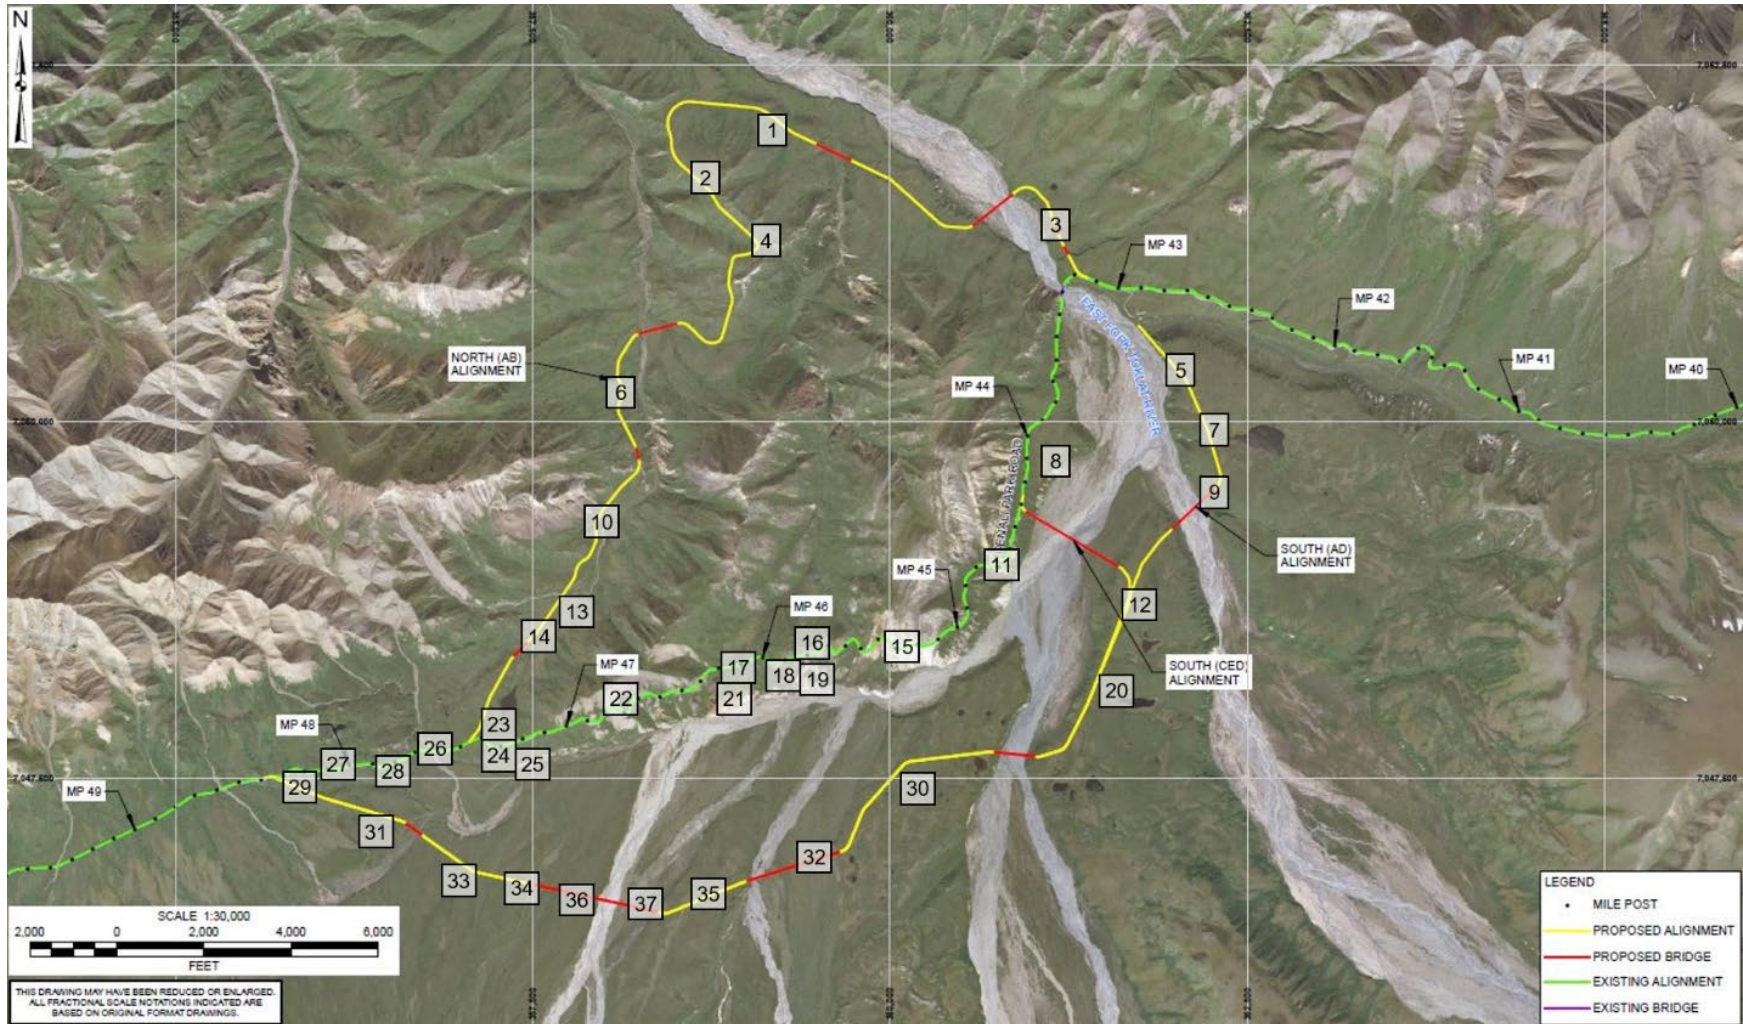
29	There is a defined zone of LOS deformation observed in both ascending and descending TCS that is moving away from descending geometry and towards ascending geometry (movement either vertically or to the west) but pattern is very consistent and in the range of 10 mm/year (0.4 in/year). These observations coincide well with a mapped discontinuous permafrost polygon. Observed trends may be indicative of a circular/slump type movement/subsidence.
30	There are general indications of vertical movements in LOS from both ascending and descending data up to 25 mm/year (1 in/year).
31	There are indications of LOS deformations in both ascending and descending TCS data on this slope
32	Generally, appears to be a more stable landform. No indications of LOS deformation from either ascending or descending geometries.
33	There are no indications of LOS deformation in either ascending or descending data.
34	There are indications of ground deformation in this zone that appear to be accentuated movement in the horizontal plane, possibly indicative of lateral slope movements. This has been predominantly observed in ascending TCS so more pronounced to moving to the east (no indication in descending TCS).

35	Vertical deformations observed in this landform up to 25 mm/year (1 in/year) LOS.
36	No signs of LOS deformation in this landform unit.
37	There are no indications of LOS deformations in this landform unit.

Figure 4-4. Location of InSAR observations from Table 4-2.

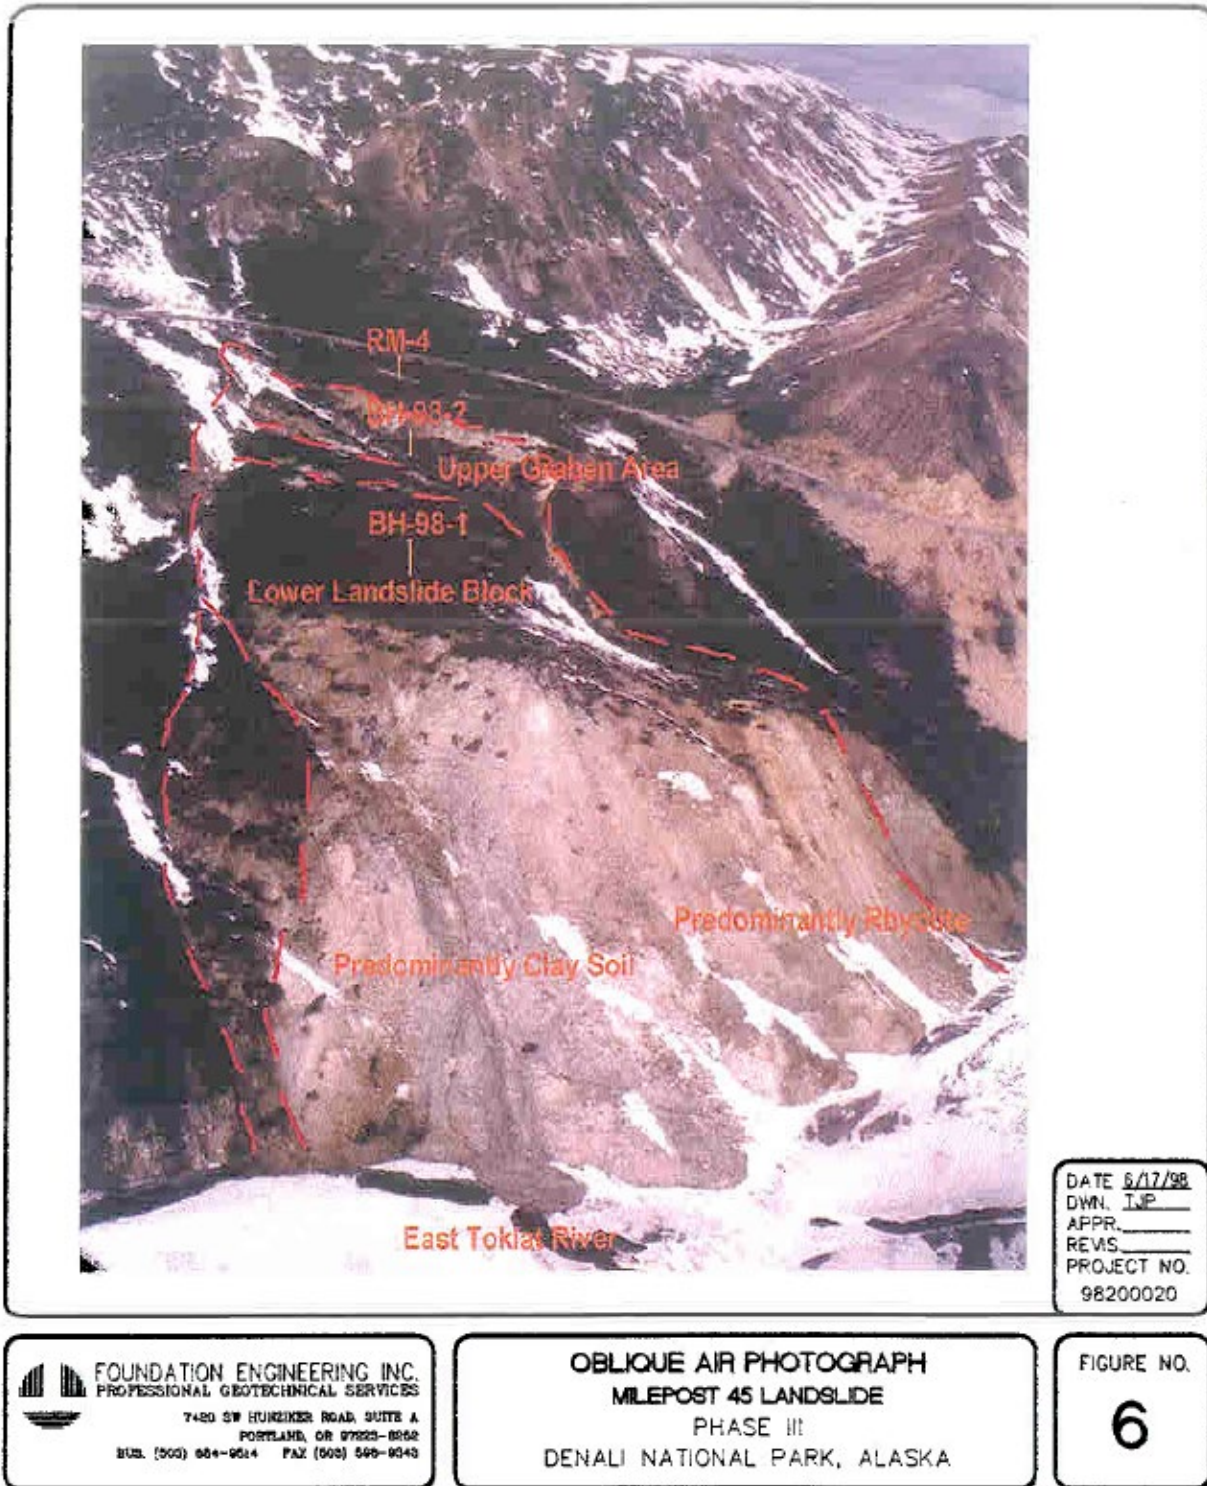
A report on the MP 45 Landslide (Bear Cave Landslide) was published in 1999. It appeared that the main landslide was a reactivated ancient landslide where frozen ground is not a significant factor. Stability analysis and movement rates indicated the main landslide was unlikely to capture the roadway with the next few decades. The secondary landslide feature was relatively shallow movement in the northwest corner of the main landslide caused by slumps and flow of saturated material. This landslide was noted to likely affect the road within the next few years. Two borings (B-98-1 and B-98-2) were completed and instrumented with inclinometer casings and vibrating wire piezometers (Foundation Engineering Inc., 1999). Figure 5-6 illustrates the Bear Cave Landslide as well as some borehole locations relative to the landslide. Figure 5-7 shows core

Figure 5-6. Oblique air photograph of the Milepost 45 Landslide.

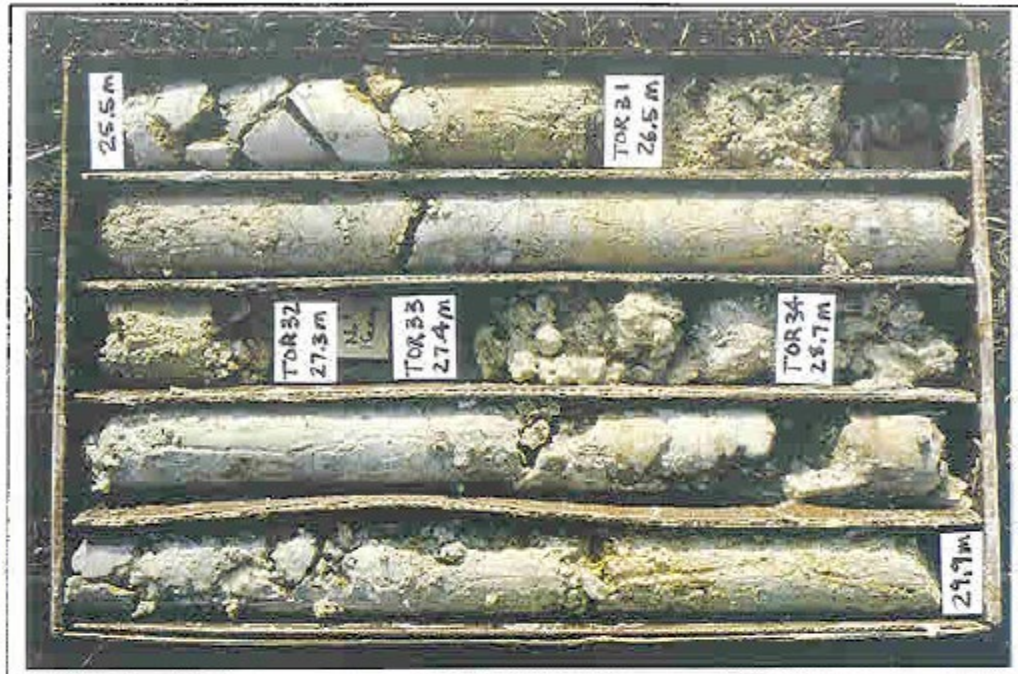
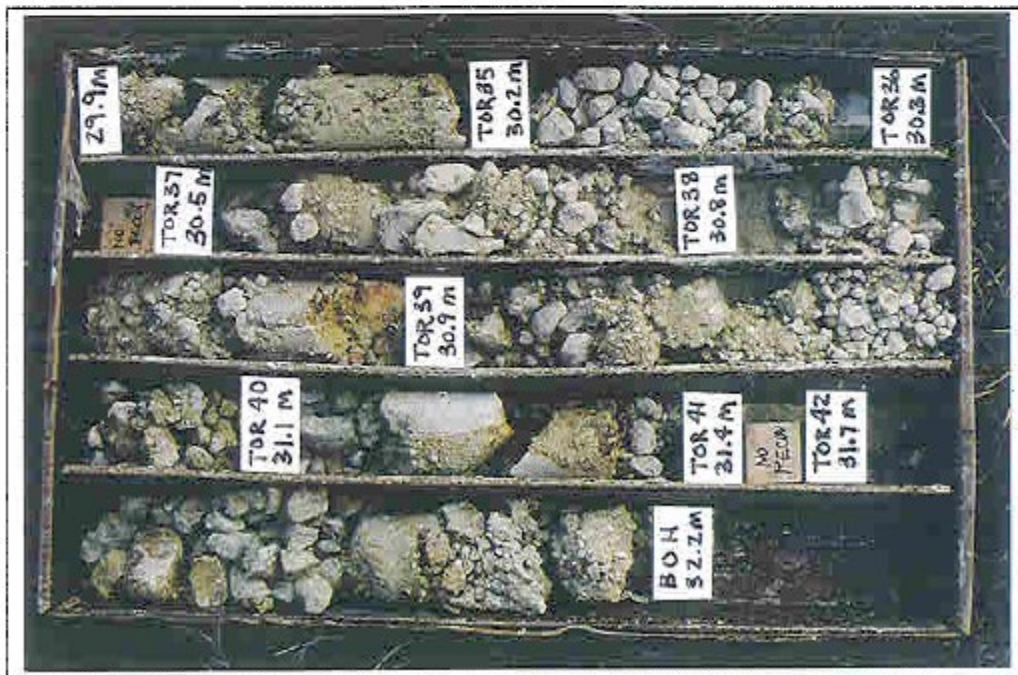
Figure 5-7. Core samples from borehole B-98-1.

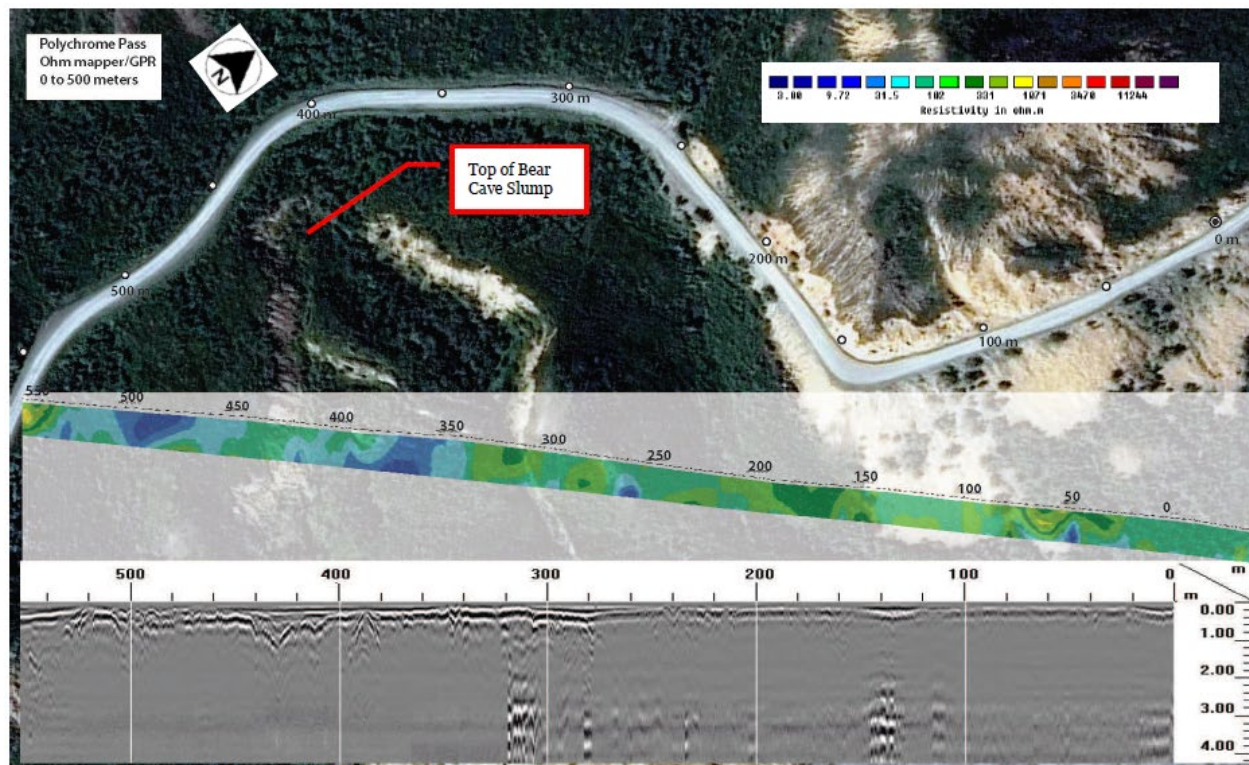
Figure 33. Polychrome Pass, 0m to 500m (1640-ft), start of transect. The view direction of this transect is oriented looking north, therefore the transect moves from right to left, east to west. The ohm-m values are very low through this section, with very low values across and above the headscarp of the Bear Cave Slump, from 250m to 500m possibly indicating higher moisture/ground water. The GPR is not remarkable at depth but a distinct reflector is visible at approximately 0.5m (1.6-ft) in depth, possibly representing the cut surface of the sub-grade. Chaotic structure is not visible in the GPR due to radar energy attenuation possibly from high moisture contents.

Figure 5-8. Resistivities at Bear Cave Landslide from the 2016 geophysical survey of Denali Park Road.

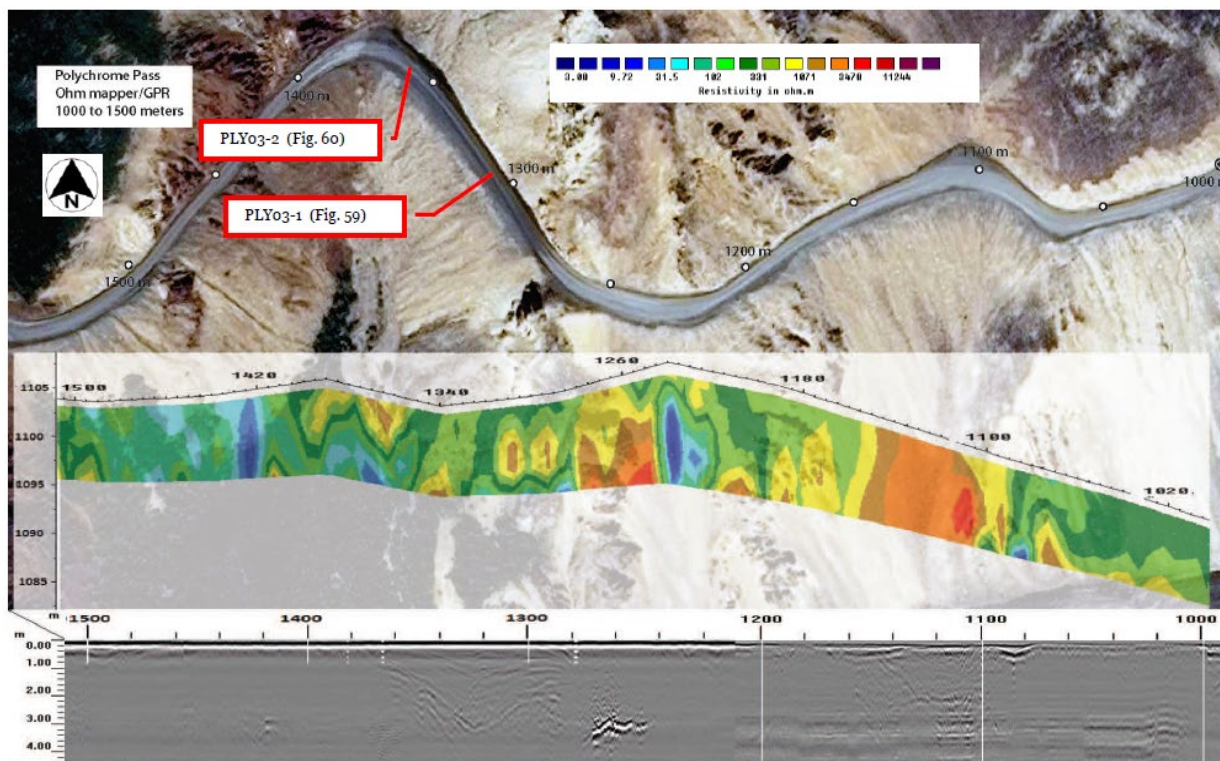
Figure 35. Polychrome Pass, 1000m to 1500m (3280-ft to 4921-ft). The ohm-m values are variable through this section with low values continuing from 950m and up to approximately 1100m. Here the roadway transcends an exposed ridge and much higher values begin and continue as the roadway cuts back into the strata and through a valley to the next ridge which is located at 1200m. This ridge has very low ohm-m values suggesting either very conductive mineralogy or moist/wet conditions at depth. At 1260m the road passes through a cut with high ohm-m values at depth, and then leads into the Pretty Rocks slide section. Through the slide section moderate near surface ohm-m values are measured with very low values at depth suggesting moist/wet conditions. The survey transcends the crotch at approx. 1390m, which is the contact between the mafic strata to the west and the felsic strata (rhyolite) to the east. After this valley, low ohm-m values are measured through to the end of the section. The GPR is very unremarkable through this section except for distinct reflections starting at 1260m where the road passes through the cut.

Figure 5-9. Resistivities at Pretty Rocks Landslide from the 2016 geophysical survey of Denali Park Road.

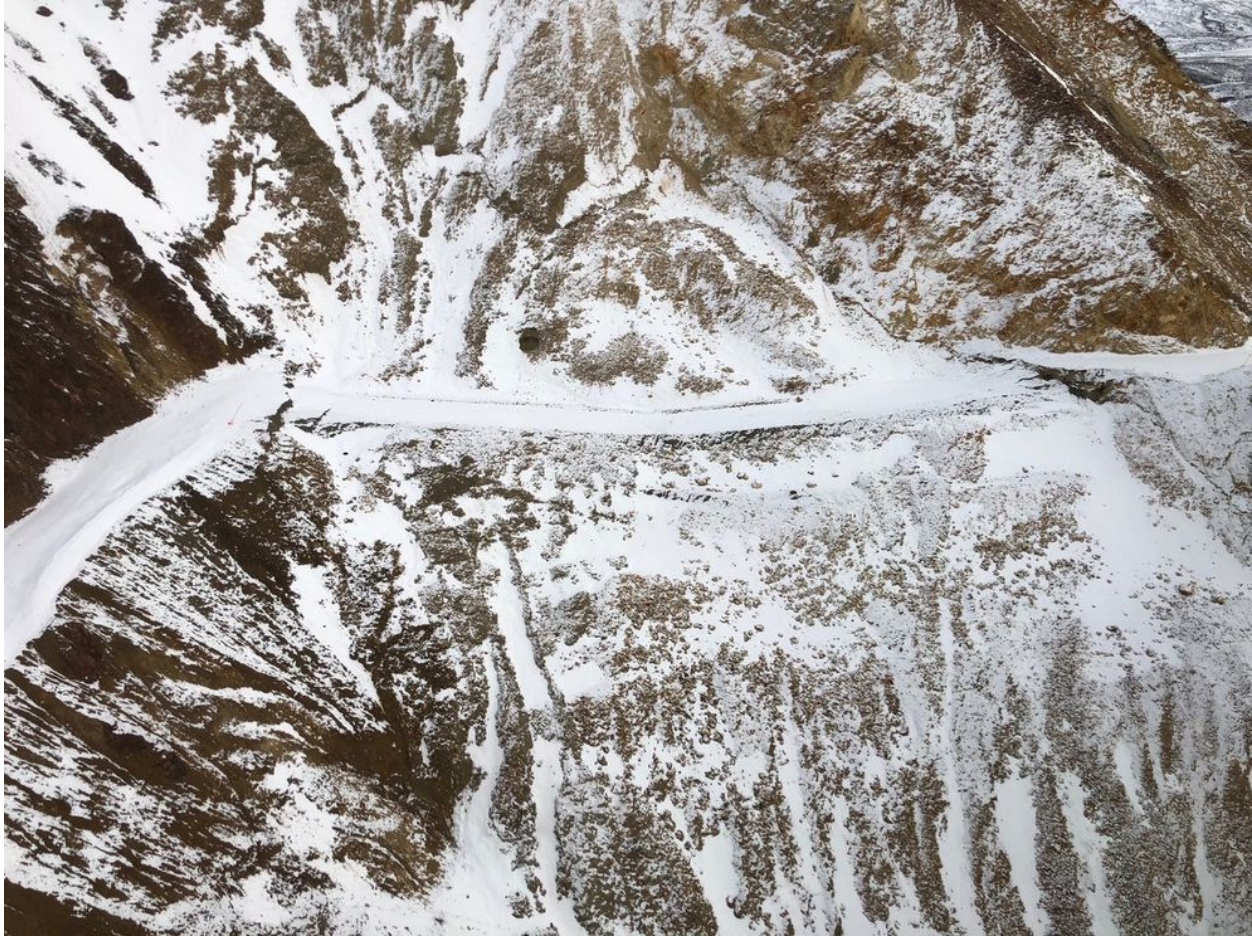
Figure 5-11. Aerial view of the Pretty Rocks Landslide area on the Denali Park Road from November 5, 2019 (Williams, 2019).

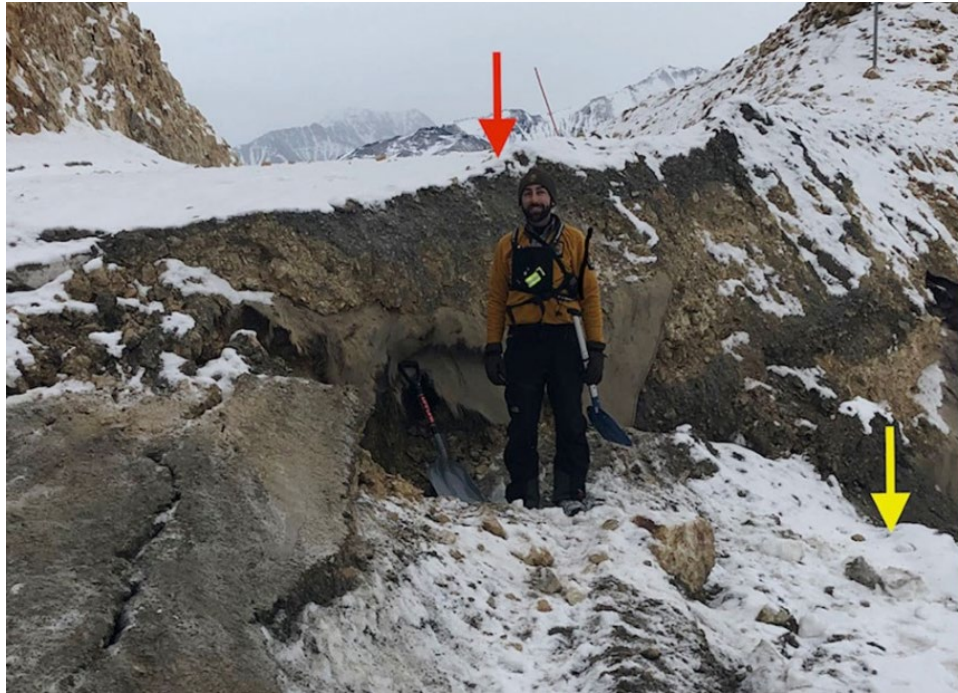
Figure 5-13. Pretty Rocks Landslide scarp at the Denali Park Road in November 2019 (NPS, 2020). The road had been displaced approximately 10 ft since September 2019 (from red arrow to yellow arrow).
