SUBJECT: **REVISED Geotechnical Memorandum 03-20**
Preliminary Pretty Rocks Landslide Bridge Feasibility and Constructability
Pretty Rocks Landslide Investigation
AK NPS DENA 10(45)

Denali National Park Unstable Slope Corridor Assessment

**GEOTECHNICAL SUMMARY REPORT OF EXISTING
CONDITIONS**

Re: Geotechnical Report 05-20, AK NPS DENA 10(49), Geotechnical Summary Report of Existing Conditions

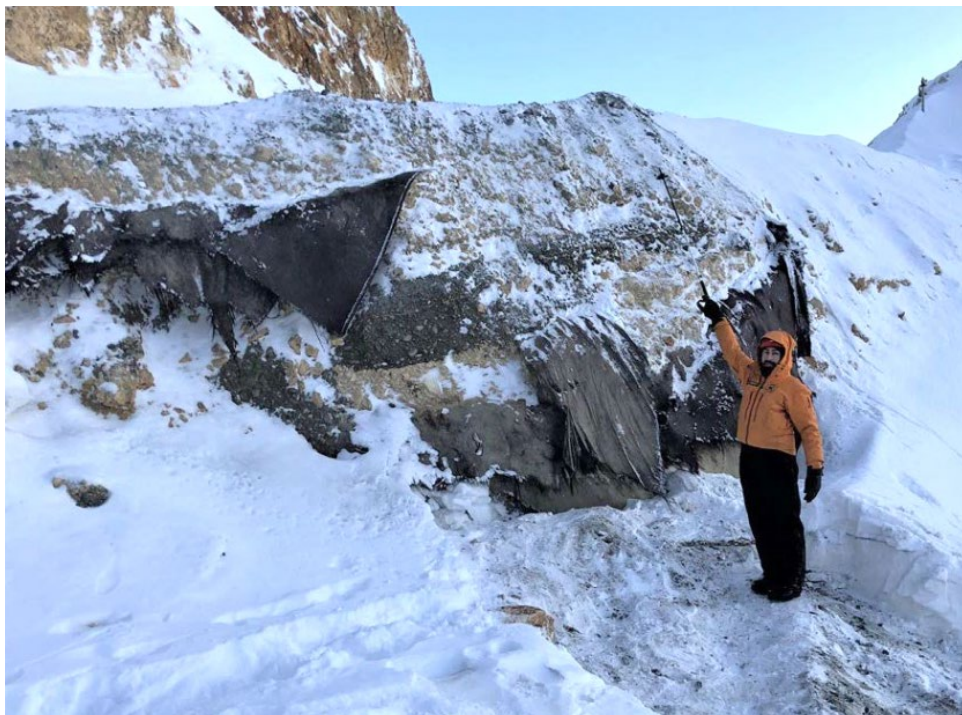
Figure 5-14. The same location as Figure 5-13 at the Pretty Rocks Landslide in January 2019 (NPS, 2020). The road had been displaced approximately 15 ft since September 2019.

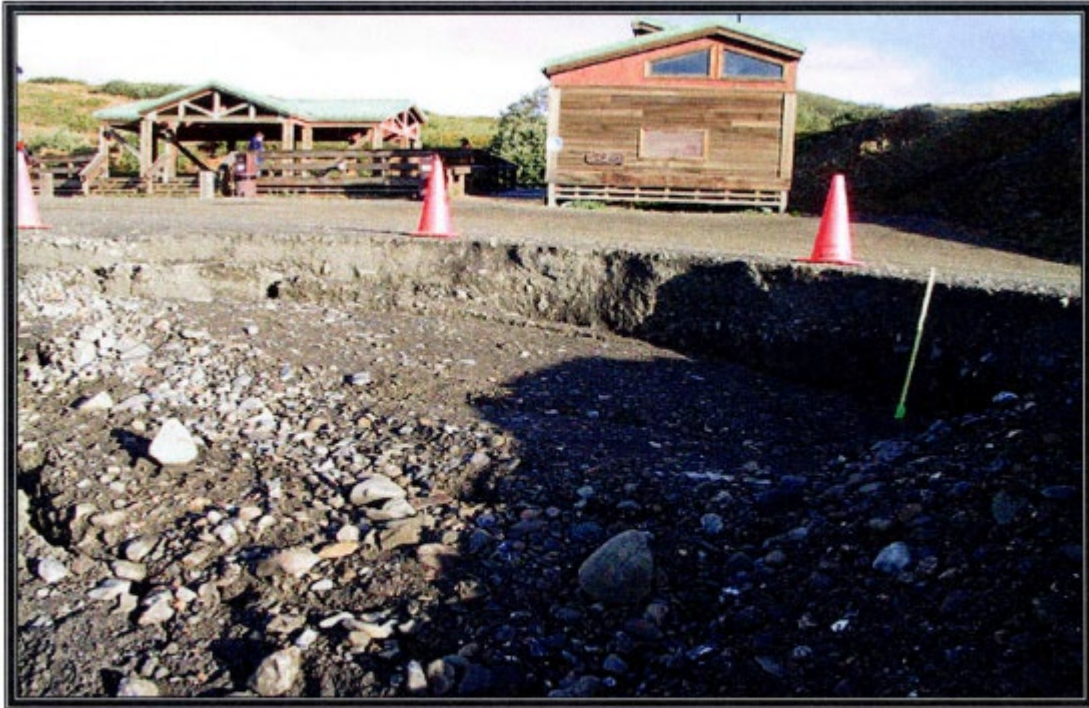
A slump at the Polychrome rest stop began to develop in late summer 2002. Winter and spring 2002-2003 were abnormally dry and no movement was observed in the slump until summer monsoonal rains began in July 2003. Over a one-week period in August 2003 the slump dropped vertically 4 ft. Two subsurface boreholes were drilled with an open-standpipe piezometer installed in PS03-1 and an inclinometer installed in PS03-2 (U.S. Department of Transportation, September 2, 2003). No groundwater measurements were able to be recorded due to an unexplained block in the hole when attempting to take measurements. It was apparent that the slump reacted quickly to precipitation. Slumping at the rest stop and roadway are shown in Figure 5-16 and Figure 5-17, respectively. See Table 5-1 for a list of boreholes (PS03-01 and PS03-02) and the instrumentation installed. Reactivation of this slump was first observed in May 2019 during spring road opening (Figure 5-18 and Figure 5-19). Subsequent orthographic imagery review suggests the landslide movement reactivated between June 6 and September

Photo 3: View to north toward rest stop facilities, August 18, 2003.
NPS/Martin Grosnick photo

Figure 5-16. View to the north toward rest stop facilities, August 18, 2003. NPS/Martin Grosnick photo.

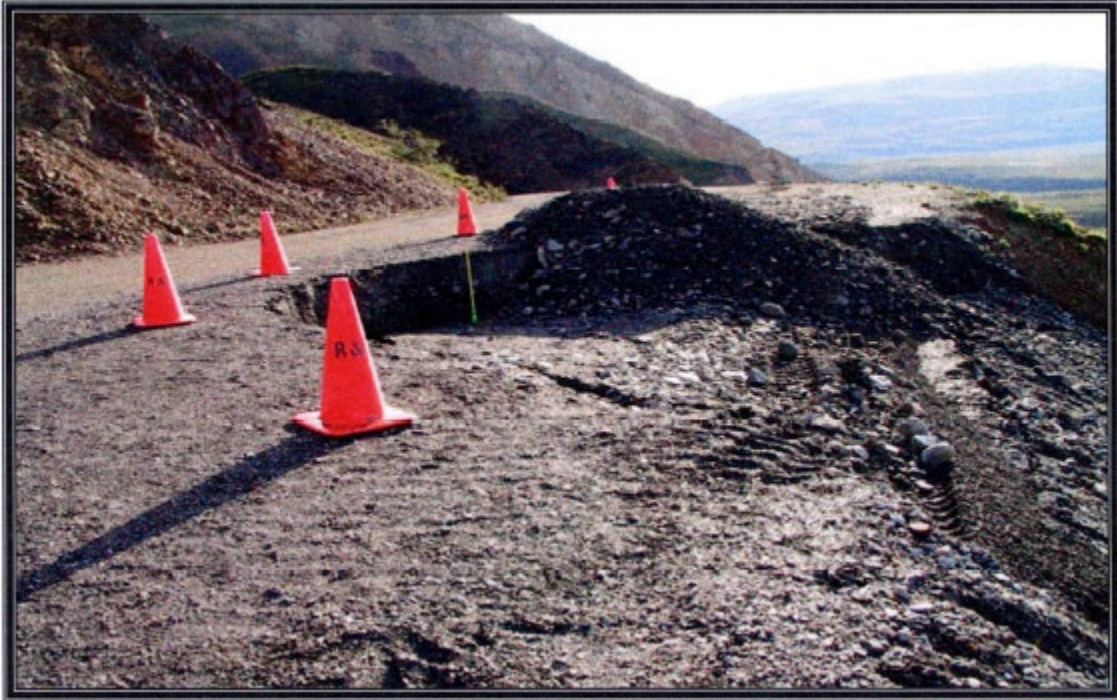
Figure 5-17. Looking east at slump on August 18, 2003. NPS/Martin Grosnick photo.

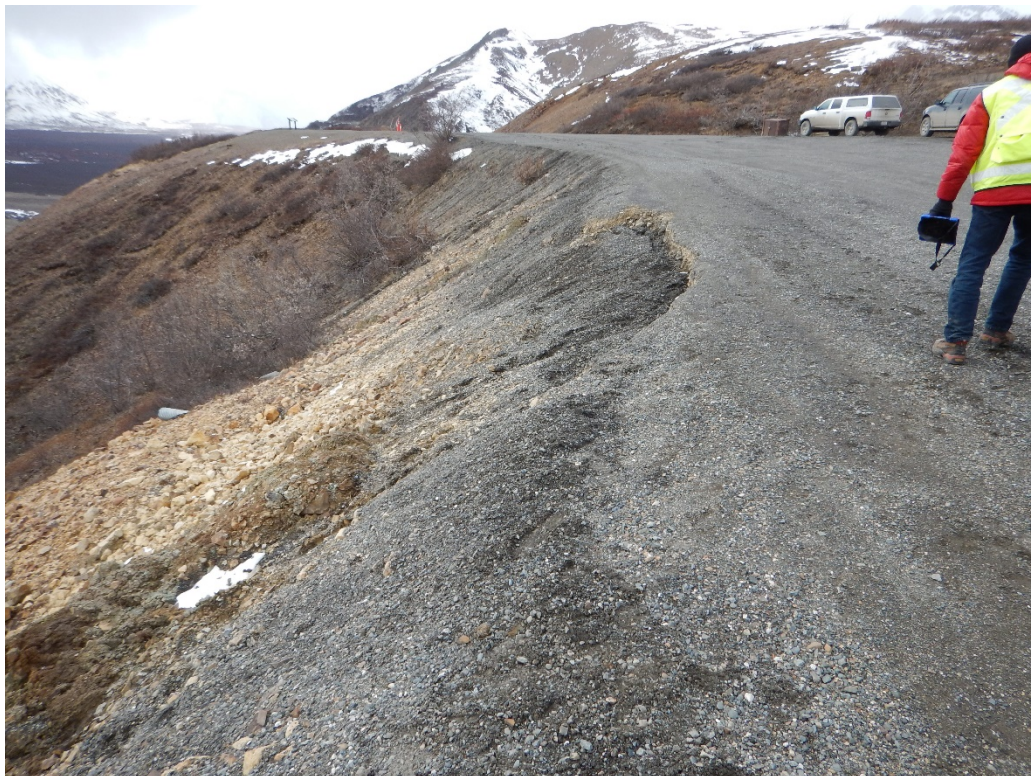
27, 2018. A vertical drop of 2 to 8 inches occurred along the shoulder along about 75 feet of road length and the scarp was promptly coned by Maintenance.

Figure 5-18. Looking west at slump during road opening in May 2019. FHWA photo, 2019.

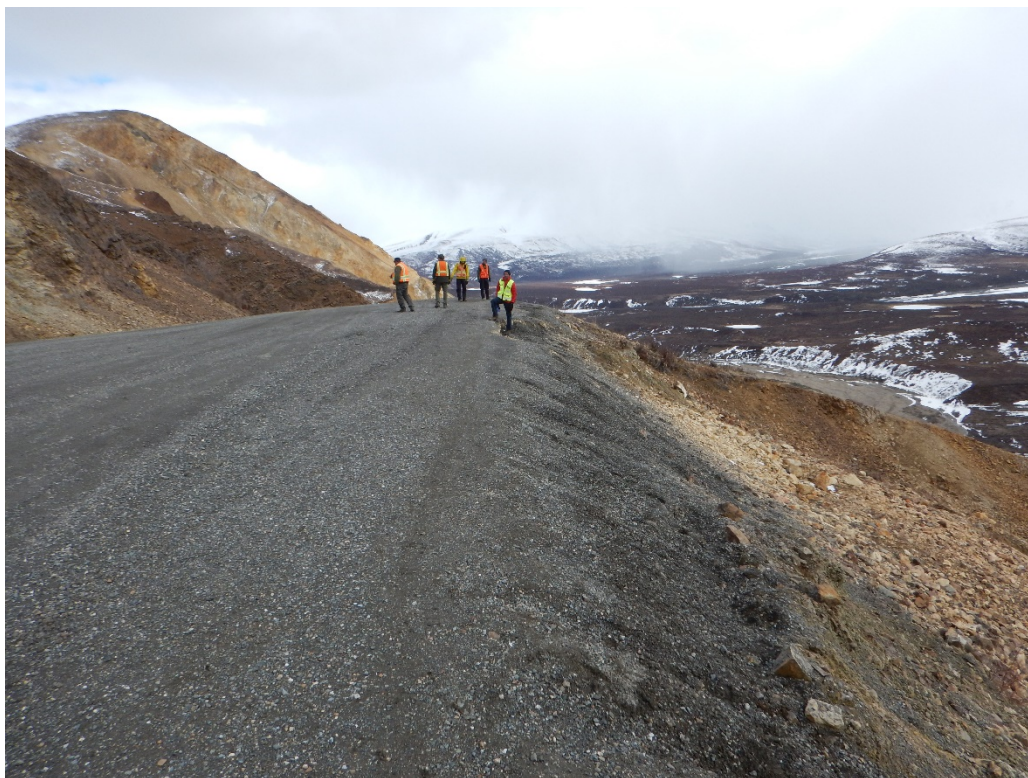
Figure 5-19. Looking east at slump during road opening in May 2019. FHWA photo, 2019.

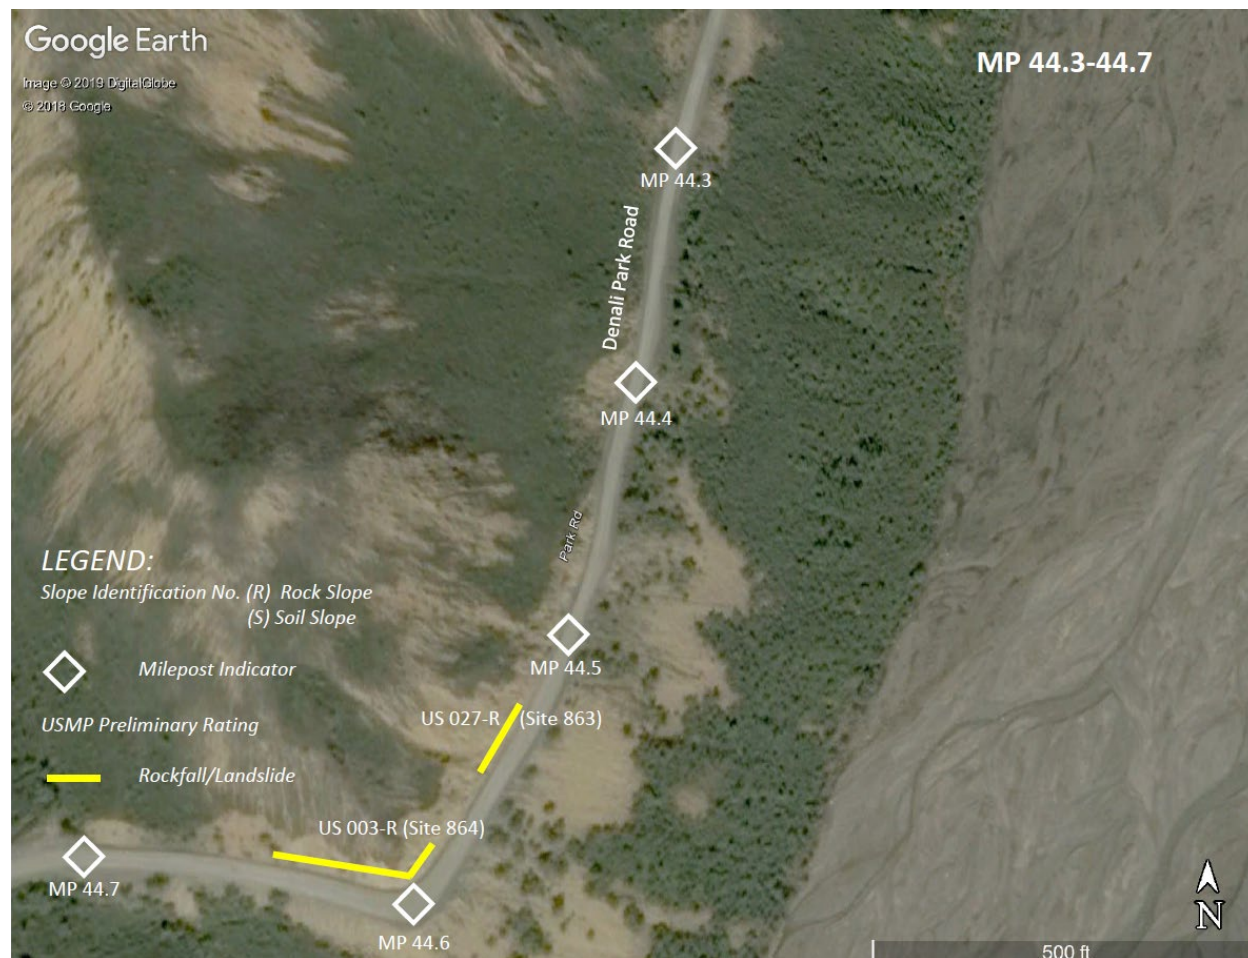
Sites 863 and 864 are both unstable slopes that generate rockfall. Site 863 has a maximum slope height of approximately 95 feet and is approximately 180 feet long. It is made up of weak to moderately strong rhyolite (igneous) rock that is causing structurally controlled planar and wedge failures and differential erosion failures consisting of boulders with a maximum block size of two feet. Site 864 has a maximum slope height of approximately 60 feet and is approximately 250 feet long. This slope is also comprised of rhyolite rock, producing structurally controlled rock failures with a maximum block size of approximately 3 feet. The approximate locations and proximities of Site 863 and Site 864 to the Denali Park Road are shown in Figure 5-23 (U.S Department of Transportation, December 2019).

Figure 5-23. Overview of Sites 863 and 864 between MP 44.57 and MP 44.64 on the Denali Park Road in Alaska (U.S Department of Transportation, December 2019).

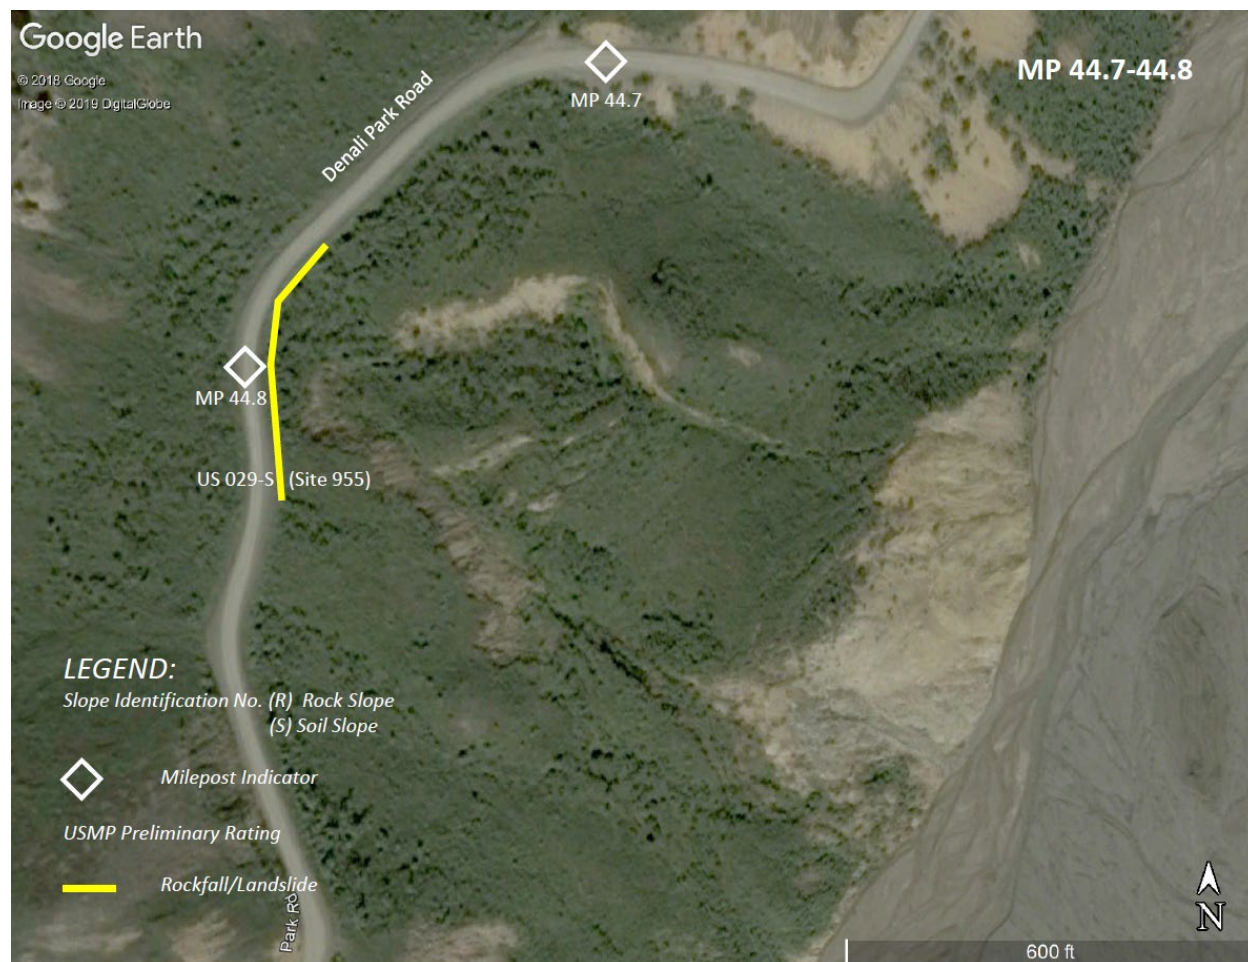
Site 955 is also known as the “Bear Cave Slump” and is a rotational landslide with an axial length of approximately 1,000 feet. It affects approximately 300 feet of the Denali Park Road. The landslide headscarp is located below the road and headscarp erosion and regression continue to impact the road. In the 1990s a deep cutoff trench lined with geotextile located in the uphill road ditch was installed to direct subsurface and surface drainage away from the landslide to a nearby culvert to mitigate landslide movement. Since construction of this ditch the regression of the landslide towards the road has slowed. However, after the historic precipitation events in August 2019, measurement of the landslide headscarp retrogression toward the roadway was observed. Regression of the landslide headscarp towards the road is monitored with periodic GPS surveys. At its shortest distance, the headscarp of the landslide is within 10 feet of the road embankment now. The location and proximity of Site 955 to the Denali Park Road is shown in Figure 5-24 (U.S Department of Transportation, December 2019).

Figure 5-24. Overview of Site 955 between MP 44.81 and MP 44.83 on the Denali Park Road in Alaska (U.S Department of Transportation, December 2019).

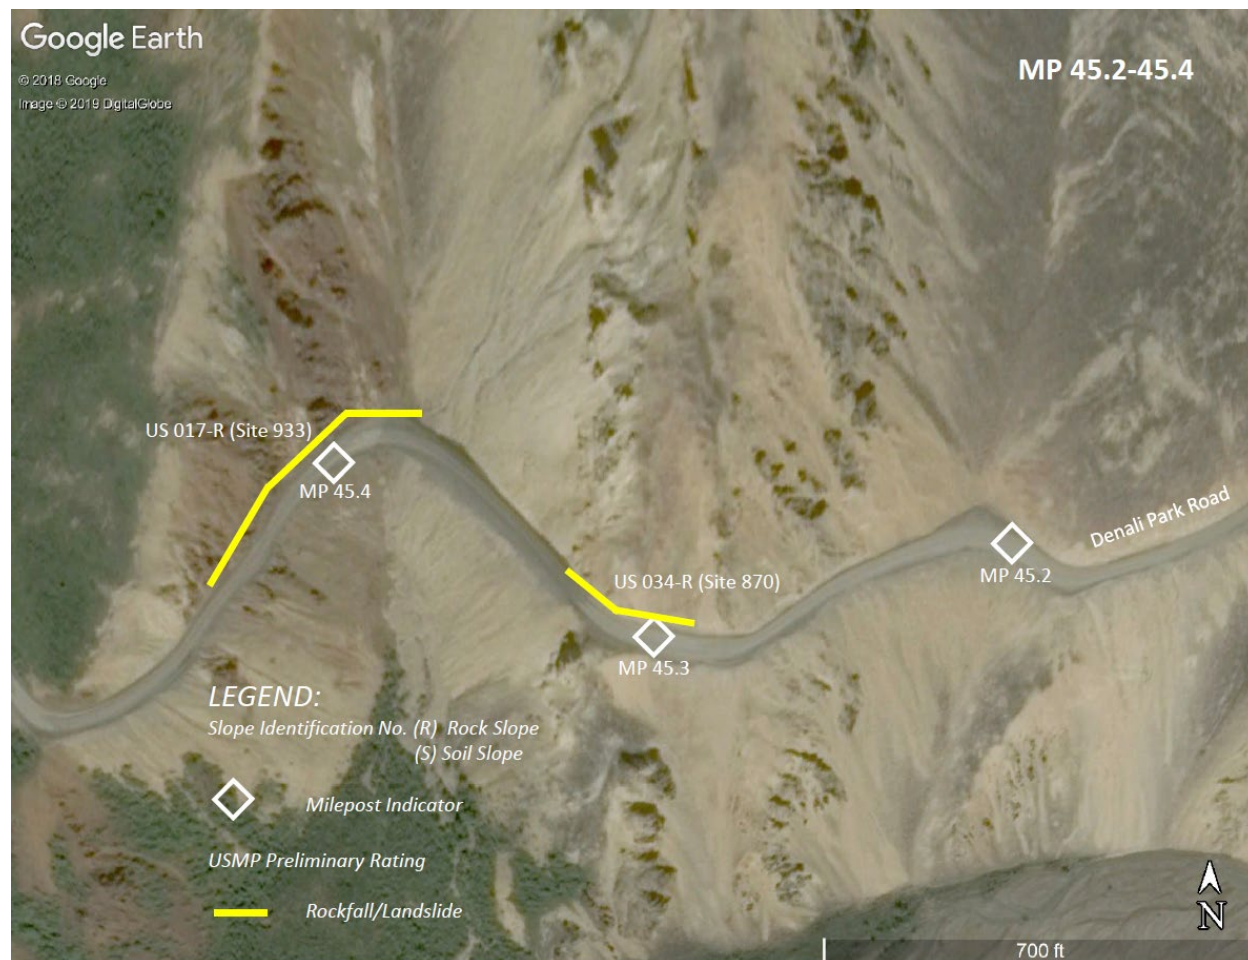
Site 870 is an unstable road cut slope with a maximum height of 55 feet and a length of 230 feet. This slope is made up of rhyolite rock that is causing wedge and planar structurally controlled rock failures with some areas of raveling and undermining occurring. The average block size is approximately 3 feet, but 5-foot blocks and debris landslide failure events up to 9 cubic yards in volume have been observed. The existing road cut is over-steepened with an angle of 40 to 41 degrees. The upper natural slope appears to be stable at an angle of 30 to 32.5 degrees.

Site 933 is an unstable slope with a maximum height of 187 feet and a length of 430 feet. This slope is comprised of loose, rhyolite rock that causes planar and wedge, structurally controlled rock failures. The maximum block size is approximately 1 foot. Rockfall ditch catchment is limited and sight distance is very limited along this section of road. The locations and proximities of Site 870 and Site 933 to the Denali Park Road are shown in Figure 5-25 (U.S Department of Transportation, December 2019).

Figure 5-25. Overview of sites 870 and 933 between MP 45.17 and MP 45.32 on the Denali Park Road in Alaska (U.S Department of Transportation, December 2019).

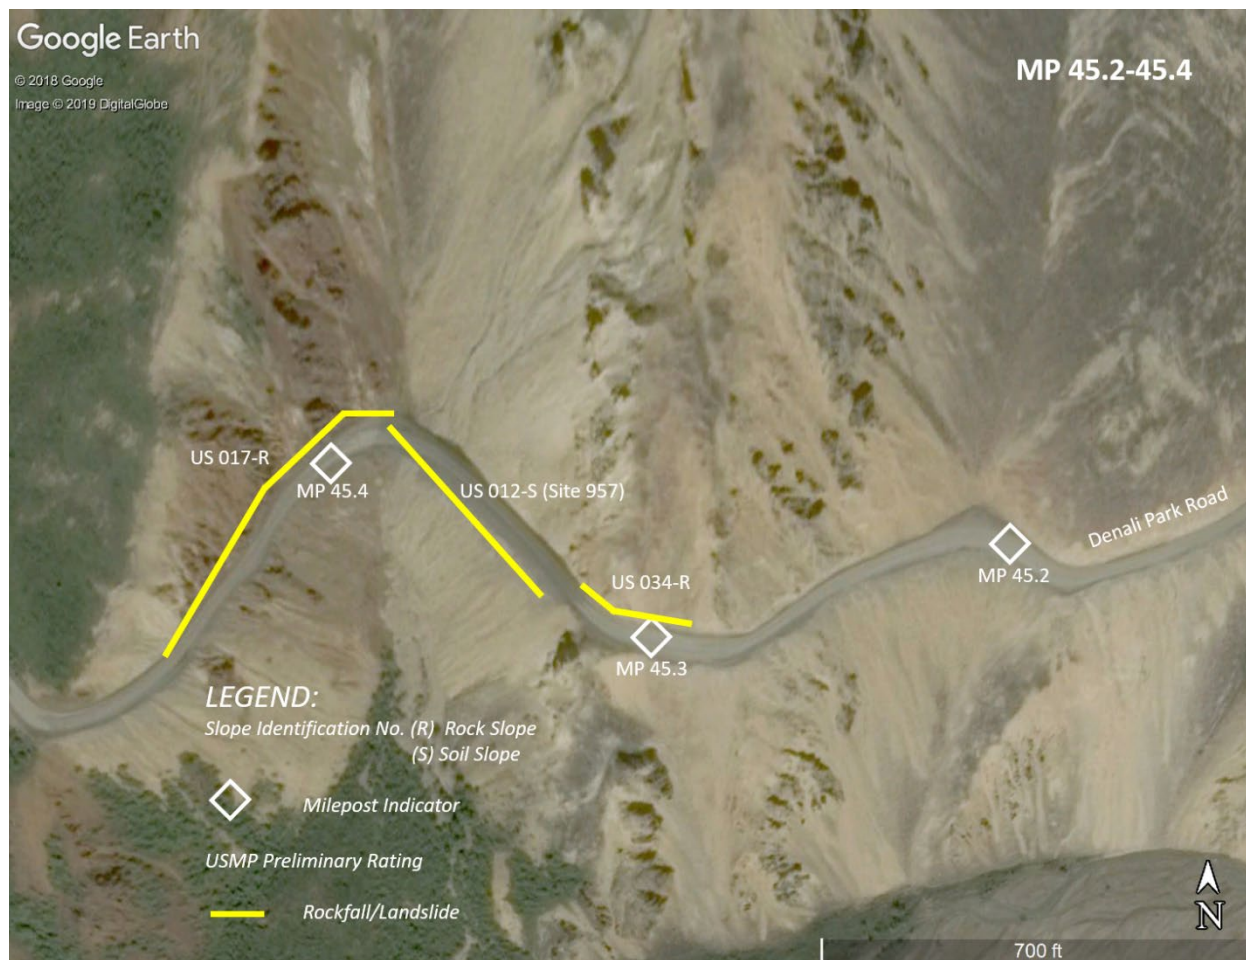
Site 957, known as “Pretty Rocks Landslide”, is a large-scale slump feature with an axial length of approximately 490 feet. The landslide affects approximately 294 feet of Denali Park Road. This slope consists of loose rhyolitic rock underlain by ice and frozen material. The failure mechanism appears to be dominantly translational debris slide events in these materials with minor rotational movement. Sight distance is limited along this section of road. In 1987, drainage control was installed below the road surface however, it has since been buried and is now ineffective (U.S Department of Transportation, December 2019). In 2018, on average, the road movement was measured at approximately 0.4 inches per day and it was difficult to maintain through the summer season by Park maintenance crews. Since August 2019, the rate of road subsidence, as a result of the continued landslide movement of the Pretty Rocks Landslide, has increased to nearly 2 inches (vertically and horizontally) per day. The location and proximity of Site 957 to the Denali Park Road is shown in Figure 5-27.

Figure 5-27. Overview of Site 957 between MP 45.34 and MP 45.41 on the Denali Park Road in Alaska (U.S Department of Transportation, 2020).

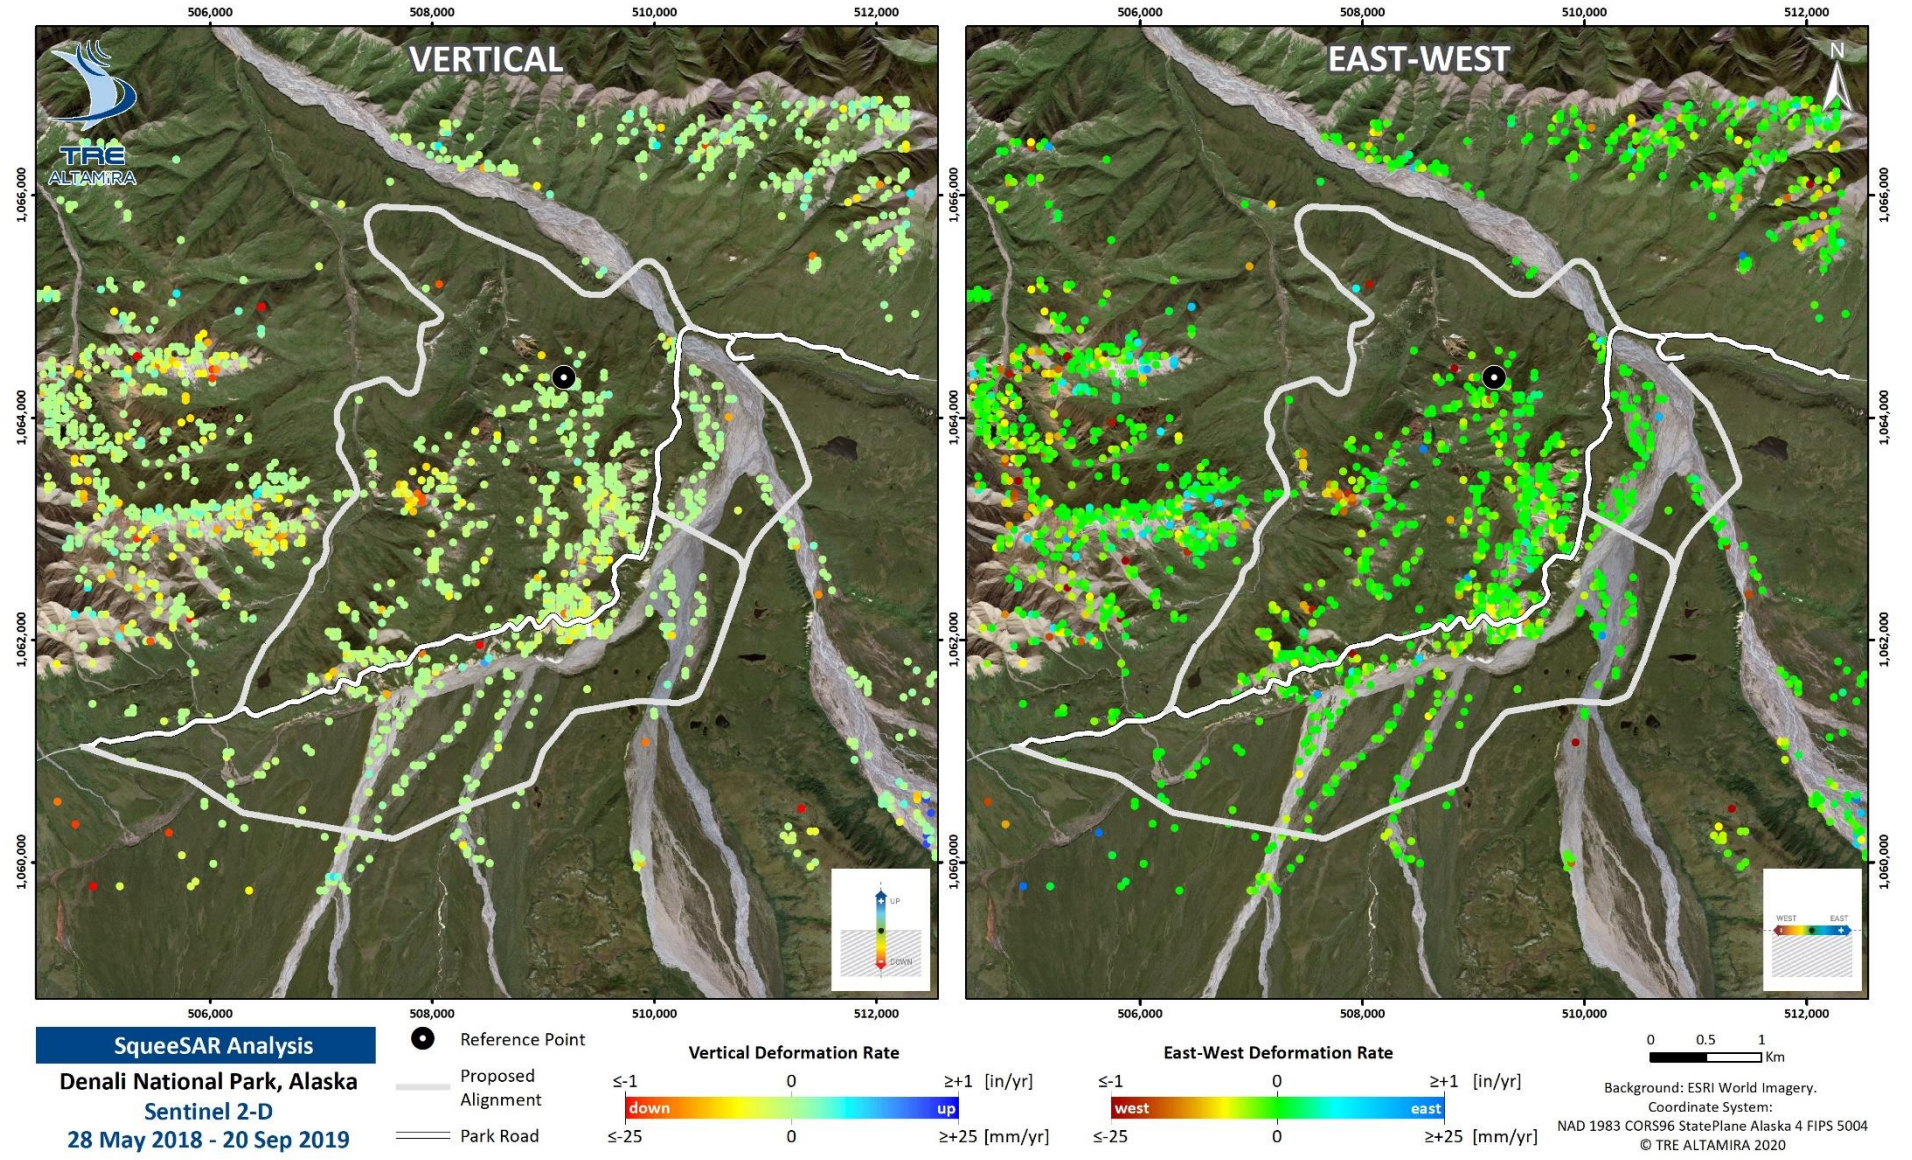
Overall, the 1-D and 2-D SqueeSAR and 1-D TCS results highlight hot spots of deformation over the existing Denali Park road and the proposed alternatives routes for 2018-2019. The shorter processing timeframe allowed for maximum measurement point coverage, especially in the descending data set. Whenever possible, TRE recommends looking at clusters of points or pixels instead of relying on isolated pixels or points. To further visualize the SqueeSAR data and its deformation time series, log in to TREmaps or download the data to use it in a GIS environment.

Figure 3: 2-D SqueeSAR results.

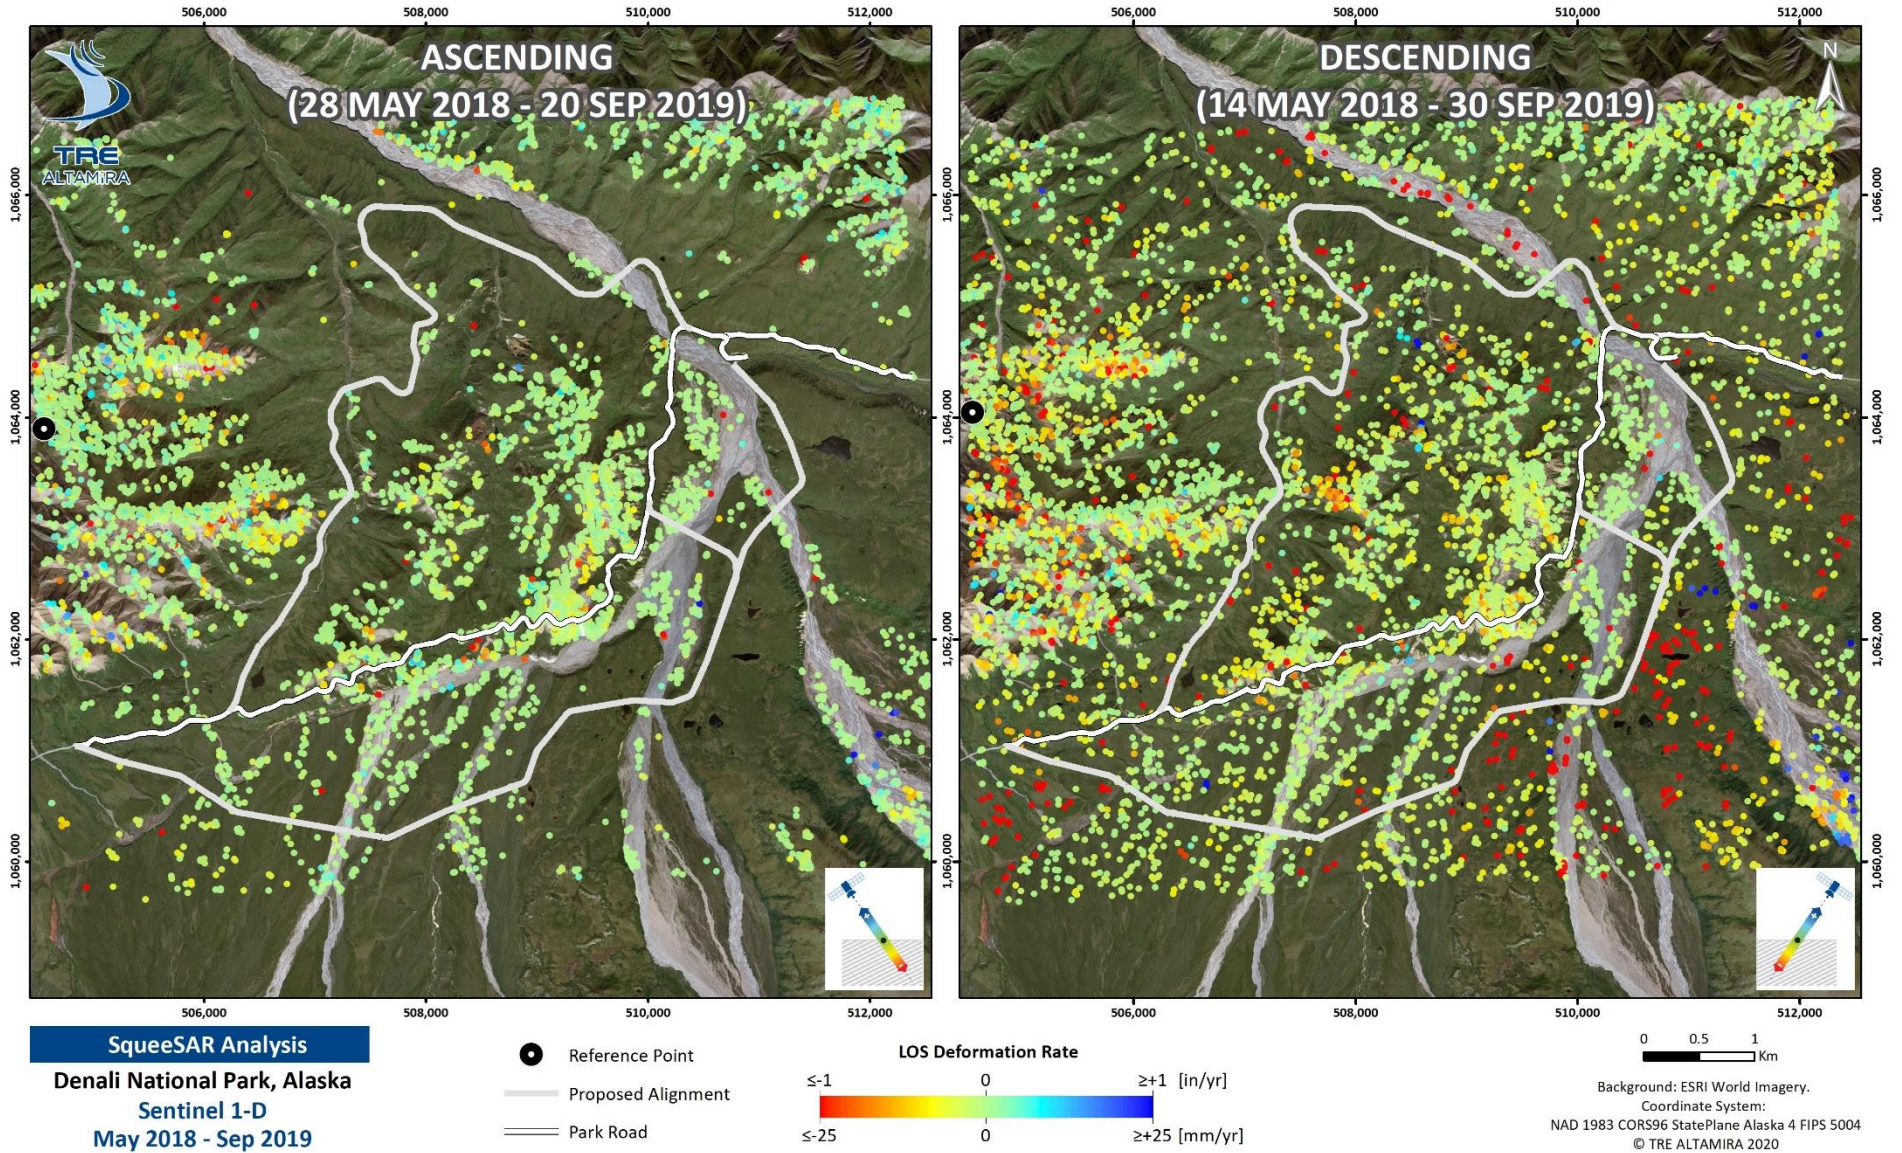
The LOS or 1-D SqueeSAR deformation rates measured in millimetres per year from the ascending archive (28 May 2018 – 20 September 2019) and descending archive (14 May 2018 – 30 September) are shown in Figure 4. These data sets are used as input to produce 2-D (East-West and Vertical) results. The descending data set provides the most coverage over the site, with an average density of 157 measurement points per square kilometre (Table 2) compared to 122 points per square kilometre for the ascending data.

Figure 4: Line-of-Sight SqueeSAR results.

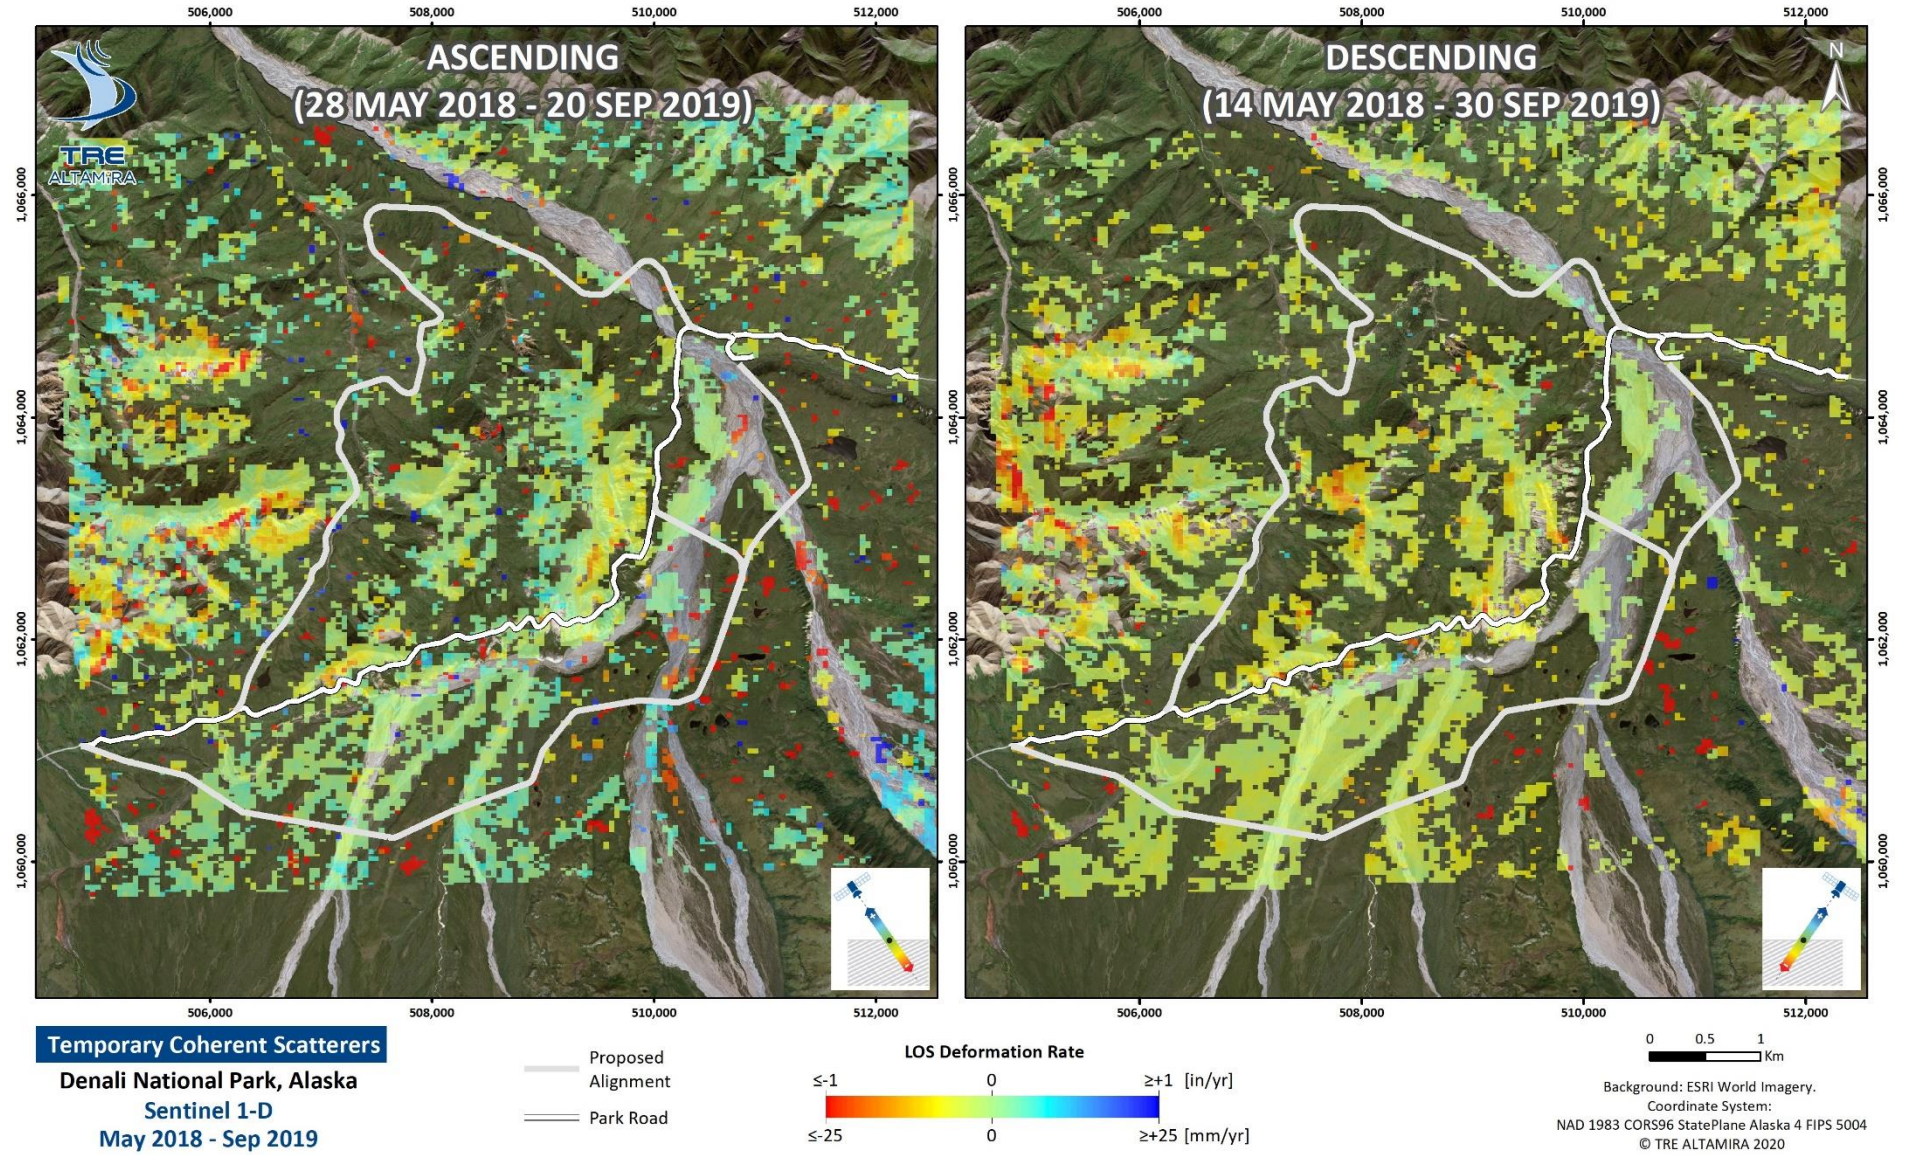
Figure 5 shows the Temporary Coherent Scatterer (TCS) results for the same ascending and descending archives. The TCS provide higher coverage in areas where there are limited LOS SqueeSAR measurement points.

Figure 5: Line-of-Sight TCS results.

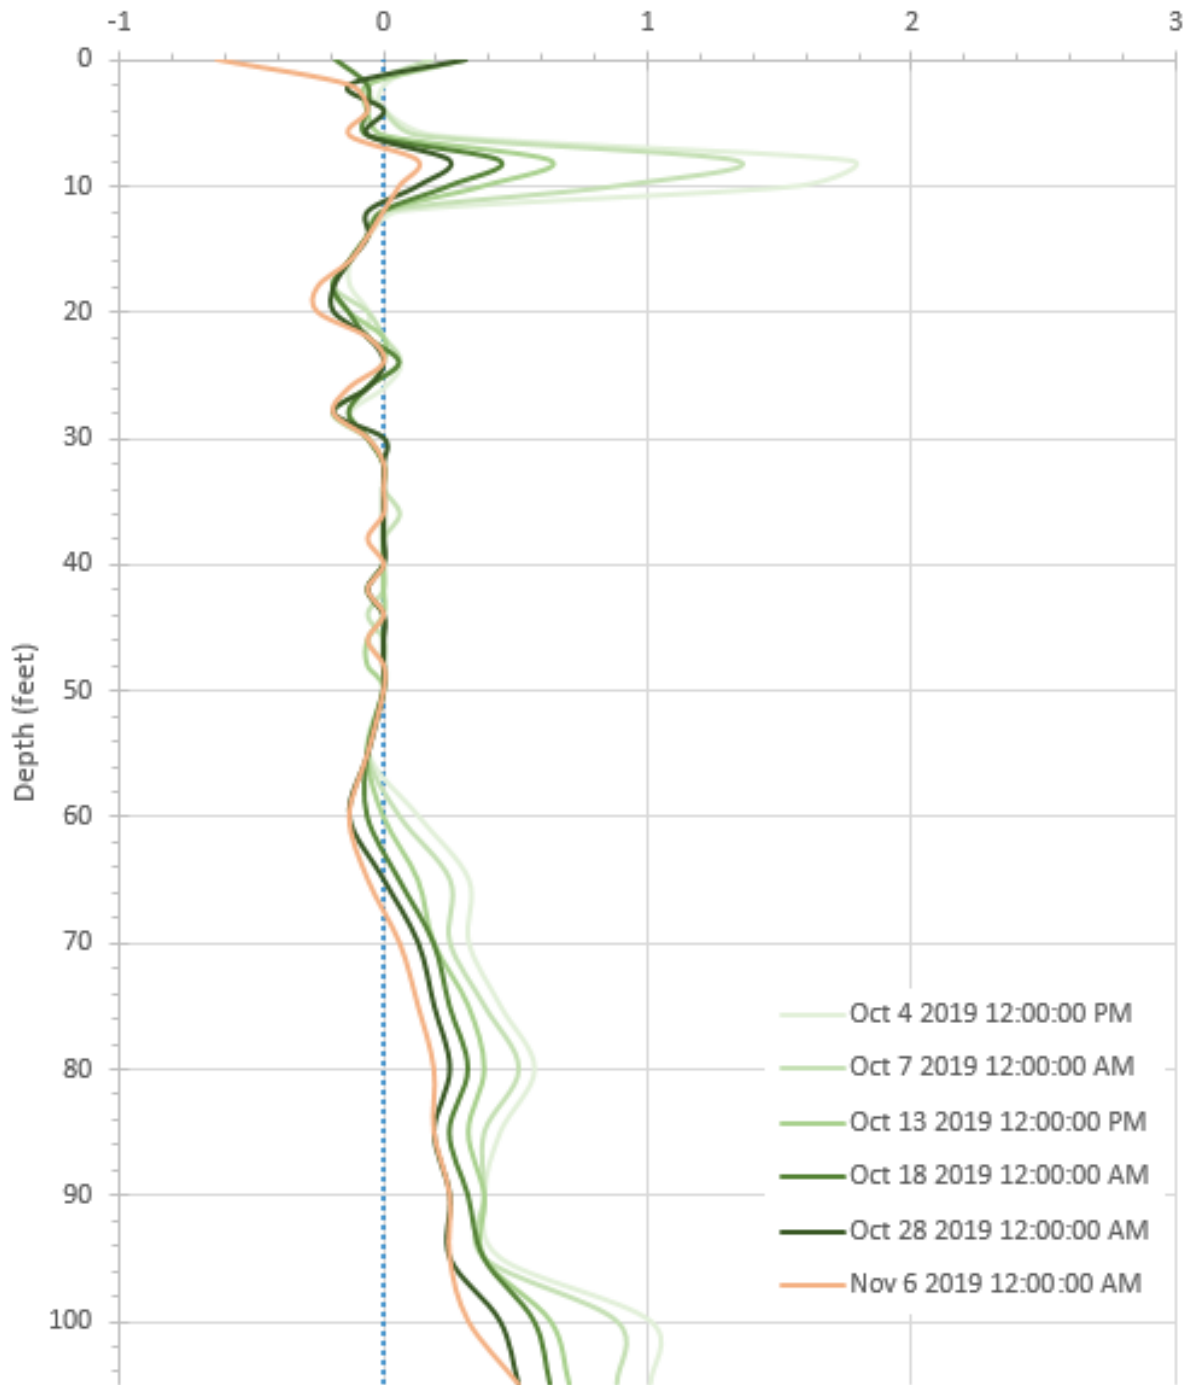
Figure 3. Thermistor (ground temperature) readings in degrees C. The temperature readings are graphed around freezing at 0 degrees C. Each colored, wavy line represents a snapshot in time. The trend indicates the temperature during drilling temporarily increased the ground temperature but it fairly quickly adjusts back to its temperature after the drilling and instrumentation has been installed.

44.5 to 55	Landslide Deposit	Frozen, Disrupted, Silty Sand with gravel; Figure 2 displays evidence of potential upper failure surface in landslide near 55 ft.
55 to 62.3	Landslide Deposit	Very stiff, Fat Clay; Figure 3 thermistor indicates below freezing temperatures.

62.3 to 80	Landslide Deposit	Angular, Silty Sand with gravel, Sandy Gravel with clay, Silty Gravel with sand and disrupted Silty Sand from 75 to 80 feet; Figure 3 thermistor data indicates transition from below to above freezing near 68 feet. Figure 2 shows basal landslide failure plane between 76 and 80 feet.
80 to 85	Landslide Deposit	Very stiff, Fat Clay; Figure 3 indicates above freezing temperatures.
85 to 100	Alluvial Deposit	Subrounded to rounded, Silty Sand with gravel to Silty Gravel with sand; this is likely the old flood plain surface before landsliding began; Figure 3 indicates above freezing temperatures.
100 to 157.1	Teklanika Formation	Extremely weak rhyolitic tuff to rhyolitic rock in a highly altered to completely weathered state to depth.

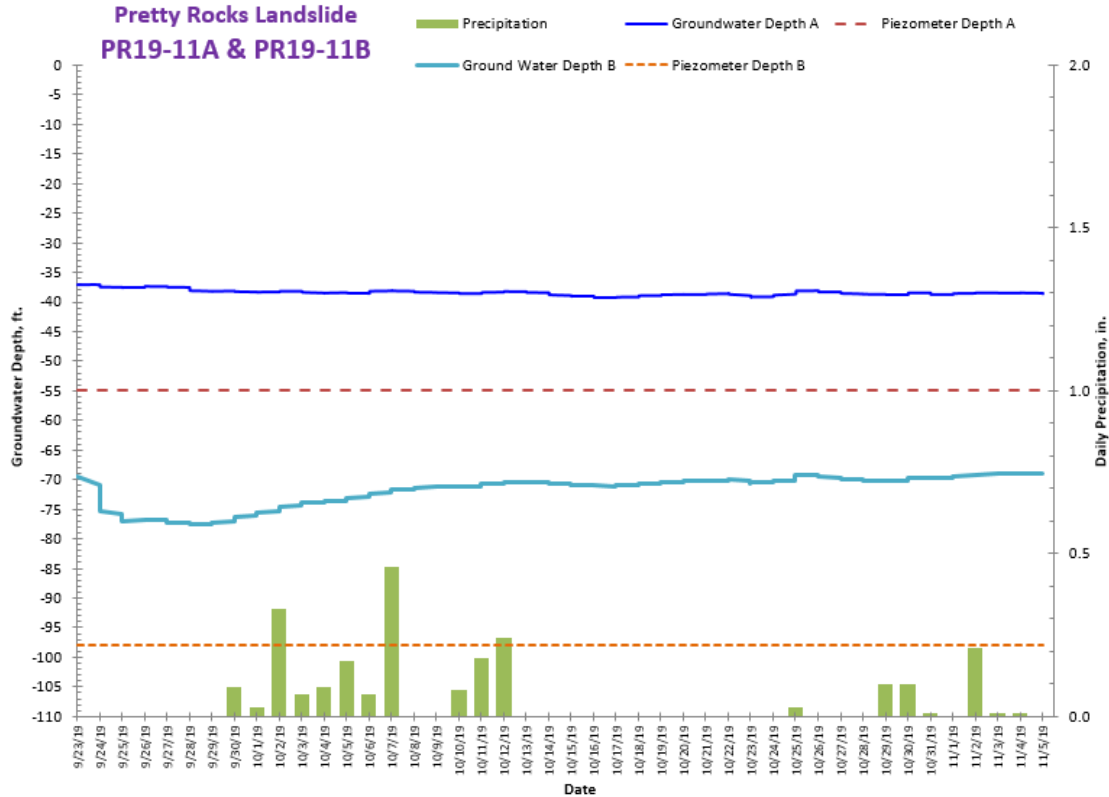
Figure 4. Groundwater data collected on top of a thick clay layer at 55 feet (A) and atop very weak bedrock at 98 feet (B), as observed in test boring PR19-11. Daily precipitation is shown at the base of the graph in green columns to compare precipitations impacts on groundwater measured at the base of the landslide.

In addition to the information presented in Table 1, the groundwater data, although limited, has been critical in developing an updated geologic model for stability analyses. At the base of the slope in test boring PR19-11, groundwater measurements in Figure 4 indicate the presence of two independent groundwater tables. The upper groundwater measuring device (vibrating wire piezometer (vwp)) is located at 55 feet below the ground surface on top of an impermeable fat clay layer that is thought to be laterally continuous. The upper groundwater table (A) shows consistent groundwater elevations between 37 and 38 feet below the ground surface, and it is assumed that it is under pressure and confined based on the frozen landslide debris and hard ice that lies above this fat clay layer. The lower vwp is located at 98 feet, just above the extremely weak and altered rhyolitic rock materials. This lower groundwater table (B) is less consistent and shows some variation between 69 and 77 feet below the ground surface. It is assumed that it is under pressure and confined by the overlying, lower fat clay unit in the landslide debris from 80 to 85 feet below the ground surface. The variation in the lower groundwater table may be more closely tied to the river fluctuations on the East Fork of the Toklat River, where a river gauge is scheduled for installation at the downstream East Fork Bridge crossing this summer.

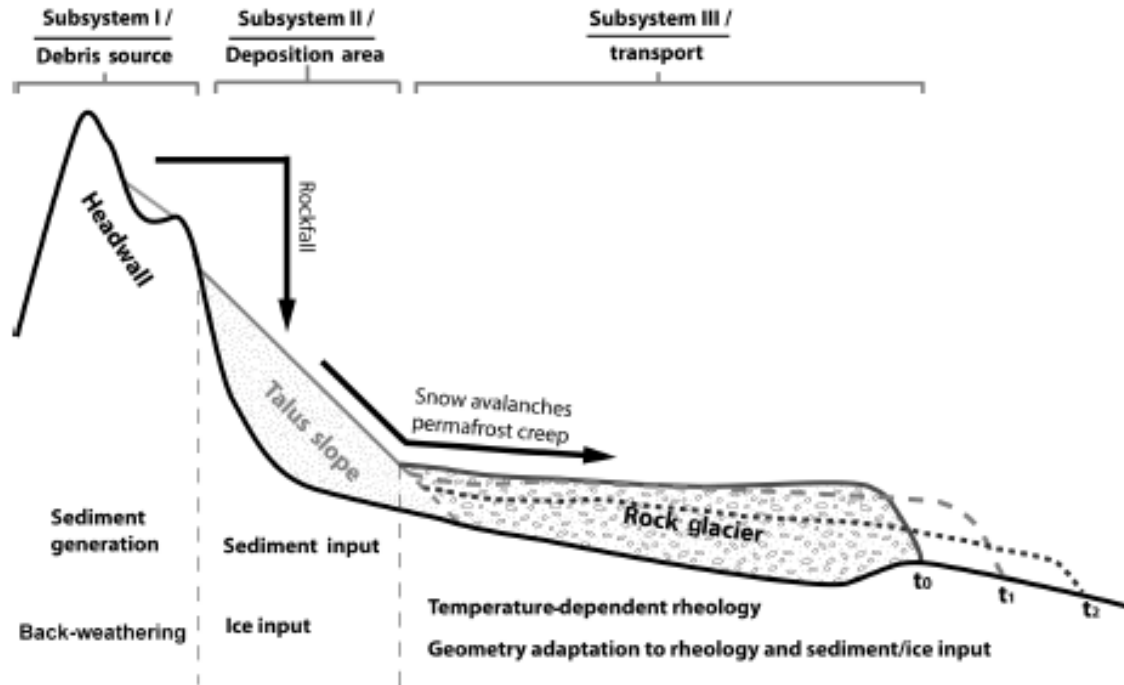
The Pretty Rocks Landslide site closely matches the recent studies of rock glaciers and frozen debris lobes being studied in cold climate areas that are experiencing warming climatic conditions, similar to Denali National Park. Figure 5 illustrates a rock glacier formation that closely matches the situation at the Pretty Rocks Landslide (Mueller, et.al, 2016), and coincidentally may explain some of the difficulties we are having with limit equilibrium modeling. Limit equilibrium modeling has different input parameters than a dynamic fluid mechanic problem for glaciers. We are unaware of research into frozen debris lobes and rock glacier modeling that is appropriate to apply to this site. For these reasons, the limit equilibrium methods being utilized for the stability analyses of this slope should be considered relative, not absolute, providing trends of improvement or worsening of the slopes stability.

Figure 5 Conceptual model of the dynamic evolution of a rock glacier system (adapted from Fig. 1 in Müller et al., 2014a). Black arrows show the sediment transport. t_0 , t_1 and t_2 show the rock glacier surface geometries at different time steps resulting from variations in environmental factors such as warming and a decrease of sediment–ice input.
