Geotechnical Report No. 11-20

**Pretty Rocks Landslide
2018-2019 Geotechnical Investigation and Conceptual
Design Alternatives Report**

**AK NPS DENA 10(45)
Denali National Park, Alaska
August 2020**

U.S. DEPARTMENT OF TRANSPORTATION
FEDERAL HIGHWAY ADMINISTRATION

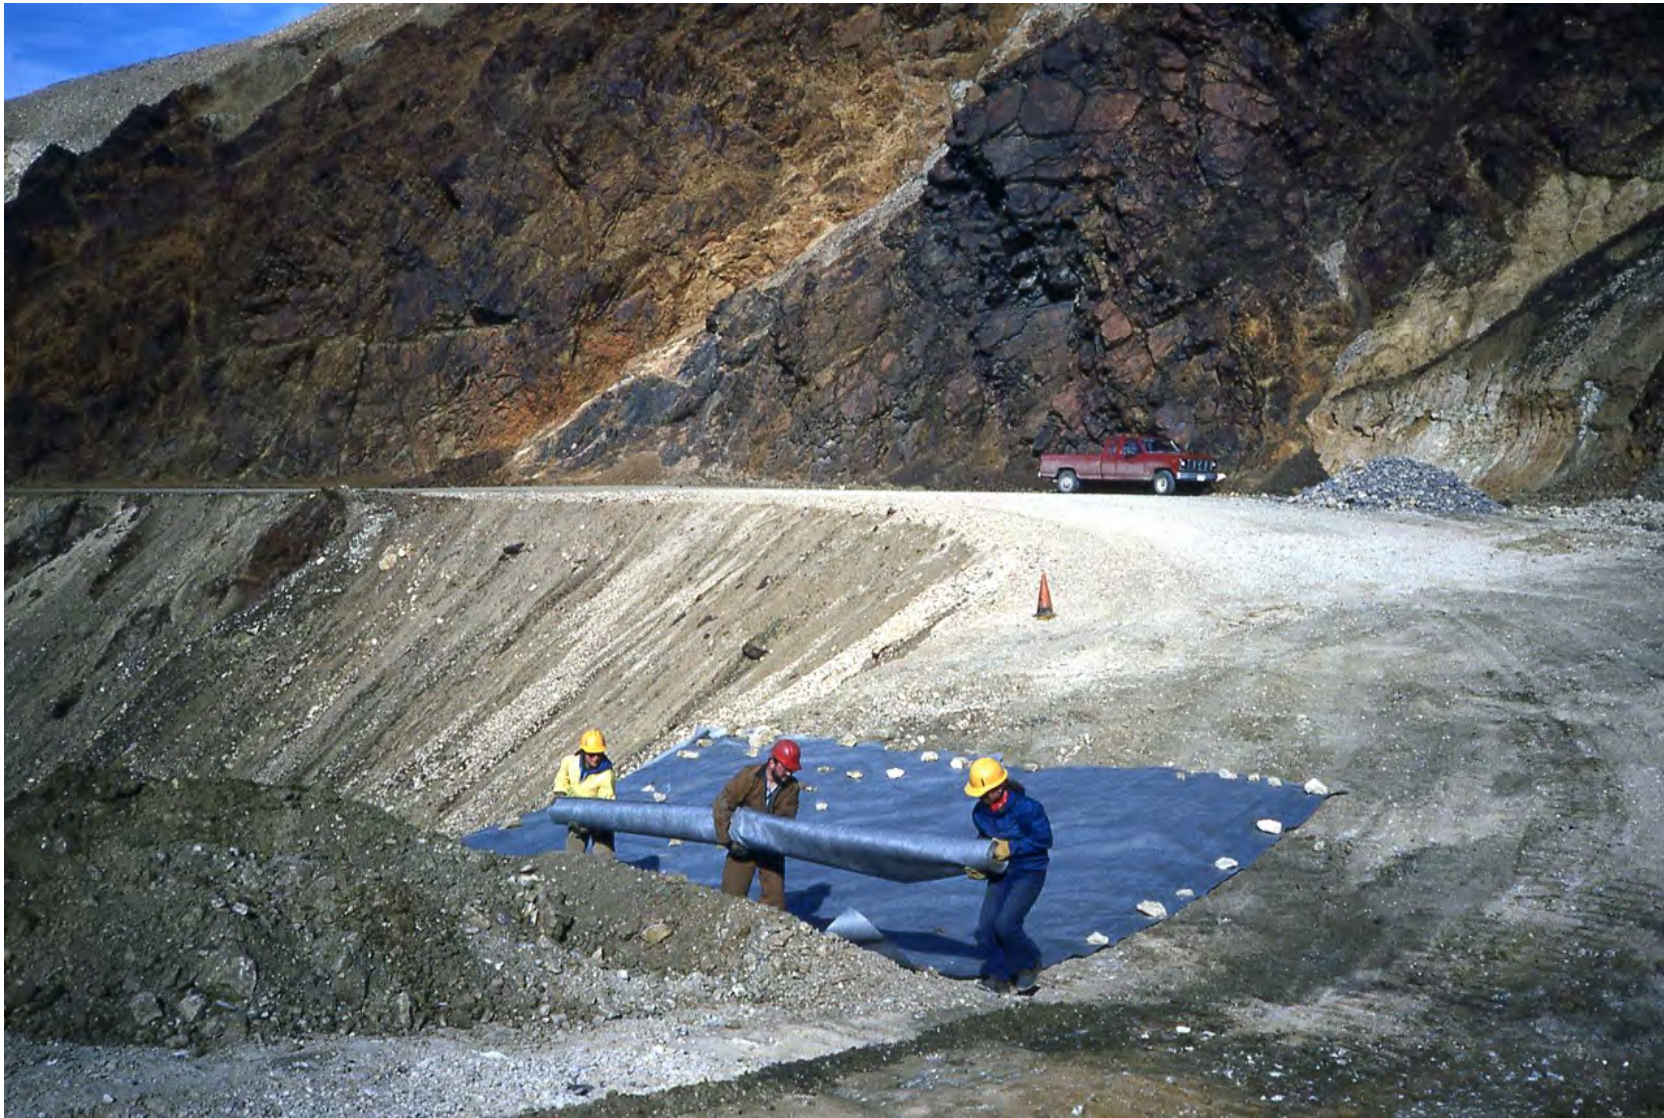
Figure 2. 1987 Installing geosynthetic layer reinforcement

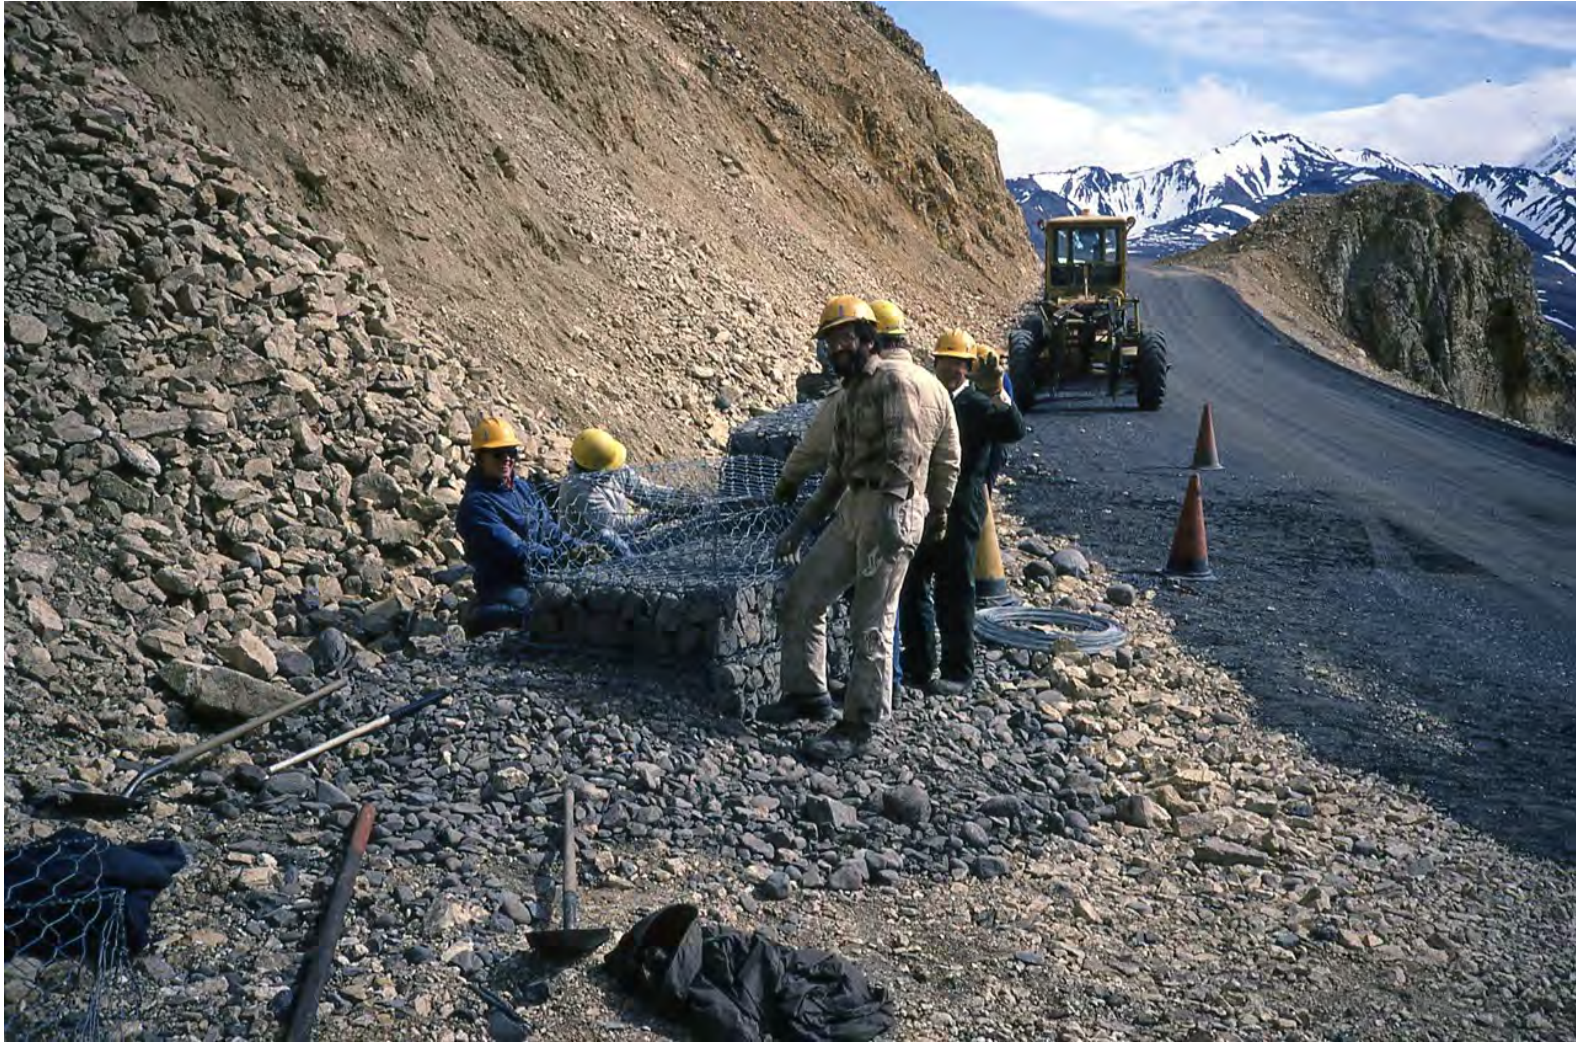
Figure 3. 1987 Installing Subsurface Drainage

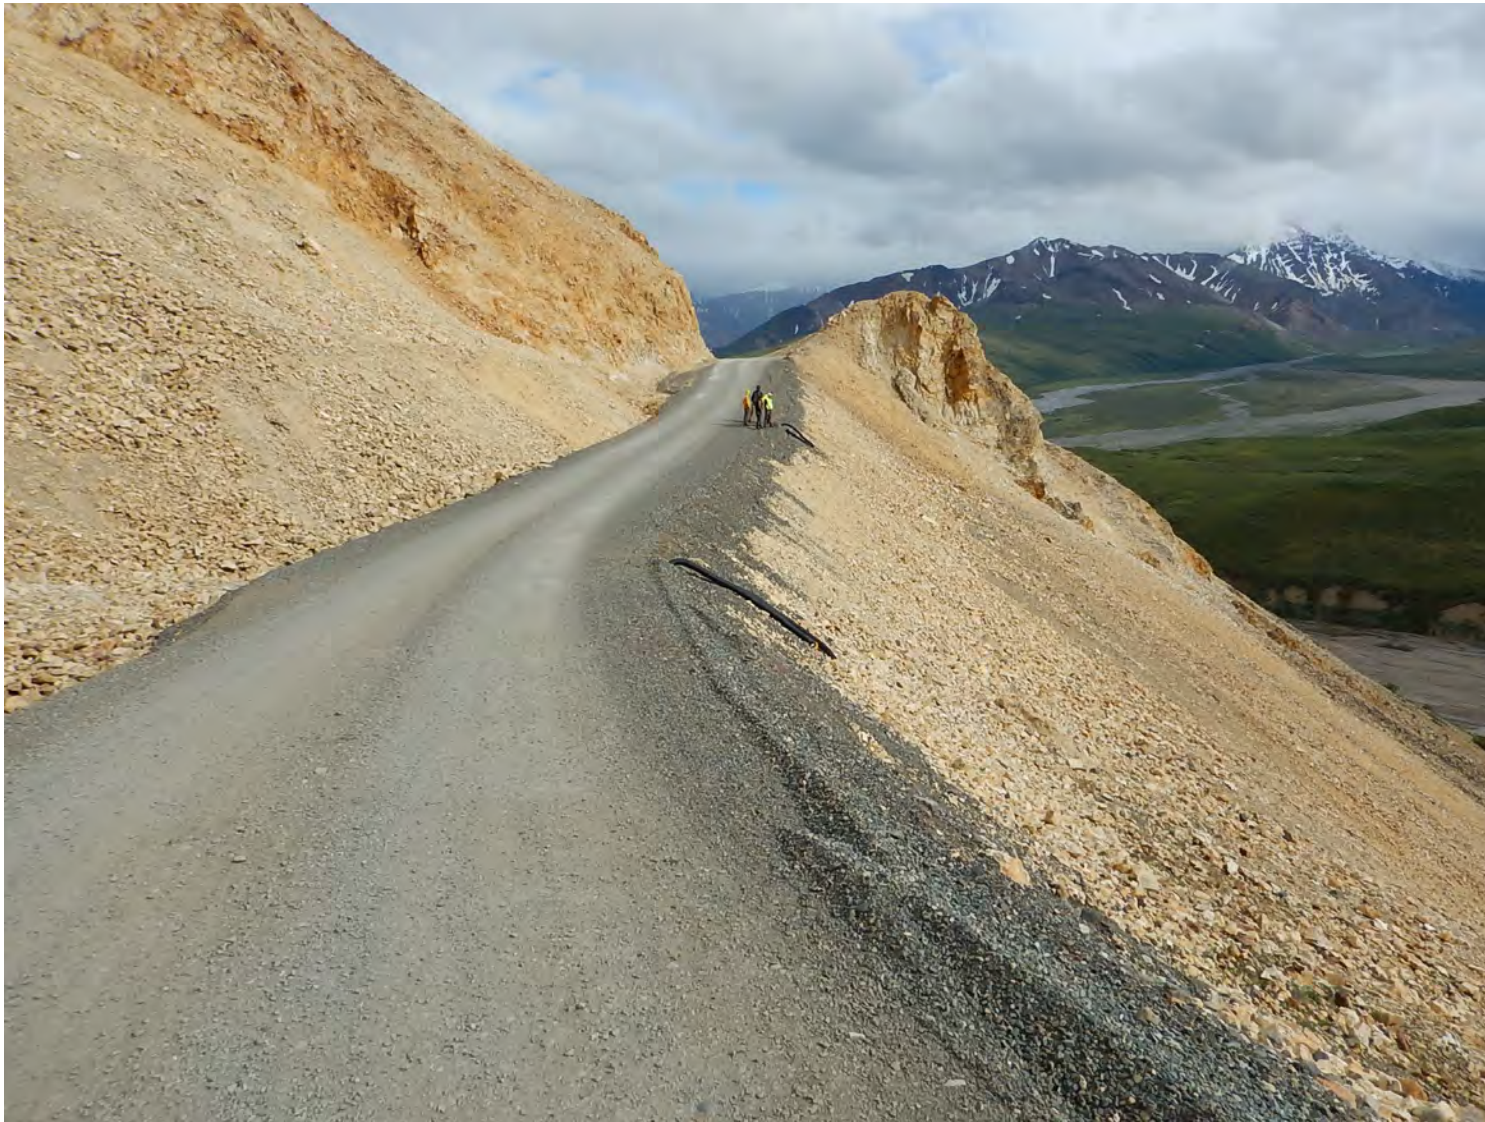
Figure 6. May 2018: After deep patch construction and conduit installation for drilling and instrumentation program

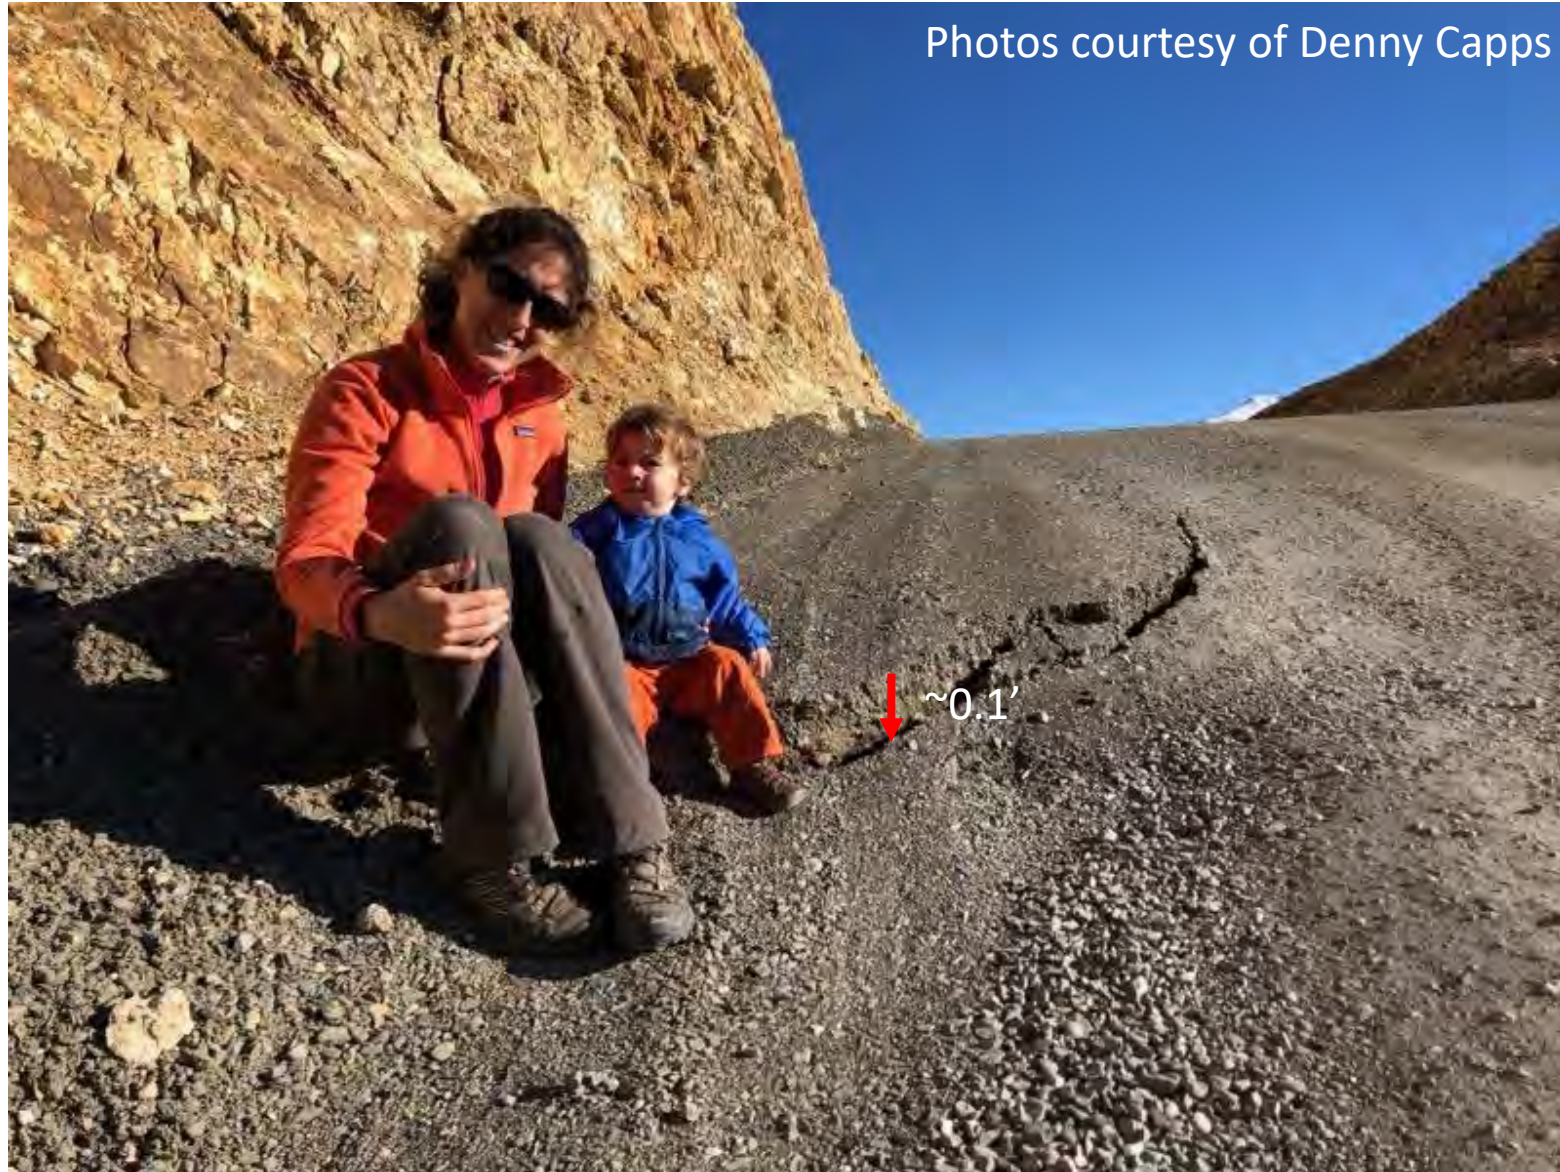
2018/2019 Sept.-March: Road surface measurements were 0.4 inches per day, or 12 inches per month; dug down east edge as far as possible and reconstructed across landslide similar to 2017 landslide repairs. (See Figures 7-9)

Figure 7. Site Photo from September 29, 2018. As reported by Denali Maintenance, last road level grading operations were on September 24th.

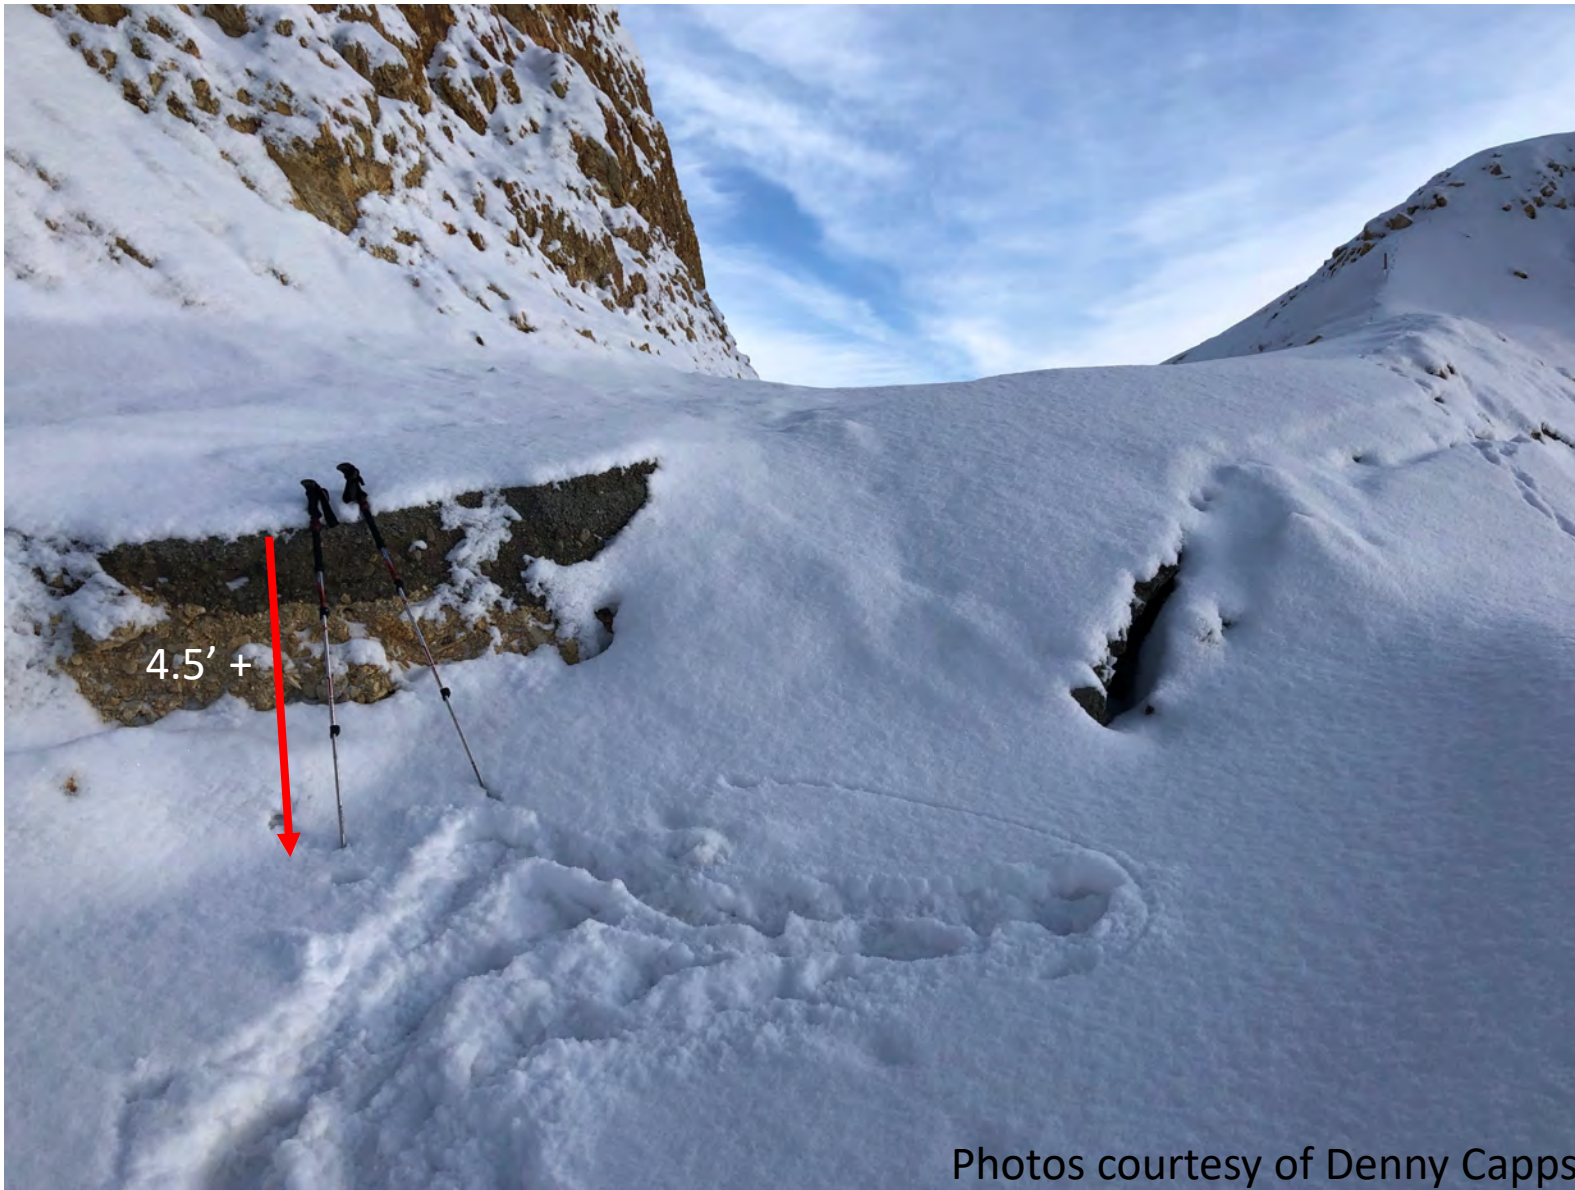
Figure 8. Site Photos from February 6, 2019

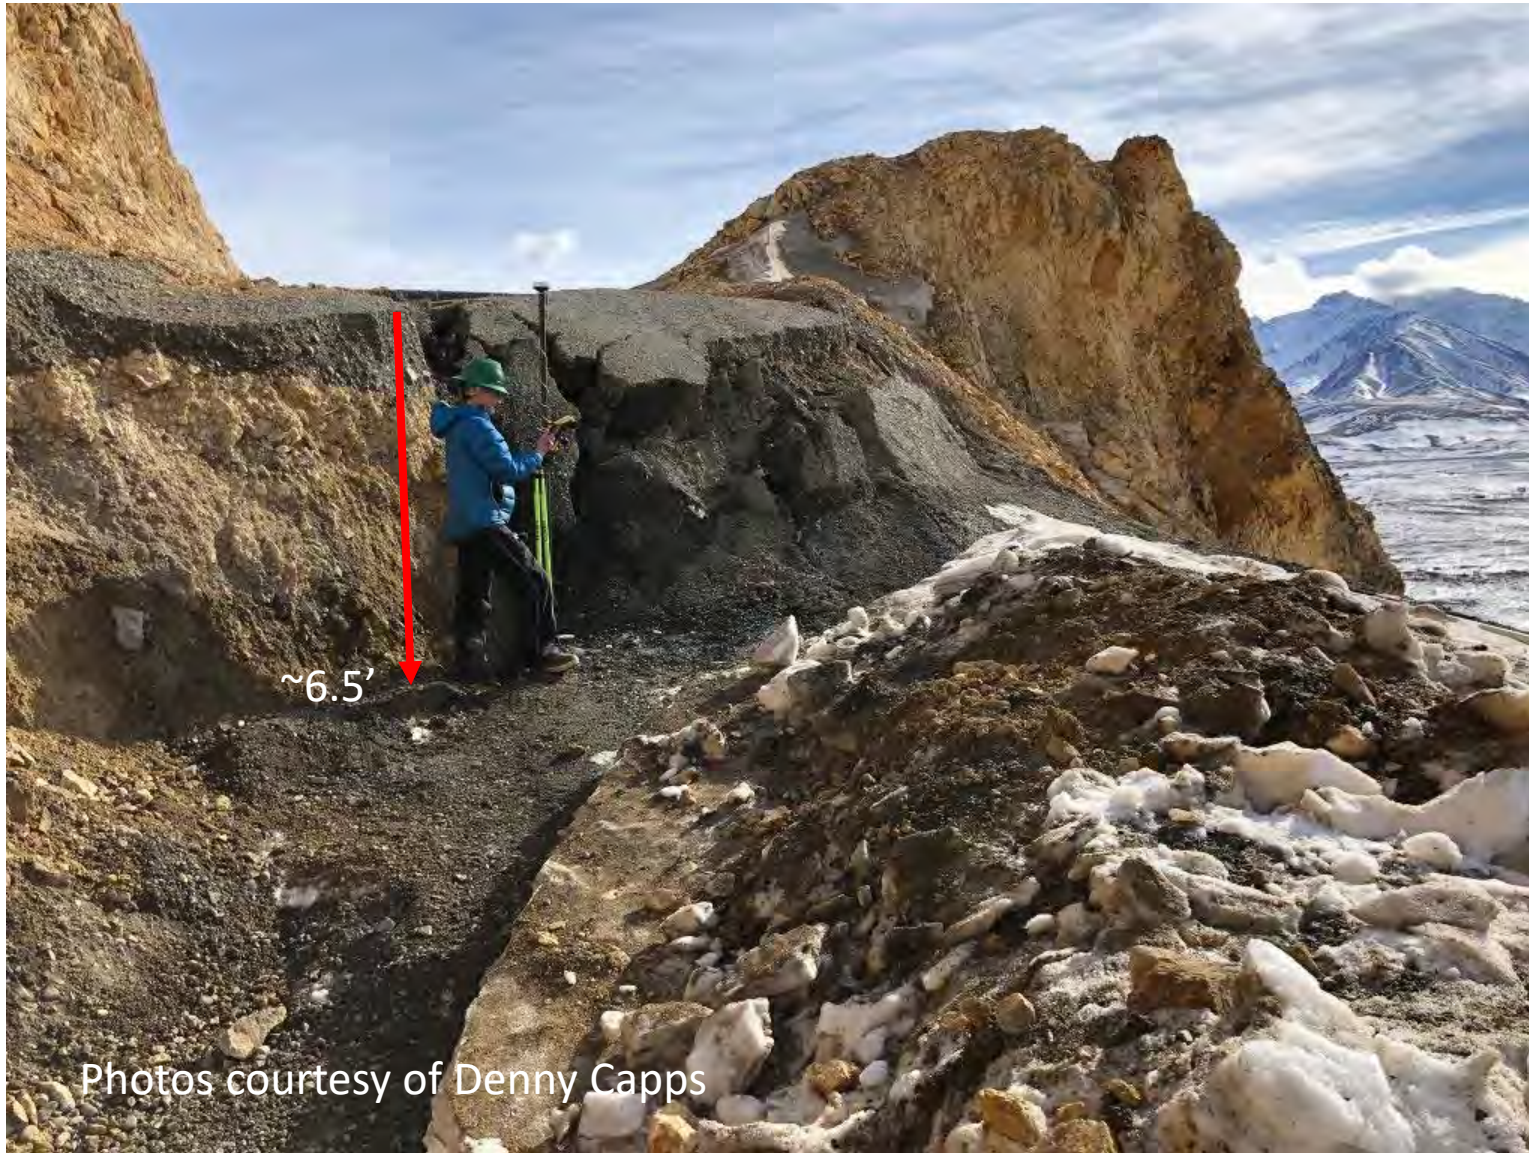
Figure 9. Site Photo from March 21, 2019. Rate of Movement from Surface Measurements:
~0.4 inches/day or ~12 inches/month

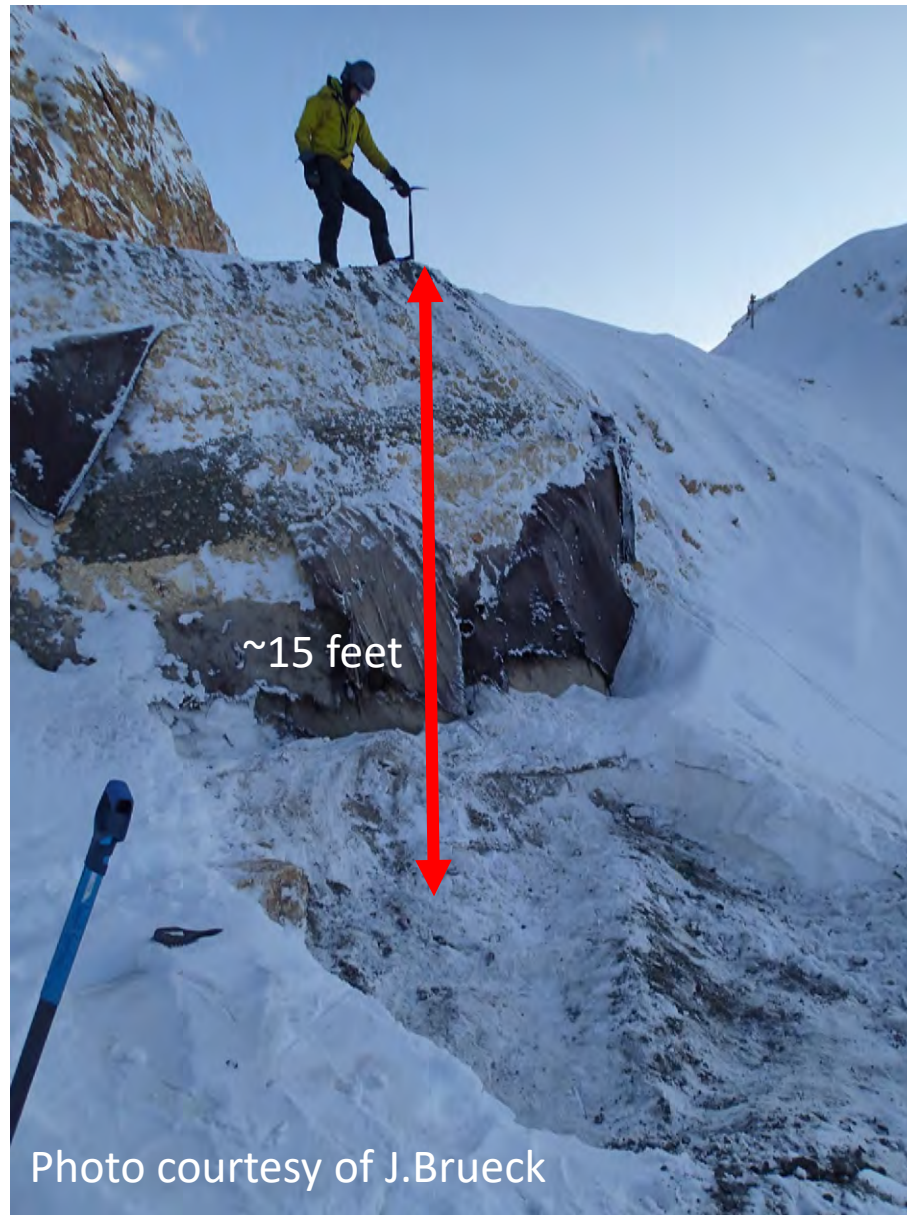
Figure 10. Site Photo from January 2020

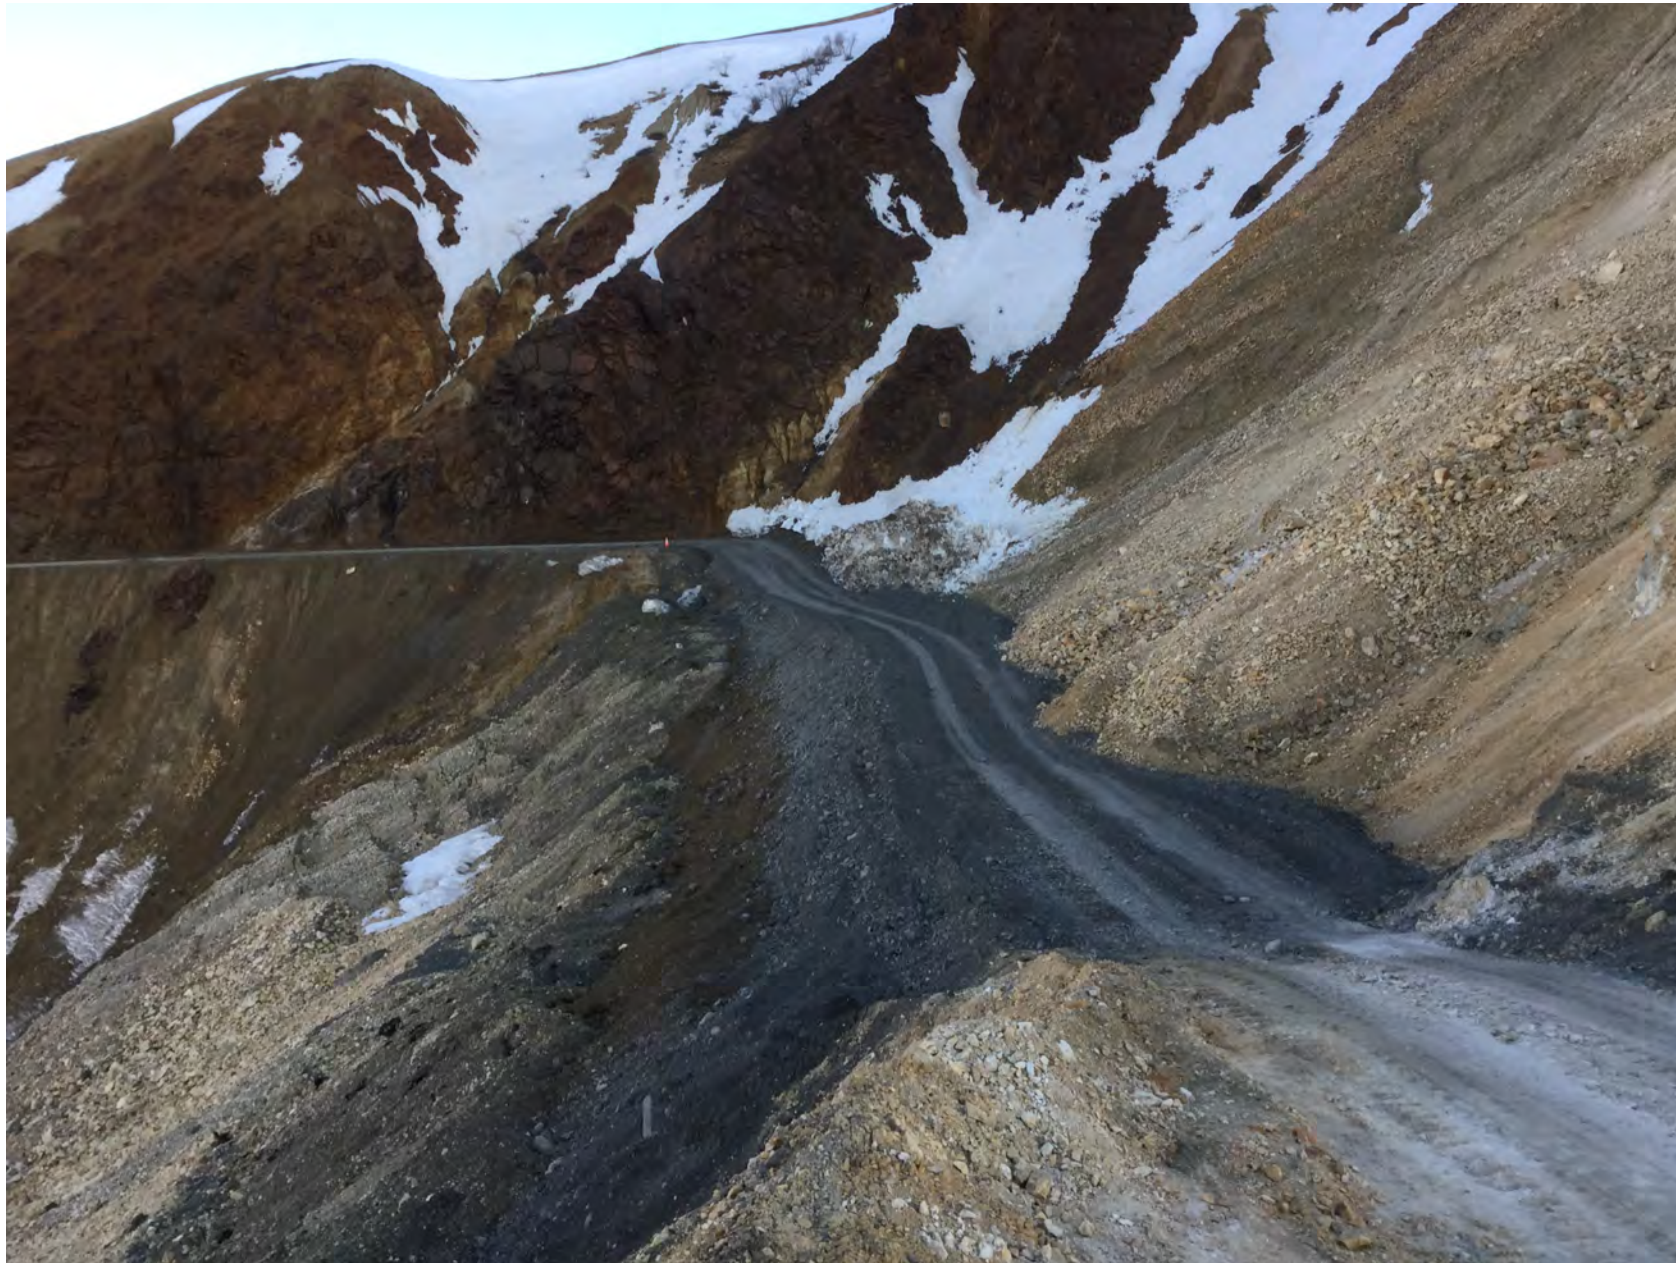
May 2020: Road temporarily repaired in time for spring road opening activities. (See Figure 11)

Figure 11. Site photo at the rebuilding of the road grade as it is brought to grade on April 29, 2020.

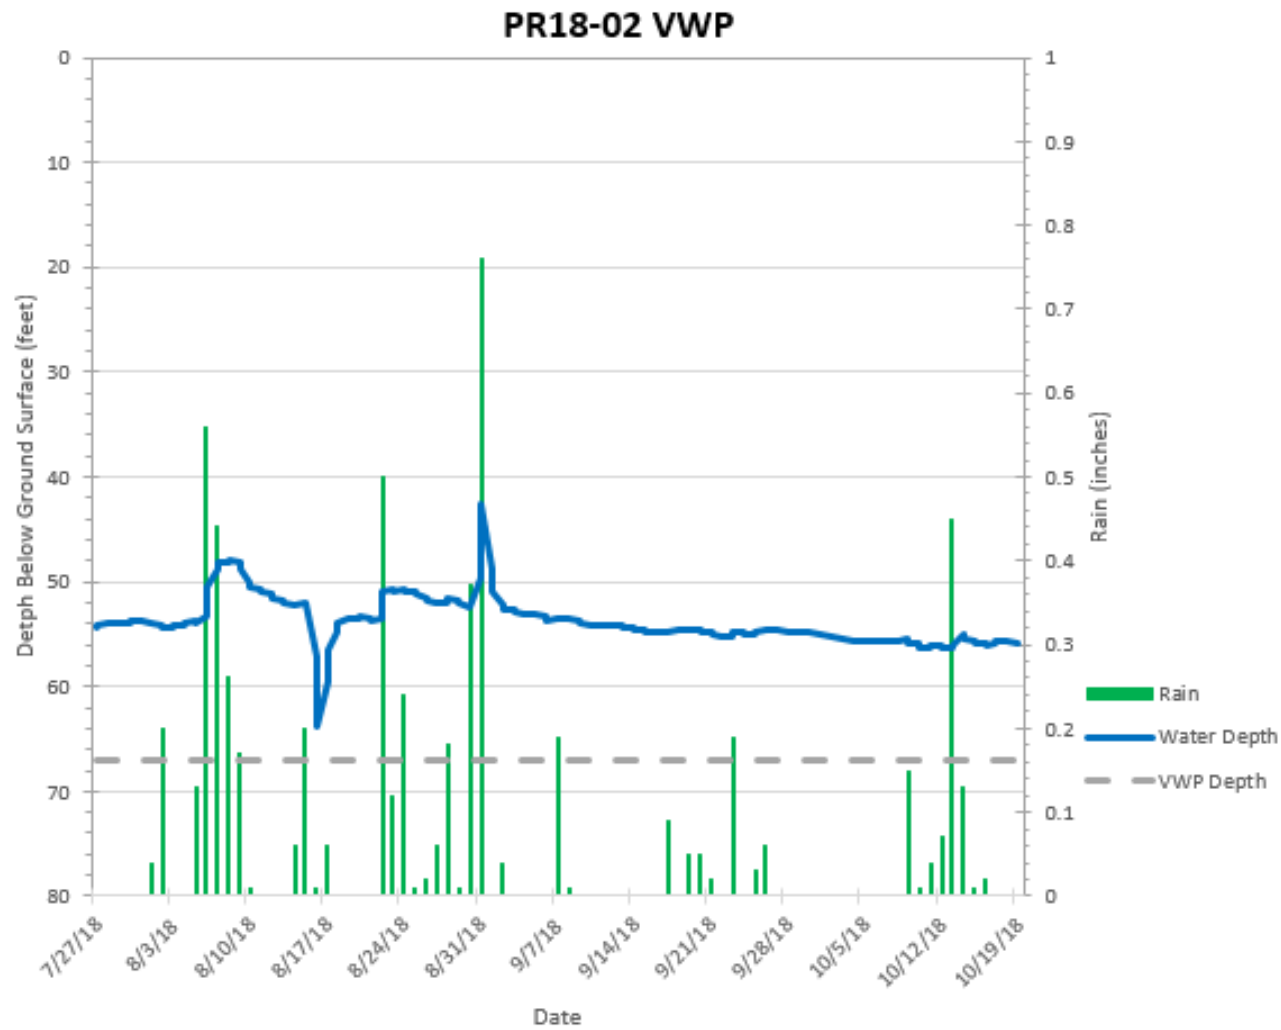
This unit consists of a thin veneer of medium dense to very dense Gravel, Cobbles, and Boulders overlying loose to medium dense Clayey Gravel and Sands (GC, SP with gravel, SC, SM, SW) with layers of cobbles and boulders throughout. A phreatic groundwater table was measured in this subsurface material unit in test boring PR18-02 in the upper landslide deposit. In PR19-02, the upper groundwater table appears to be closely related to air temperature (snow melt runoff) and precipitation events (Figure 19). This material is subject to annual freezing, known as the active layer, to depths in excess of 12 to 16 feet; otherwise the instrumentation data and drilling observations suggest this material is not part of the permafrost layer described below. Based on the 2018 test borings and thermistor string data, this unit ranges from 12.5 to 36 feet bgs.

Figure 19. When measured, groundwater appears very responsive to precipitation and snow-melt in the upper landslide deposit.

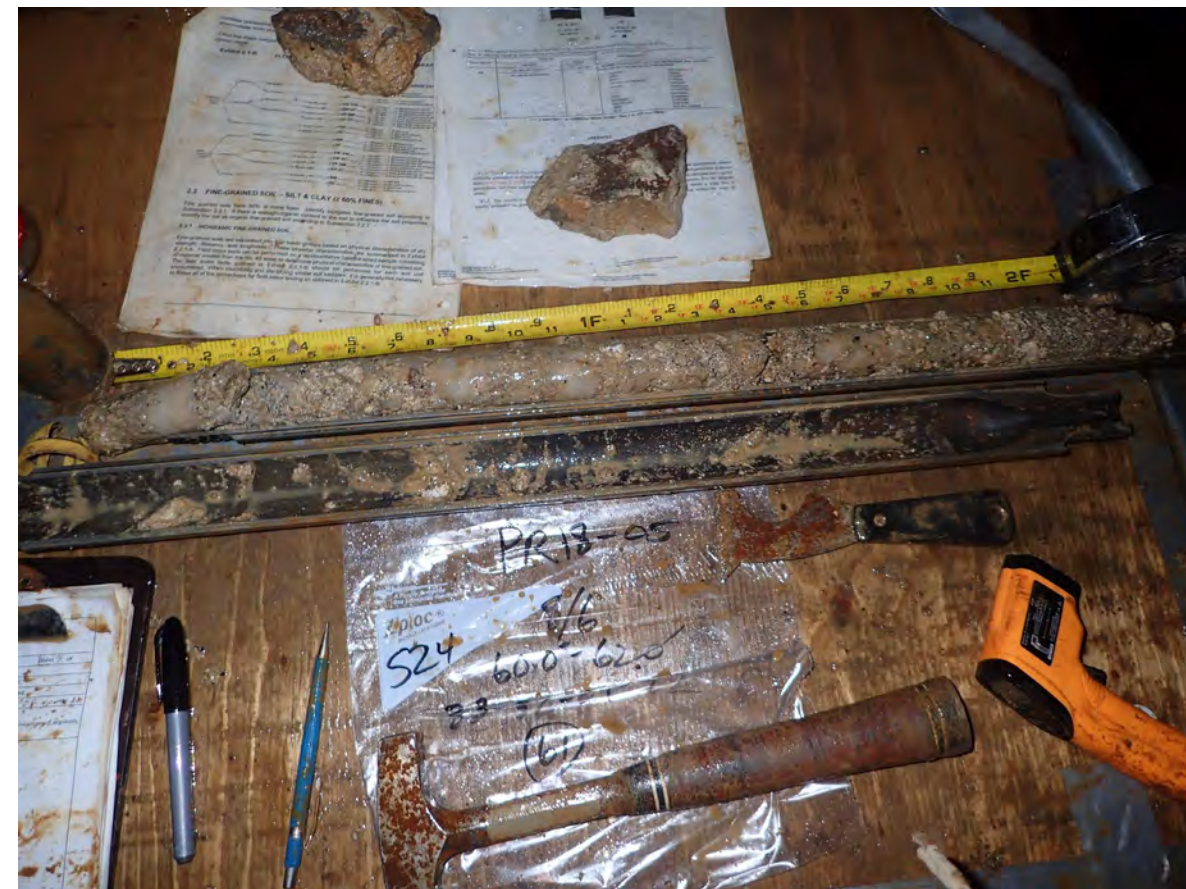
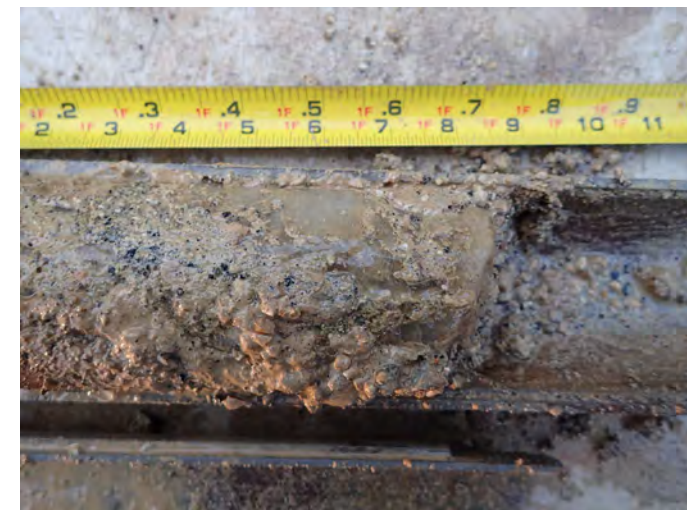
The thermistor string instrumentation data suggests that the drilling action warmed the subsurface materials and massive to ice-rich permafrost soils are likely to be more extensive than encountered and observed during the drilling operations. For example, in Figure 21, the observed ice rich soils during drilling was between 72.5 and 88.4 feet bgs. The thermistor data suggests that once the ground recovered and stabilized from the drilling operations, the ice rich soils are likely from 36 to 88.4 feet bgs. This is a significant change and can be seen in the 2018 test boring instrumentation data provided in Appendix F.

Figure 21. The drilling actions warmed up the “warm” permafrost, as can be seen in this thermistor string plot of PR19-02. Note that in the test boring, observations of massive to ice-rich soils was confined to 72.5 to 88.4 feet below the ground surface (BGS), but the thermistor readings indicate a restabilizing of the subsurface conditions following drilling, measuring freezing temperatures and potential ice rich soils between 36 and 88.4 feet bgs.

Presence of Permafrost
Likely Below Freezing at 35'

PR18-02
 0-72.5' Clayey Gravel and Sands
 72.5-88.4' Ice-Rich Soils (36-88.4')
 88.4-140.3' Volcanic Ash (Tek Clays (CH))

Thermistor Readings Discontinued
after shearing on 1/24/2019

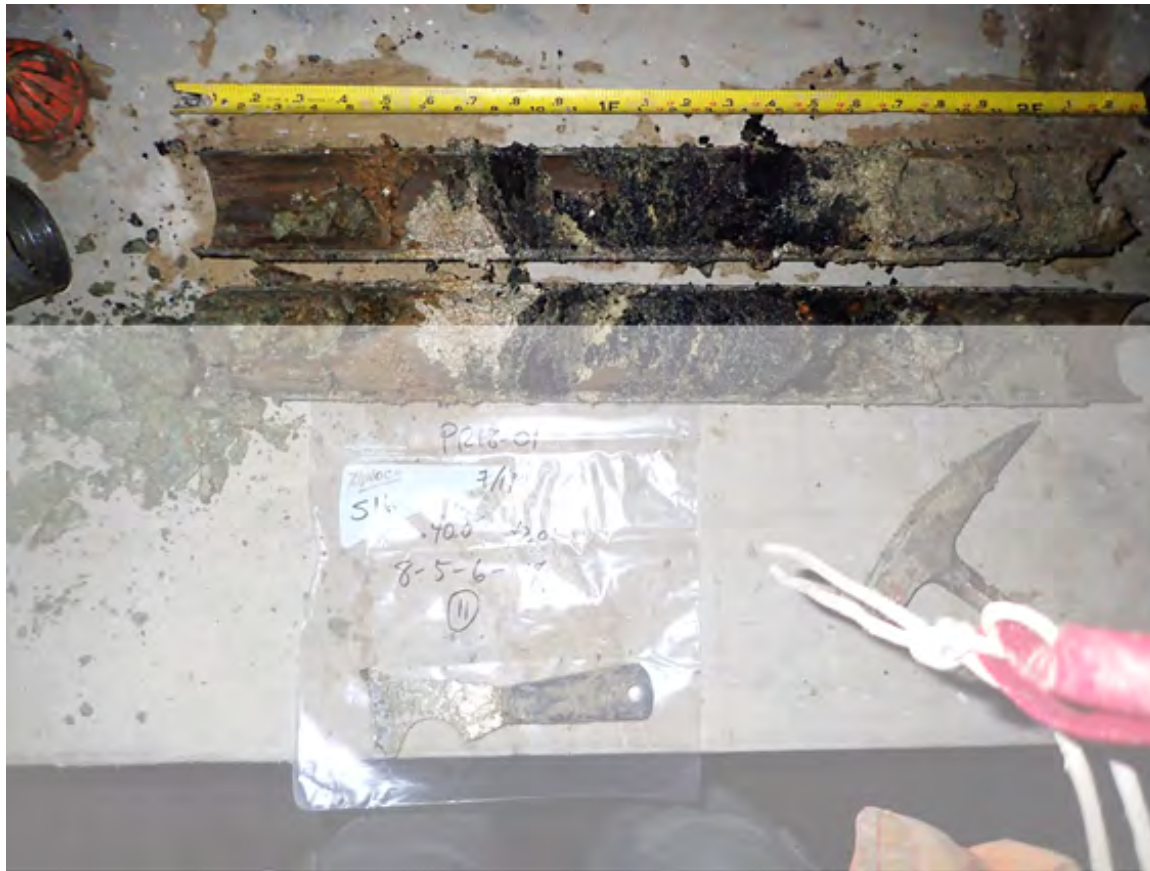
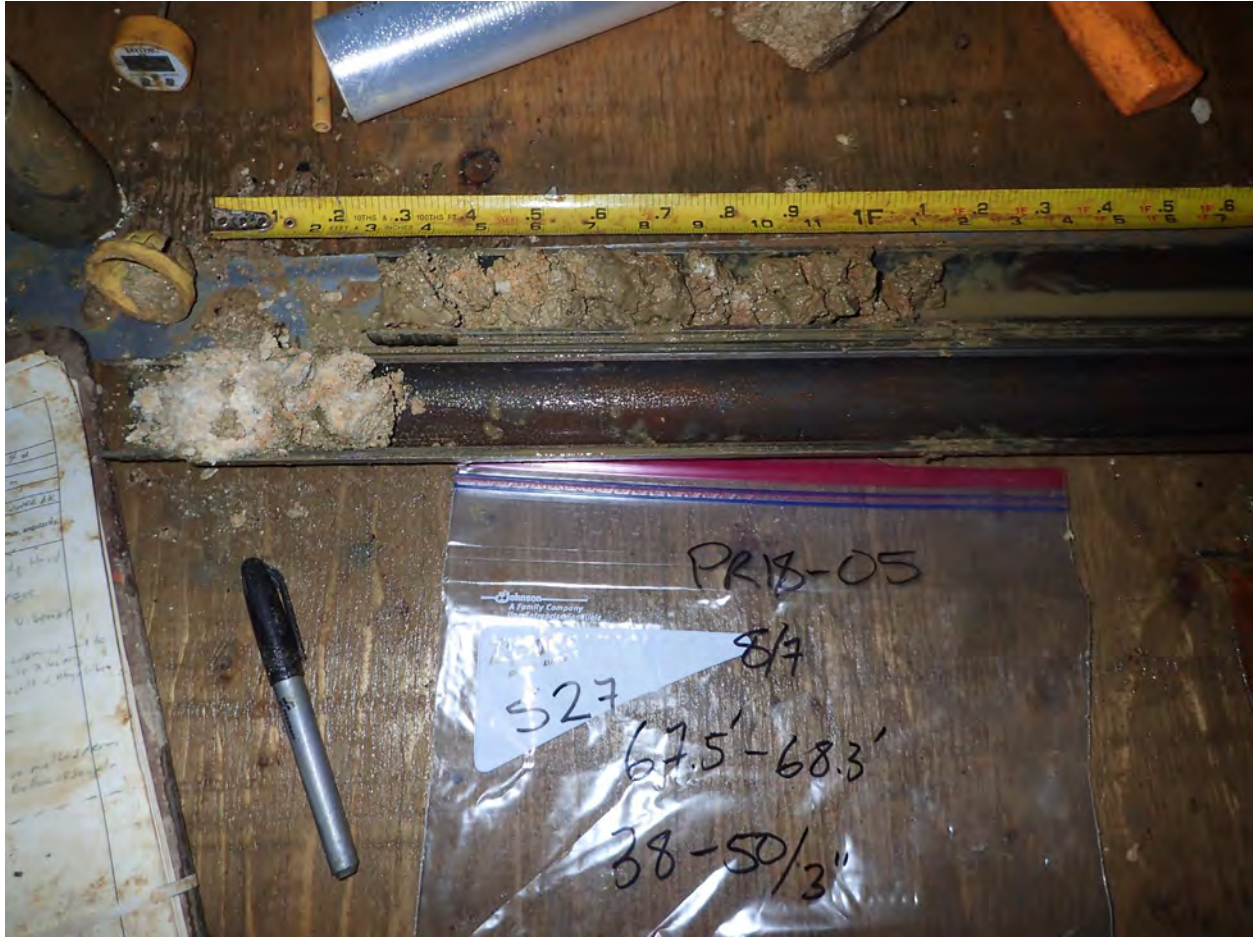
Figure 24. Slope inclinometer measurements in PR18-05 and a photograph of the core recovered that contains the abrupt failure plane and change in materials.

-Sharp failure zone at 66 to 68 feet along the very weak rock surface/geologic contact; downward compression of the casing below the failure plane.
 -10 days of readings before shearing at 3.5 to 4 inches of total landslide deflection movement.

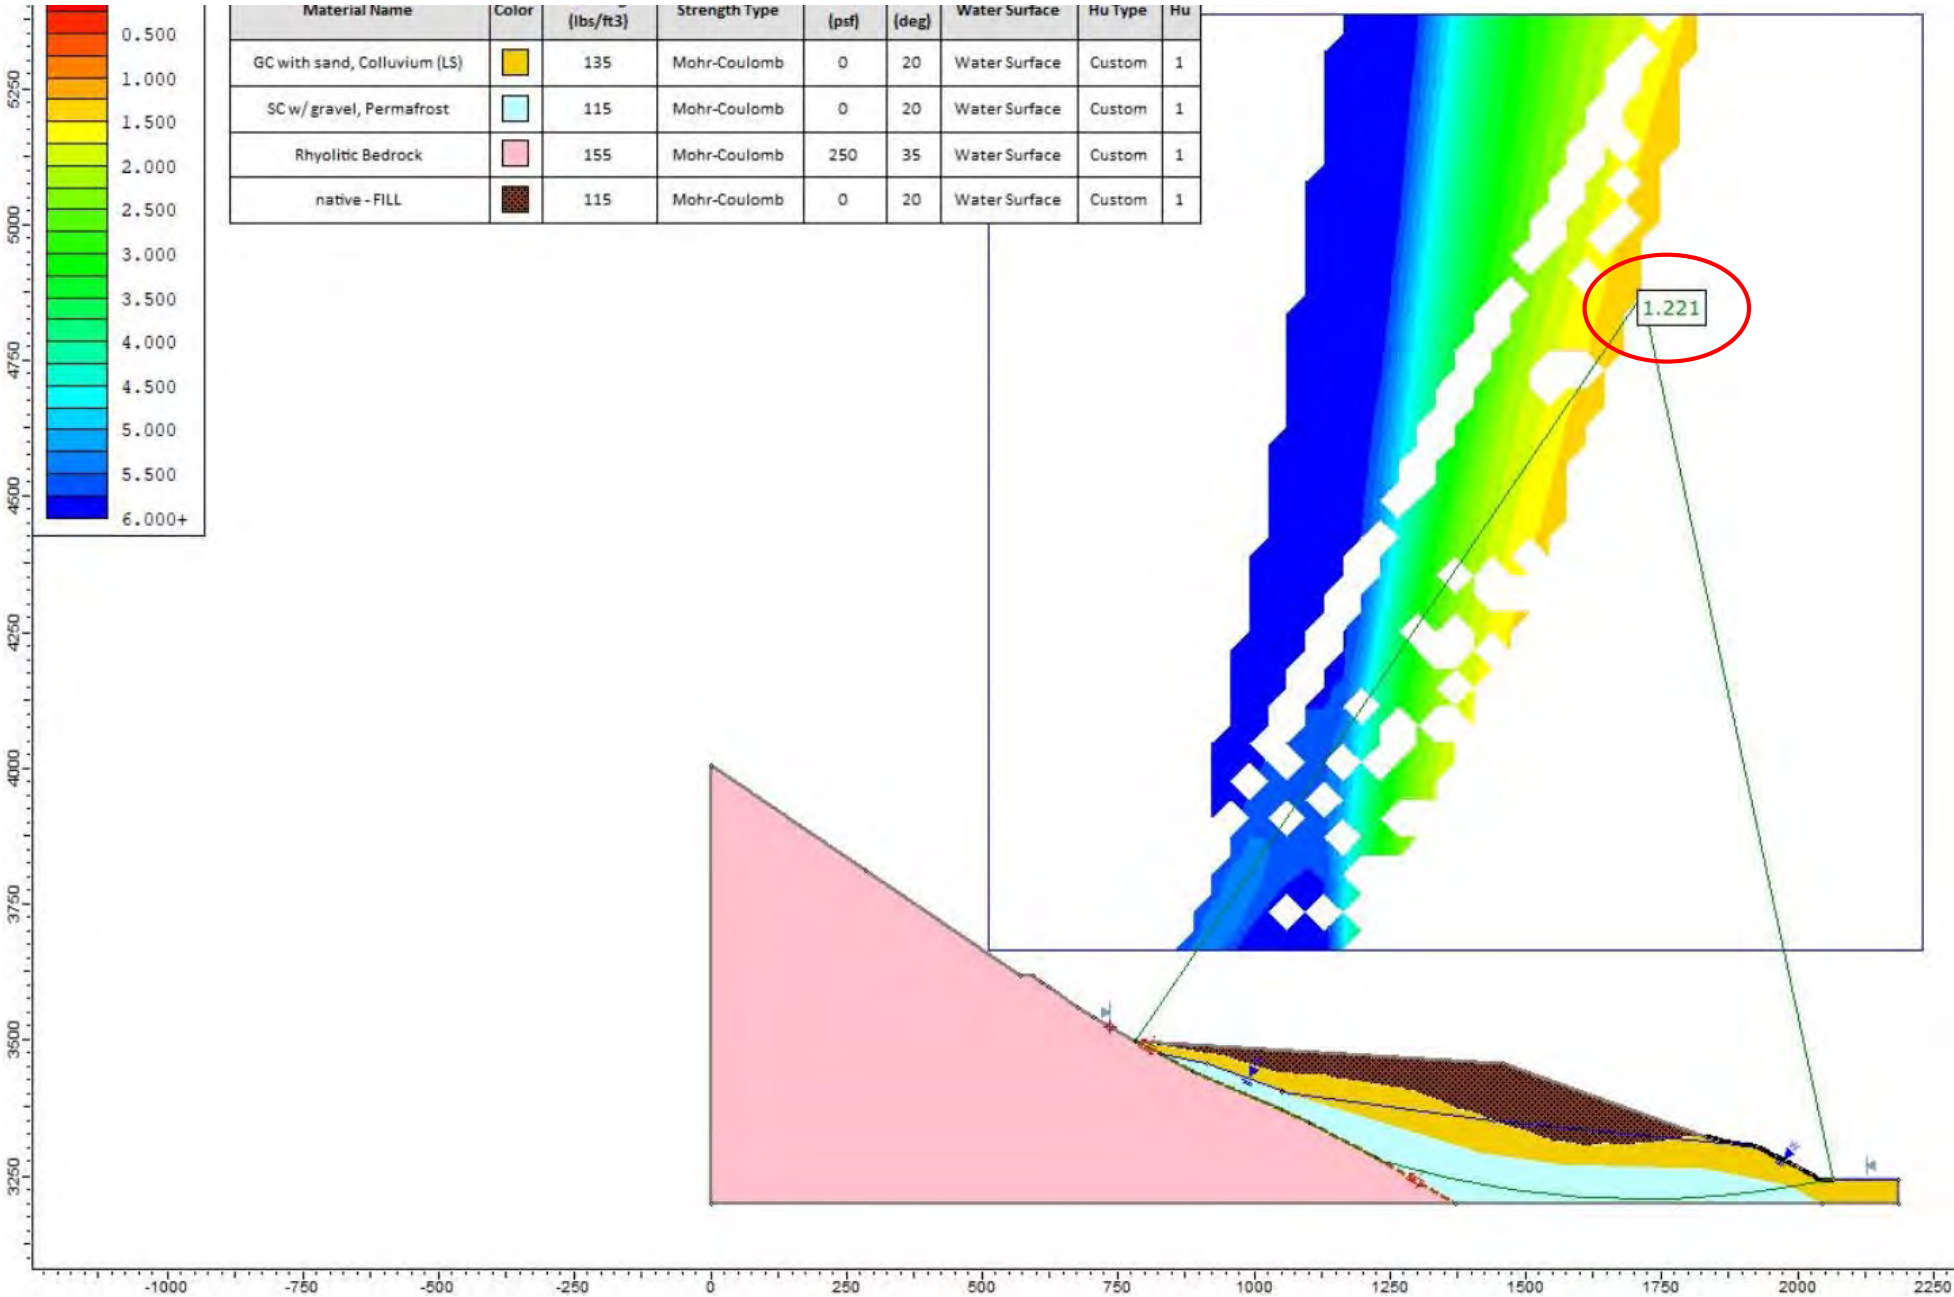
This appears to be another promising avoidance measure by removing the upper landslide and placing it on the lower portion of the slope at a stable configuration. Figure 35 provides a near-design standard factor of safety of 1.25. We have assumed based on the width of the upper landslide and a cut slope of 1V:1.5H that a rough approximation of the excavated materials with a 20% swell factor once placed at the base of the slope will be about 1.1 million cubic yards. To evaluate this conceptual design alternative, the following considerations were developed:

Figure 35. A Rocscience SLIDE software graphical output for the preliminary analyses of the removal of the upper, unconsolidated landslide material and placing it on the lower portion of the landslide

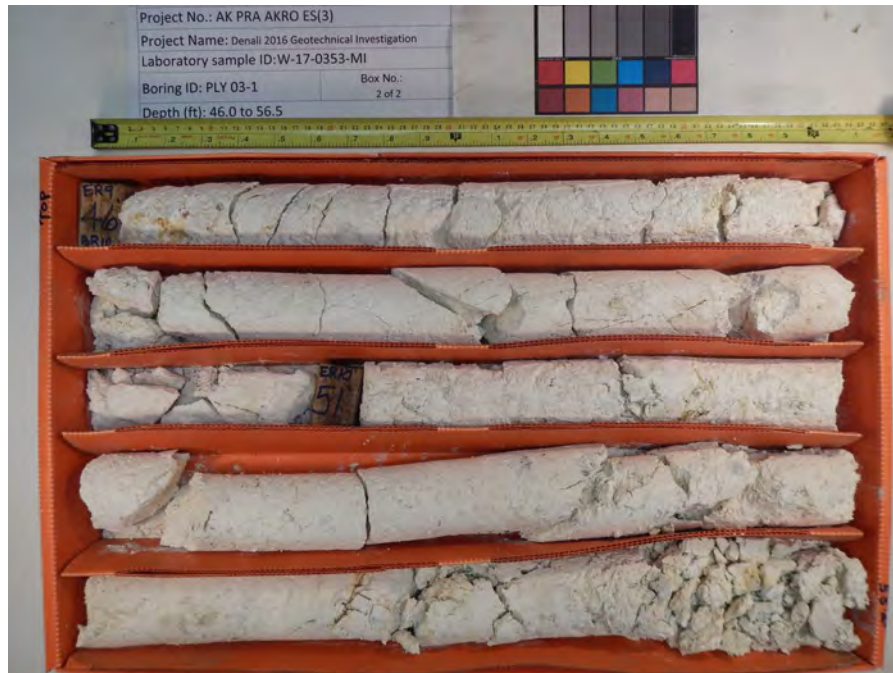
Figure PLY03-1.2 Depth: 46ft to 55.5ft
Note: Final depth mislabeled at 56.5 ft. Actual final depth is 55.5 ft.
