Geotechnical Report No. 11-20

**Pretty Rocks Landslide
2018-2019 Geotechnical Investigation and Conceptual
Design Alternatives Report**

**AK NPS DENA 10(45)
Denali National Park, Alaska
August 2020**

U.S. DEPARTMENT OF TRANSPORTATION
FEDERAL HIGHWAY ADMINISTRATION

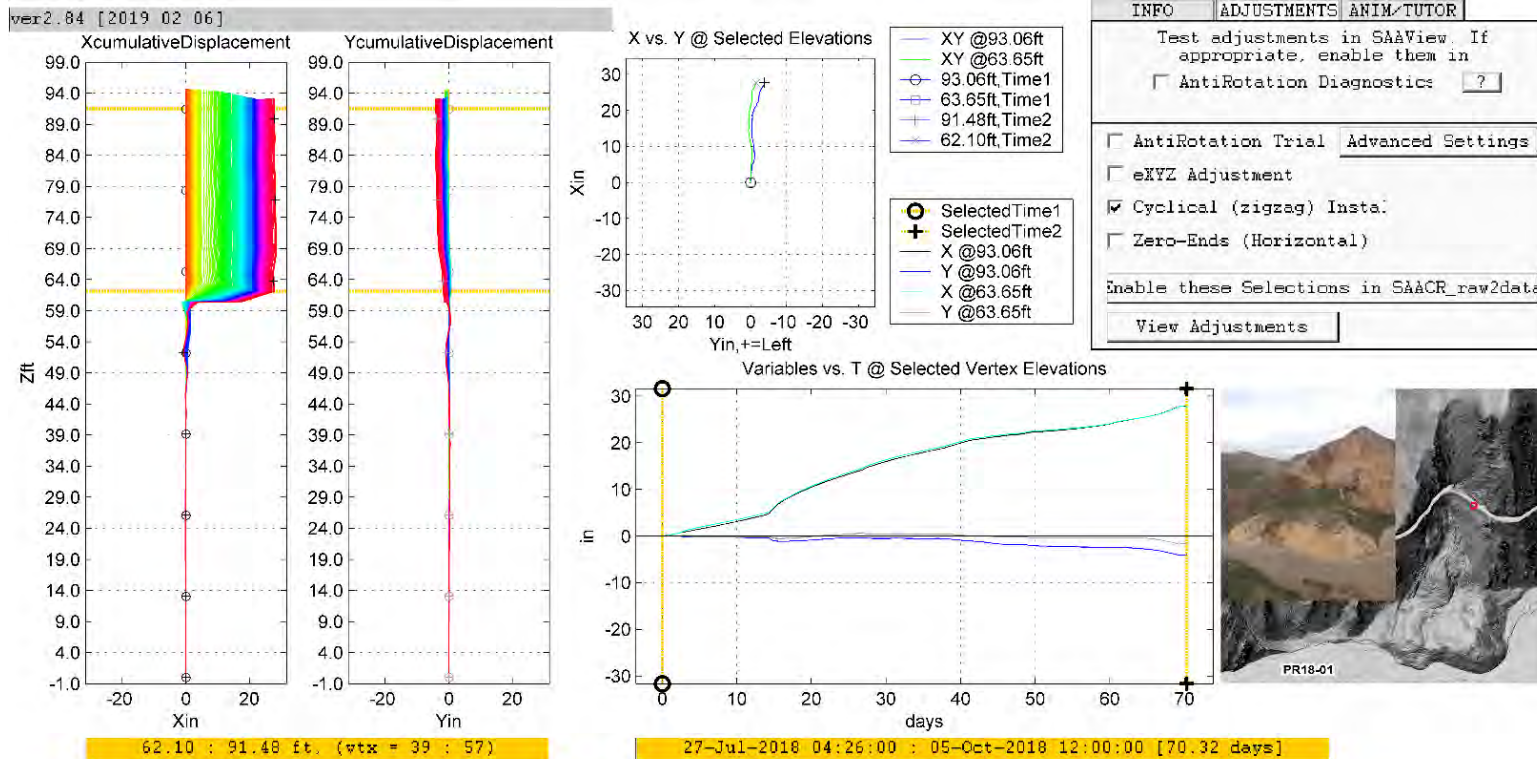
PR18-01 (Saa 221178) Cumulative Displacement

The total landslide displacement at 62 feet from the bottom of the hole is around 28 inches in 70 days.

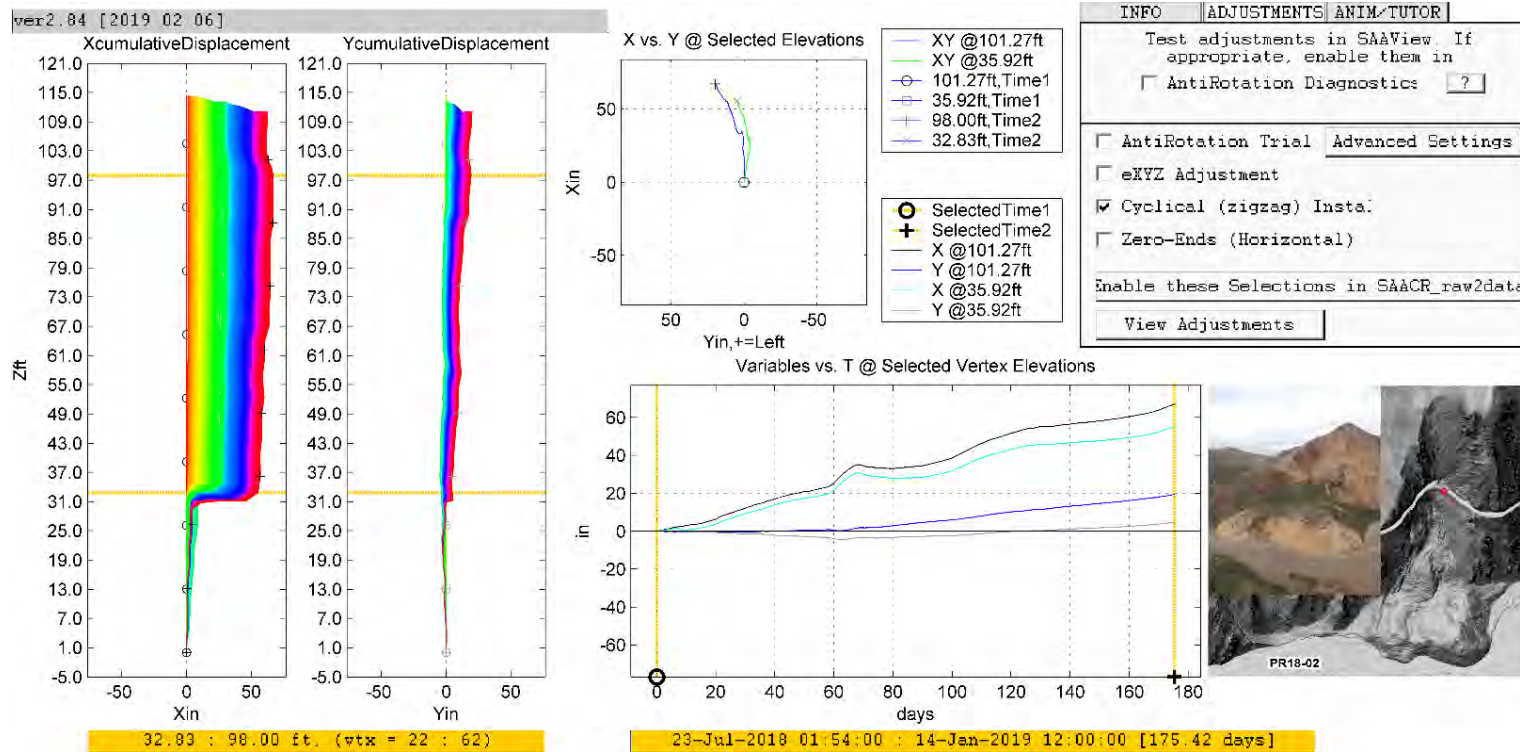
PR18-02 (Saa 221182) Cumulative Displacement

Note: SAA measurements are from the bottom of the hole to the top of the hole. Magnitude of Landslide displacement is measured in inches and represented by the rainbow colors. The left part of the graph show the total movement down slope, and the right part of the graph show the movement right. The total landslide displacement at 33 feet from the bottom of the hole is around 68 inches in 175 days.

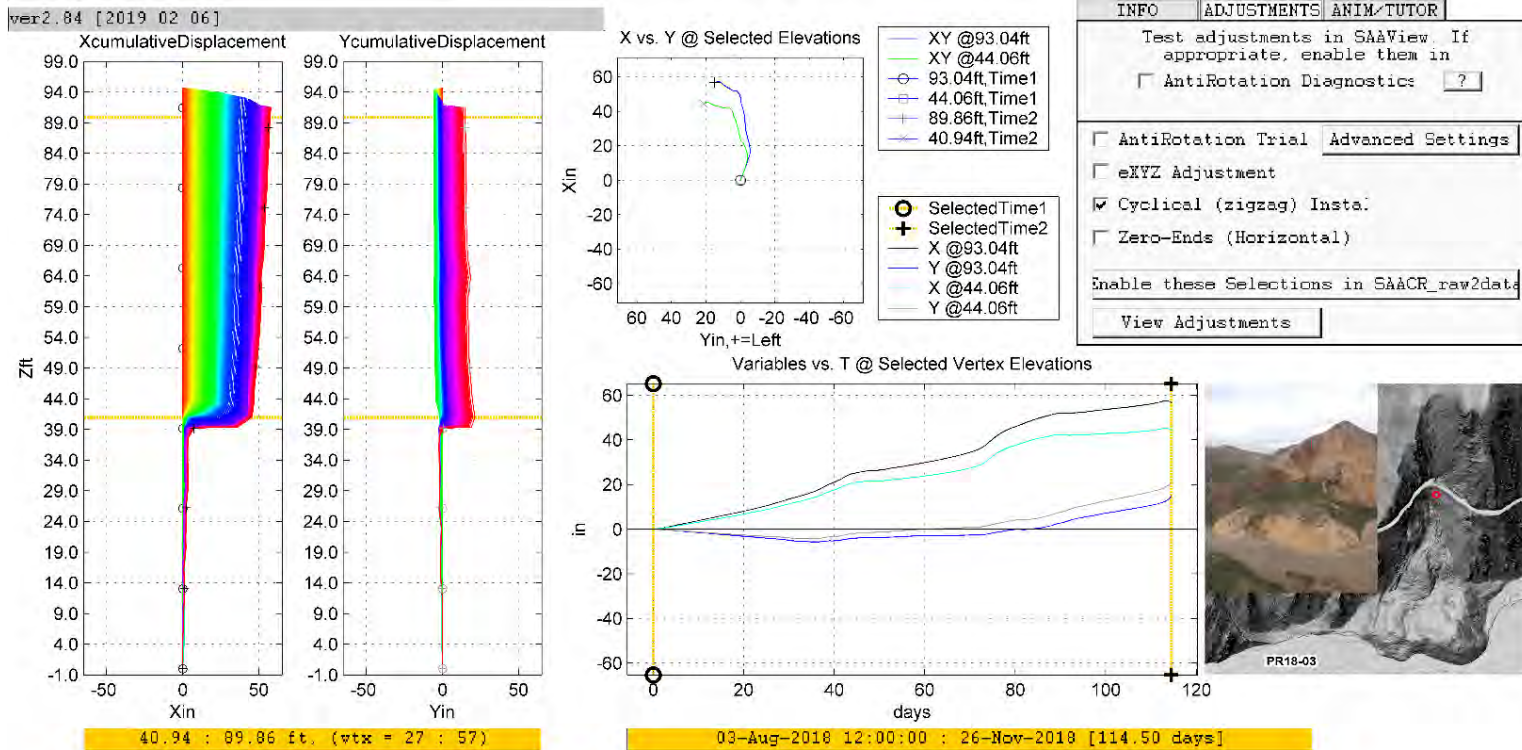
PR18-03 (Saa 221189) Cumulative Displacement

Note: SAA measurements are from the bottom of the hole to the top of the hole. Magnitude of Landslide displacement is measured in inches and represented by the rainbow colors. The left part of the graph show the total movement down slope, and the right part of the graph show the movement right. The total landslide displacement at 41 feet from the bottom of the hole is around 60 inches in 115 days.

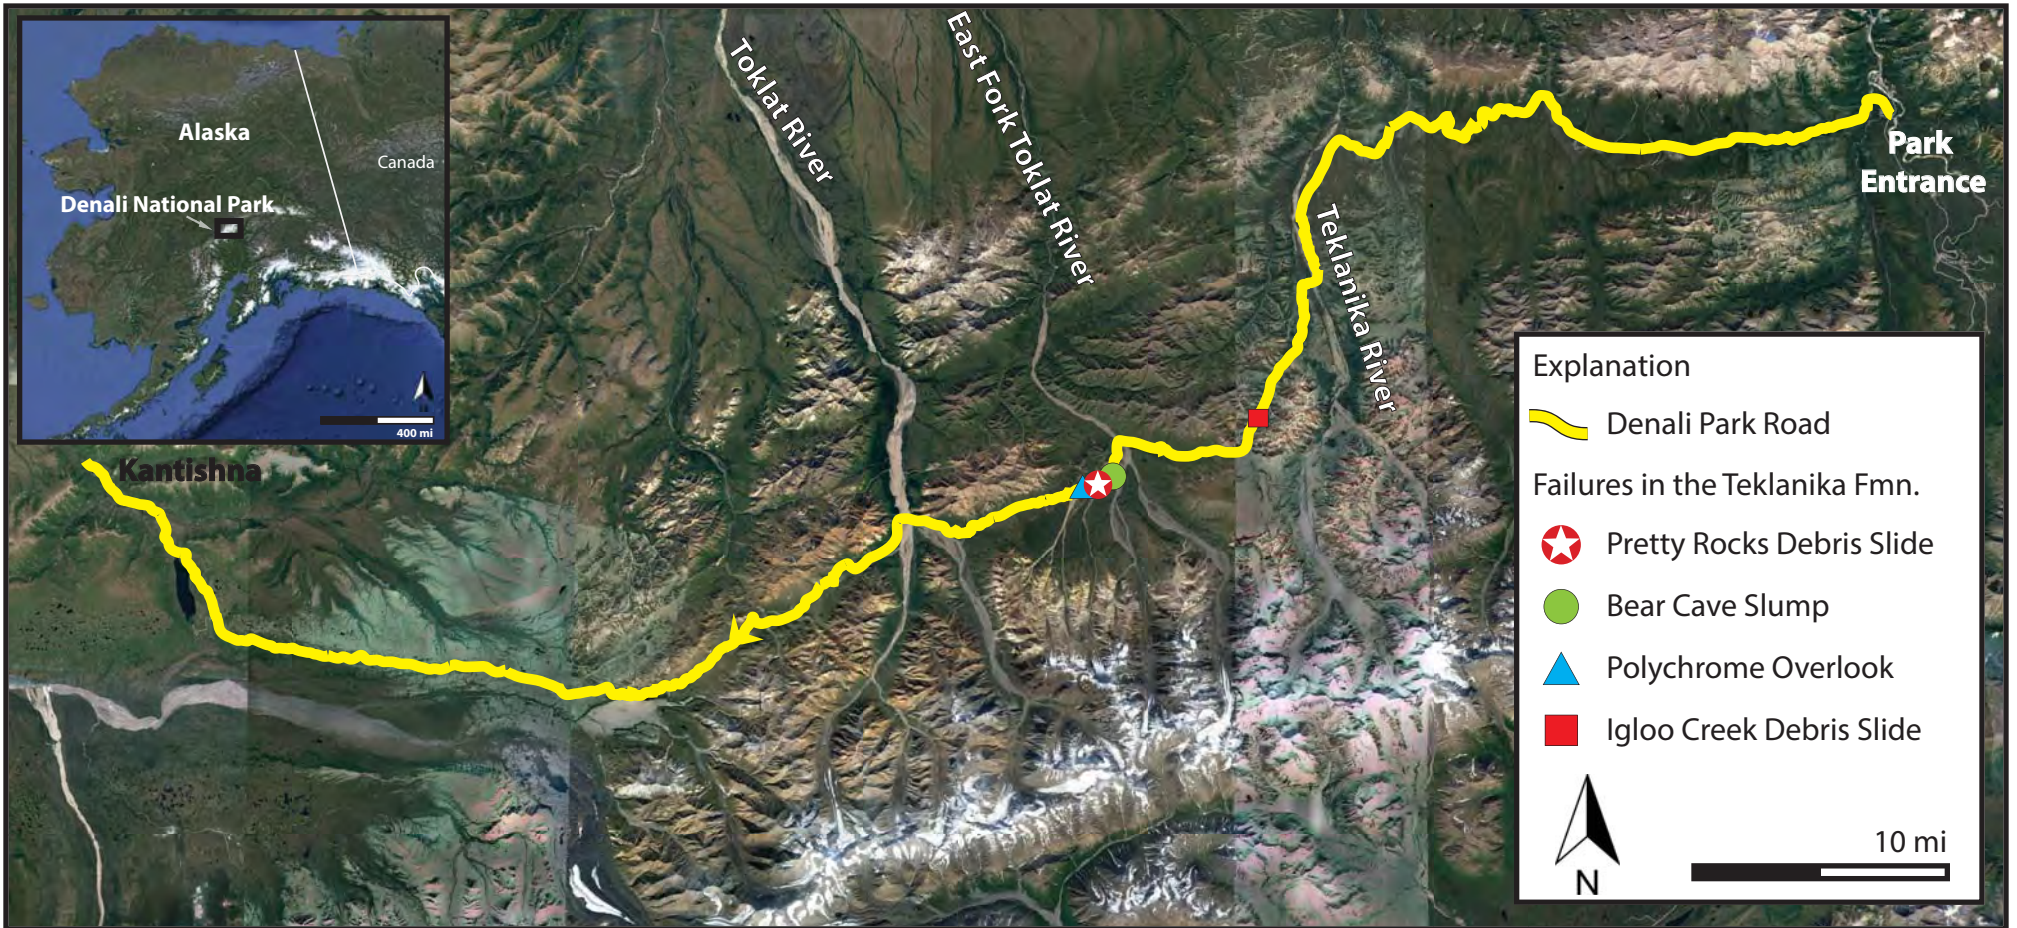
Figure 1: Map of Denali Park Road highlighting failures that have occurred or are occurring within the Teklanika Formation. Note that 3 of the 4 failures are occurring in close proximity to one another within Polychrome Pass. Imagery from Google Earth.

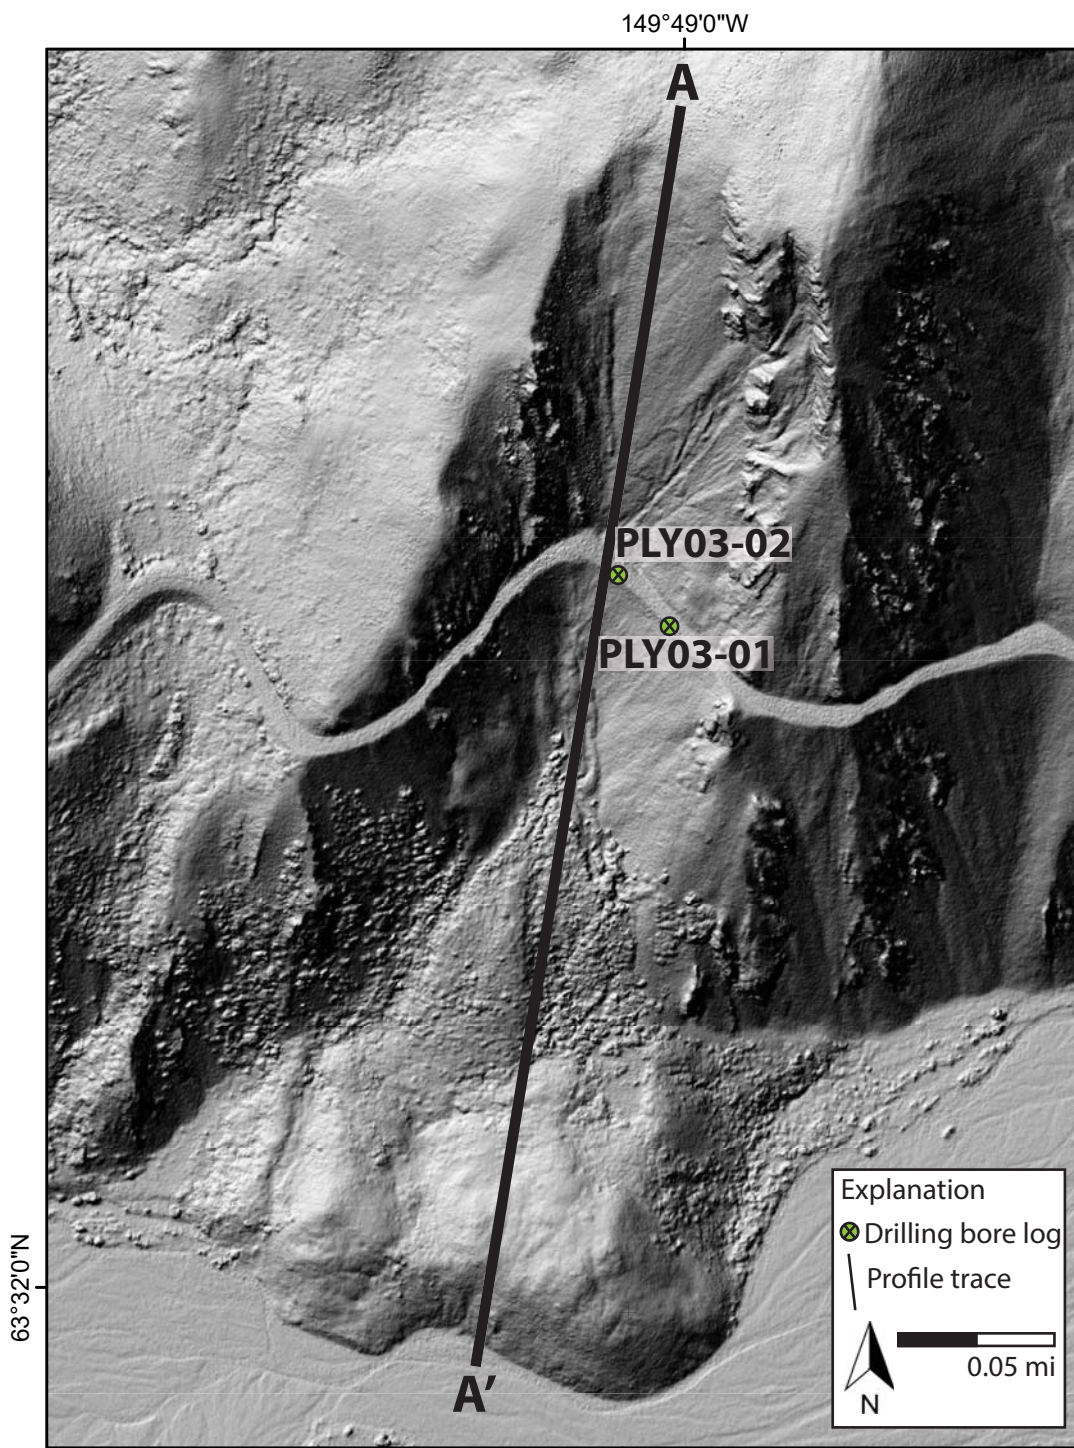
In June 2003, the Federal Highway Administration drilled two bore logs – PLY03-1 and PLY03-2 –through the road surface into the Pretty Rocks slope (Figs. 4, 11). Rock descriptions, field blow counts, and N-values were provided (Appendix B). PLY03-1 was drilled to a depth of 55.5 ft. Ground ice was first mentioned at 20.4 ft. The driller switched from augering to coring at 36.0 ft depth. N values range from 8 to >60. PLY02-3 was drilled to a depth of 101.2 ft. Ground ice was first recorded at ~40.5 ft. The driller switched from augering to coring at a depth of 40.9 ft. N values range from 10 to >60.

Figure 4: Location of slope profile and drilling bore logs collected by the Federal Highway Administration (FHWA) in June 2003 (left). A - A' profile (below).

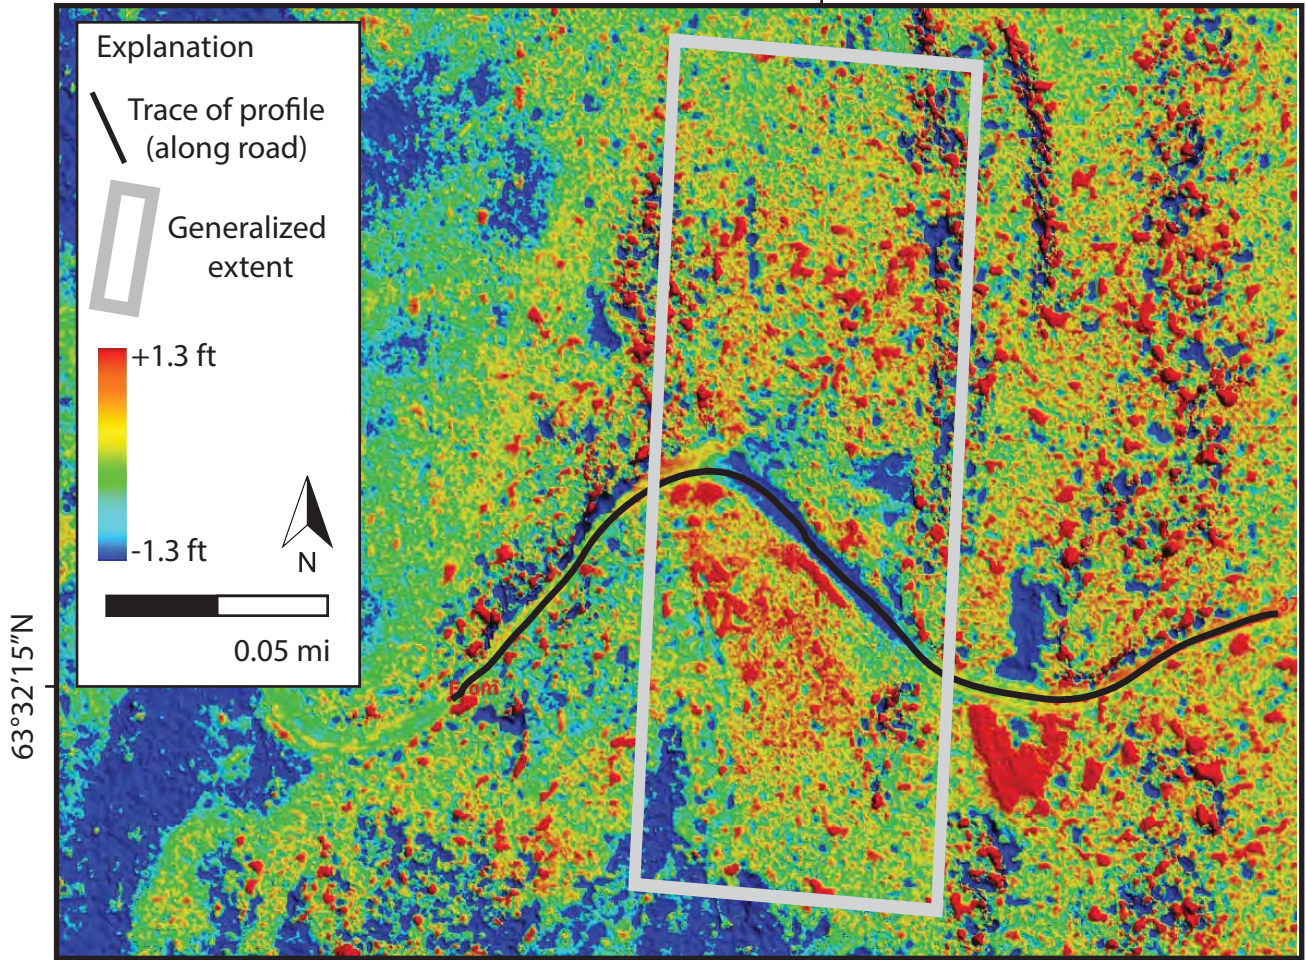
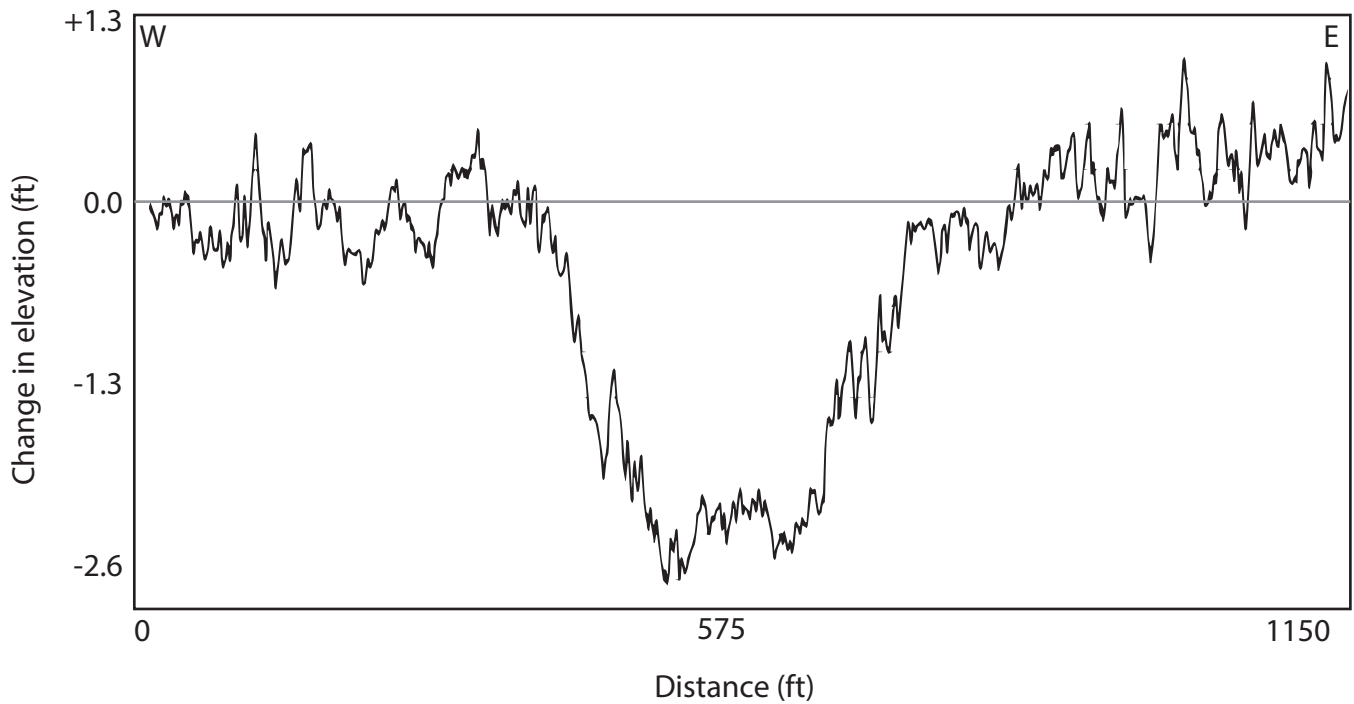
Figure 5: Difference elevation model from June 2015 to June 2016 (top), including road profile from west to east (bottom). Constructed by Dr. Matt Nolan, Fairbanks Fodar, University of Alaska Fairbanks. Note decrease in elevation along and above the road within the generalized extent, and the increased elevation below the road (see also Photo B).

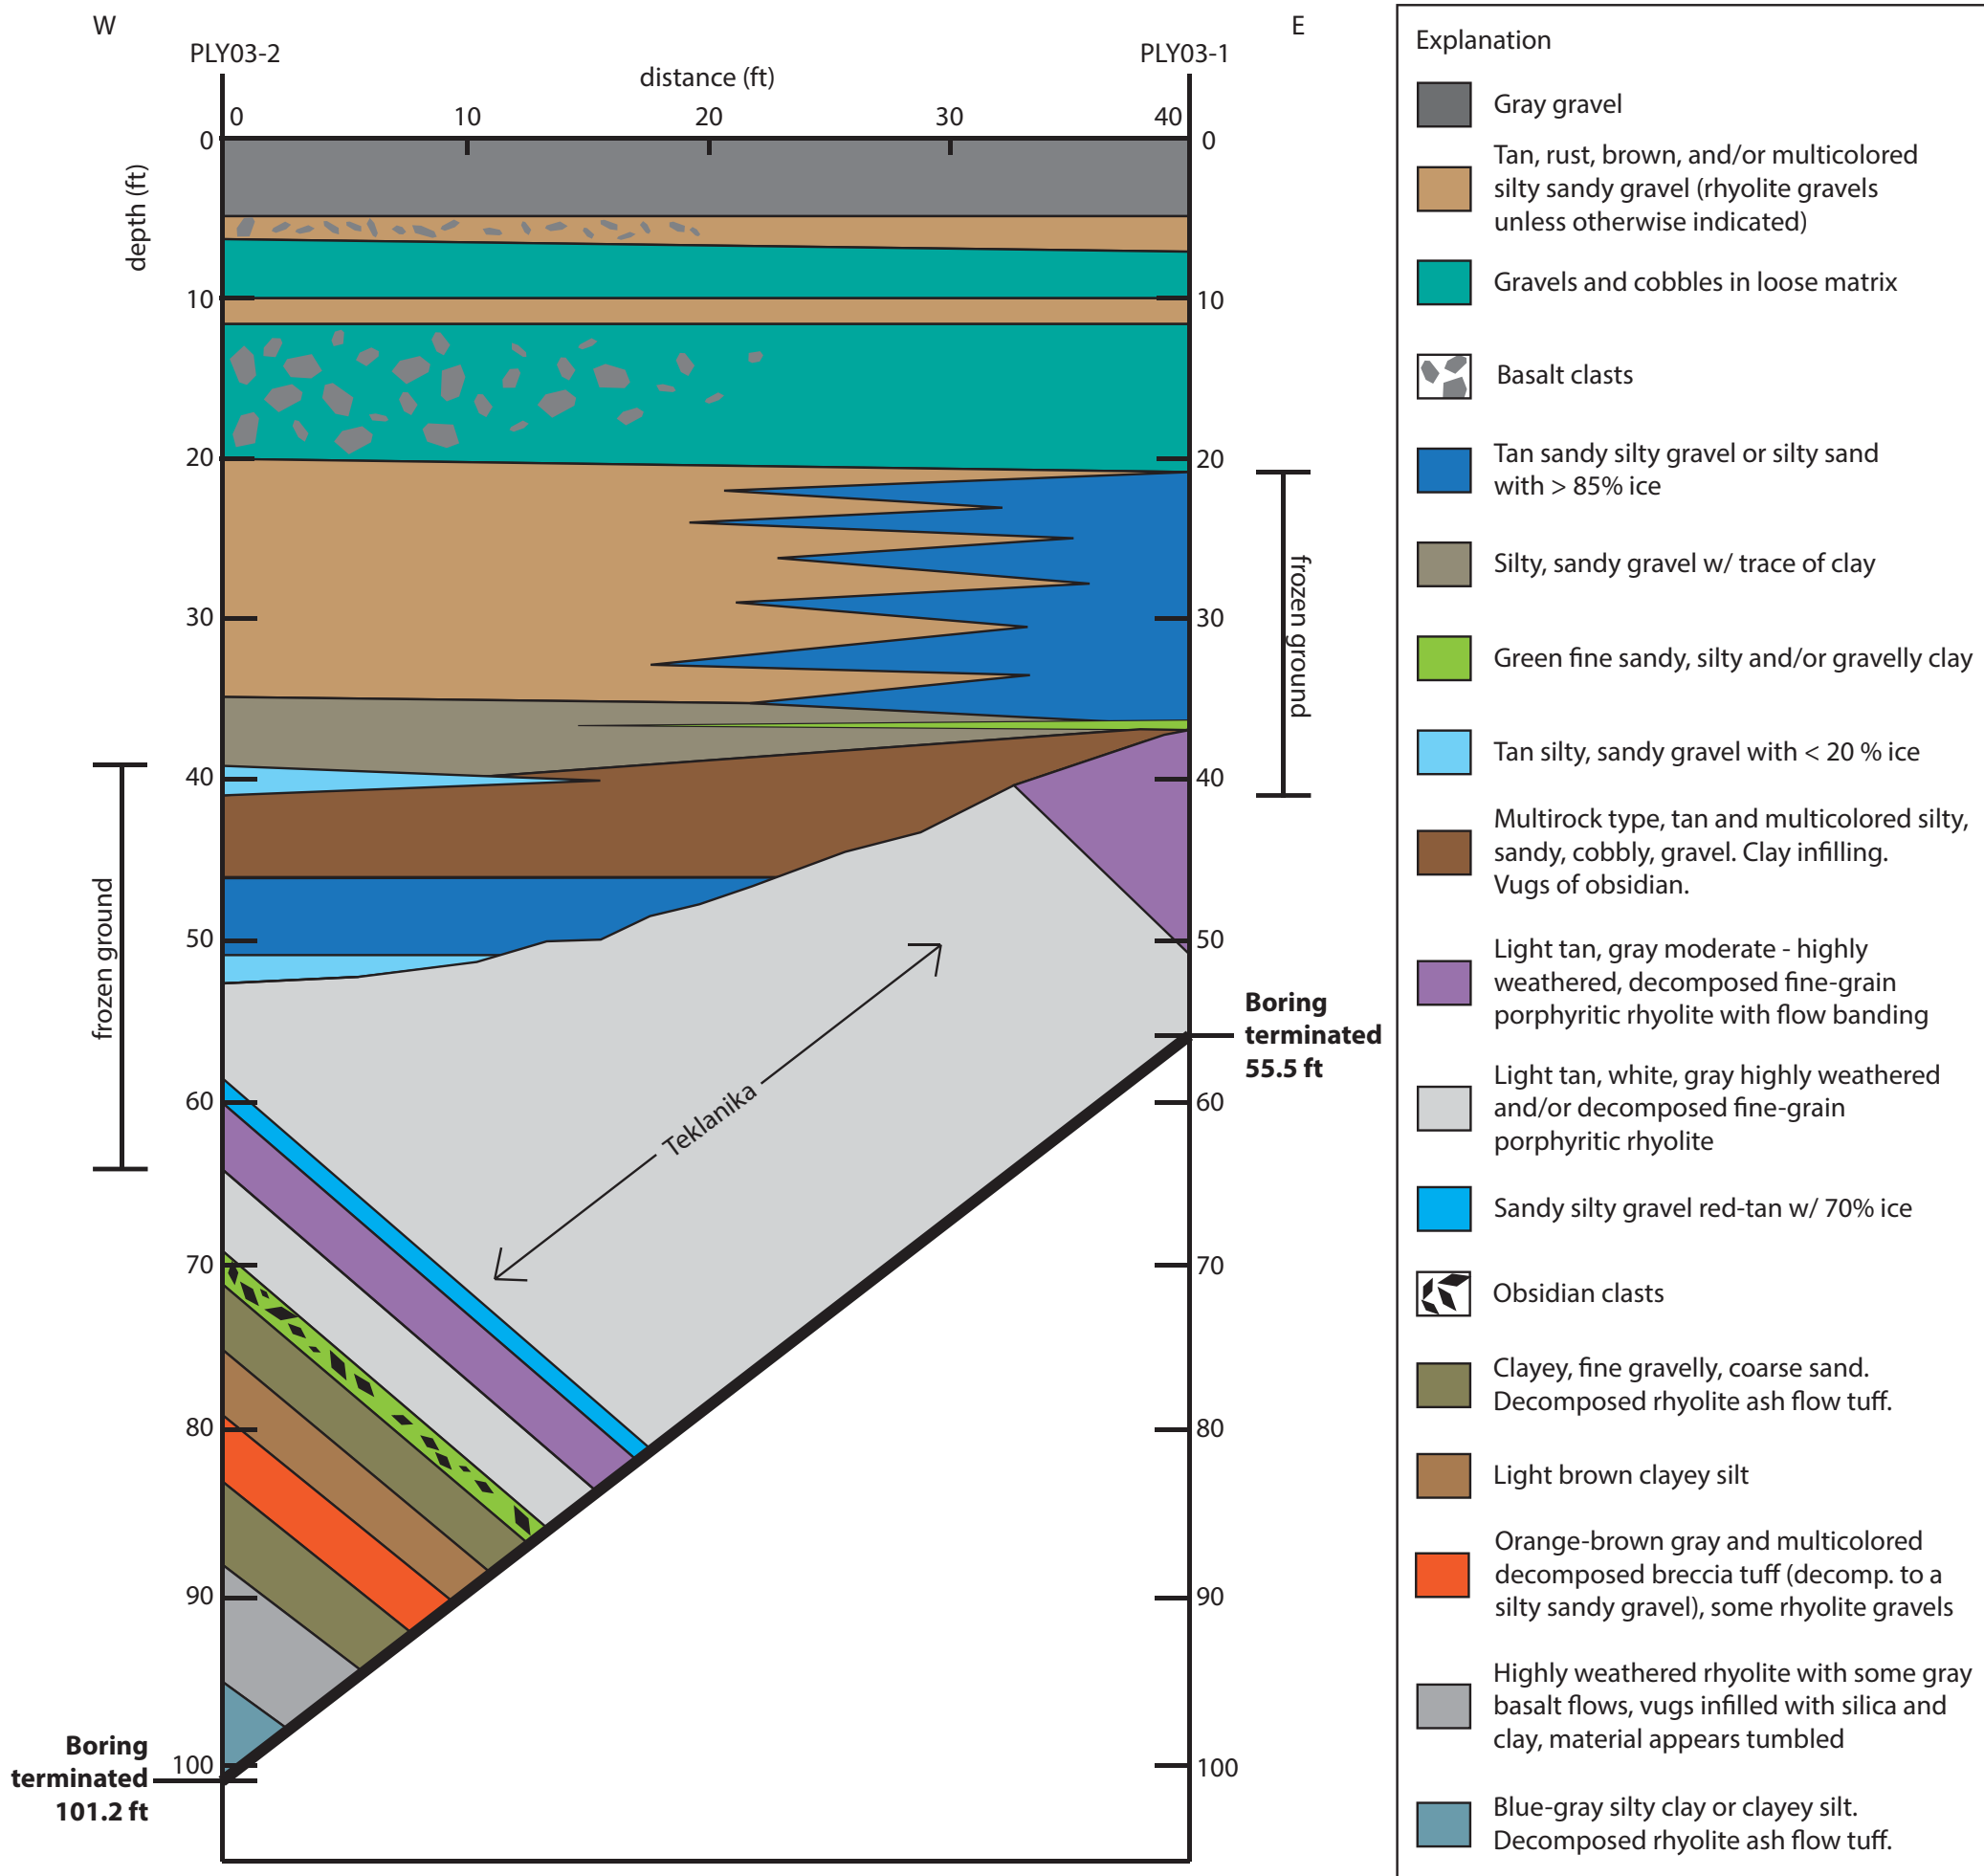
Figure 11: Geologic cross section based on drilling bore logs from the FHWA. See Fig. 4 for locations. Representative descriptions directly from bore logs. Modifiers were considered interchangeable unless deemed inappropriate (ex. “sandy gravels” and “gravelly sands” were grouped together). Boulders, cobbles, and gravels are of rhyolitic origin unless otherwise indicated.

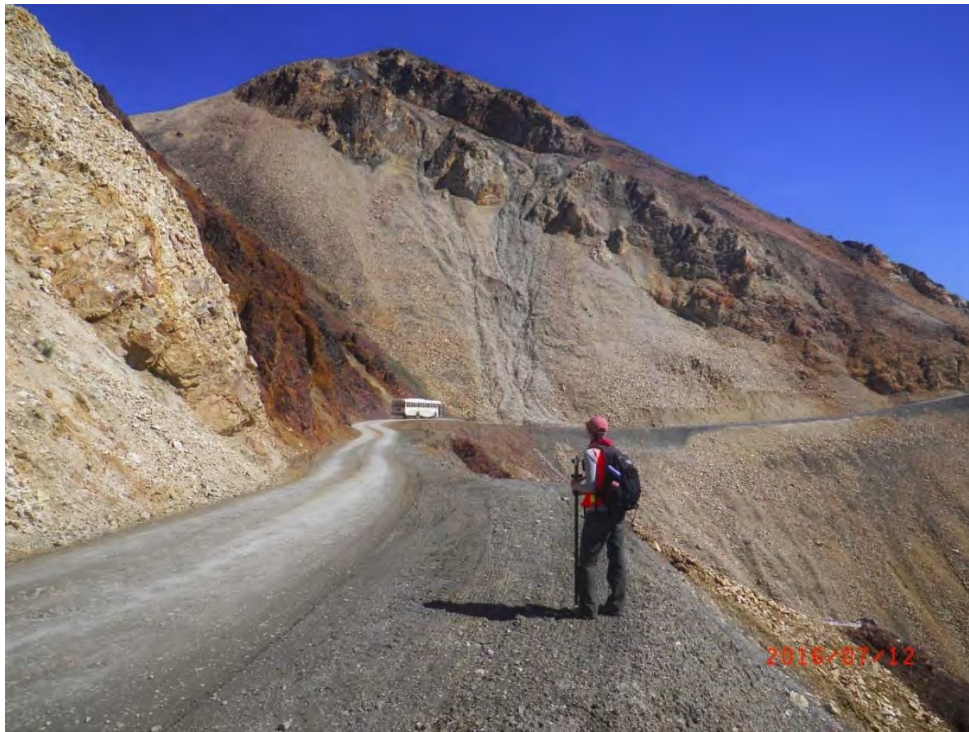
Figure 13: Pretty Rock colluvium slope. Note the drainage of dark perlite-derived material into the main slope, and the homogenous, weathered colluvium on the upper left. Photo taken looking roughly northeast.

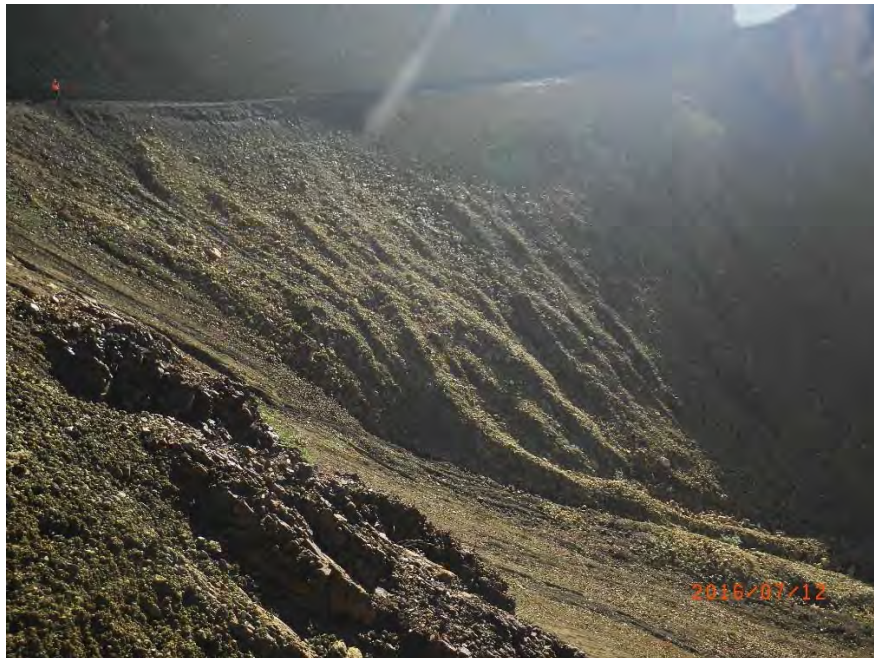
Figure 14: Convex morphology seen below the road. Numerous debris flow levees also visible. Person for scale. Photo taken looking northeast.

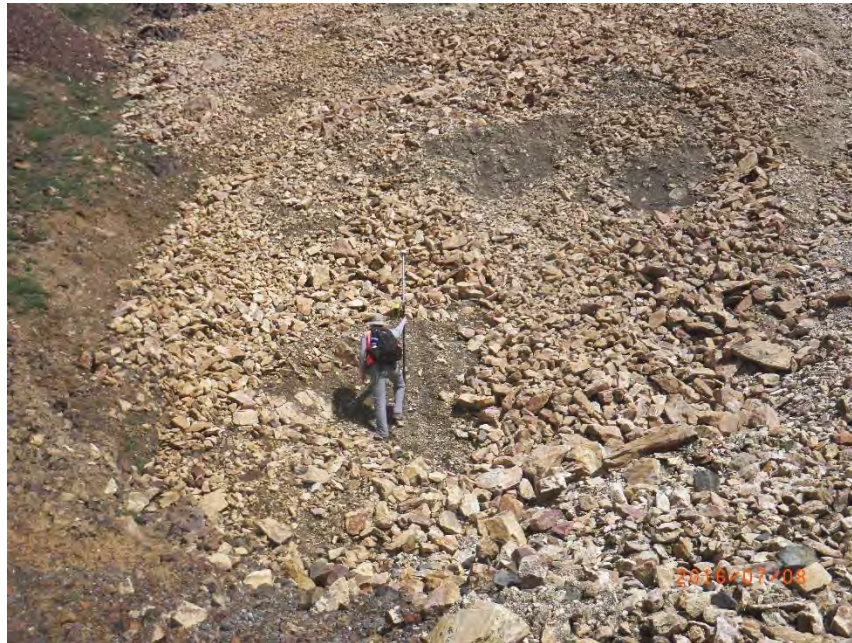
Figure 15: Outline of western boundary of failure area, and patches of slope devoid of cobble- to boulder-sized clasts. Picture taken roughly above the location of the western road crack.

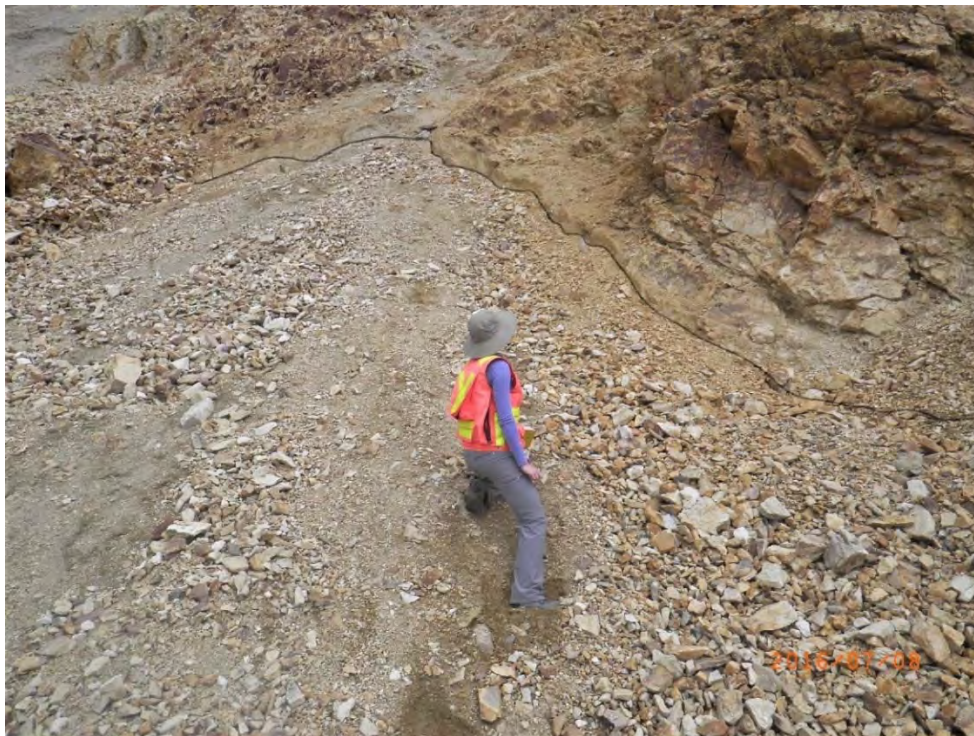
Figure 16: Outline of eastern boundary of failure area as defined by the crack between bedrock and colluvium. Crack is a continuation of eastern road crack. Highlight added for clarity. Offset averaged 1 foot.

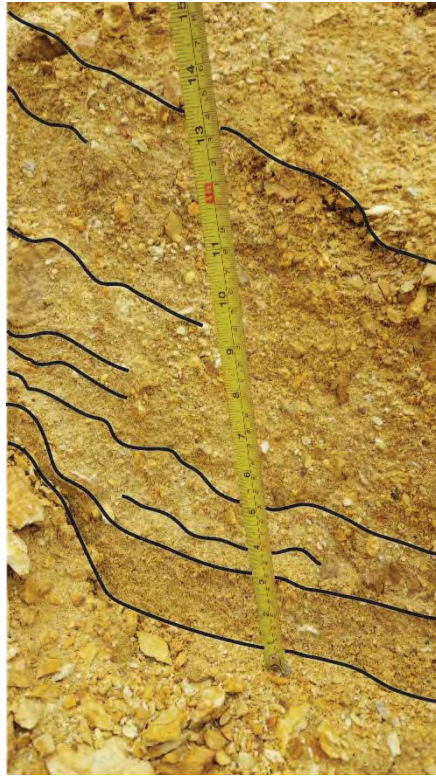
Figure 17: Lineations visible in the scarp of the crack pictured in Photo D. Features highlighted for clarity.

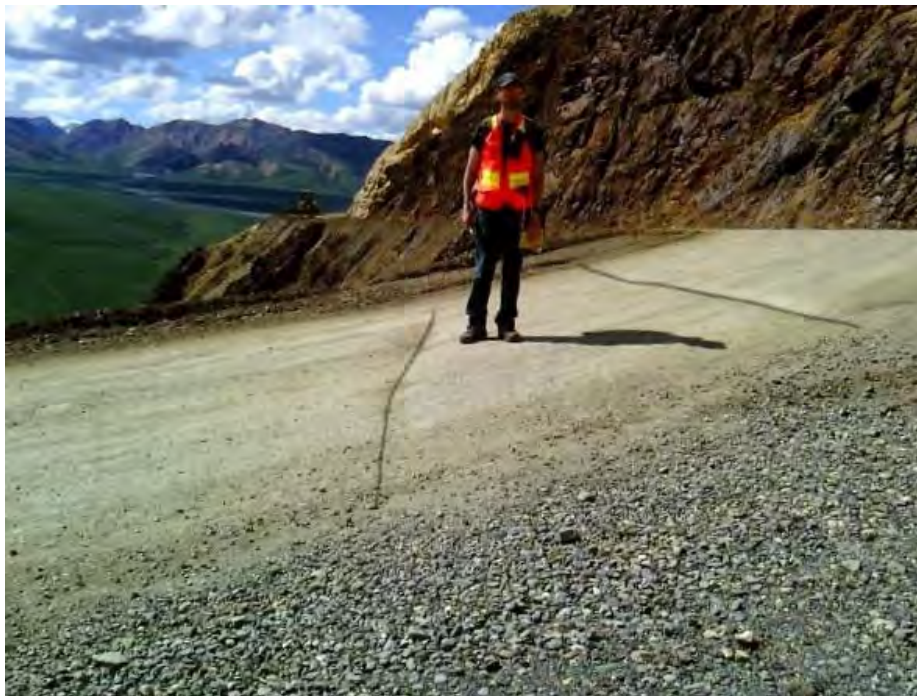
Figure 18: Western road cracks. The crack on the right is longer, more prominent, and was visible more often during field work. Highlights added for clarity, but do not represent extent of cracks. Photo taken looking southwest.

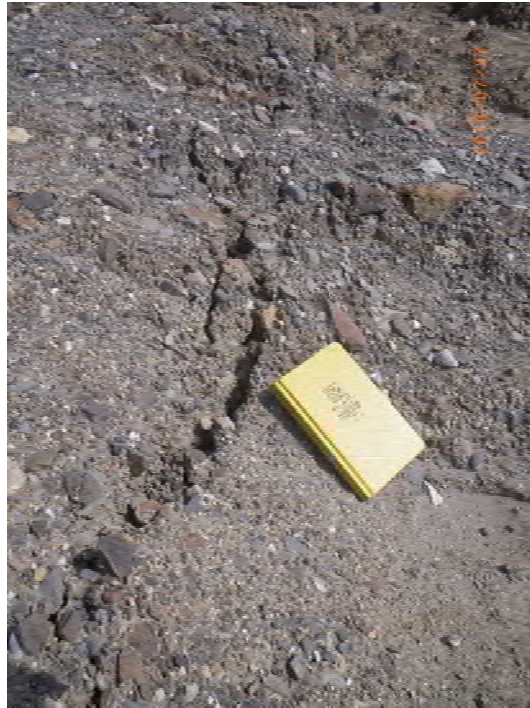
Figure 19: Detail of western road crack. Offset varied based on road maintenance and precipitation.

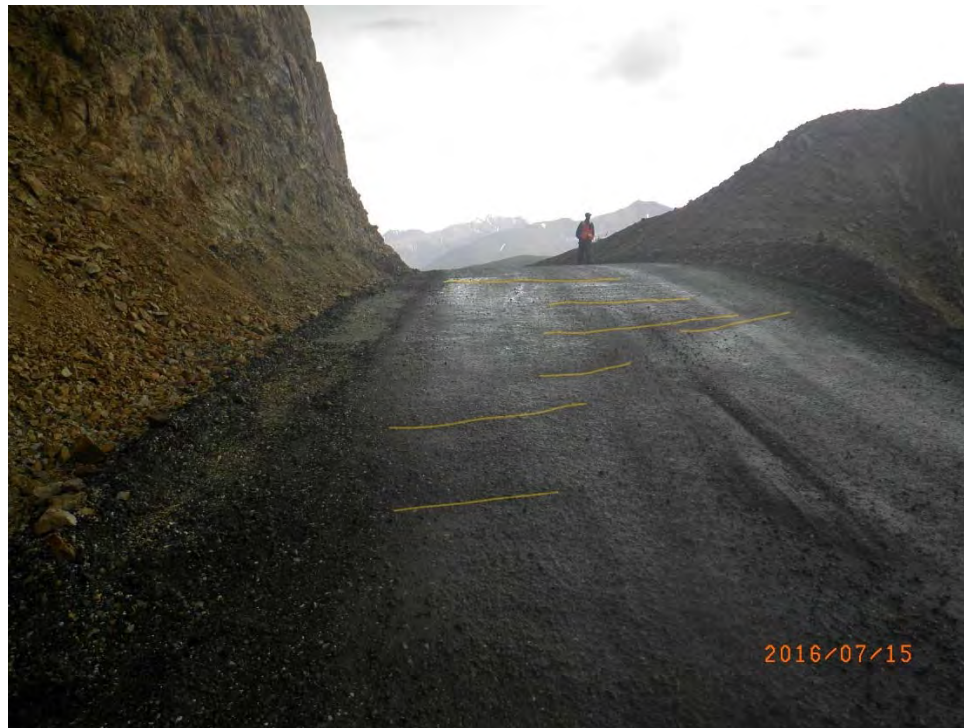
Figure 20: Eastern, en echelon road cracks. Highlights added for clarity. Photo taken looking east.

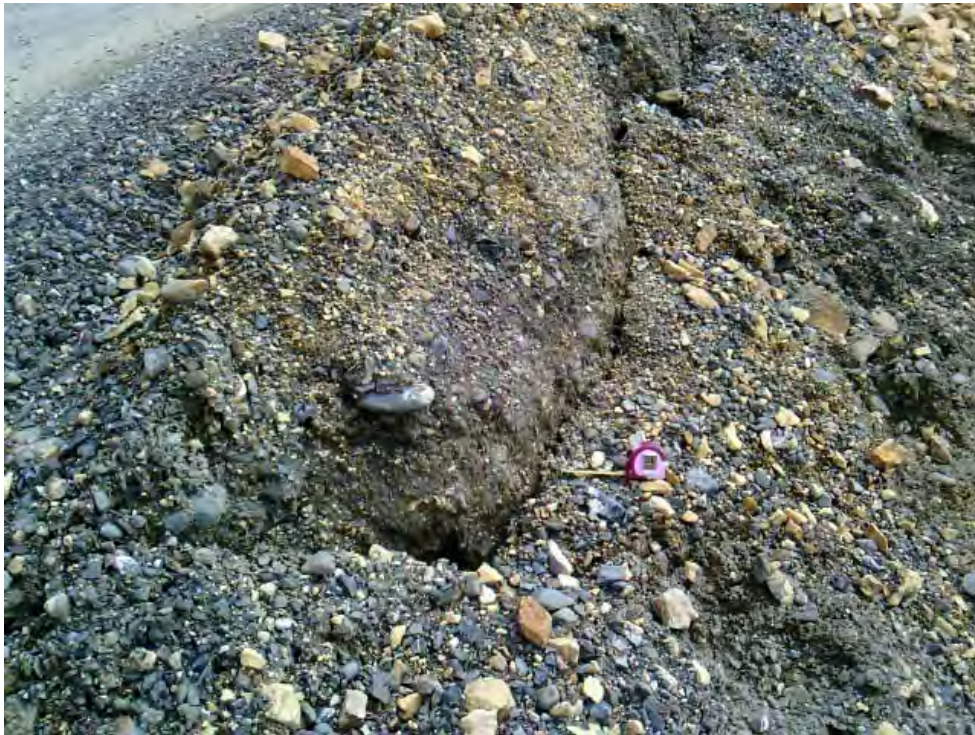
Figure 21: Detail of eastern road crack where it continues below the road and turns easterly to propagate parallel to the road surface. Offset averaged 1 ft. Photo taken looking east. Tape measurer for scale.

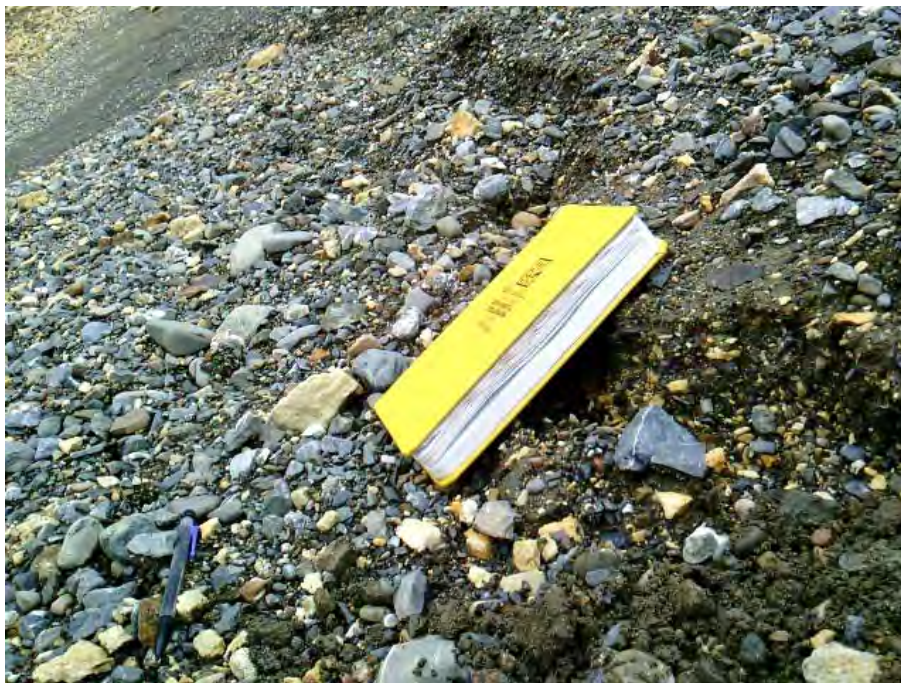
Figure 22: Crack directly below the road which developed during field work (July 2016). Coincides with band of significantly increased elevation (Fig. 5). Photo taken looking west.

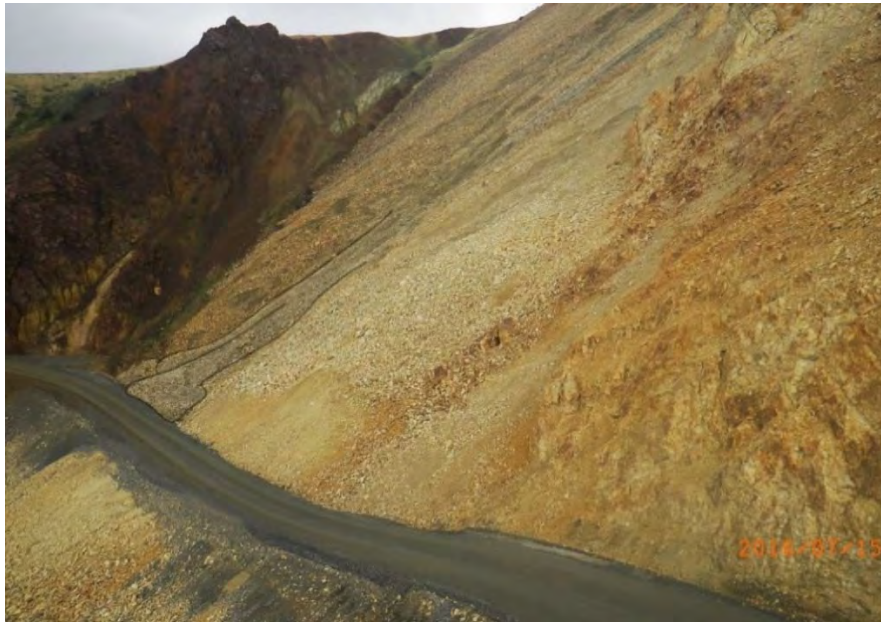
Figure 23: Two debris flows occurred on June 30, 2016. Partial outline of features highlighted for clarity. Road is one lane wide. Photo taken looking northwest.

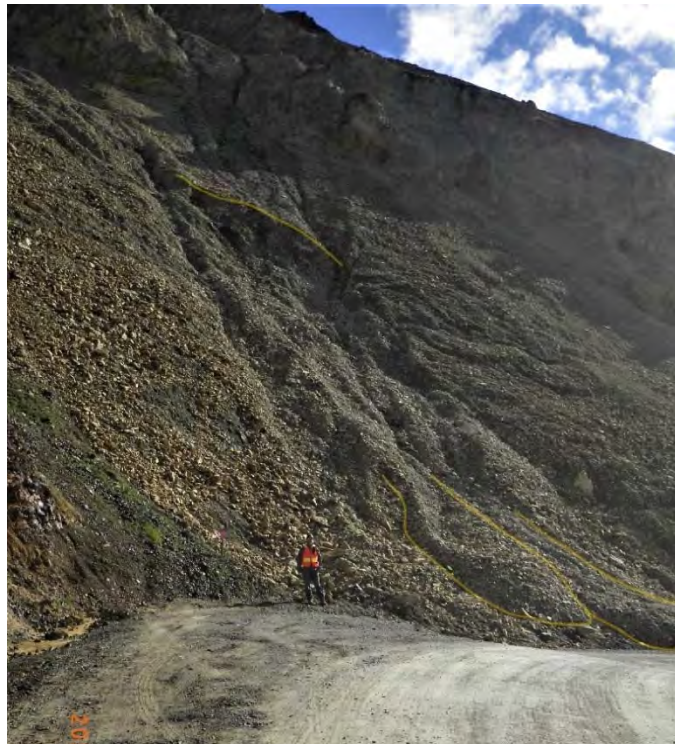
Figure 24: Debris flows seen looking northeast. Scarp and lobe deposits highlighted for clarity. Eastern lobe extends beyond the photo frame.

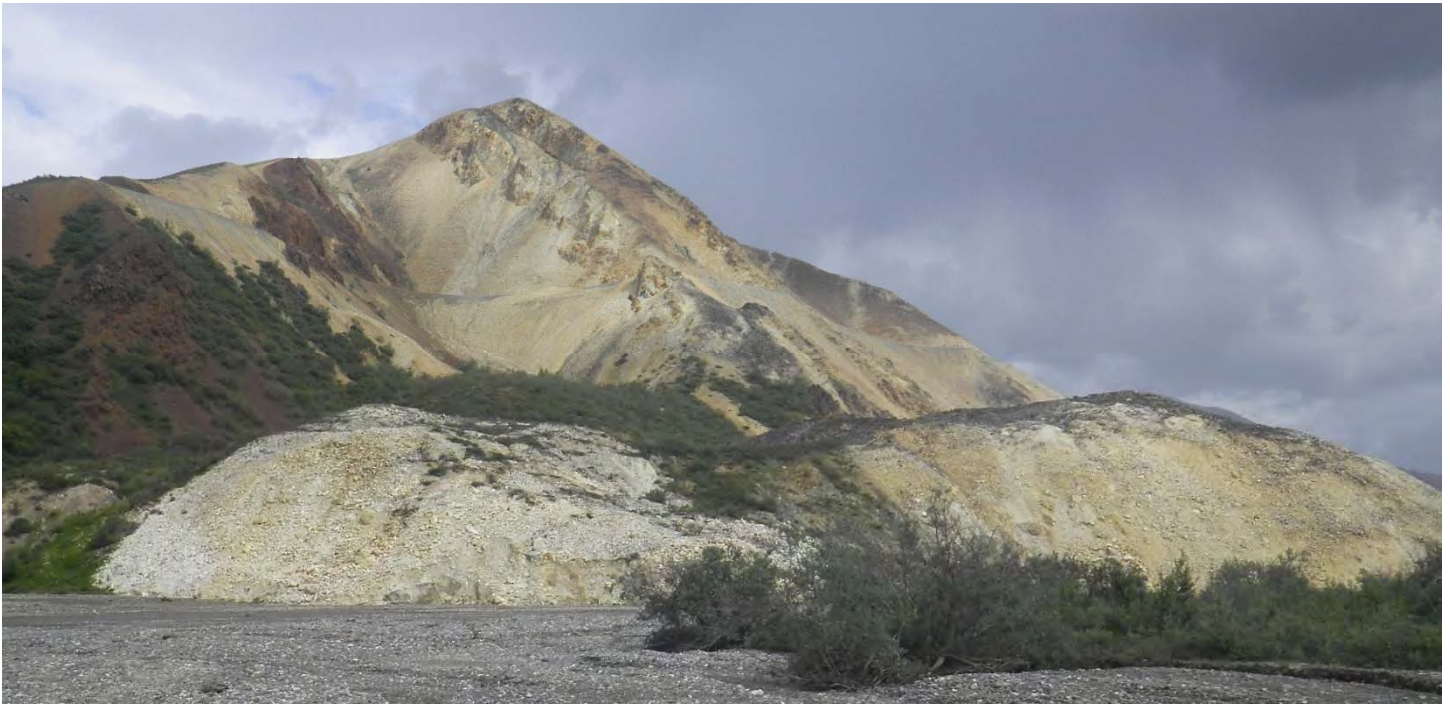
Figure 25: Pretty Rocks failure slope and lobe deposits seen from the East Fork Toklat River tributary. Photo taken looking north. Road visible in upper slope for scale.

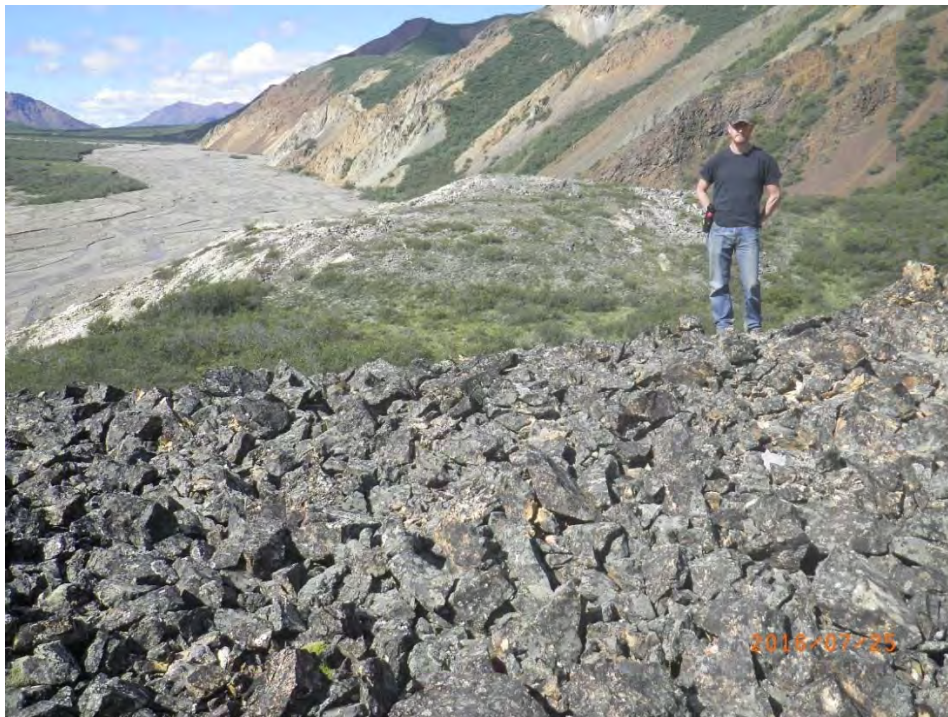
Figure 26: Lower lobes emplaced on streambed of East Fork Toklat River tributary below Pretty Rocks slope. Eastern lobe in the foreground, western lobe in the background. Note differences in surface coloration due to lichen coverage. Photo taken looking west.
