Geotechnical Report No. 11-20

**Pretty Rocks Landslide
2018-2019 Geotechnical Investigation and Conceptual
Design Alternatives Report**

**AK NPS DENA 10(45)
Denali National Park, Alaska
August 2020**

U.S. DEPARTMENT OF TRANSPORTATION
FEDERAL HIGHWAY ADMINISTRATION

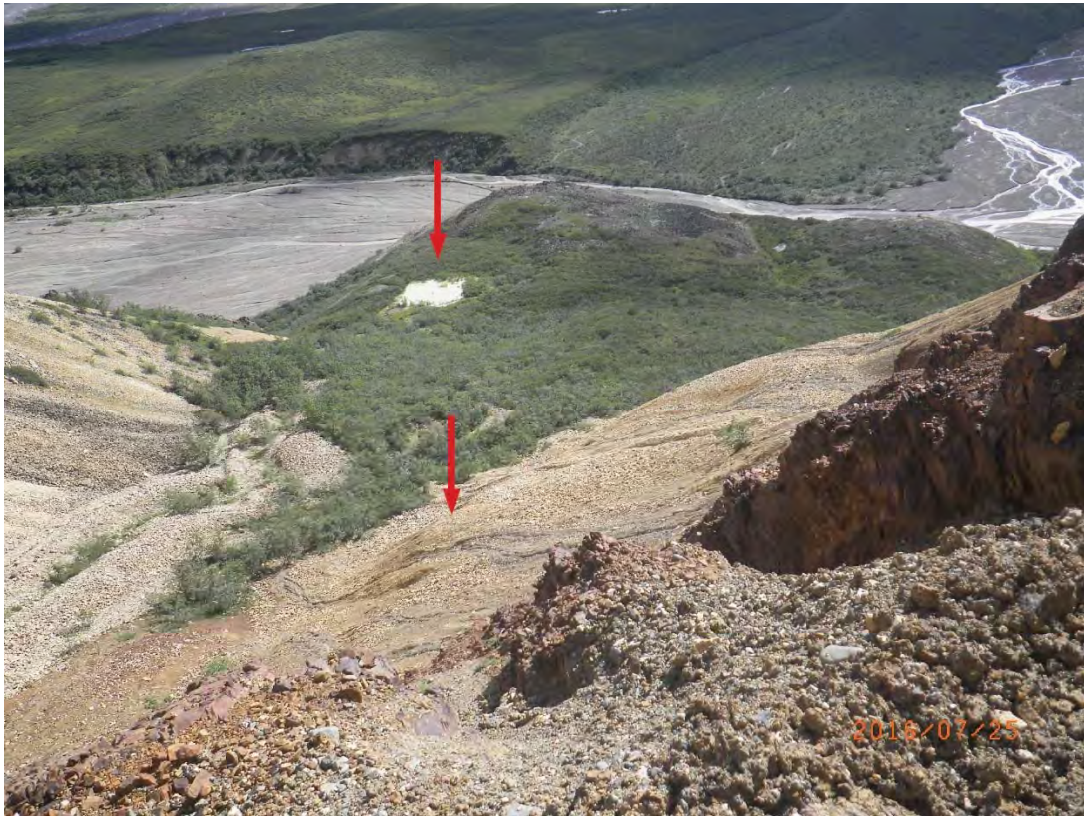
Figure 27: Top arrow indicates sediment-laden ephemeral pond which develops on the lower eastern lobe after heavy precipitation. Bottom arrow indicates large bulge which stretches up and to the right, across the slope of primarily basaltic colluvium. Photo taken from road, looking approximately southeast.

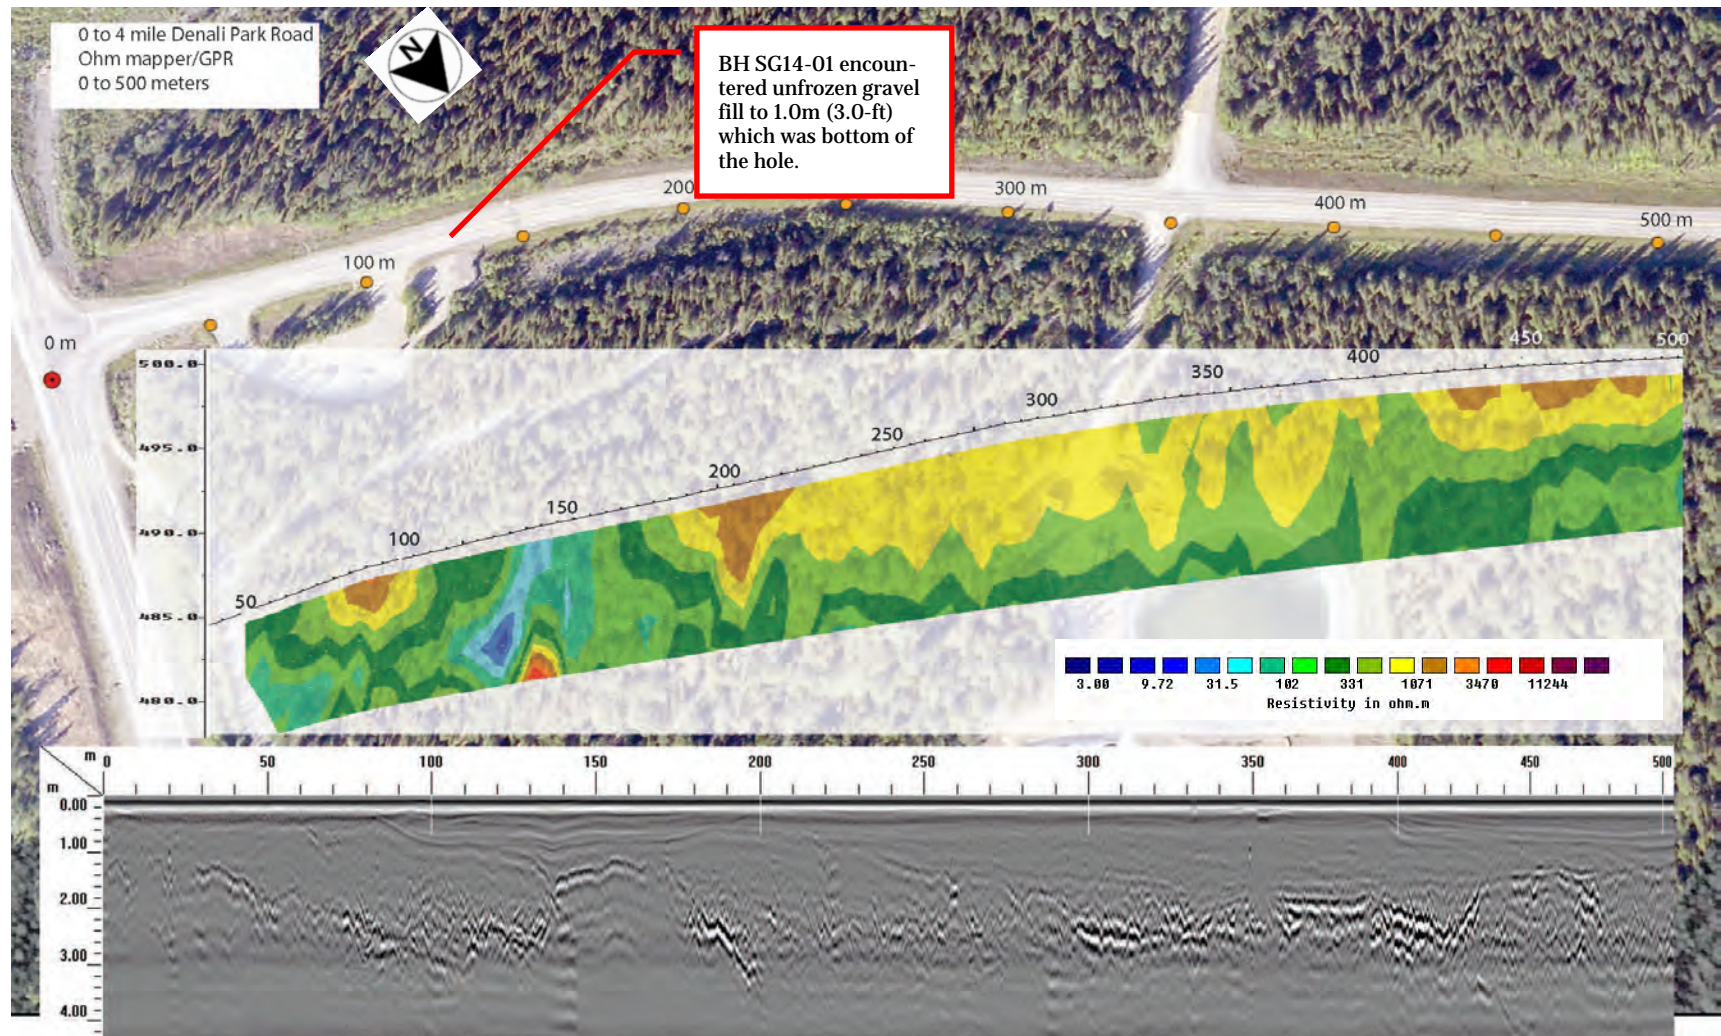
Figure 8. Park Road mile 0 to 4, 0m to 500m (1640-ft), start of transect. The view direction in these images is generally looking south, therefore the transect progresses from left to right, east to west. The starting location was at the junction with the Parks Hwy. The CCR indicates low to moderate resistivity in the near surface for most of this section. The GPR indicates a correlating strong reflector at approximately 2m (6.6-ft) depth. We interpret this to be relatively dry fill material placed for road construction. Near surface frozen ground is not indicated here.

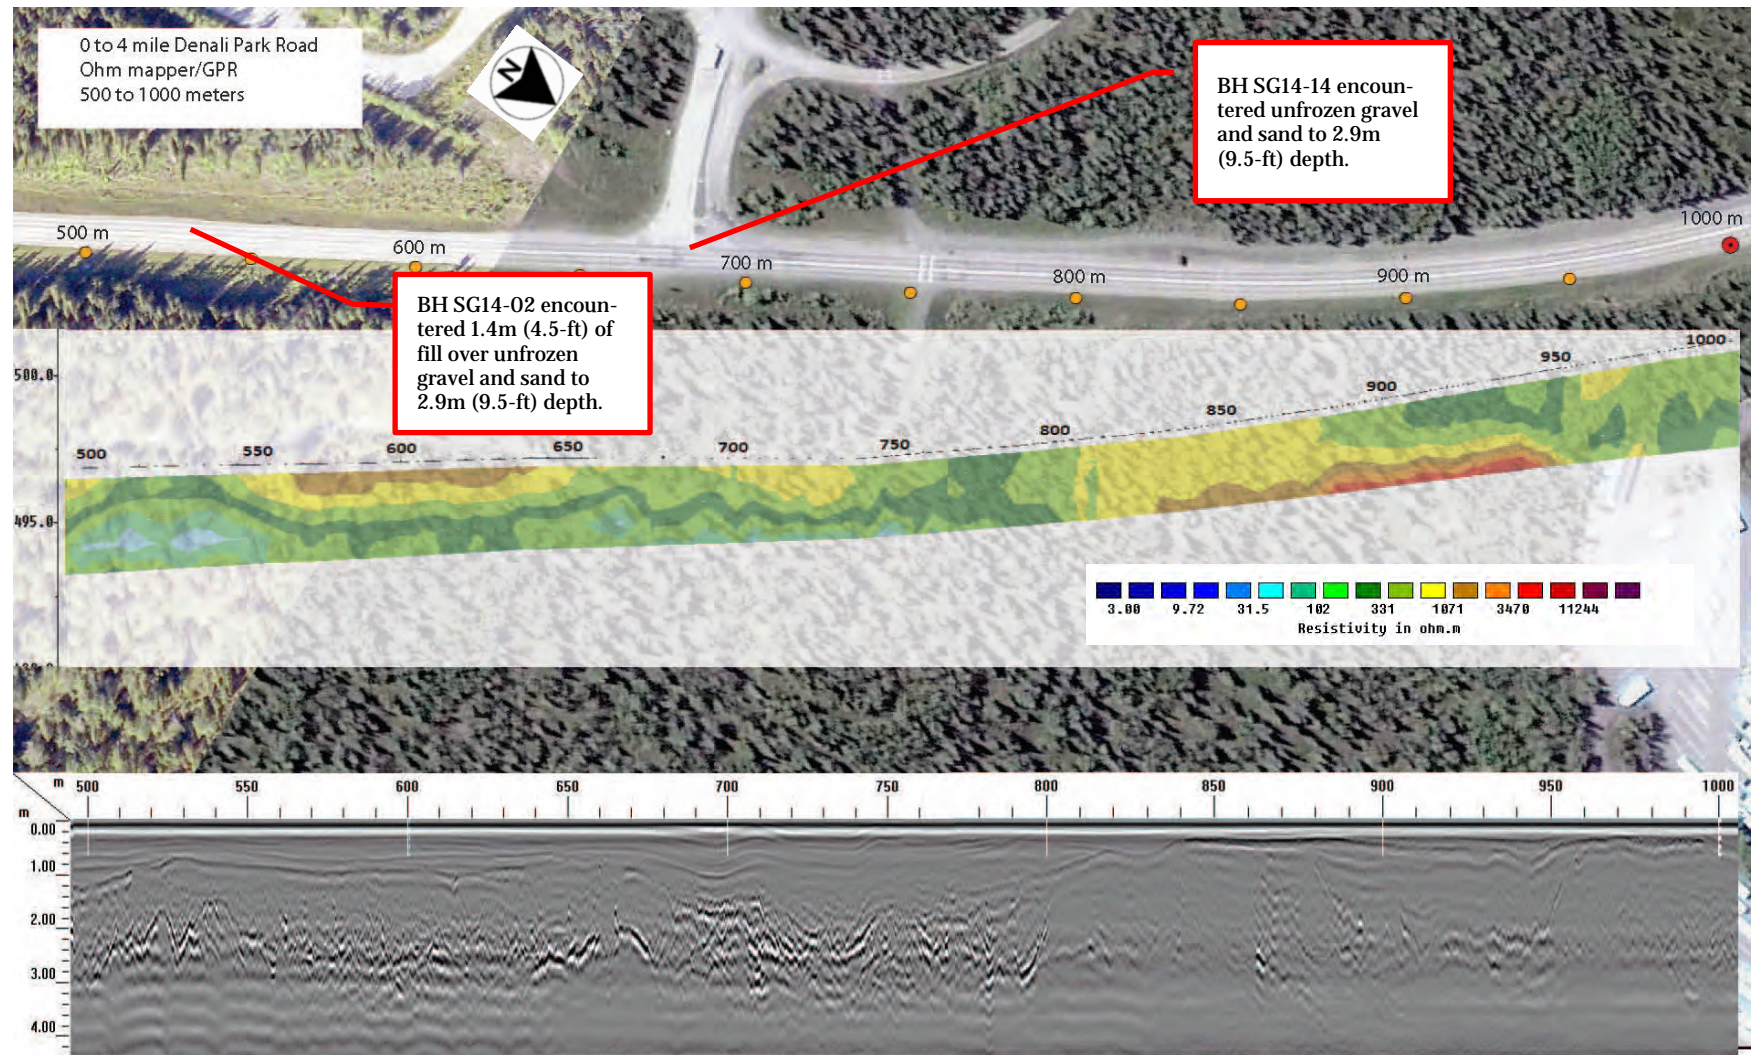
Figure 9. Park Road mile 0 to 4, 500m to 1000m (1640-ft to 3280-ft). The CCR reports low to moderate ohm-m values at the near surface indicating fill material with a definitive low value layer directly below. Ground water may be inferred at approx. 550m and 700m. Significant road deformation was noted at approx. 700m. The GPR reports strong reflections at a depth of 2.5m (8.2-ft), and in the area of 700m these reflectors are very distorted indicating deeper warping which is then reflected at the surface. No frozen ground is indicated at 700m, so this may be related to a buried organic layer or poorly consolidated fine grained layer with excess water. Starting at 800m to 950m the CCR indicates moderate to high ohm-m values and this could indicate three possibilities; 1) deeper ice-rich material, 2) deeper bedrock indication, or 3) deeper clay layer indication, where a lacustrine deposit is known in this area.

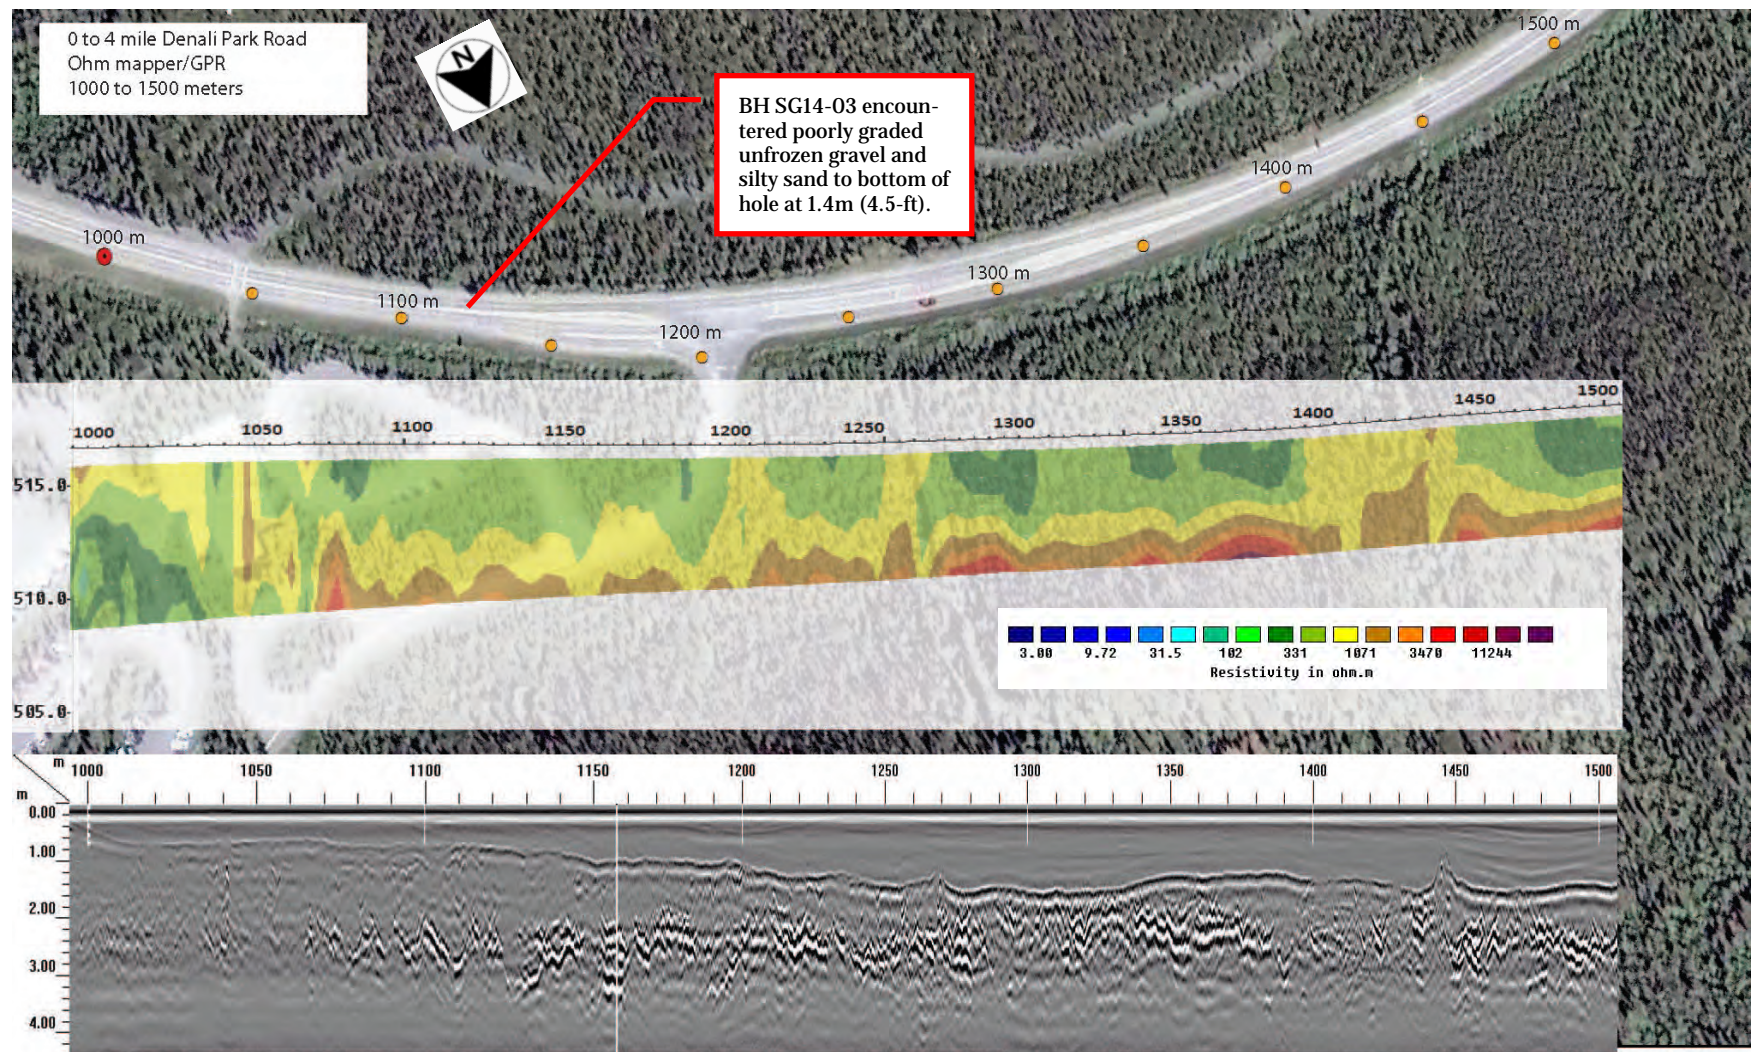
Figure 10. Park Road mile 0 to 4, 1000m to 1500m (3280-ft to 4920-ft). The CCR indicates a continuing trend from 1050m to 1500m which was noticed previously from 800m to 950m with deeper, moderate to high resistivity values. The GPR provides strong imaging in this area with a strong reflector boundary suggesting top of the native surface, or top of bedrock lying below roadway fill material. The chaotic reflectors from 2.5m depth indicates rocky material, weathered/fractured rock. Boreholes TH83-1 (MP 0.7), TH83-2 (MP 0.85) and TH83-3 (MP 0.95) (Figures 68, 69, and 70) drilled in this area show sandy angular gravel starting from 2.5m (8.2-ft) depth and this may be an indication of the weathered rock. The CCR and GPR surveys together suggest that weathered bedrock exists over more competent bedrock. No frozen ground is indicated.

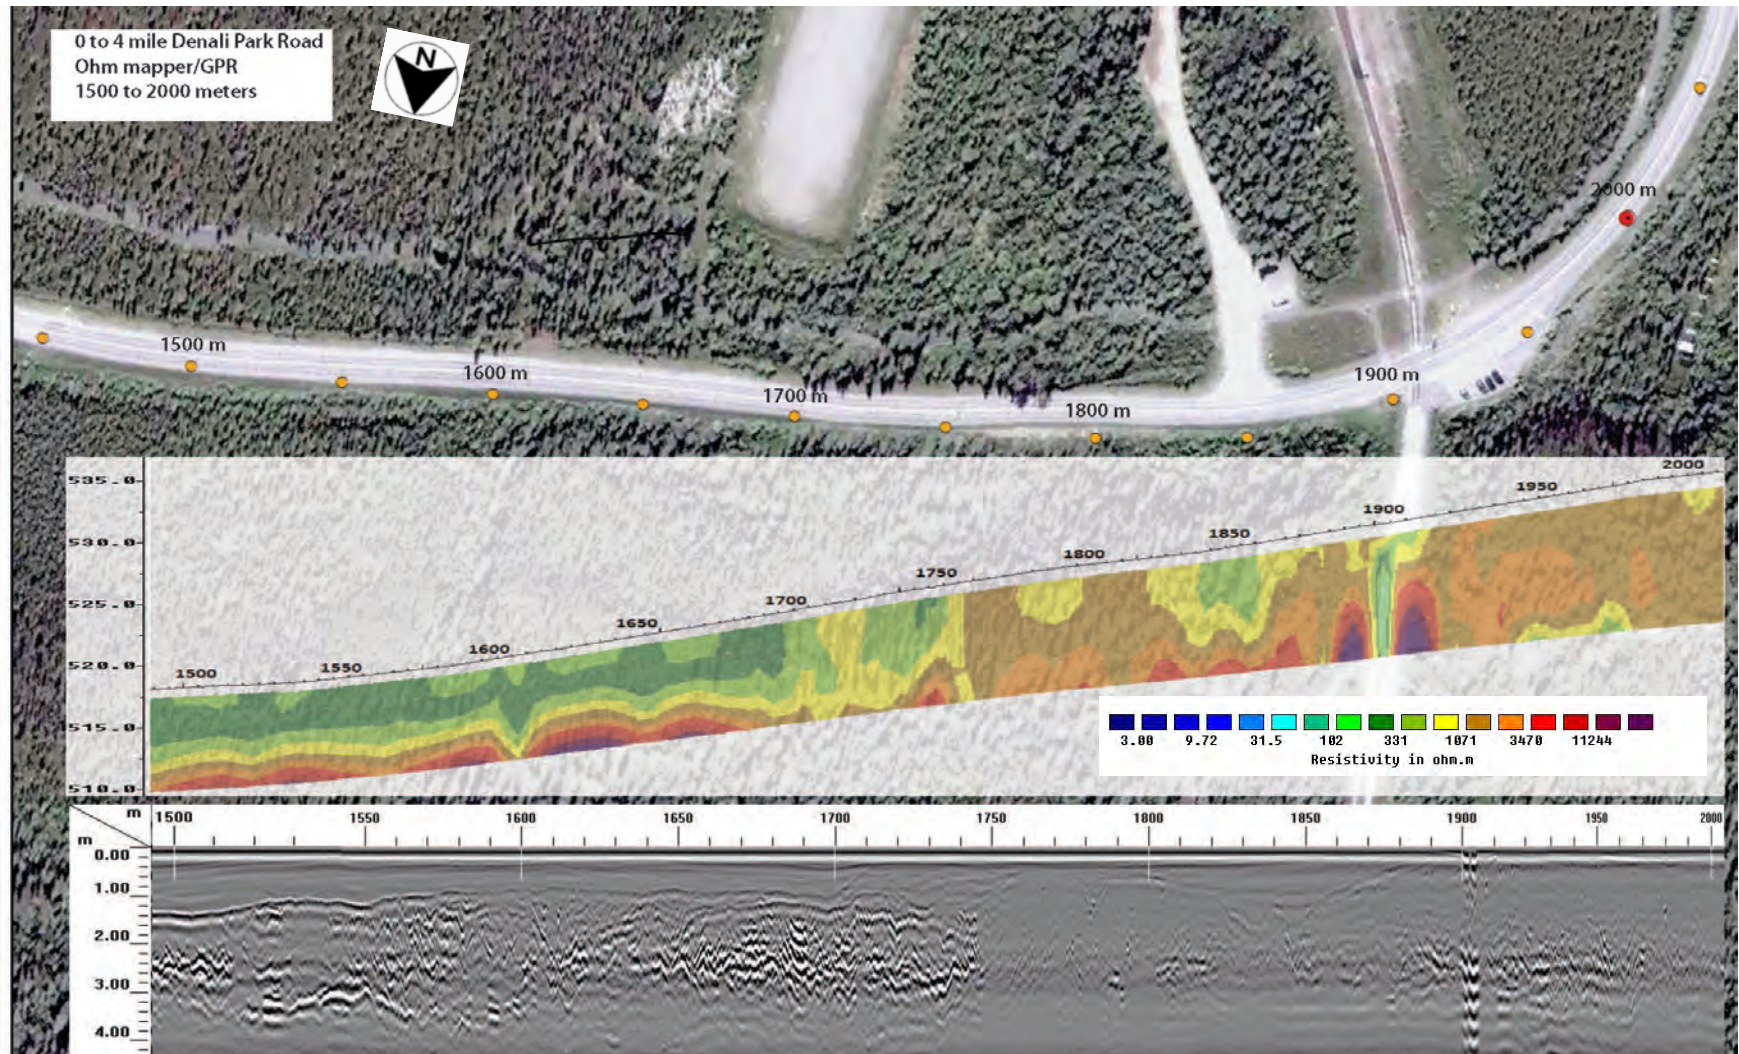
Figure 11. Park Road mile 0 to 4, 1500m to 2000m (4920-ft to 6560-ft). The interpretation of weathered/fractured rock overlying bedrock, as imaged in Figure 10 continues in this figure at depth. Low ohm-m value material overlays possible bedrock from 1500m to 1750m, and the bedrock appears to become more near surface at 1750m in the vicinity of the railroad crossing and beyond. Very high ohm-m values are associated with the railroad tracks specifically. Chaotic GPR reflectors are again noticed from 1500m to 1750m suggesting a rocky layer (weathered/fractured bedrock). Attenuation of the GPR signal occurs coincidentally at 1750m, where attenuated GPR is often associated with excessive clay mineral deposits or water. In this instance we believe clay minerals associated with weathered/fractured bedrock are indicated. No near surface frozen ground is indicated.

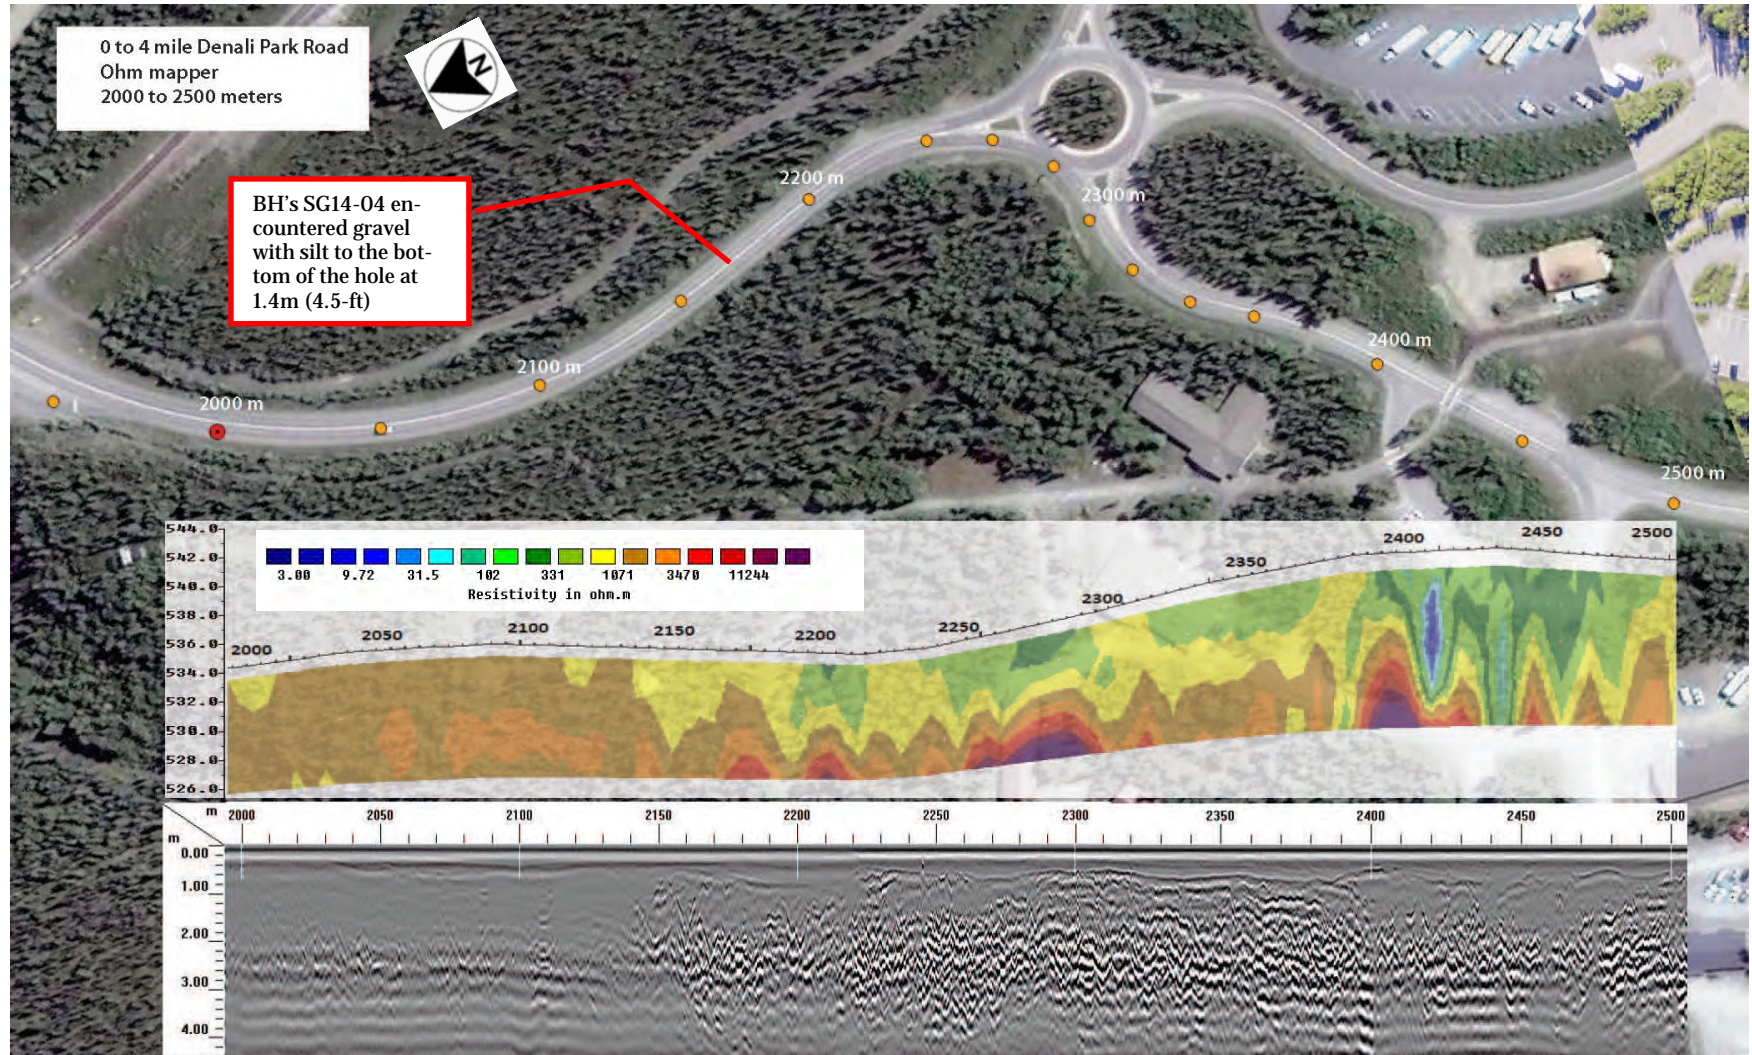
Figure 12. Park Road mile 0 to 4, 2000m to 2500m (6562-ft to 8200-ft). The interpretation of weathered/fractured rock overlying bedrock, as interpreted in Figure 10 continues in this figure with very strong chaotic reflectors visible from 2150m to 2500m and coincident high ohm-m values at depth. A near surface high conductivity feature is indicated at ~2400m with low ohm-m values and coincident dropping of the upper strong GPR reflector. A water line crosses the road at approximately 2420m.

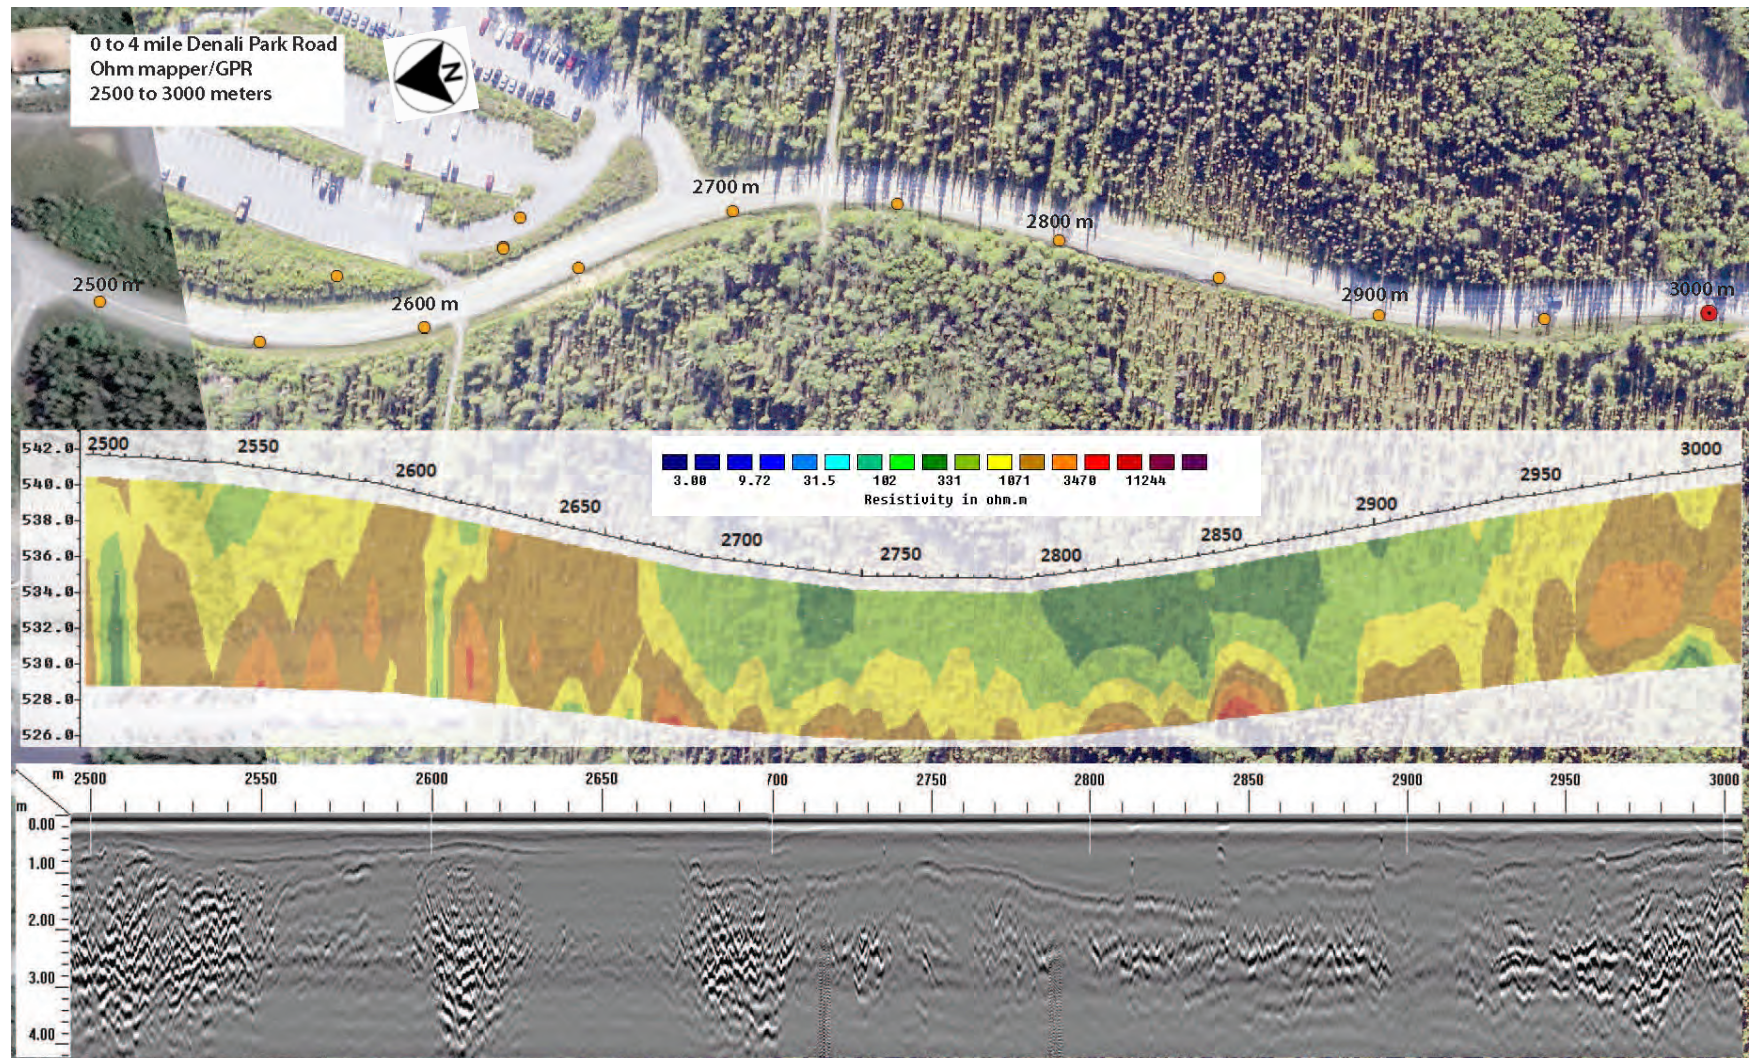
Figure 13. Park Road mile 0 to 4, 2500m to 3000m (8200-ft to 9840-ft). The interpretation of weathered/fractured rock overlying bedrock, as imaged in Figure 11 and previous images continues in this figure. At approximately 2950m it can be seen the chaotic reflectors in the GPR become very near surface. The intermittent attenuated GPR returns, such as at 2650m are interpreted as either wet material or high in clay mineral content.

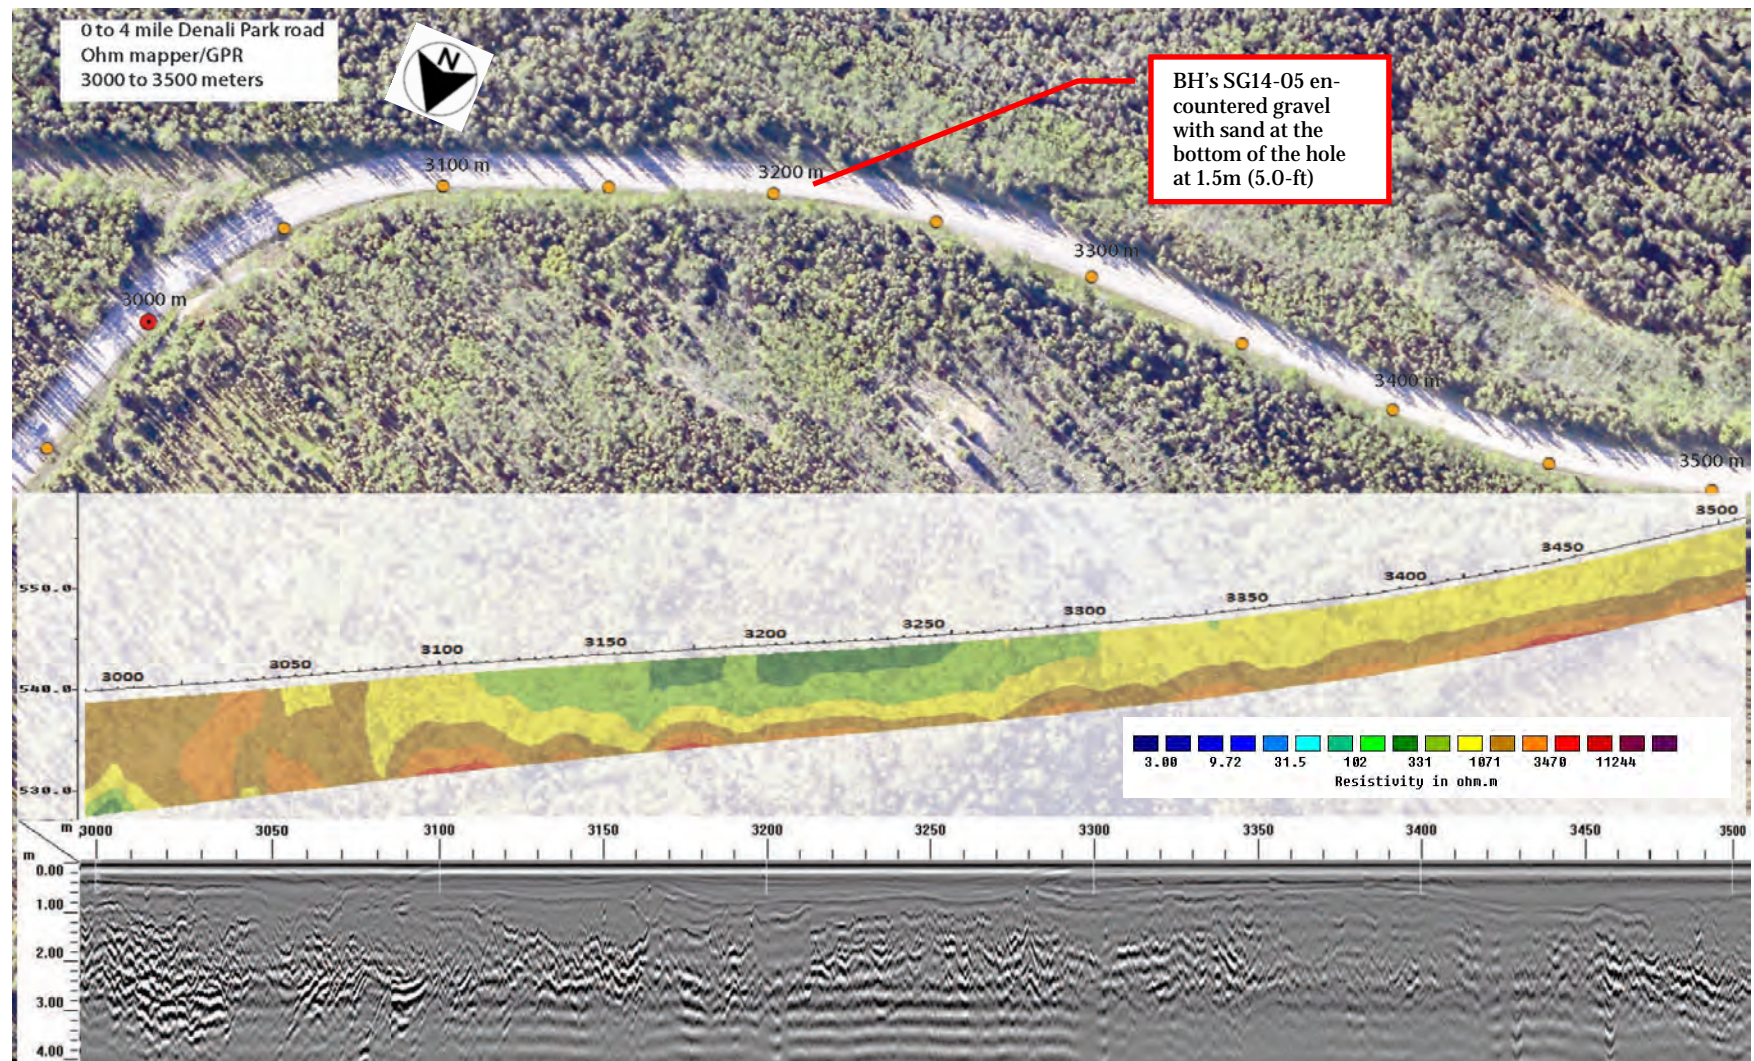
Figure 14. Park Road mile 0 to 4, 3000m to 3500m (9840-ft to 11483-ft). The same interpretation of near surface weathered/fractured rock overlying bedrock continues. Starting at approximately 3100m the bedrock appears to not be as close to the surface as from 2950m to 3100m.

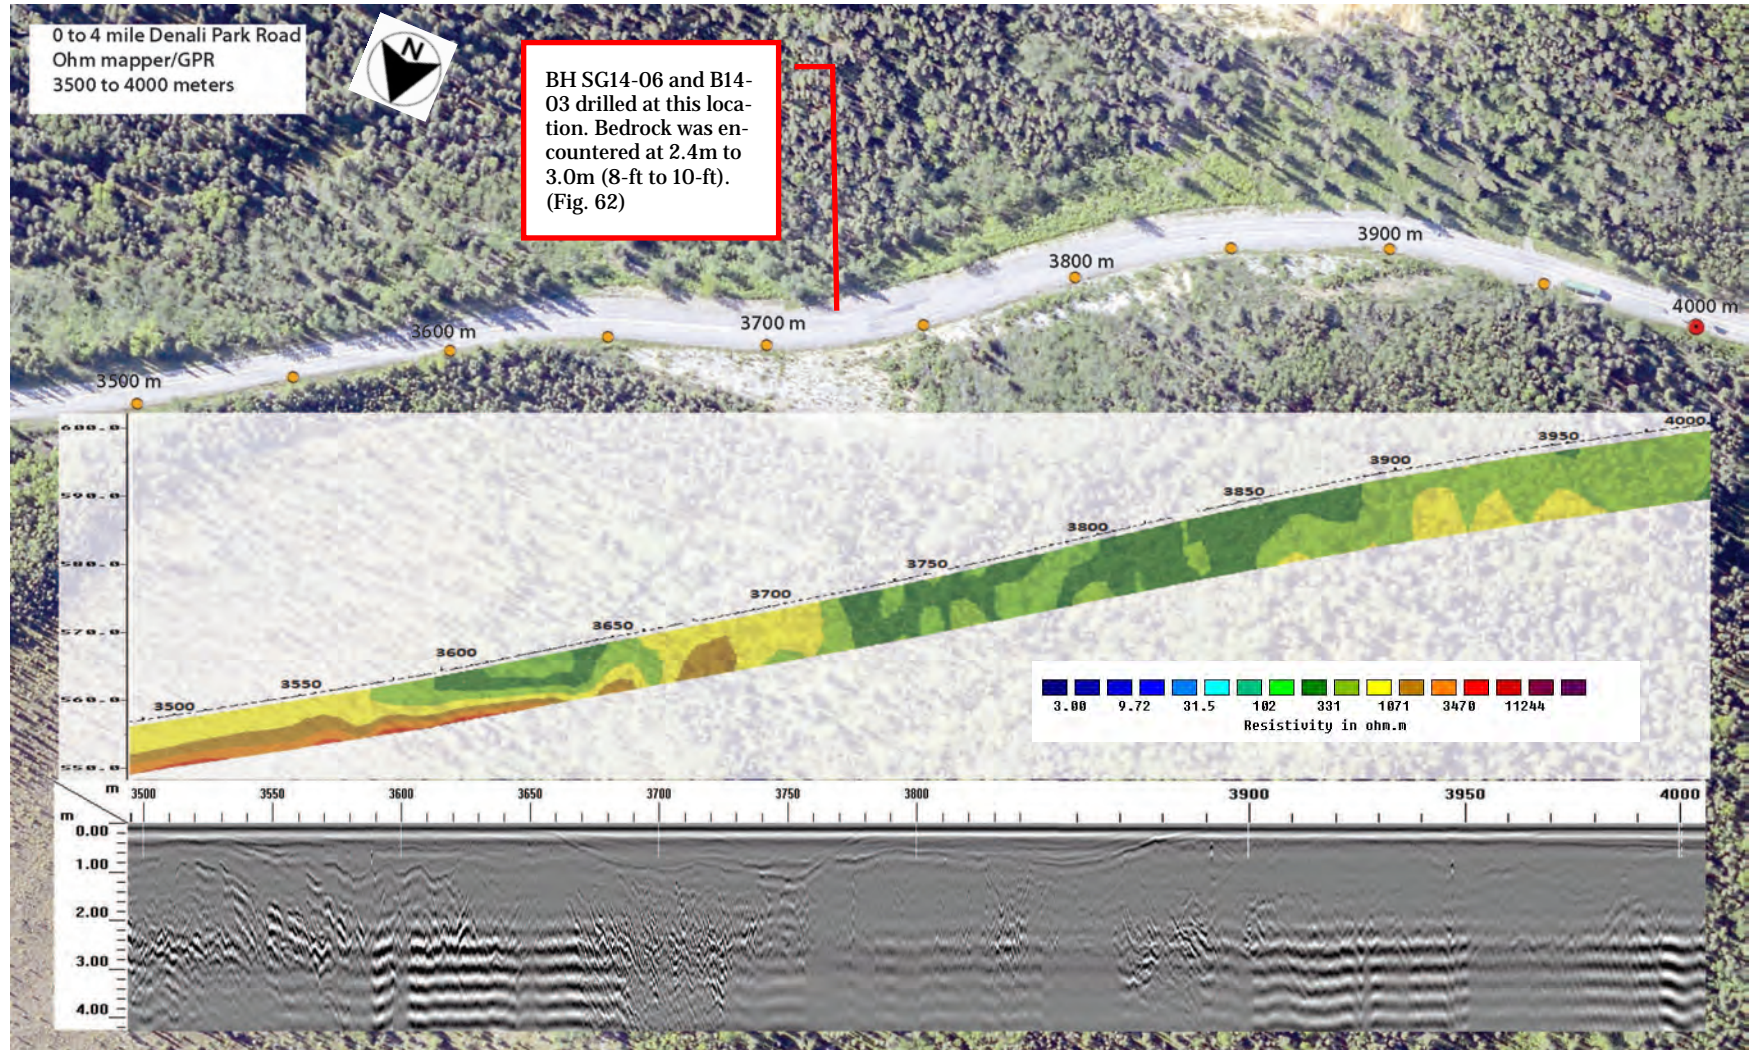
Figure 15. Park Road mile 0 to 4, 3500m to 4000m (11483-ft to 13123-ft). The weathered/fractured rock overlying bedrock interpretation from the previous figures continues. The GPR image shows very strong bedrock fracture inclination at 3550m. At approximately 3700m the ohm-m values are noticed to significantly change. The chaotic near surface GPR reflectors are not as prominent and at greater depth, and the coinciding CCR indicates a change from moderate to consistently low ohm-m values. We infer this to indicate a change in subgrade material from bedrock and fill to substantially more fill material. TH83-4 was drilled in this vicinity and showed bedrock at 2.5m (8.0-ft) (Fig. 71) .

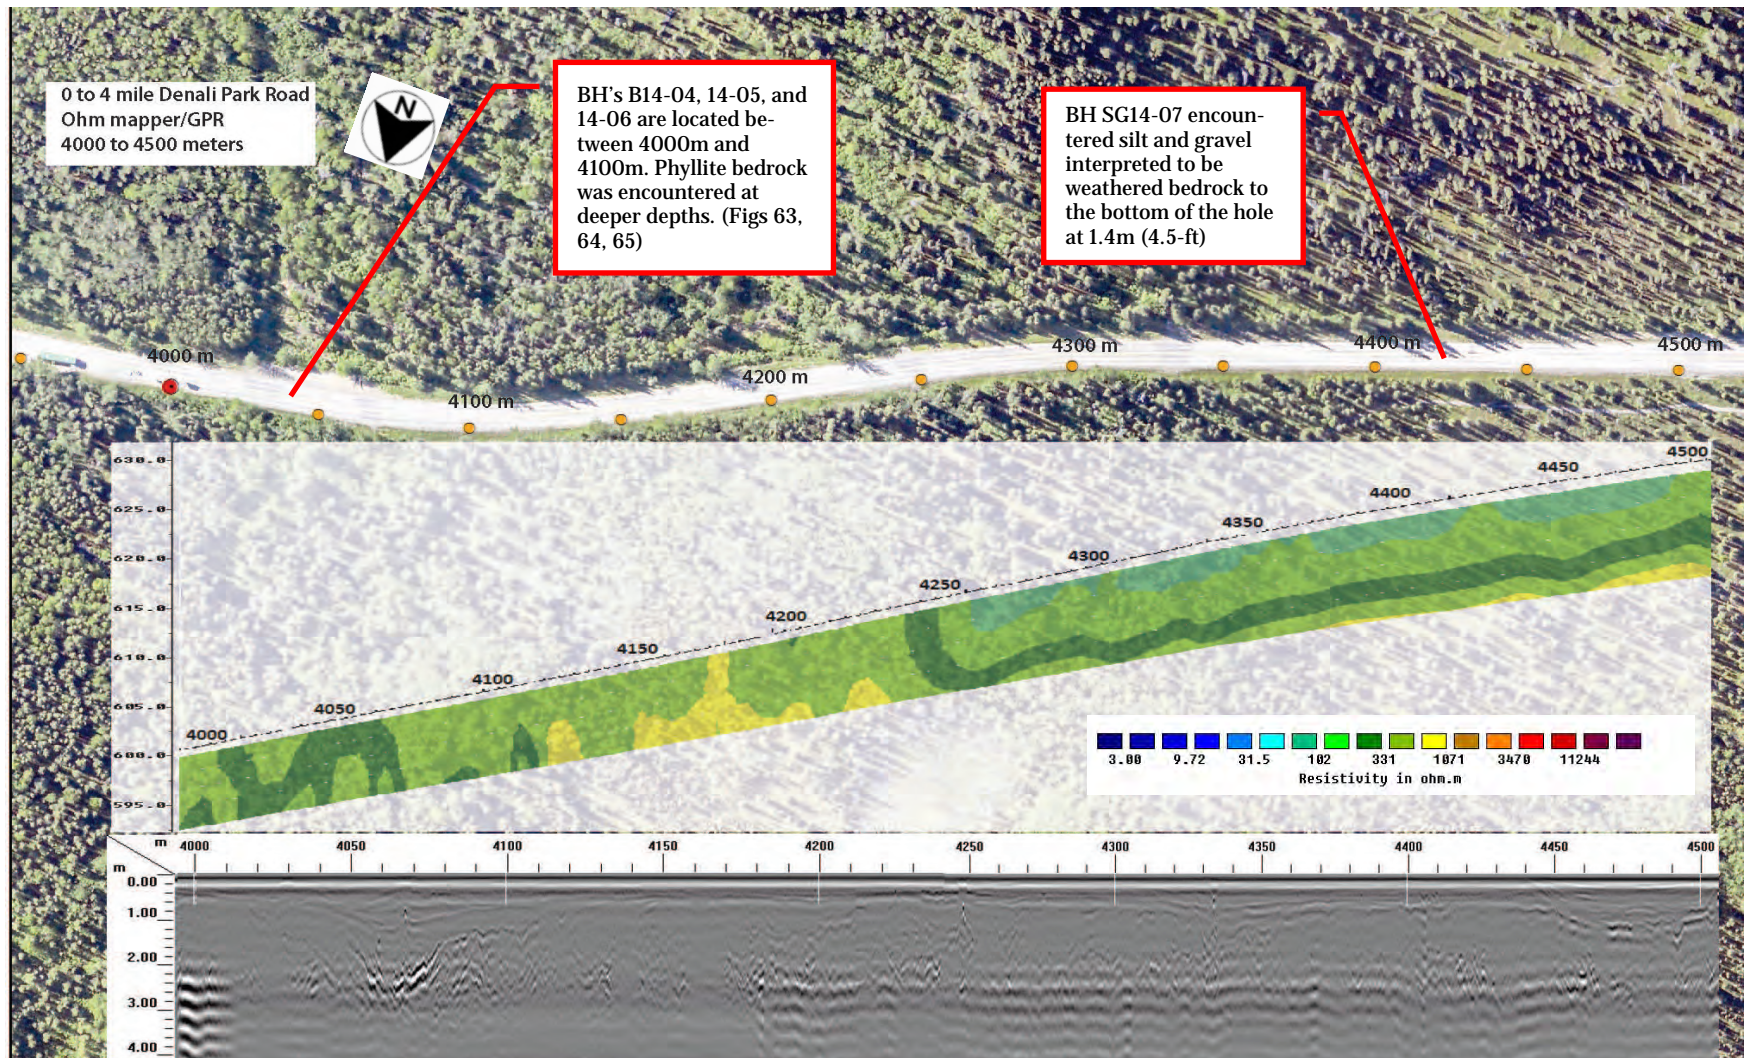
Figure 16. Park Road mile 0 to 4, 4000m to 4500m (13123-ft to 14764-ft). Boreholes B14-04, B14-05, and B14-06 are located between 4000m and 4100m. Comparison of CCR data and the drill logs are shown in figures 63, 64, and 65 respectively. The boreholes report phyllite bedrock at depth with silt. The interpretation of significantly deeper fill material starting at approximately 3700m continues through this section. The CCR continues to report low ohm-m values in the upper most of the surveyed section and the GPR reflectors are non-distinct through most of the section and this may be due to the higher silt content noted in the drill logs. It can be seen that moderate ohm-m values are just beginning to be reported at the very deepest depth of the section.

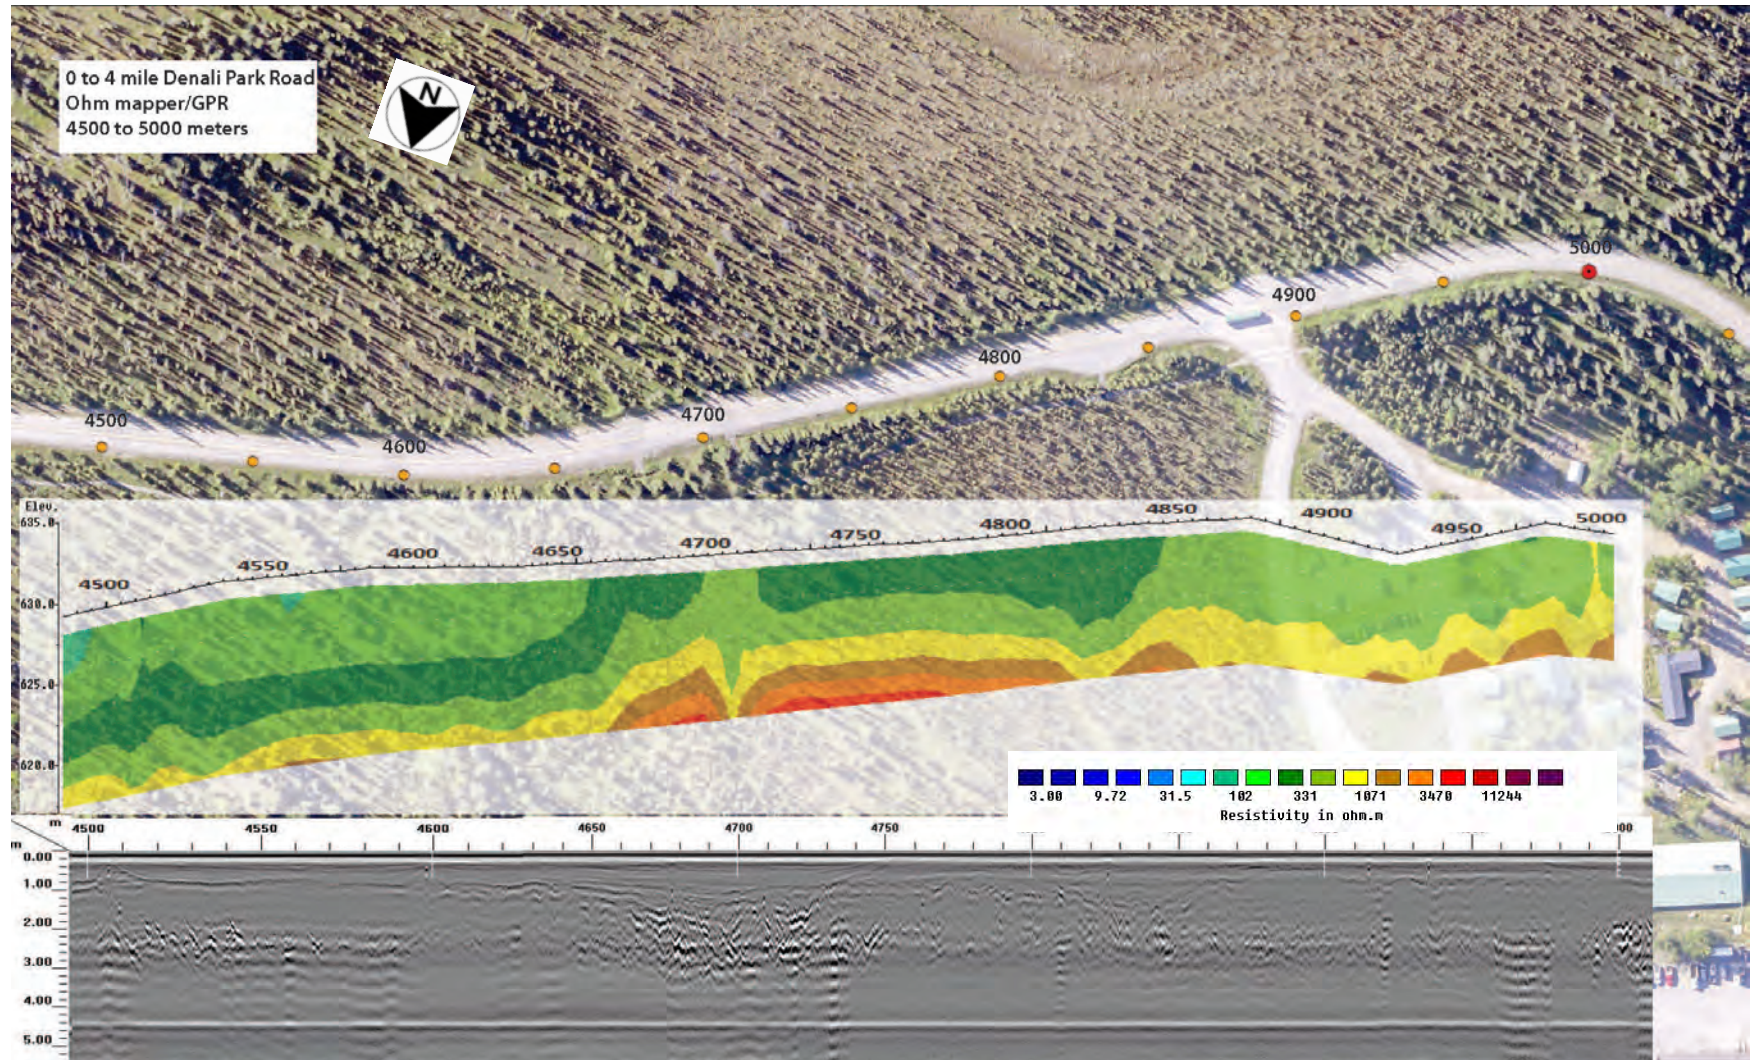
Figure 17. Park Road mile 0 to 4, 4500m to 5000m (14764-ft to 16404-ft). The moderate ohm-m values noticed at the very deepest portion of the previous section are now moving upward and are more easily seen, with moderate to high values seen from 4650m to 4850m. Our first interpretation is again deeper weathered/fractured rock overlying bedrock and becoming increasingly near surface at 4650m to 4850m. It is known ice-rich permafrost is in the area due to thaw-settlement issues to C-Camp, therefore imaging of ice-moderate to ice-rich frozen ground is not ruled out. Additionally the GPR reflections in this area are indicative of disrupted sub-base and base layer material possibly due to the construction of an appurtenance at approximately 4700m. .
