Geotechnical Report No. 11-20

**Pretty Rocks Landslide
2018-2019 Geotechnical Investigation and Conceptual
Design Alternatives Report**

**AK NPS DENA 10(45)
Denali National Park, Alaska
August 2020**

U.S. DEPARTMENT OF TRANSPORTATION
FEDERAL HIGHWAY ADMINISTRATION

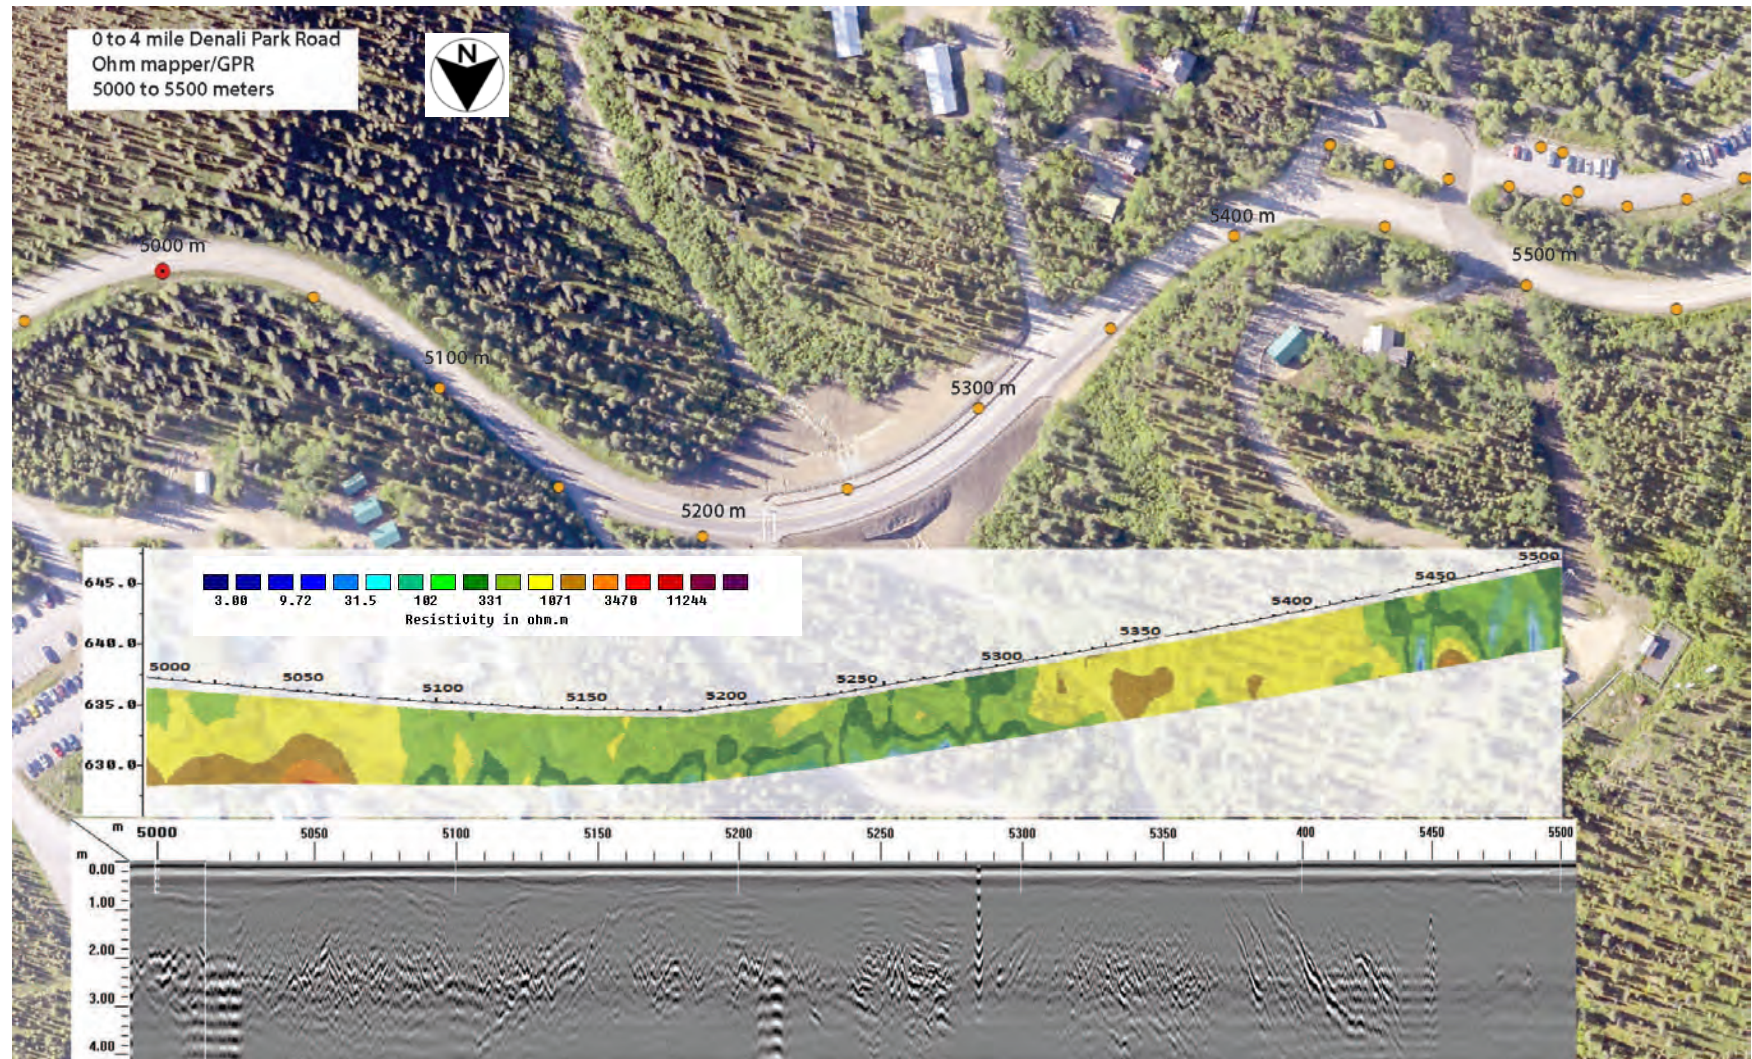
Figure 18. Park Road mile 0 to 4, 5000m to 5500m (16404-ft to 18044-ft). Moderate ohm-m values are reporting at either abutment of the causeway over the creek, starting at 4650m and continues to 5100m. Crossing the creek yields very low ohm-m values consistent with fill material, and very low ohm-m values are noticed at the very deepest section of the fill material and this coincides with the probable increase in moisture below the creek level. The ohm-m values rise again at 5300m to 5400m. These higher ohm-m values either side of the creek could either be weathered/fractured bedrock or ice-moderate to ice-rich permafrost. It was noted that possible permafrost was excavated during the creek causeway construction. The GPR image indicates a clear disruption of the substrate in the vicinity of the reconstructed drainage appurtenance extending from 5150m to 5325m. A steeply inclined reflector is displayed in the GPR at 5400m and this is possibly indicative of bedrock structure. Very low ohm-m values are noticed to start at approximately 5450m to the end of the section, extending nearly full depth, indicating moist conditions.

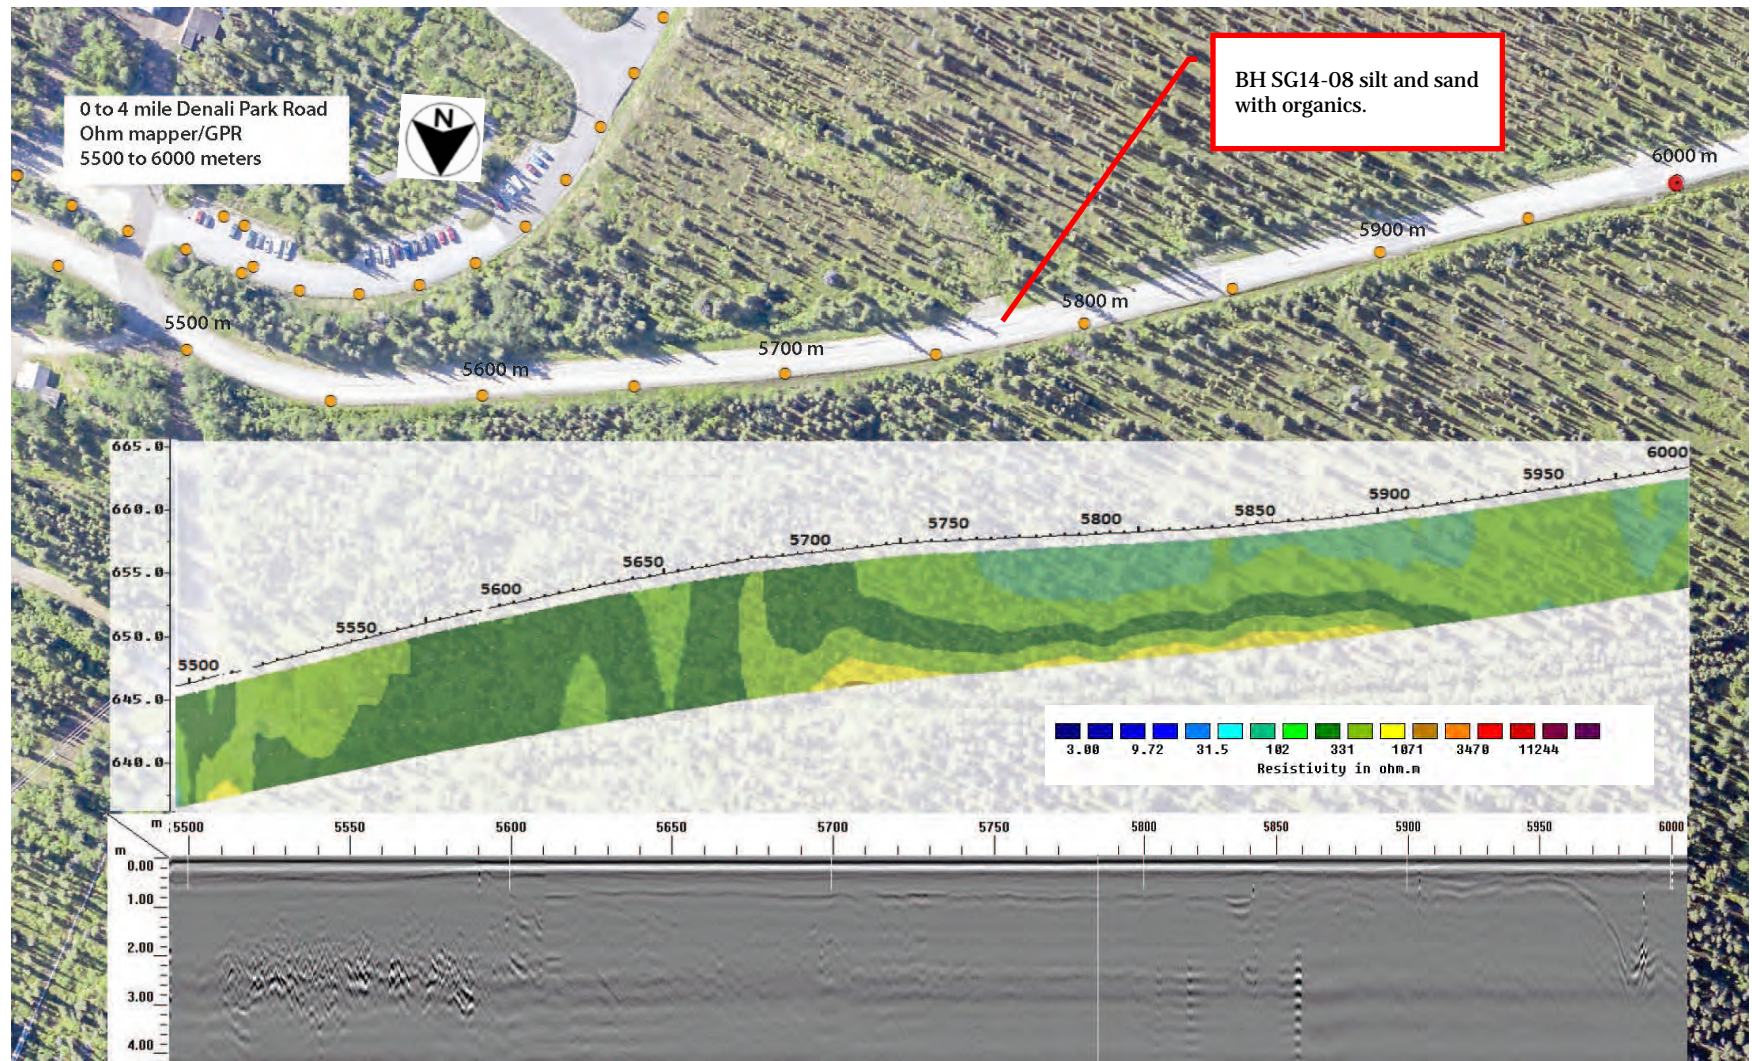
Figure 19. Park Road mile 0 to 4, 5500m to 6000m (18044-ft to 19685-ft). Very low ohm-m values which started at 5450m in the previous section continue through this section as well. An increase in near surface moisture content is inferred starting at 5750m though to 6000m. Moderate ohm-m values are noted from 5700m to 5900m and this may be a rising bedrock surface or possibly ice-moderate to ice-rich permafrost at depth. The GPR returns are very minimal through this section indicating increase in moisture content or clay mineral composition. TH83-5 drilled in this vicinity showed peat and silty fine sand, unfrozen (Fig. 72).

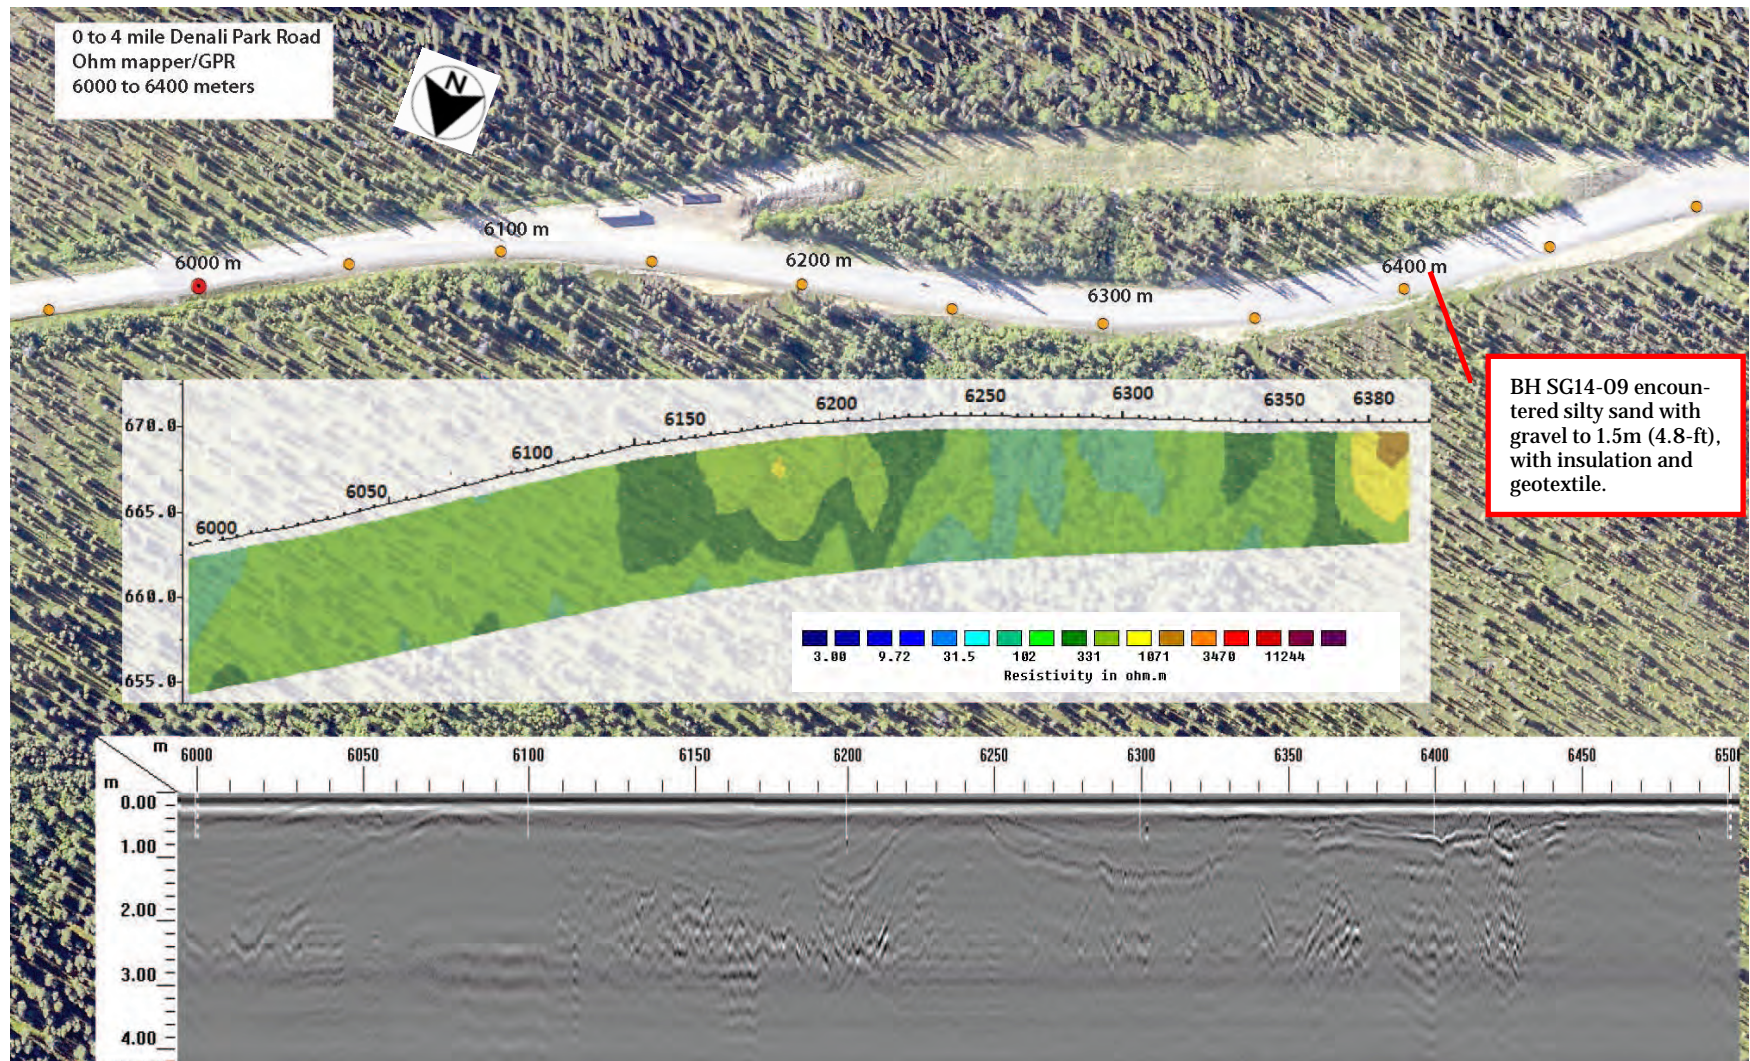
Figure 20. Park Road mile 0 to 4, 6000m to 6400m (19685-ft to 21000-ft), end of transect. Low ohm-m values continue through this section with very low values noticed from 6250m to 6325m, which may be indicative of a 1.0m (3.0-ft) deep sub-excavation with installed geotextile and select fill, with possible increases in the moisture content of the base material. Road realignment occurred at this location due to landslide to the south, and 7.5cm (3.0in) of buried insulation was installed from 6375m to 6475m. Underdrains installed in this area discovered trapped water in the insulated section. The GPR is not overly reflective through this section, however a down drop of a subsurface reflector is clearly seen coincidentally at the inferred high moisture location from 6250m to 6325m, and a strong reflector is visible at approximately 6400m which is very possibly the buried insulation. TH83-6 was drilled in this vicinity (MP 3.9) and showed unfrozen silty sandy gravel with clay at 6.2m (20.5-ft) (Fig. 73).

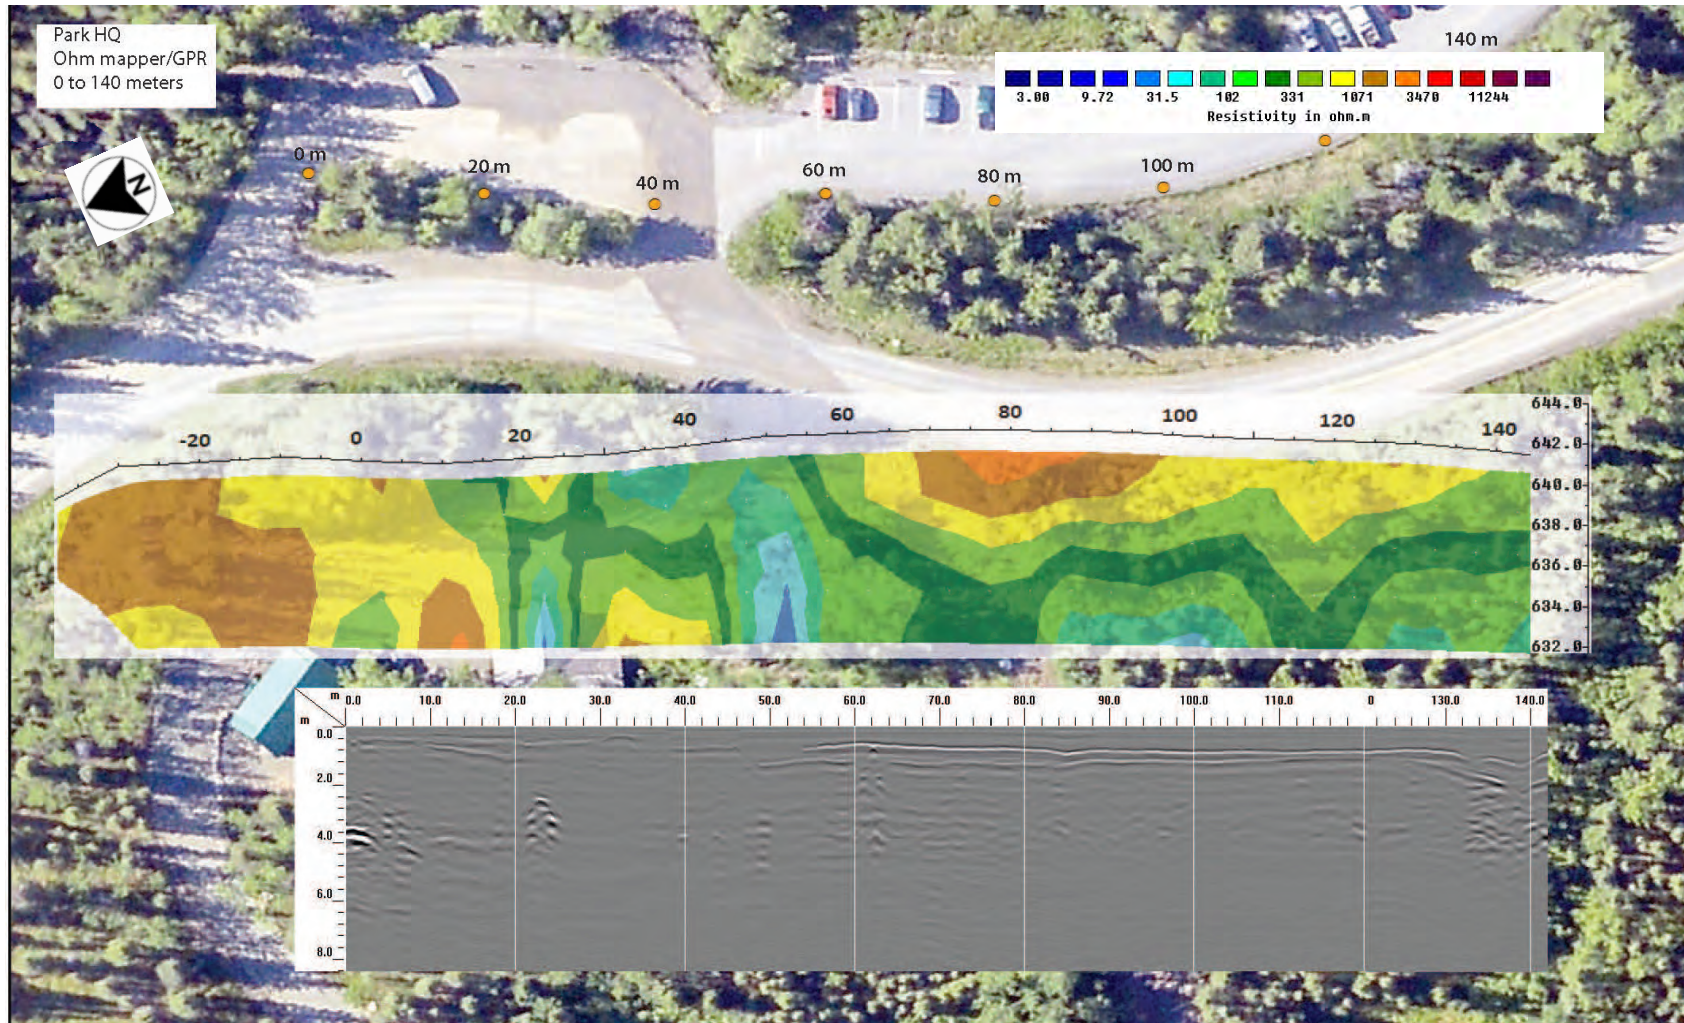
Figure 21. HQ/Dog Kennels Parking Lot 0m to 140m (460-ft), start of transect. The view is looking south and the transect progresses from left to right, east to west. Full depth moderate ohm-m values are reported from the start, -40m (-131-ft) to approximately +20m (65.6-ft), and this coincides with the values reported in Figure 18 from 5325m to 5425m. Starting at 55m a strong GPR reflector is noticed at 0.6m (2.0-ft) depth, which coincides with the start of the parking loop area pavement. This reflector has strong polarity change from black to white to black (-, +, -), indicating a distinct change from a higher dielectric material over a lower dielectric material. We believe this to be a buried insulation layer installed under the paved parking lot, possibly to thermally protect ground ice from thaw. The GPR returns are generally poor through this section. Beginning at 50m very low ohm-m values are noted which

extend under near surface moderate ohm-m values to the end of the section. This may indicate permafrost overlying talik (previously frozen materials), or ice-rich sediments overlying ice-poor sediments.

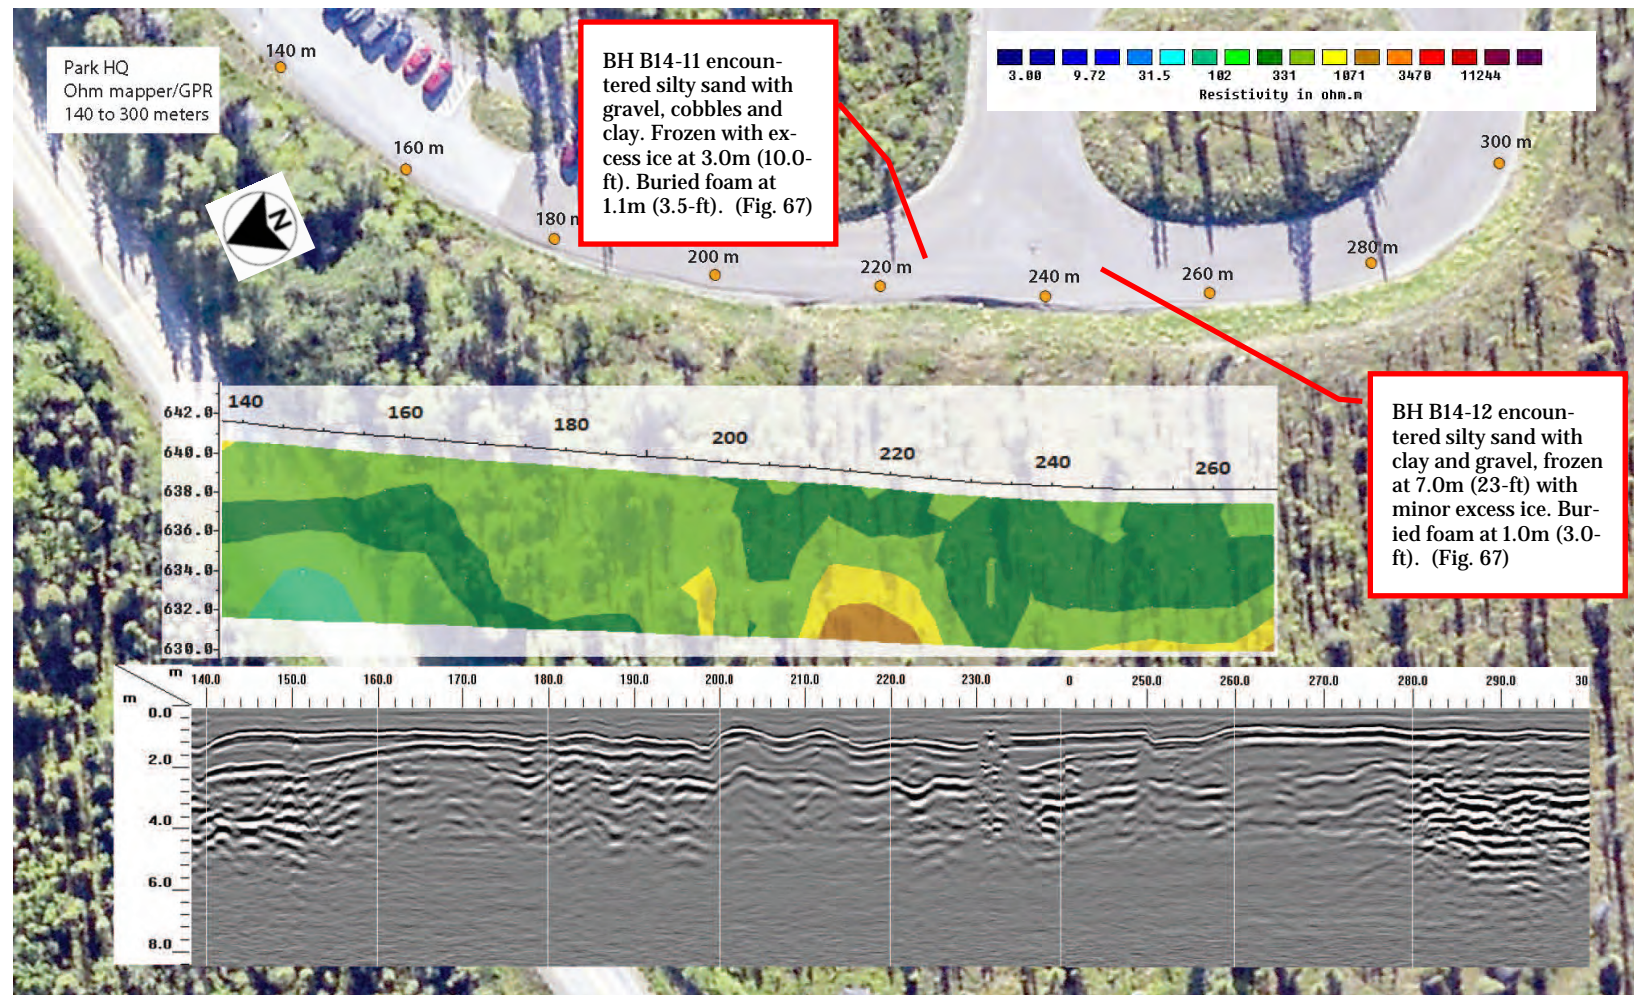
Figure 22. HQ/Dog Kennels Parking Lot 140m to 300m, end of transect. The very near surface strong polarity reversal continues through to the end of the transect at 300m. A high resistivity anomaly exists at 220m which is approximately the location of severe settlement observed in the parking lot. Therefore these resistivity values may be inferred as moderate to high ground ice content. The moderate ohm-m values are visible at depth through to the end of the transect. Boreholes BH14-11 and BH14-12 report significant ice at 10 feet and 20 feet depth respectively. The GPR results in this section are very distinctive with chaotic to systematic layering visible, either indicating weather/fractured bedrock at depth, or sequences of sediment or man placed fill material.

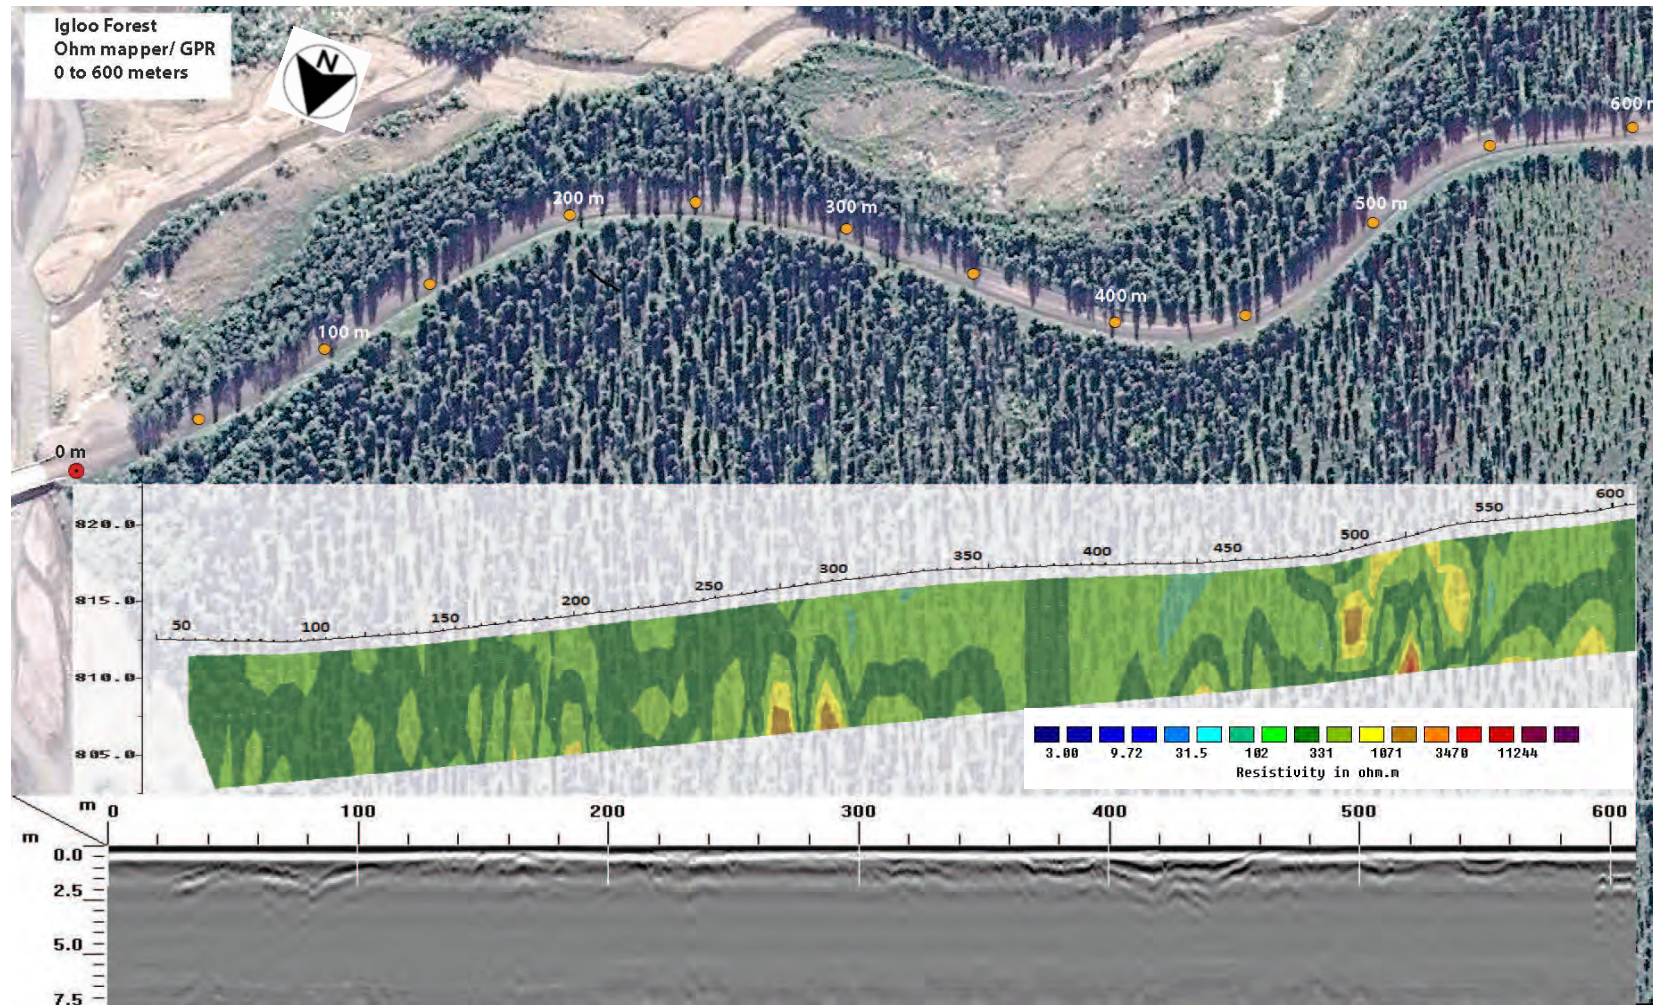
Figure 23. Igloo Forest, 0m to 600m (1969-ft), start of transect. The view direction in these images is generally looking east, therefore the transect progresses from left to right, north to south. This section reports very low ohm-m values through the length of the section to full depth, with sporadic moderate to high ohm-m anomalies. The GPR is non-distinct and this may be due to moderate to high ground water contents and/or mineral clay compositions. No extensive frozen ground is inferred in this section. This terrain does not exhibit surface expression consistent with frozen material at depth.

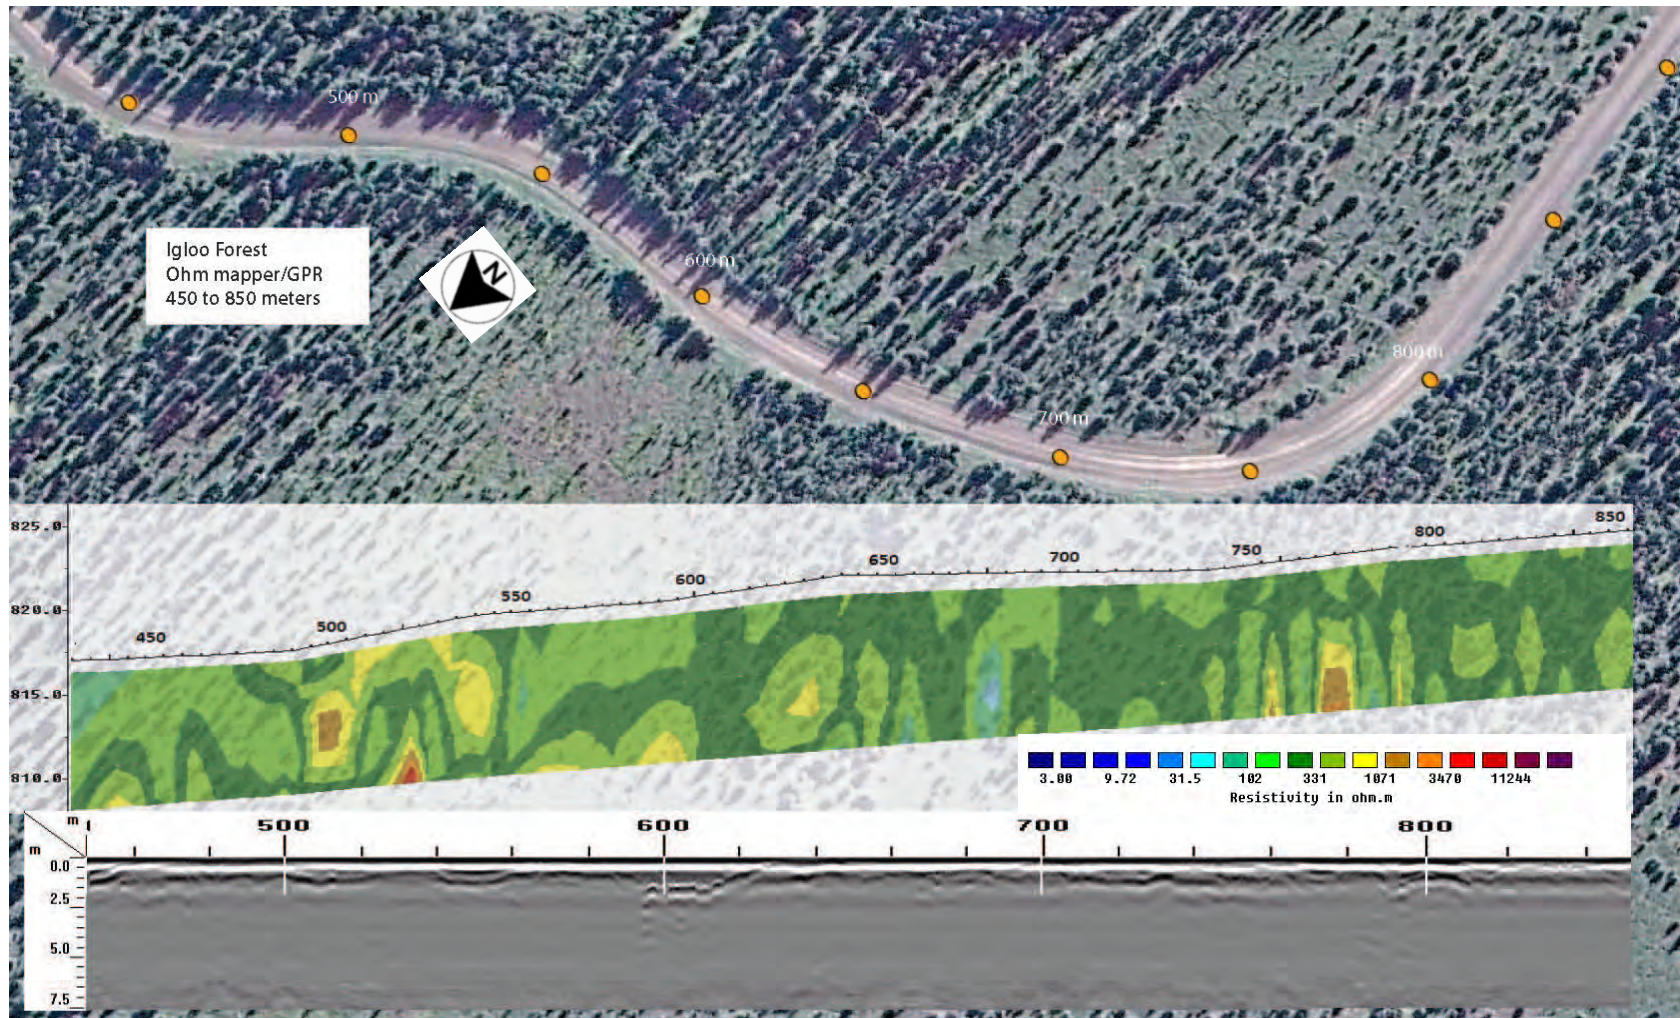
Figure 24. Igloo Forest, 450m to 850m (1476-ft to 2789-ft) . This section reports much the same as in Figure 23. An inferred high moisture anomaly is seen at approximately 670m with very low ohm-m values.

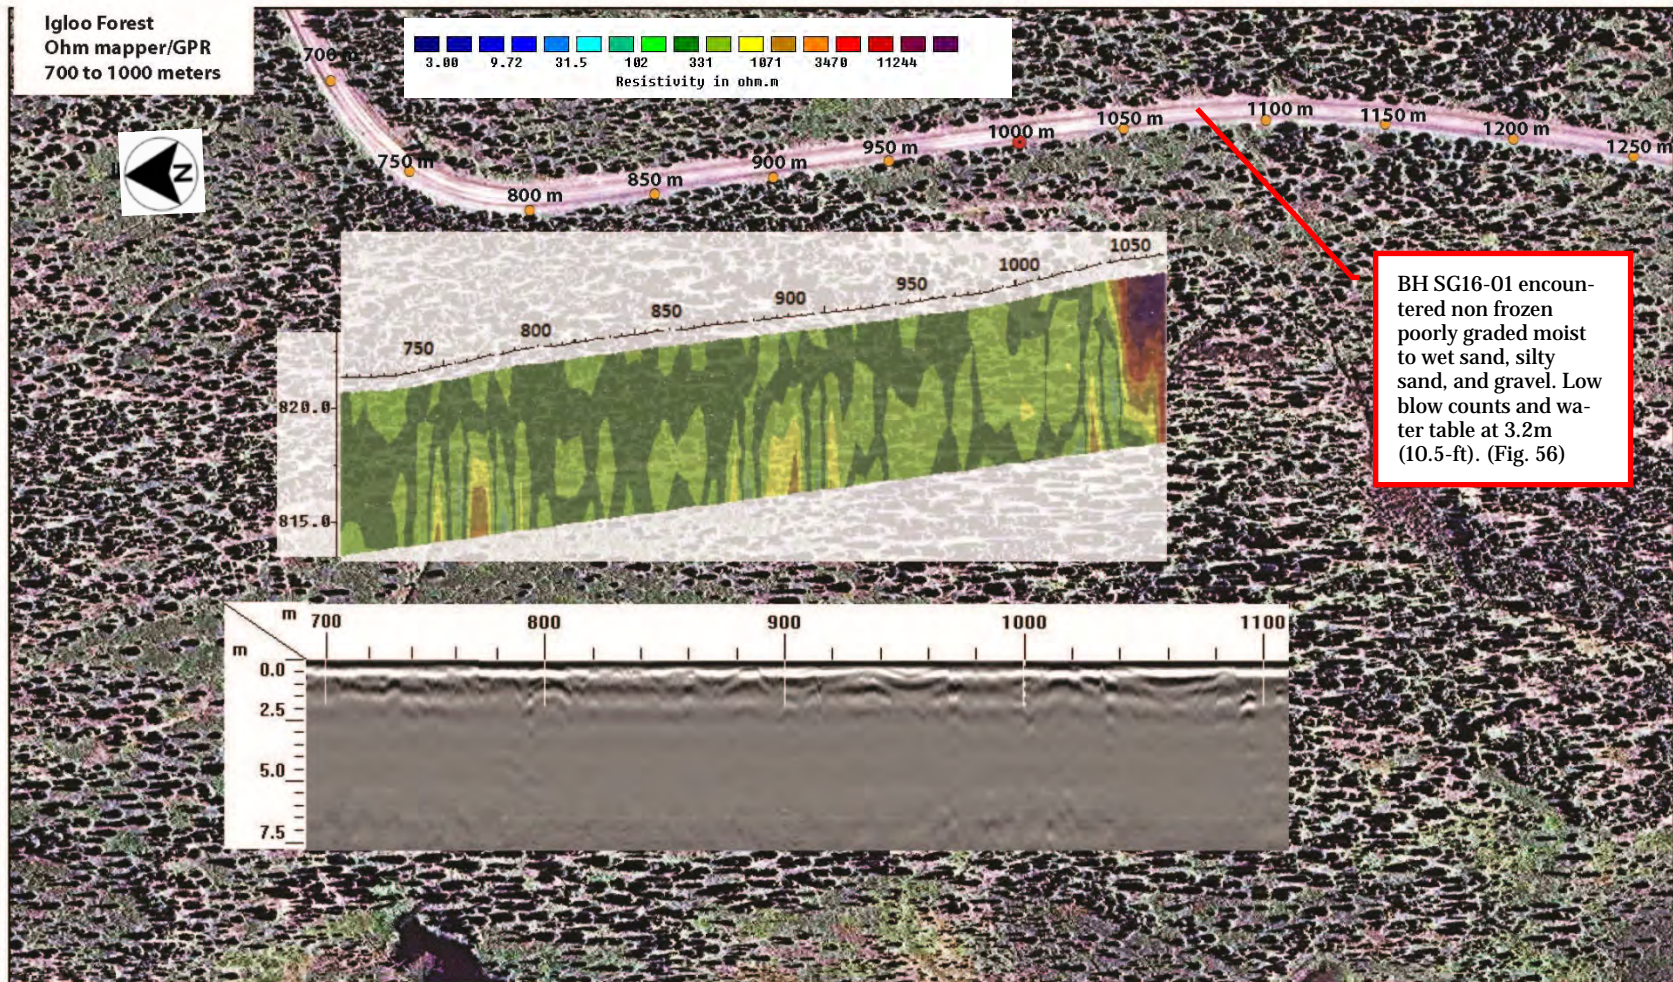
Figure 25. Igloo Forest, 700m to 1000m (2297-ft to 3280-ft). This section reports much the same as in Figures 23 and 24. However, a distinctive high ohm-m value anomaly is noticed at 1050m, which appears to be located in the near surface. It is unknown the origin of this anomaly.

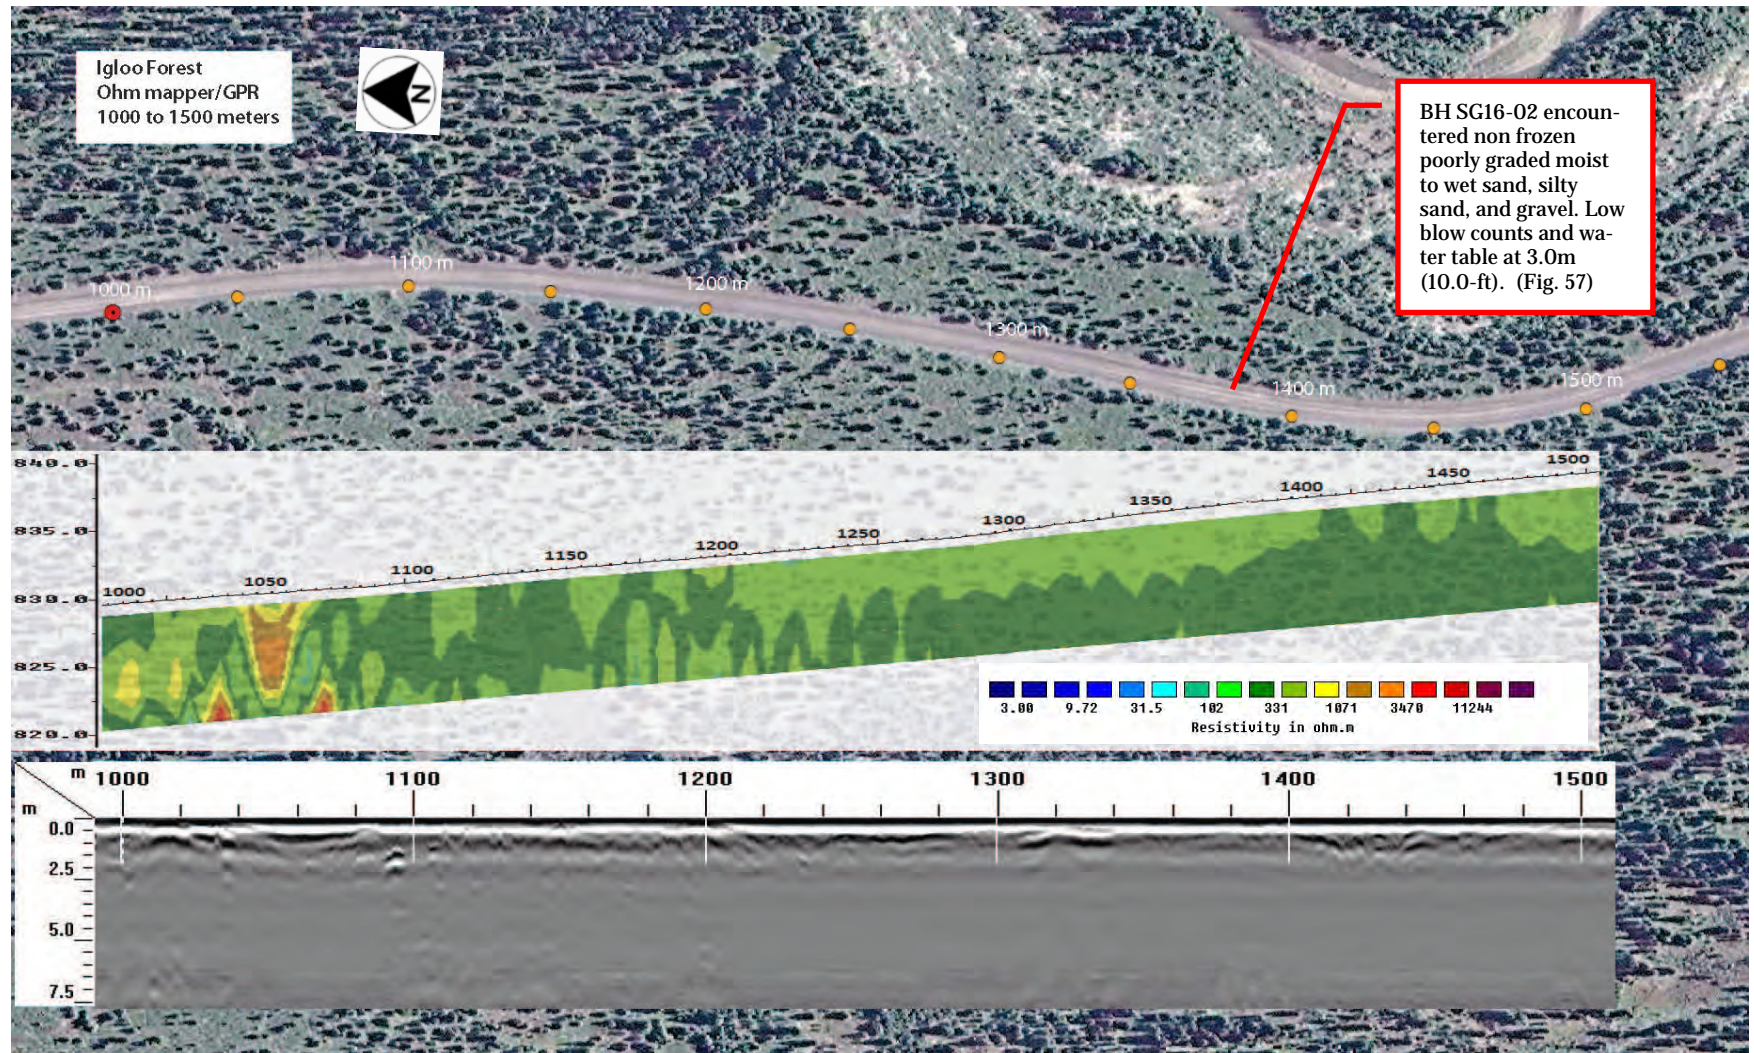
Figure 26. Igloo Forest, 1000m to 1500m (3280-ft to 4921-ft). This section is much as the previous sections. The sporadic moderate ohm-m anomalies disappear completely after 1050m. The road becomes closer to the evident flood plain meanders suggesting the sediments at this section may be recently reworked and homogenizing the material. No frozen ground is indicated in this section.

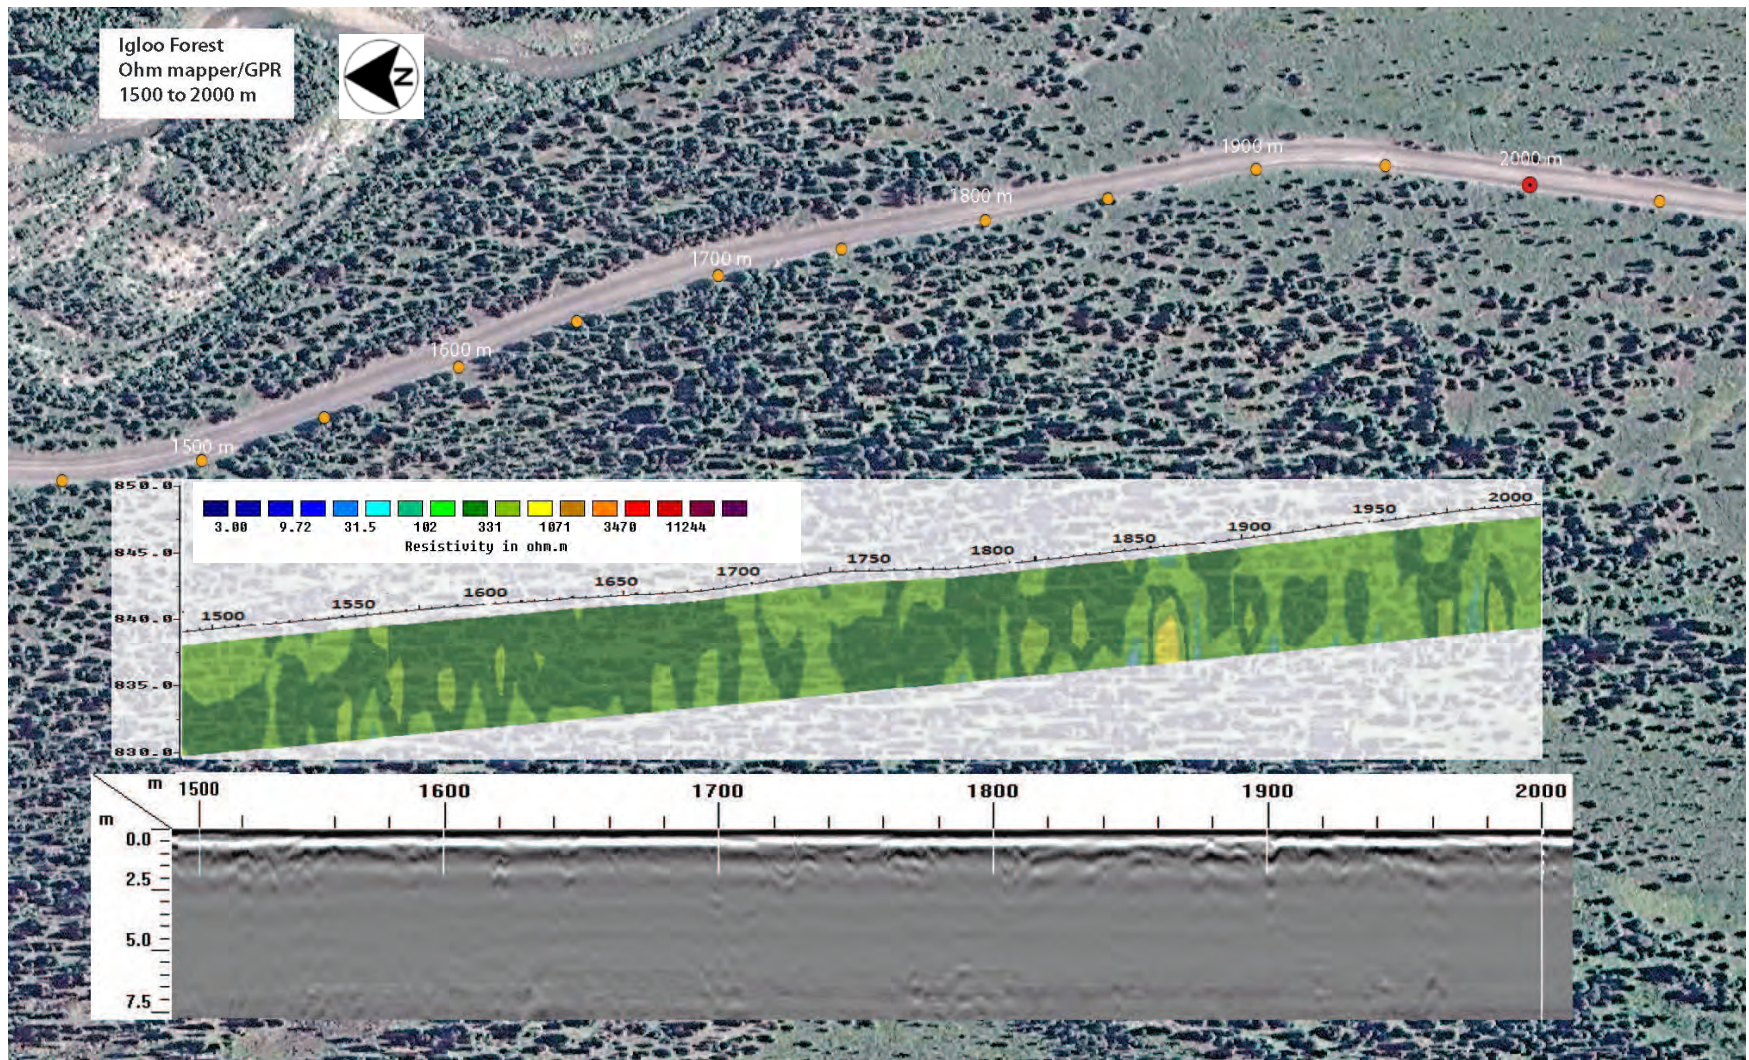
Figure 27. Igloo Forest, 1500m to 2000m (4921-ft to 6562-ft). This section reports much as the previous section.

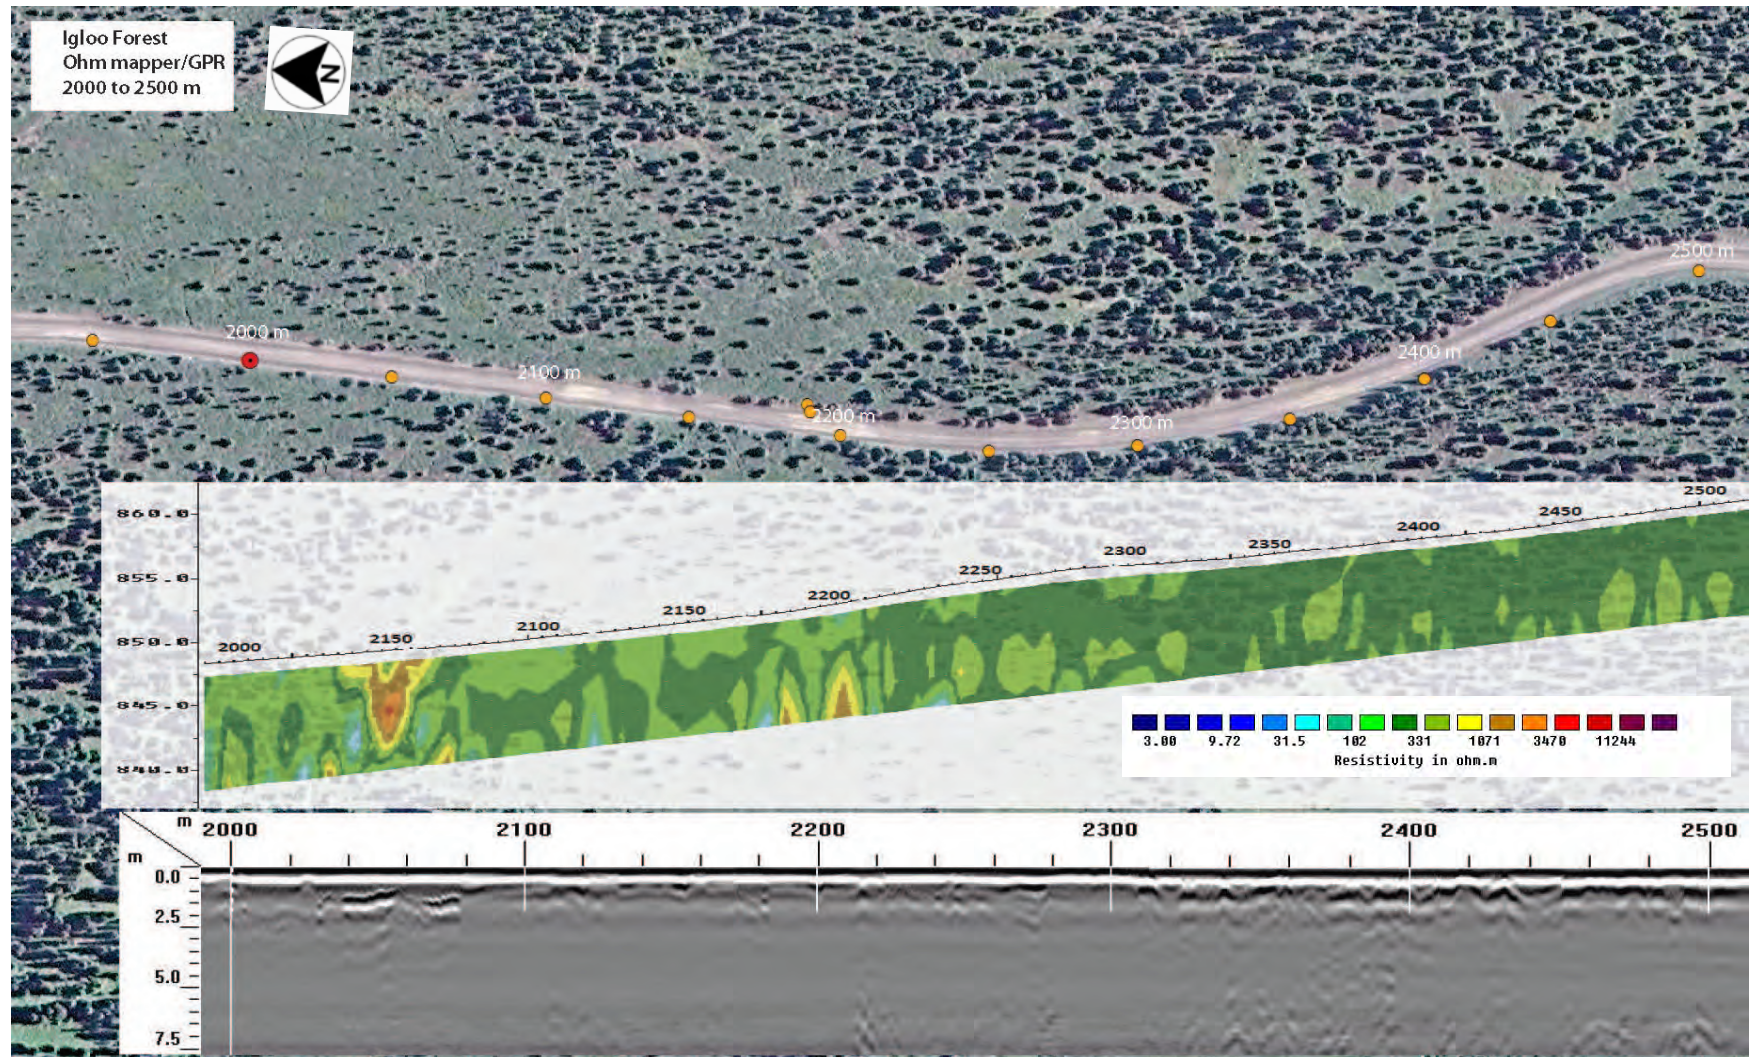
Figure 28. Igloo Forest, 2000m to 2500m (6562-ft to 8202-ft). This section reports much as the previous section. A distinctive higher ohm-m value anomaly exists at 2150m and we infer this to be a roadway drainage appurtenance near the surface. Starting at 2000m to 2250m we see emerging higher ohm-m values with interspersed very low ohm-m values. Two higher ohm-m value anomlies exist side-by-side at 2200m and these either represent deeply buried emplaced massive ice, or possibly the top surface of a bedrock feature. The GPR is unremarkable in this section.
