Geotechnical Report No. 11-20

**Pretty Rocks Landslide
2018-2019 Geotechnical Investigation and Conceptual
Design Alternatives Report**

**AK NPS DENA 10(45)
Denali National Park, Alaska
August 2020**

U.S. DEPARTMENT OF TRANSPORTATION
FEDERAL HIGHWAY ADMINISTRATION

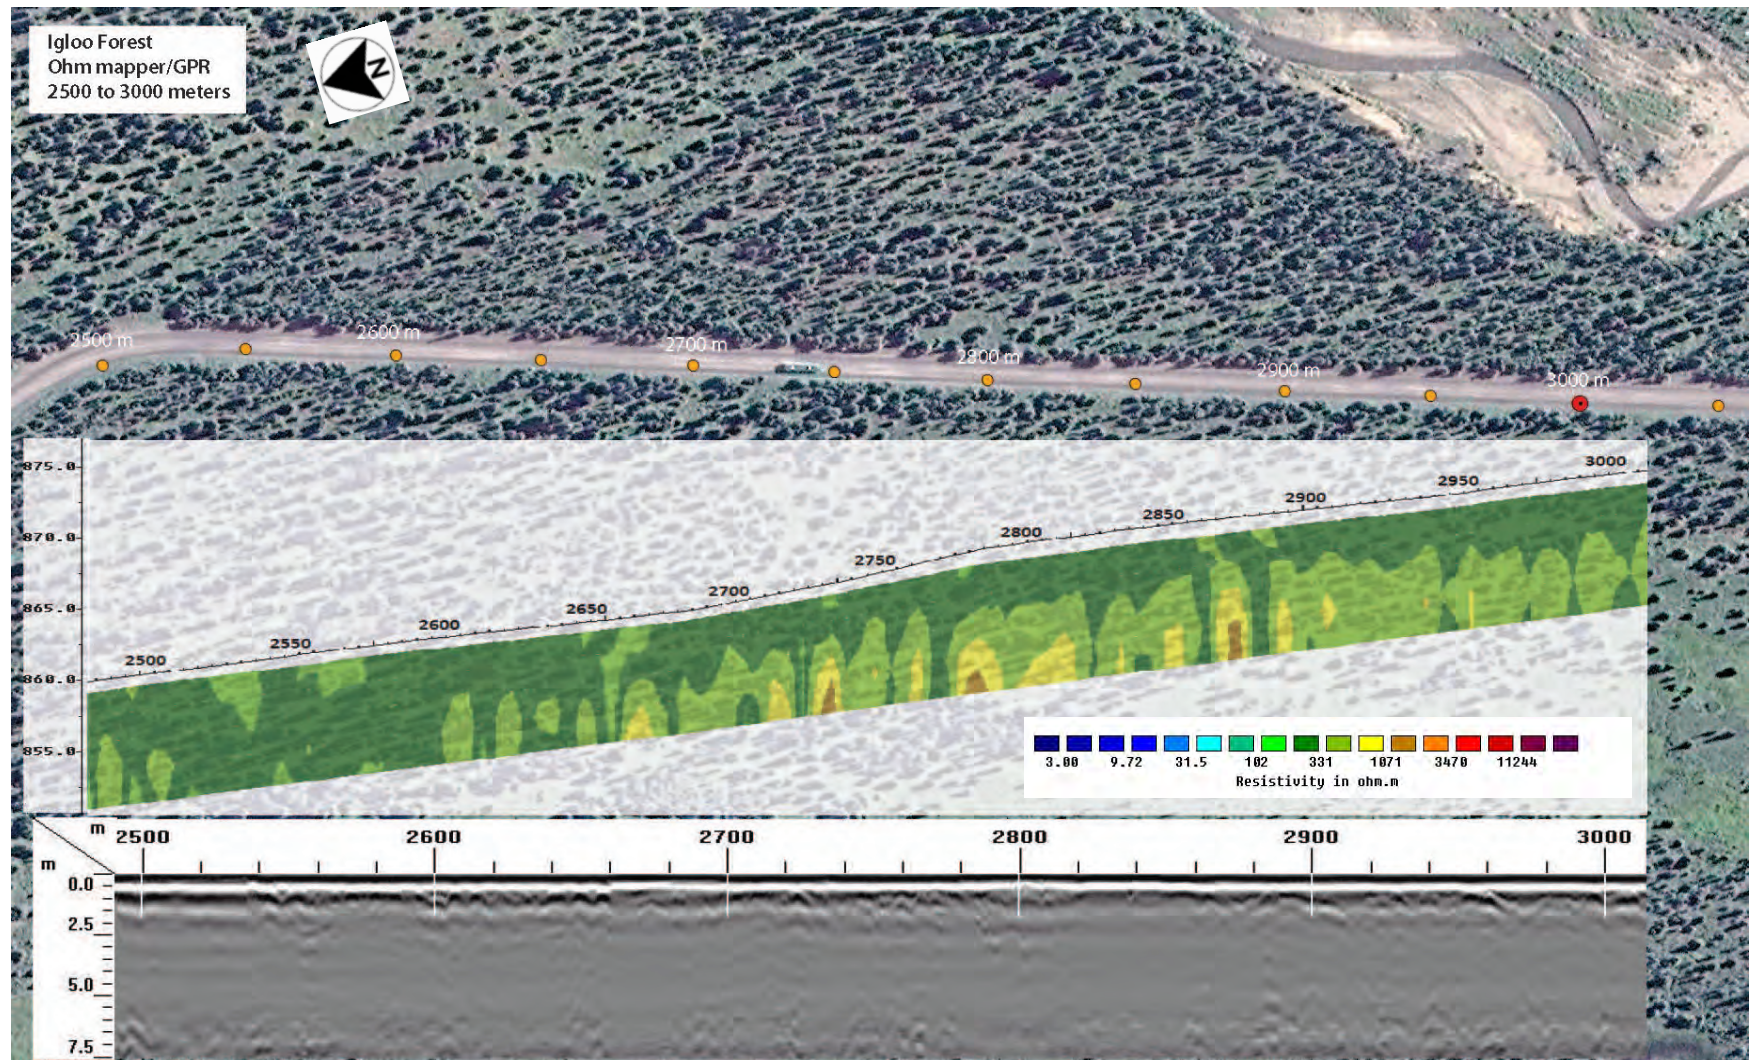
Figure 29. Igloo Forest, 2500m to 3000m (8202-ft to 9843-ft). This section reports much as the previous section. At 2650m higher ohm-m value anomalies begin to appear at depth and these represent deep buried emplaced massive ice, or more probably this the top surface of a deeper bedrock feature. The GPR is unremarkable in this section.

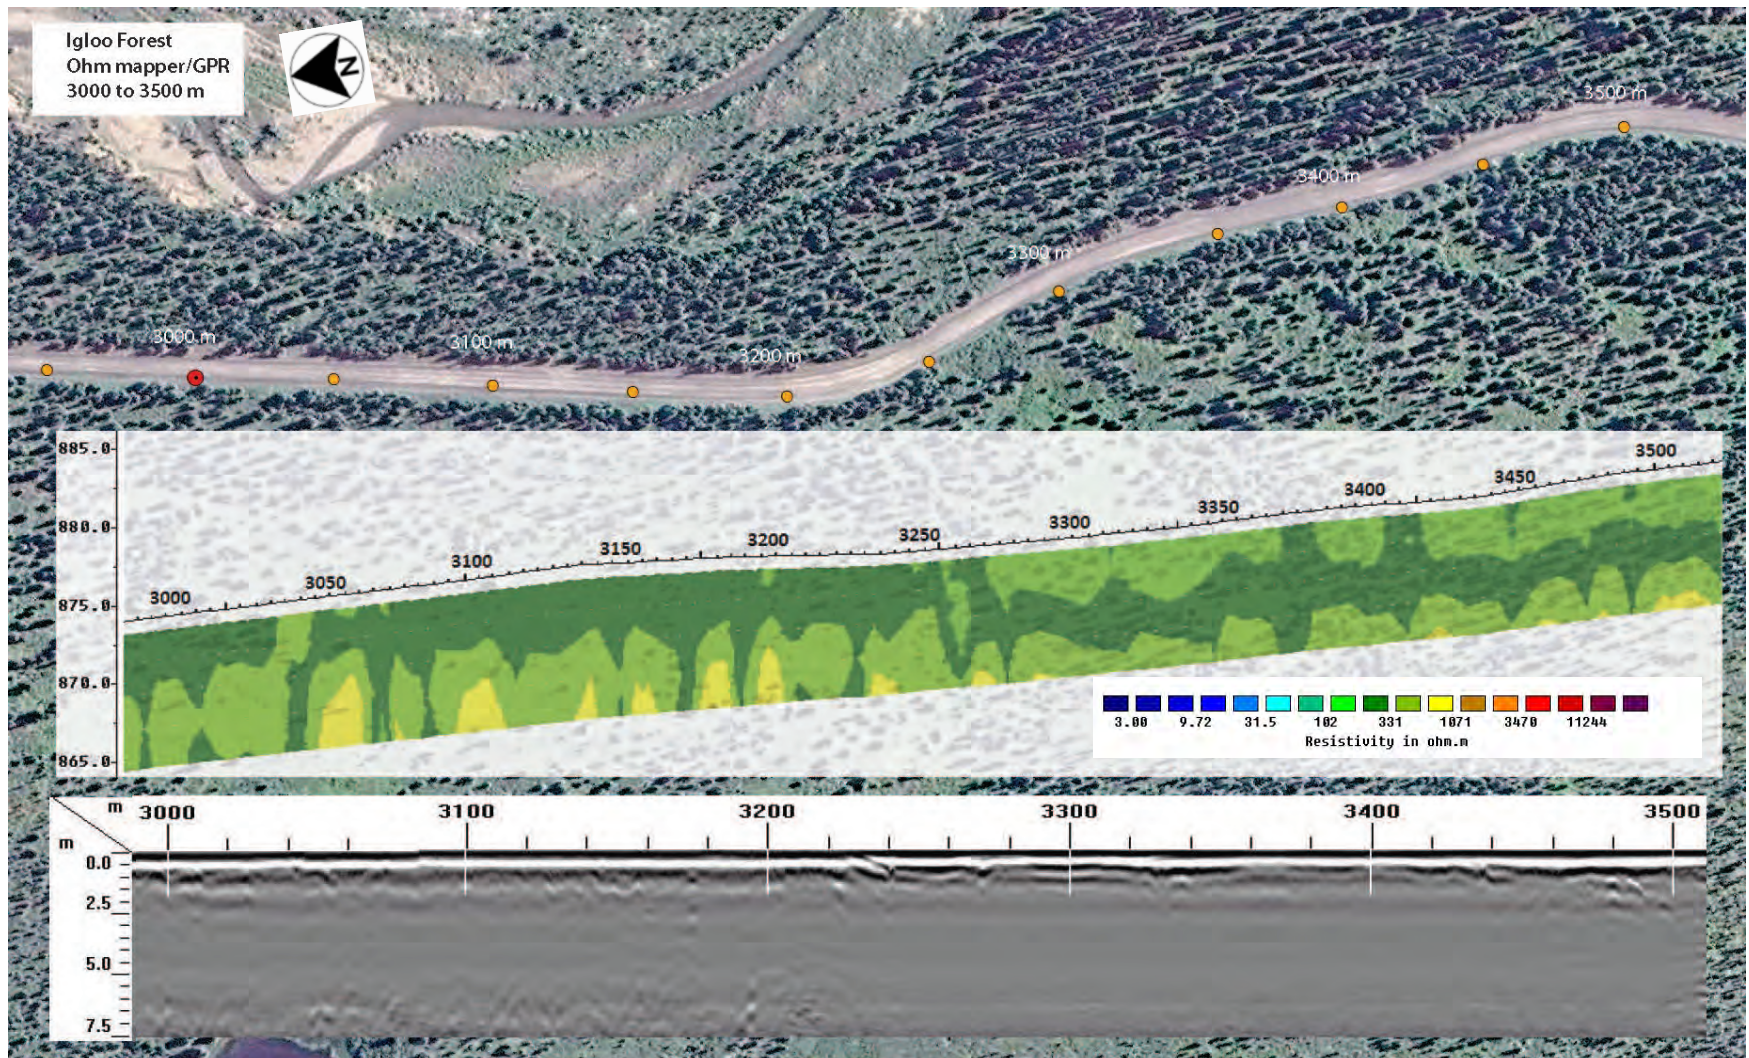
Figure 30. Igloo Forest, 3000m to 3500m (9843-ft to 11,483-ft). This section reports much as the previous section with a continuation of the deeper and moderate ohm-m anomalies which most probably represents the top surface of a deeper bedrock feature. The GPR faintly reports reflectors at depth from 3000m to 3250m, coinciding with the moderate ohm-m values.

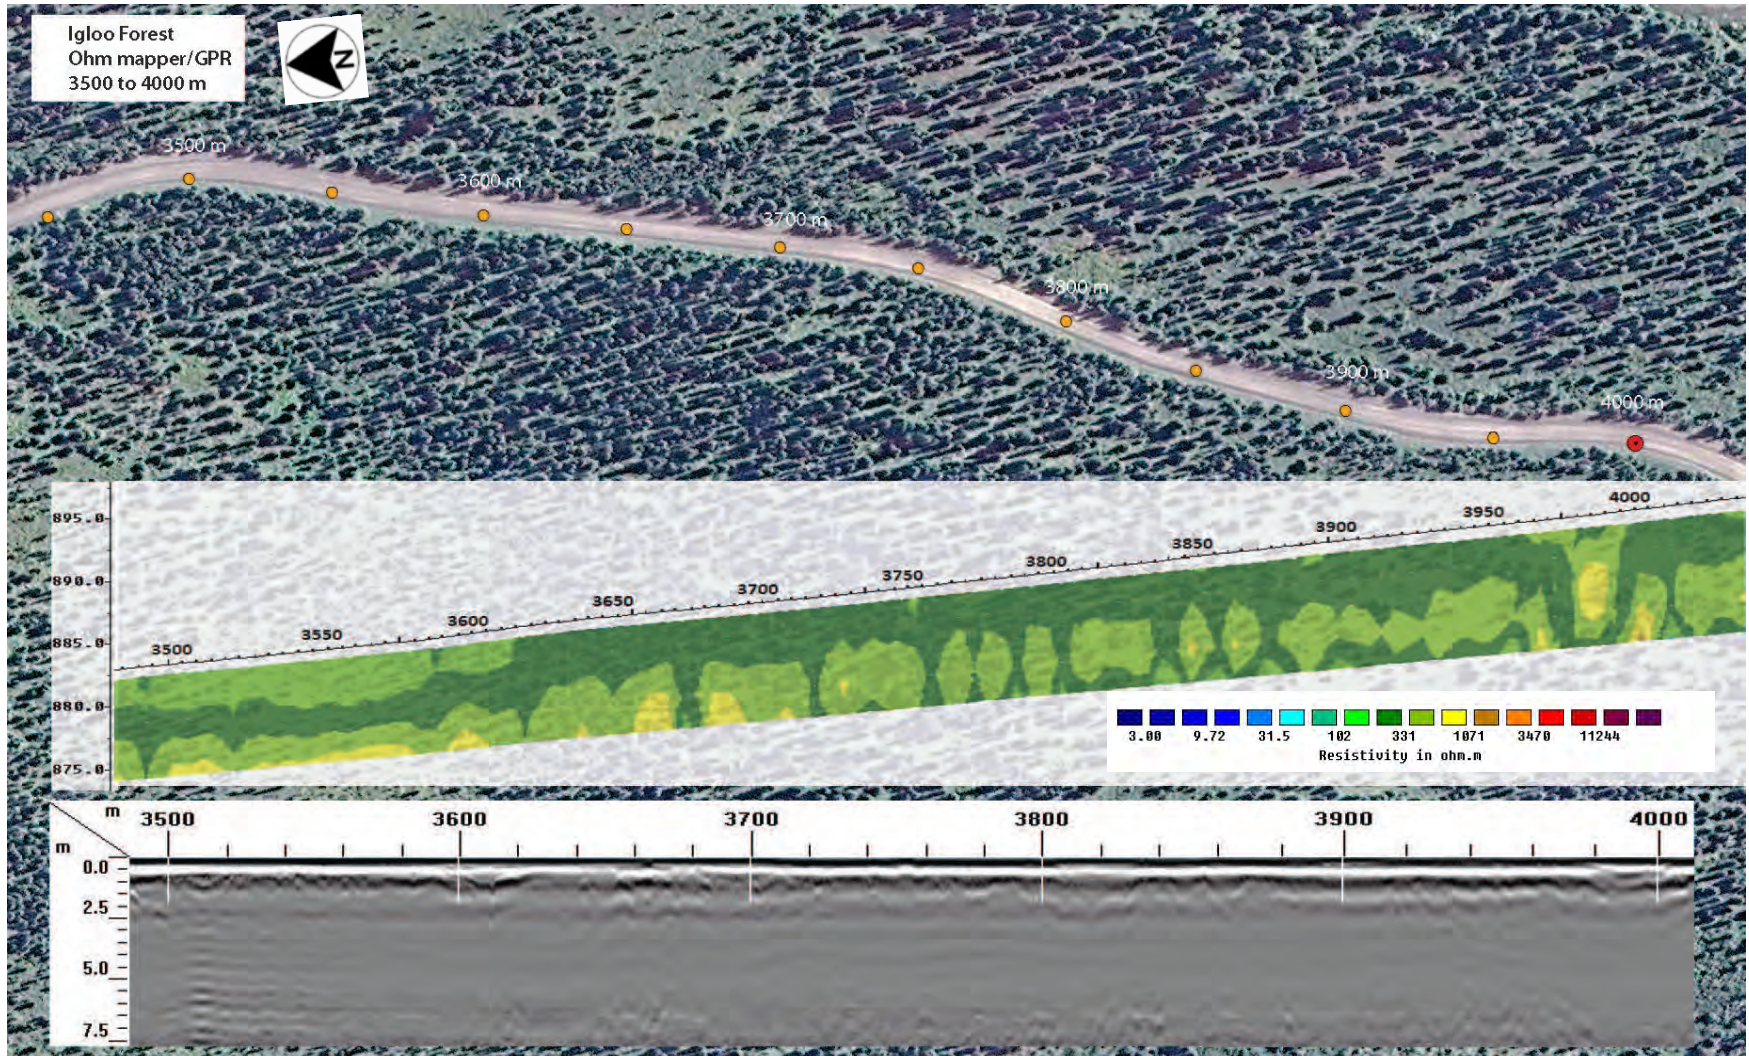
Figure 31. Igloo Forest, 3500m to 4000m (11,483-ft to 13,123-ft). This section reports much as the previous sections with a continuation of the deeper and moderate ohm-m anomalies.

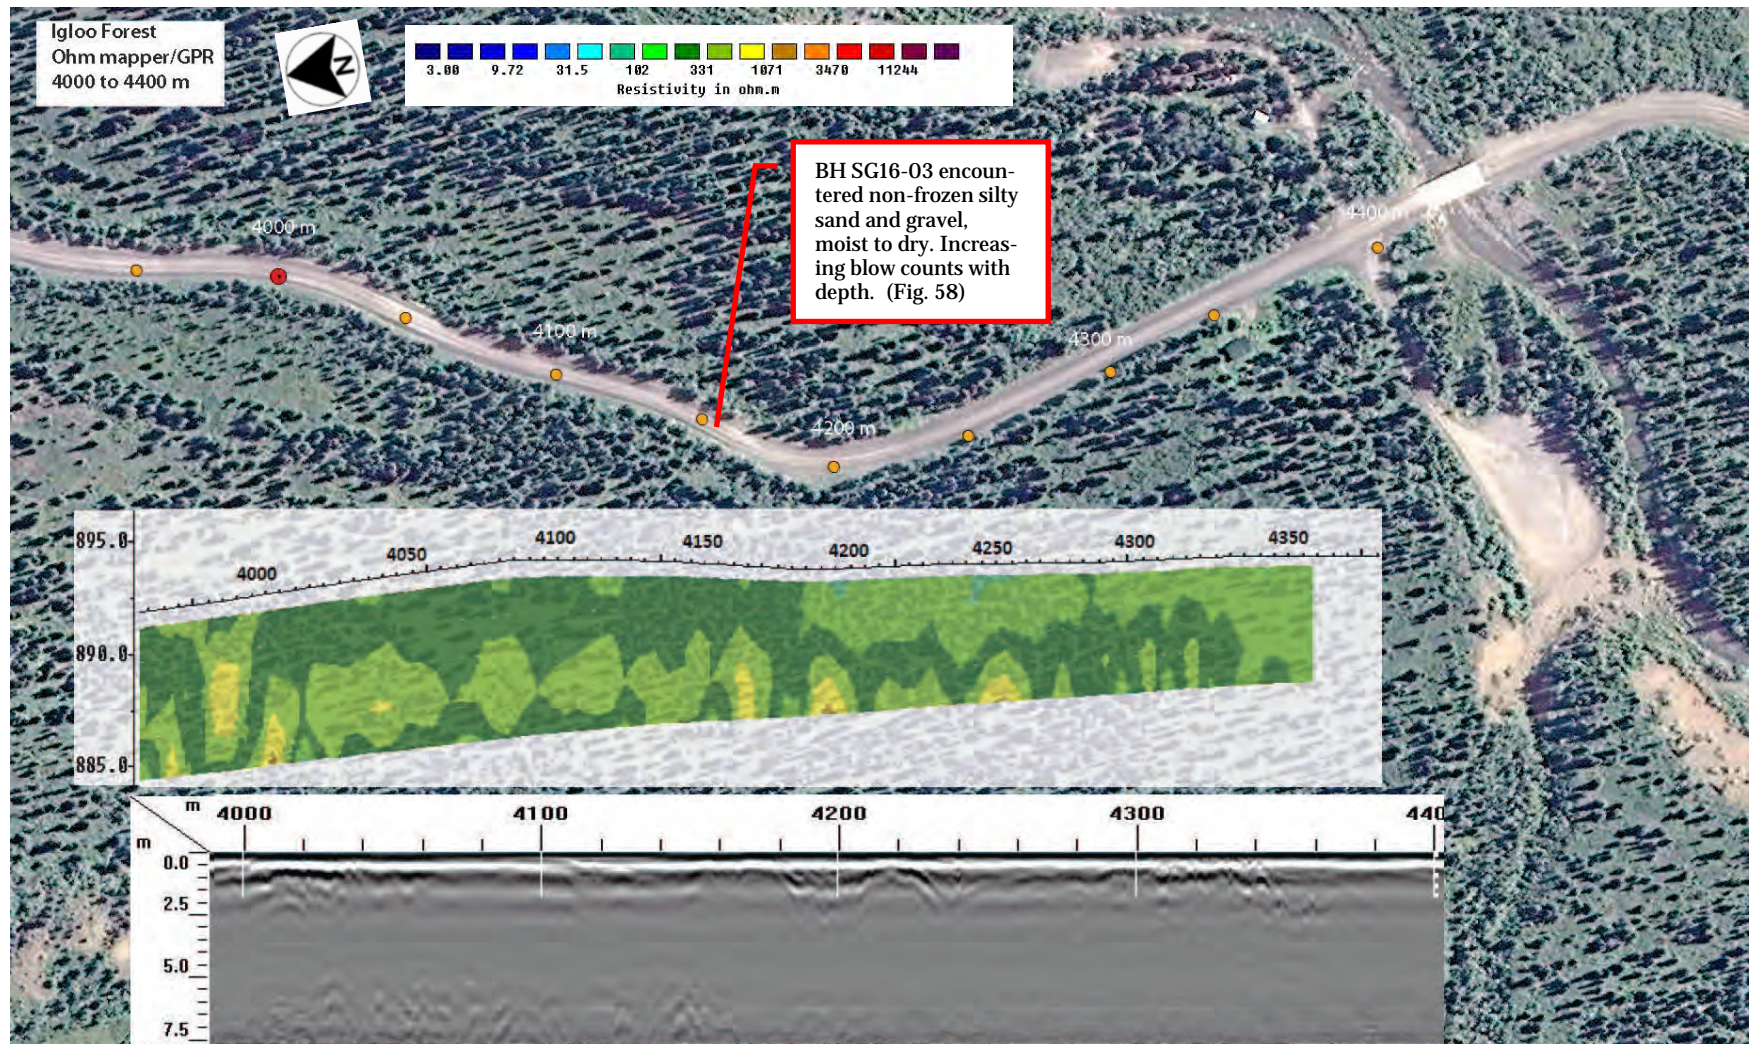
Figure 32. Igloo Forest, 4000m to 4400m (13,123-ft to 14,435-ft), end of transect. This section reports much as the previous sections with a continuation of the deeper and moderate ohm-m anomalies. The GPR through this entire section was not remarkable.

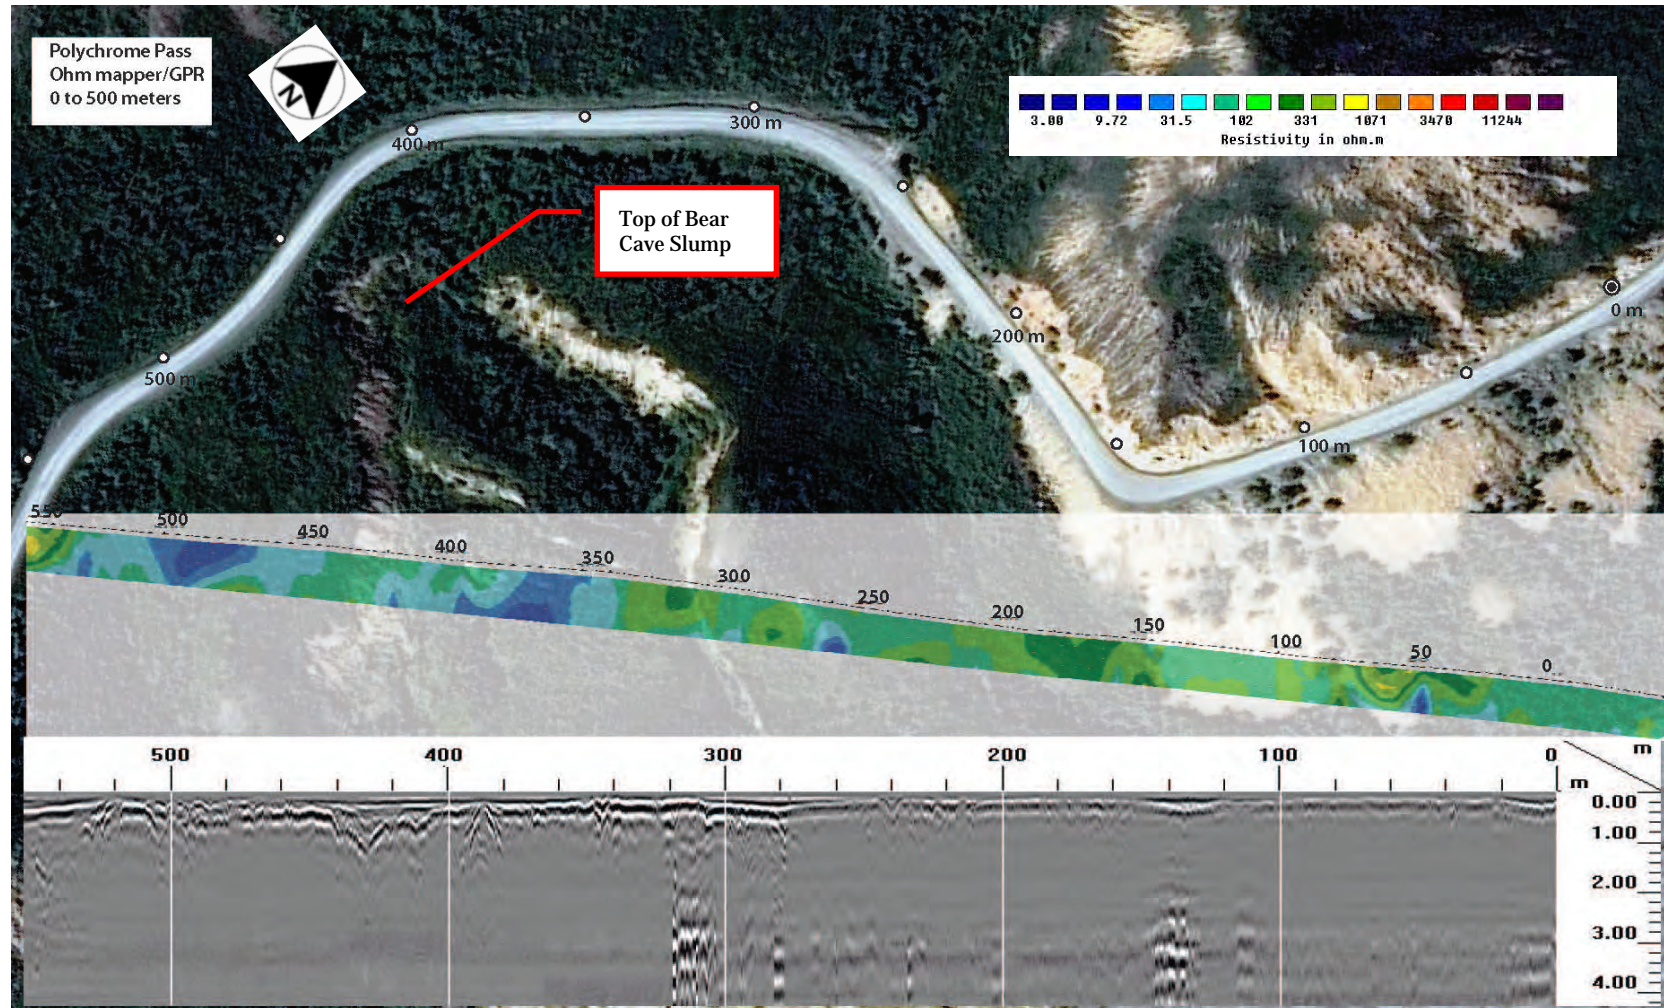
Figure 33. Polychrome Pass, 0m to 500m (1640-ft), start of transect. The view direction of this transect is oriented looking north, therefore the transect moves from right to left, east to west. The ohm-m values are very low through this section, with very low values across and above the headscarp of the Bear Cave Slump, from 250m to 500m possibly indicating higher moisture/ground water. The GPR is not remarkable at depth but a distinct reflector is visible at approximately 0.5m (1.6-ft) in depth, possibly representing the cut surface of the sub-grade. Chaotic structure is not visible in the GPR due to radar energy attenuation possibly from high moisture contents.

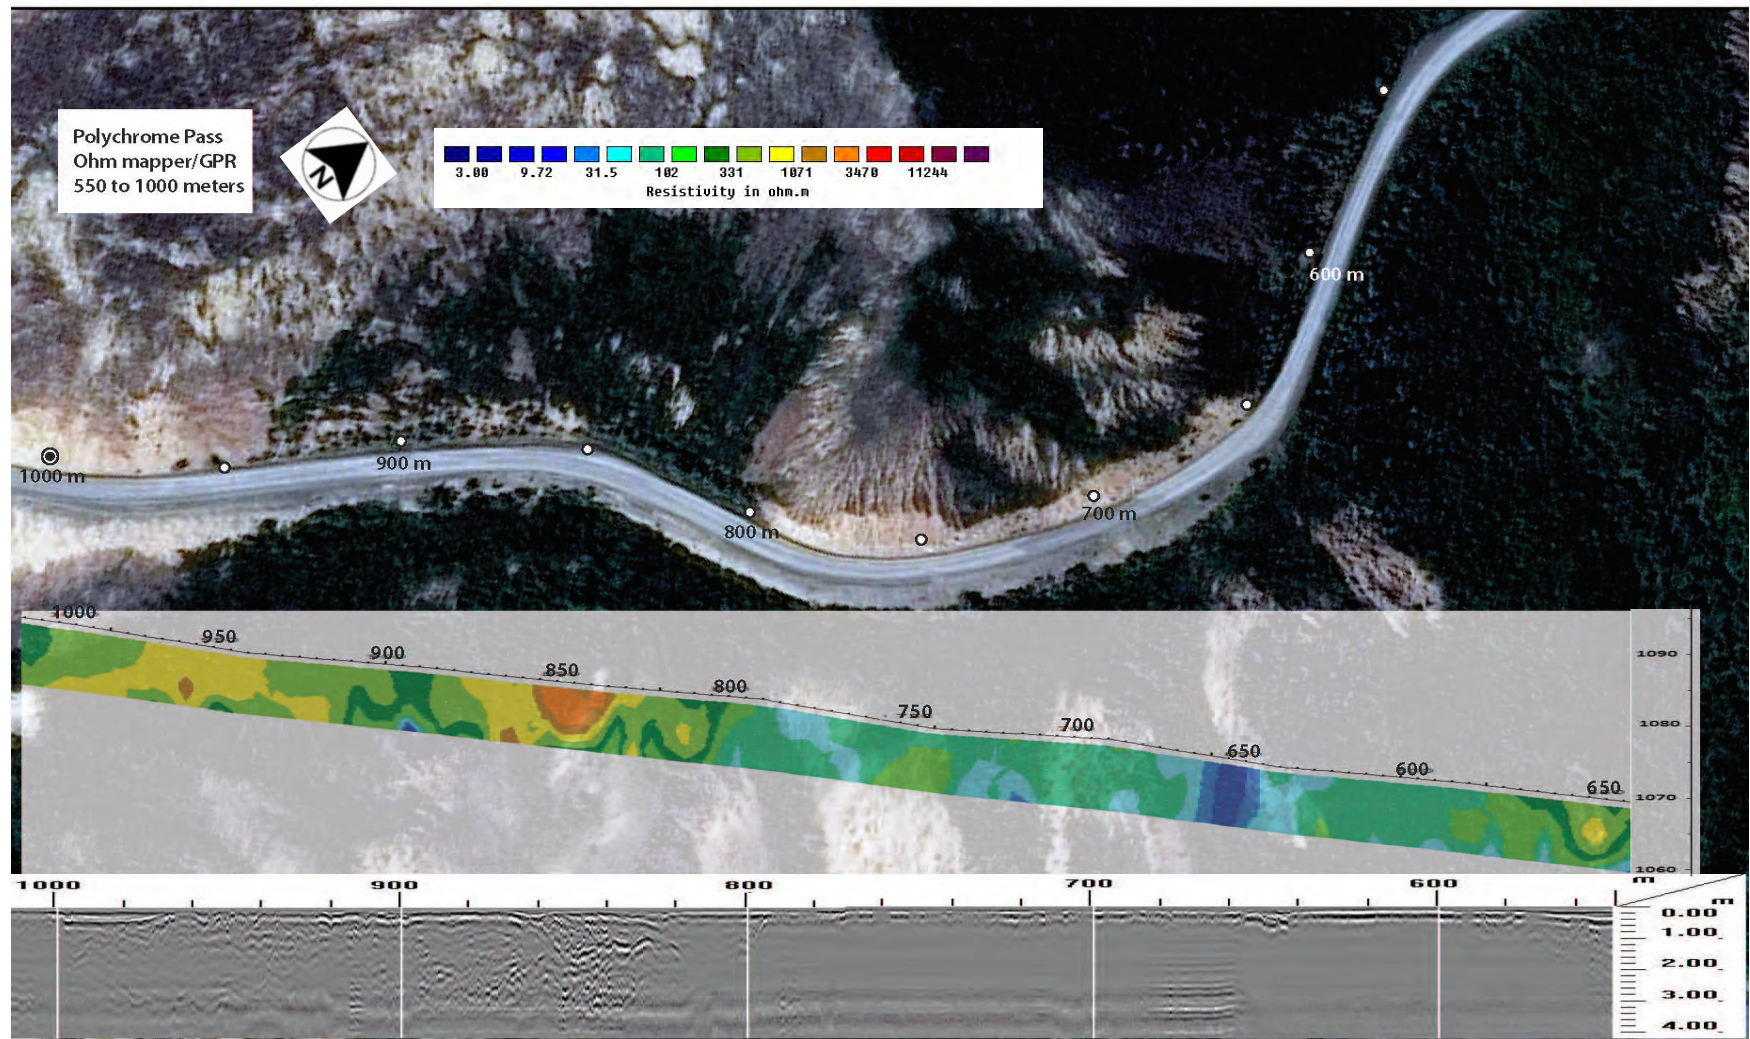
Figure 34. Polychrome Pass, 550m to 1000m ((1804-ft to 3280-ft). The ohm-m values are comprised of two distinct sections. From 650m to 800m the values are very low, indicating either moist/wet conditions, or very conductive mineralogy. At 800m moderate ohm-m values at the near surface coincide with the departure from the roadway rock cut, to a shallow fill section through 950m. The GPR is generally unremarkable except significant structure is visible in the shallow fill area. The ohm-m values and the visible GPR reflections in this portion of the section suggest drier conditions.

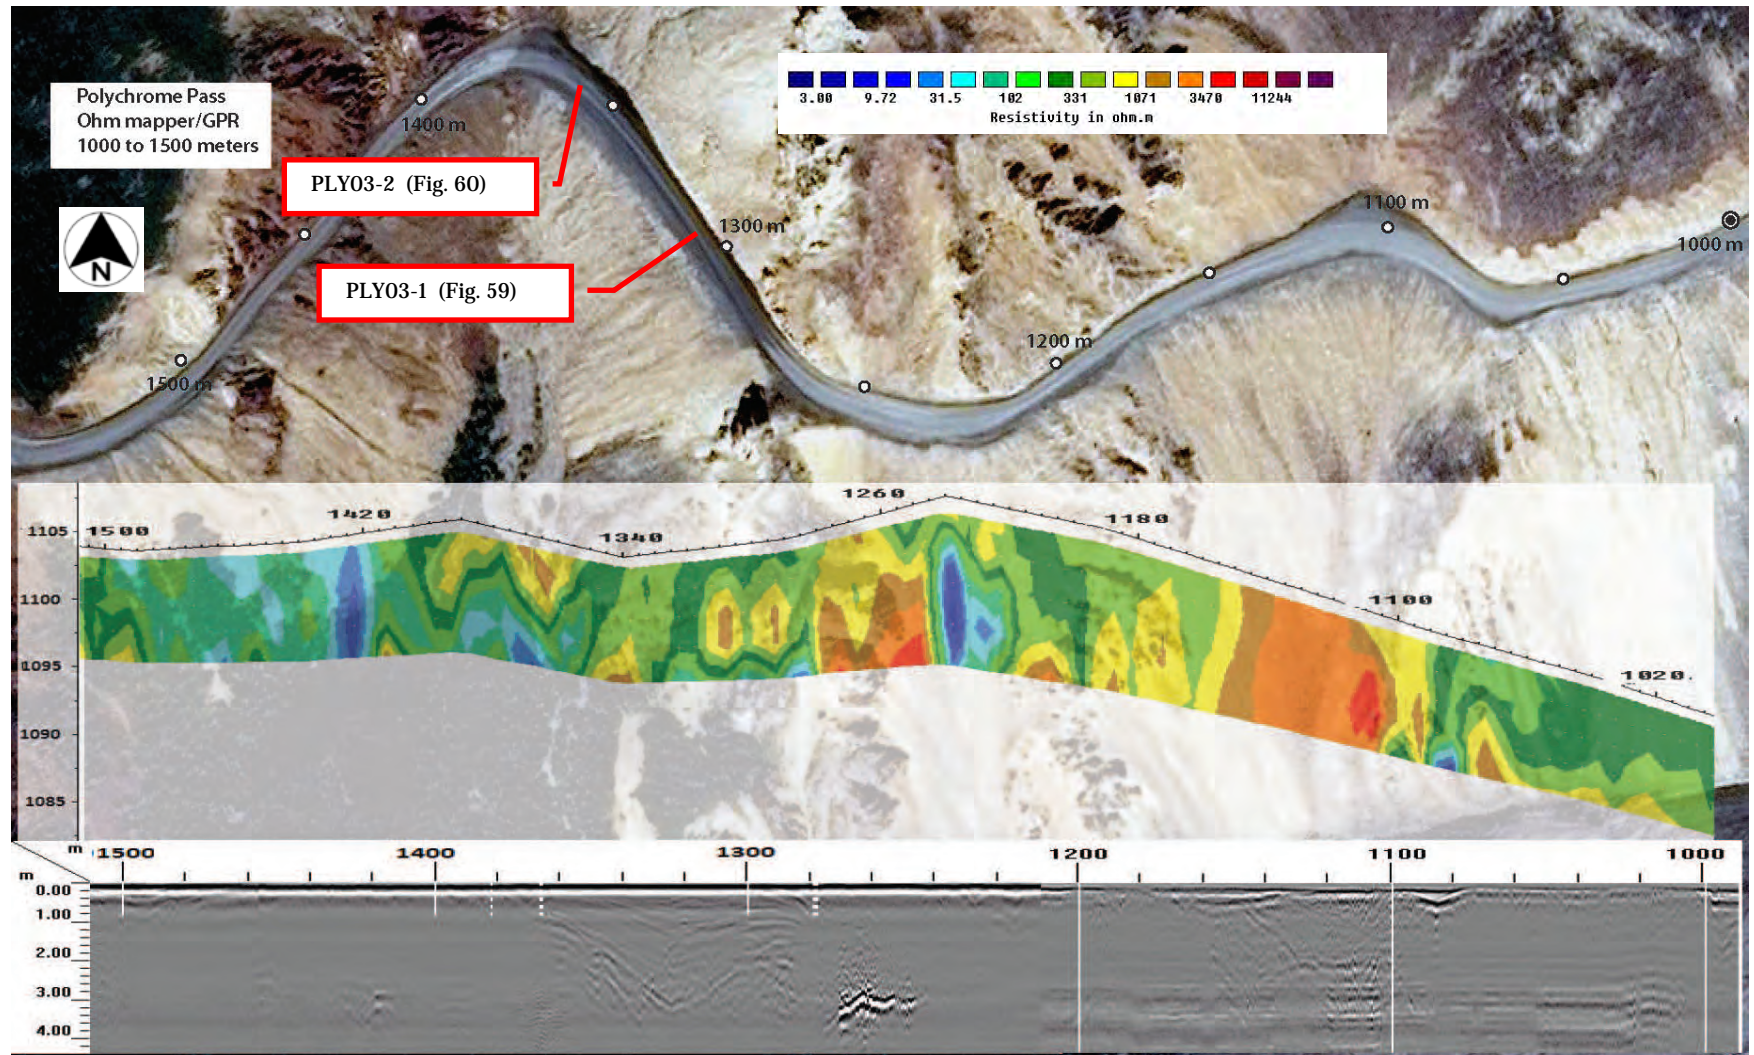
Figure 35. Polychrome Pass, 1000m to 1500m (3280-ft to 4921-ft). The ohm-m values are variable through this section with low values continuing from 950m and up to approximately 1100m. Here the roadway transcends an exposed ridge and much higher values begin and continue as the roadway cuts back into the strata and through a valley to the next ridge which is located at 1200m. This ridge has very low ohm-m values suggesting either very conductive mineralogy or moist/wet conditions at depth. At 1260m the road passes through a cut with high ohm-m values at depth, and then leads into the Pretty Rocks slide section. Through the slide section moderate near surface ohm-m values are measured with very low values at depth suggesting moist/wet conditions. The survey transcends the crotch at approx. 1390m, which is the contact between the mafic strata to the west and the felsic strata (rhyolite) to the east. After this valley, low ohm-m values are measured through to the end of the section. The GPR is very unremarkable through this section except for distinct reflections starting at 1260m where the road passes through the cut.

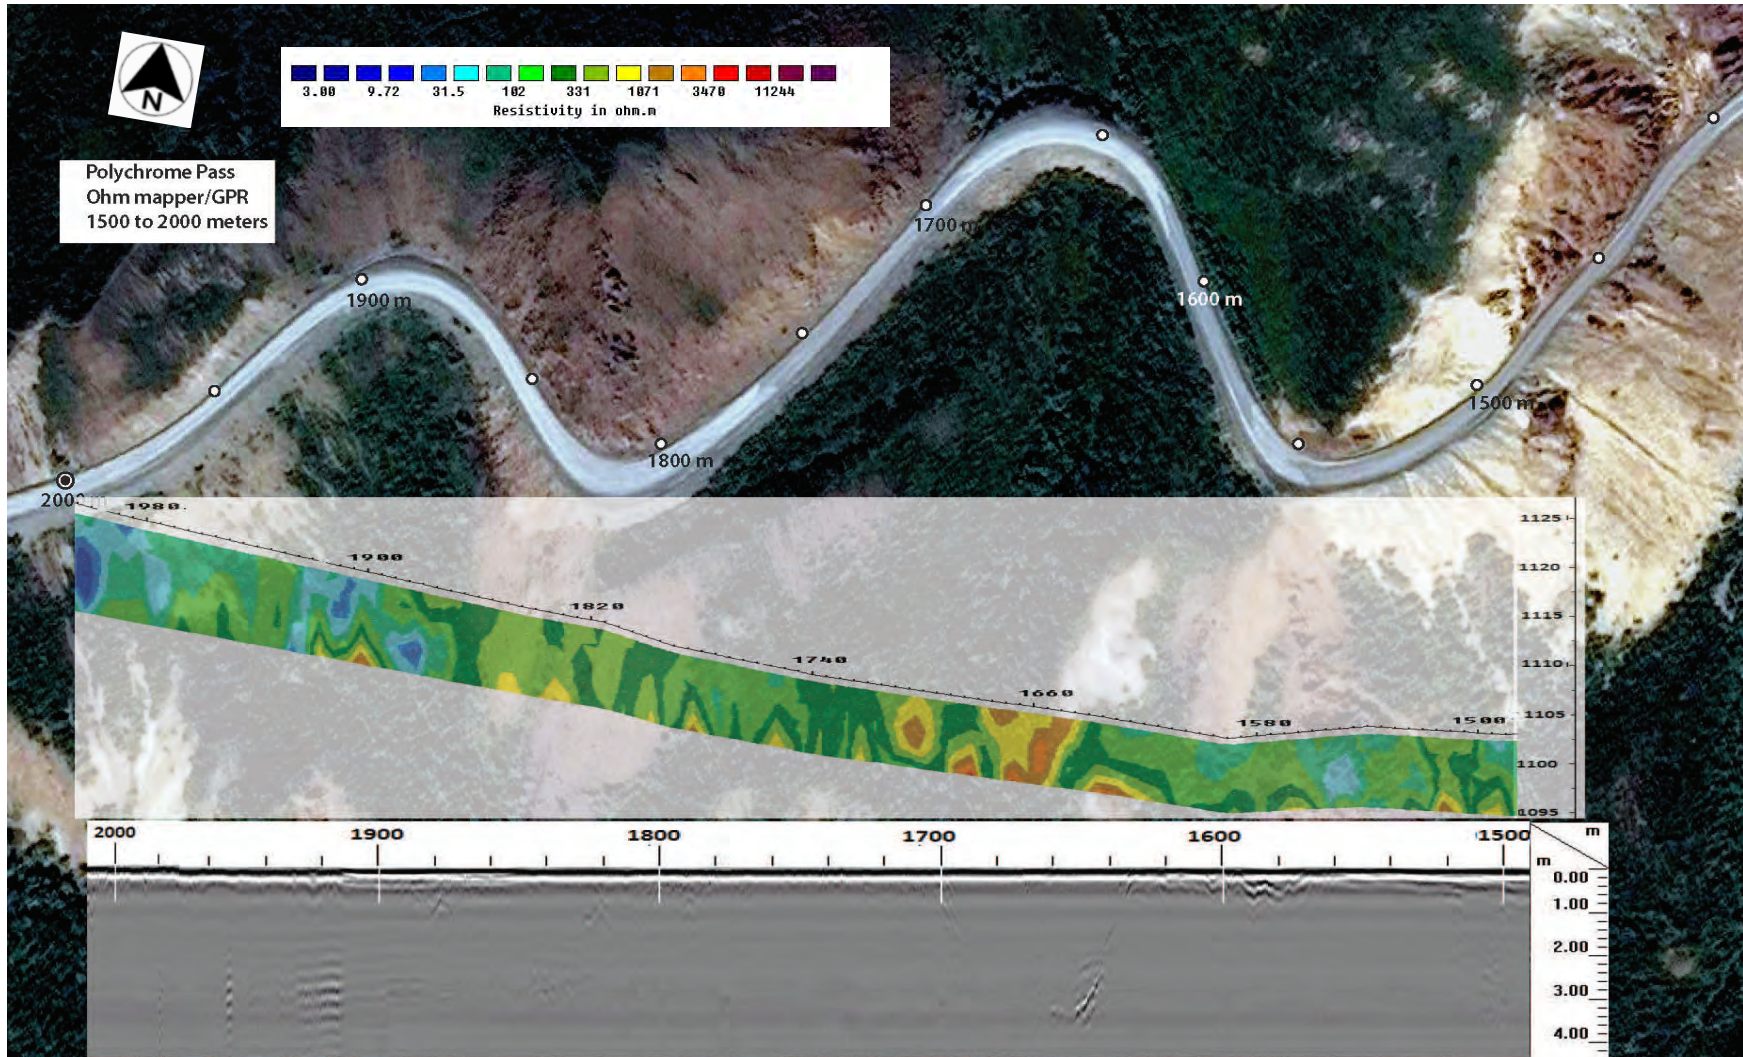
Figure 36. Polychrome Pass, 1500m to 2000m (4921-ft to 6562-ft). The ohm-m values are not as highly varied through this section, with generally low values throughout except for moderate near surface values at 1660m, and moderate values at the extreme depth starting at 1500m to 1900m. The GPR provides no distinct reflections through this area.

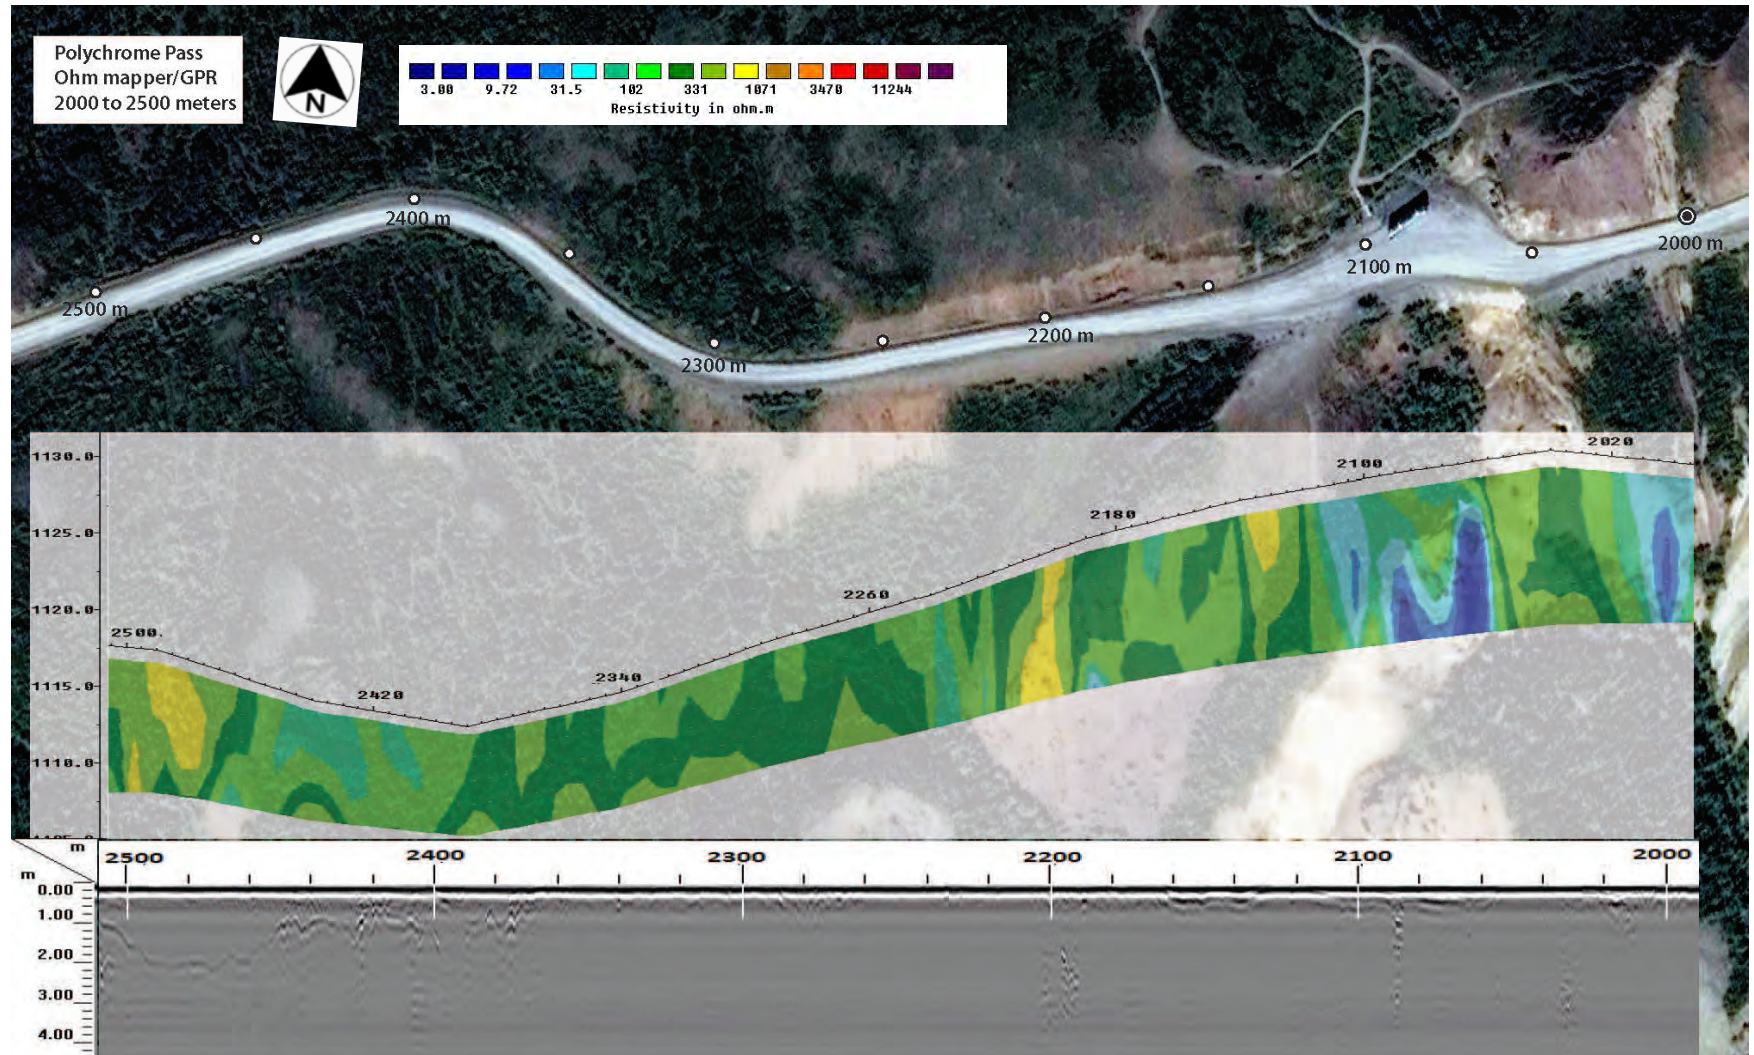
Figure 37. Polychrome Pass, 2000m to 2500m (6562-ft to 8202-ft). The ohm-m values through this section are varied with very low values just before and through the overlook area. These low values are possibly high moisture values of the clayey ash deposit seen on the north side of the overlook, which appears to fold over the two sides of the cut. The values moderate through the remaining section with no distinctive anomalies other than what appears to be lower resistivity at approximately 2400m. The GPR is unremarkable through this section.

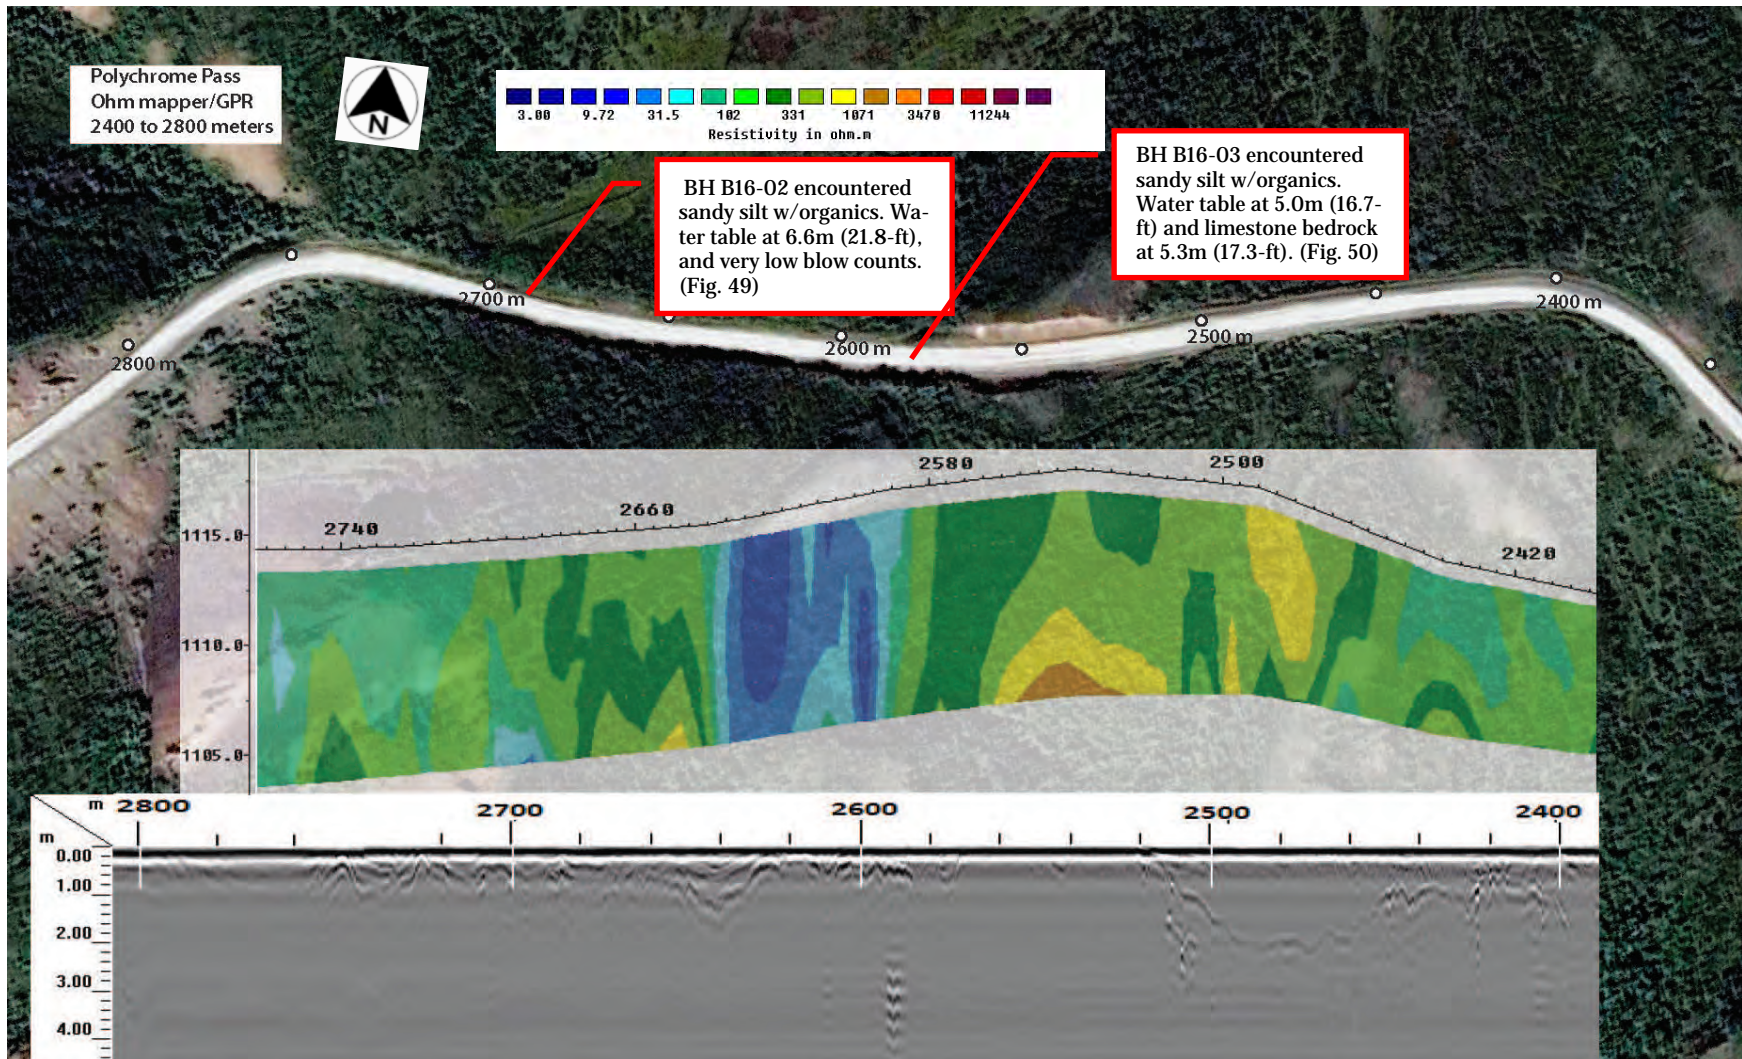
Figure 38. Polychrome Pass, 2500m to 2800m (8202-ft to 9186-ft), end of transect. The ohm-m values are generally low through this section with the low values continuing from the previous section at 2400m to 2480m. Near surface and deeper values increase while passing through a small road cut at 2540m, indicating bedrock which was encountered in BH B16-03. Very low values are encountered at 2600m to 2640m and this coincides with surface water immediately adjacent to the road on the north side. The values increase only slightly through to the end of the section. The GPR is unremarkable except for distinct near surface reflections visible showing a down drop of the subgrade surface from 2440m to 2500m, and a smaller dip from 2625m to 2660m.

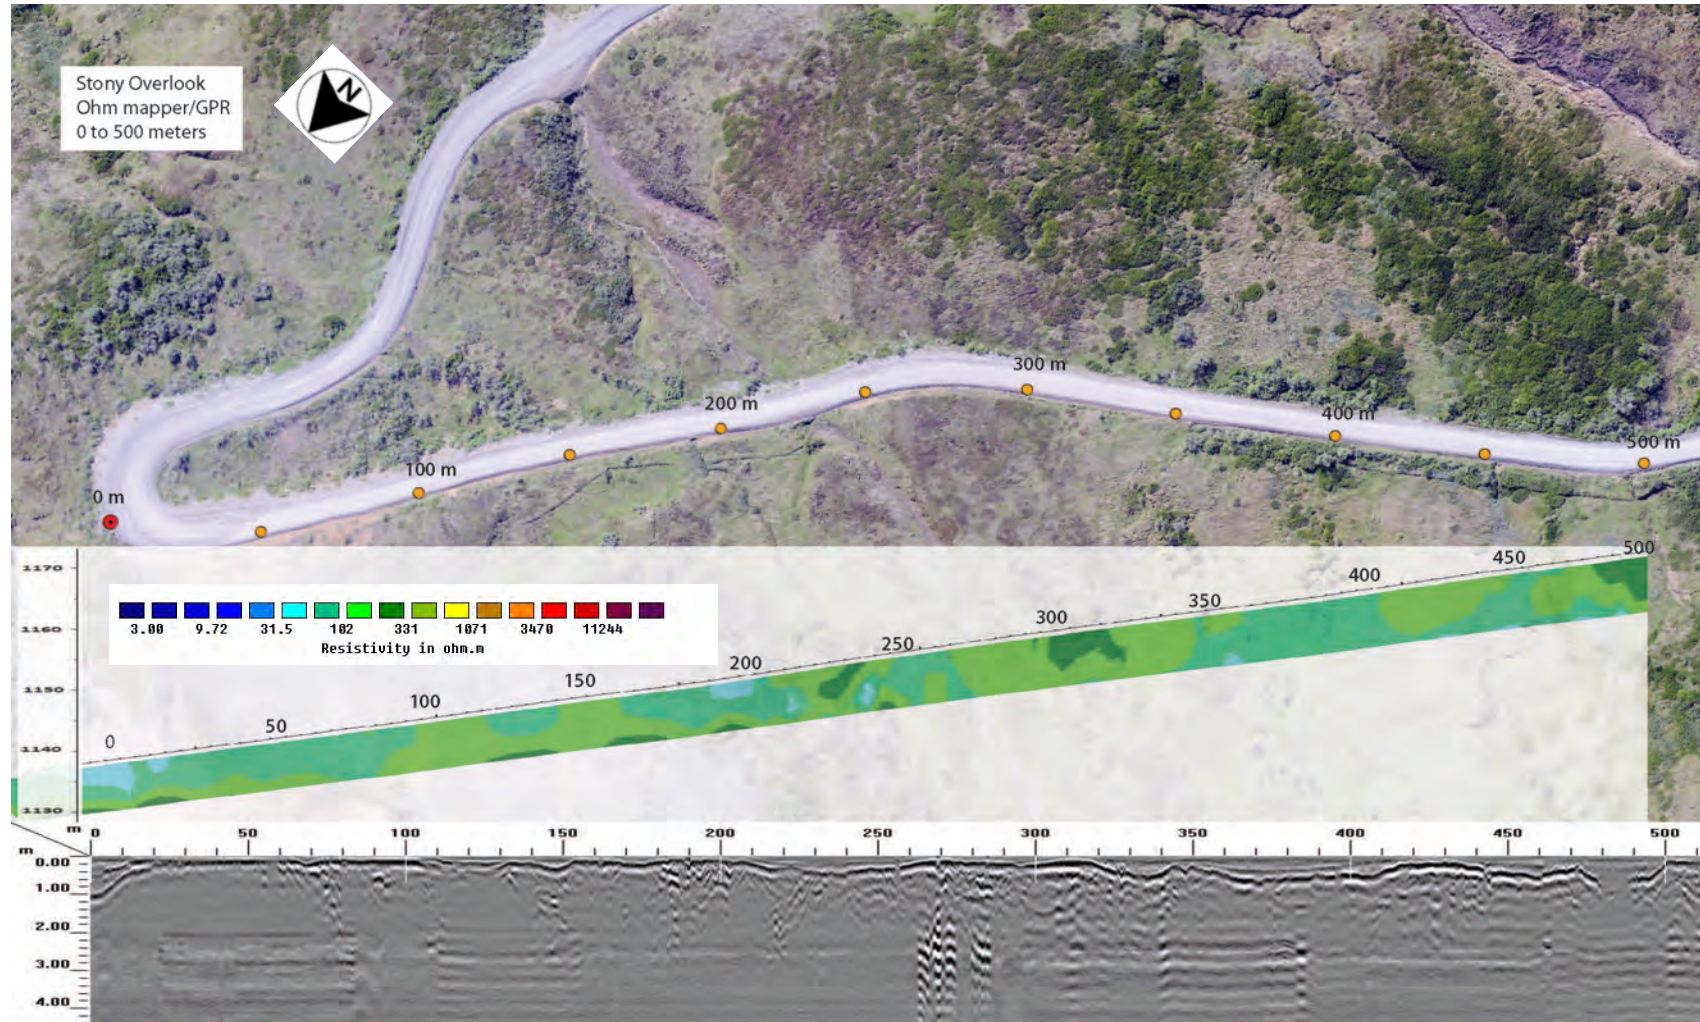
Figure 39. Stony Overlook, 0m to 500m (1640-ft), start of transect. The view direction of this transect is oriented generally looking south, therefore the transect moves from left to right, east to west. The ohm-m values are very low through this first section generally indicating either moist/wet conditions or high conductivity bedrock to depth. The GPR image reports a strong reflector at 0.5m to 1.0m (1.6-ft to 3.3-ft) depth, which is inferred to be the native surface prior to the road construction. No ice-rich frozen ground is indicated in this section.
