Geotechnical Report No. 11-20

**Pretty Rocks Landslide
2018-2019 Geotechnical Investigation and Conceptual
Design Alternatives Report**

**AK NPS DENA 10(45)
Denali National Park, Alaska
August 2020**

U.S. DEPARTMENT OF TRANSPORTATION
FEDERAL HIGHWAY ADMINISTRATION

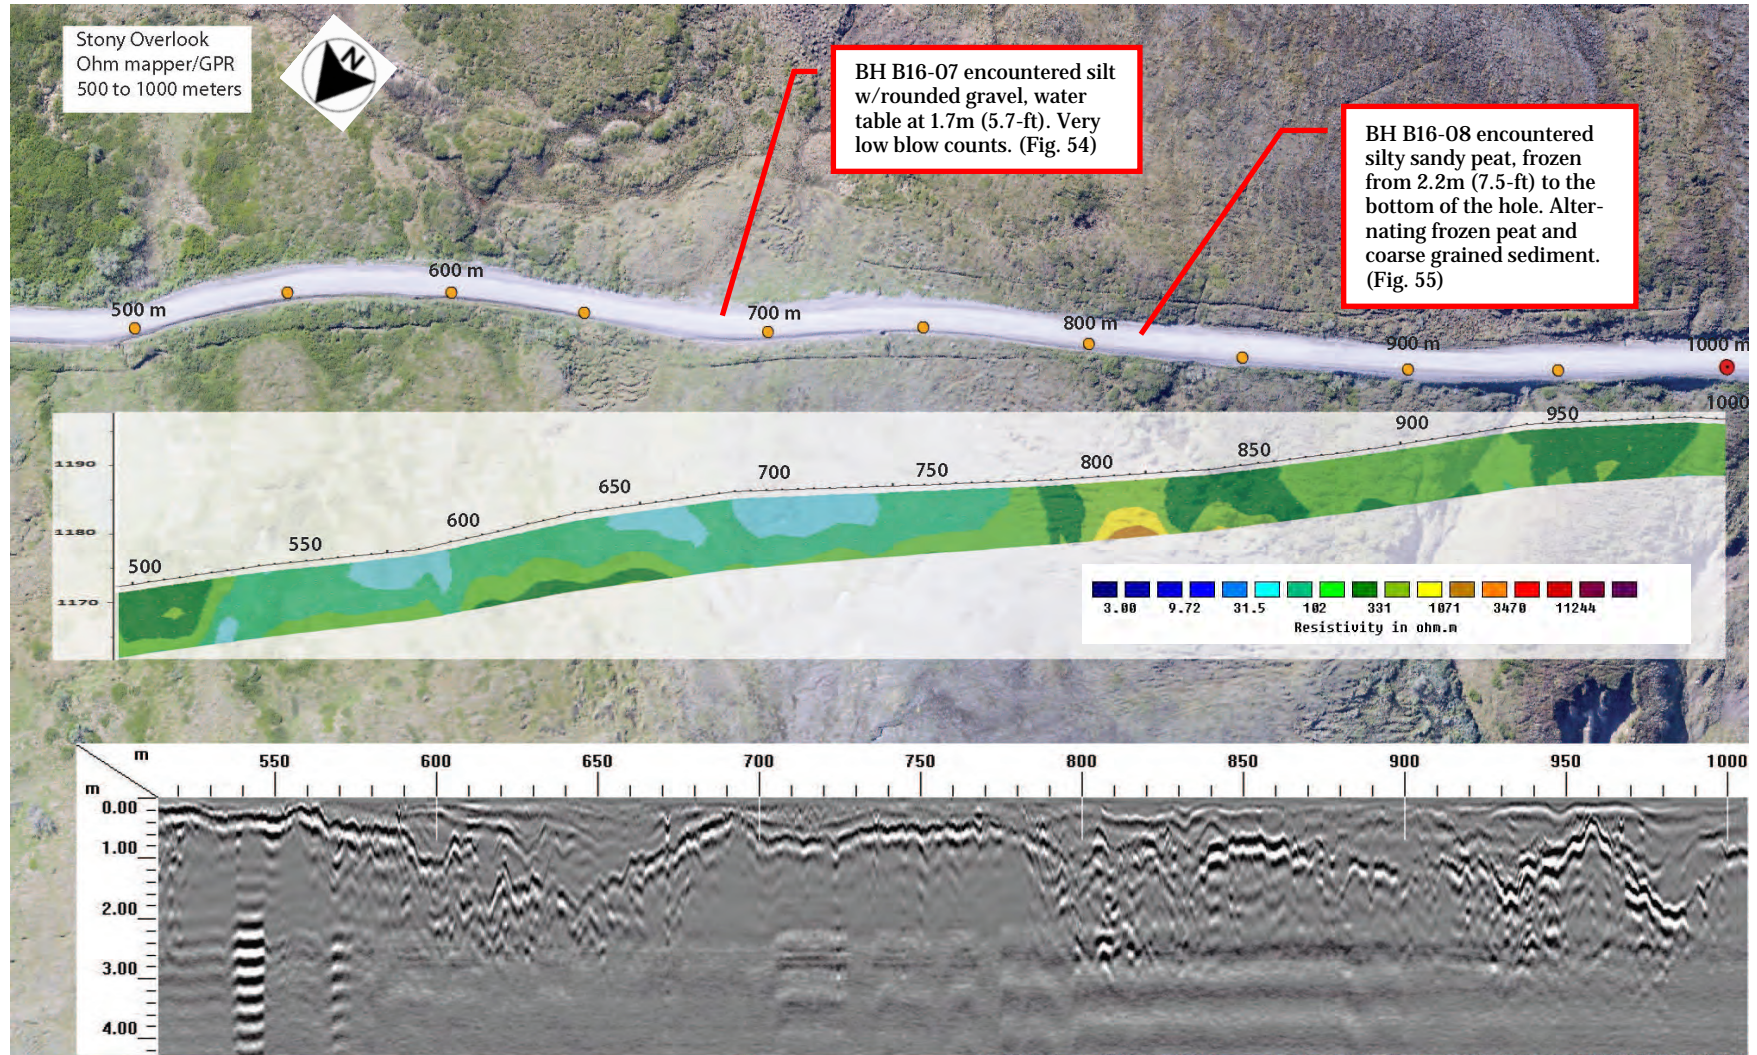
Figure 40. Stony Overlook, 500m to 1000m (1640-ft to 3280-ft). The ohm-m values for the portion from 500m to 750m indicates moist/wet conditions nearly full depth. A high resistivity anomaly exists at approximately 800m and appears to be associated with a natural drainage feature on the north side of the road, and drilling indicates buried frozen peat and fine grained sediments. This is followed by slightly elevated ohm-m values vs. the first half of the section. The GPR reflectors are very strong through this section indicating good imaging of what is believed to be the native surface prior to road construction. The primary reflector has a polarity change from white to black to white (+, -, +), which indicates a higher dielectric material over a lower dielectric material, with one explanation as water perched on the top of a confining layer. Deep natural drainage features at 650m and 980m appear to be filled to level the roadway.

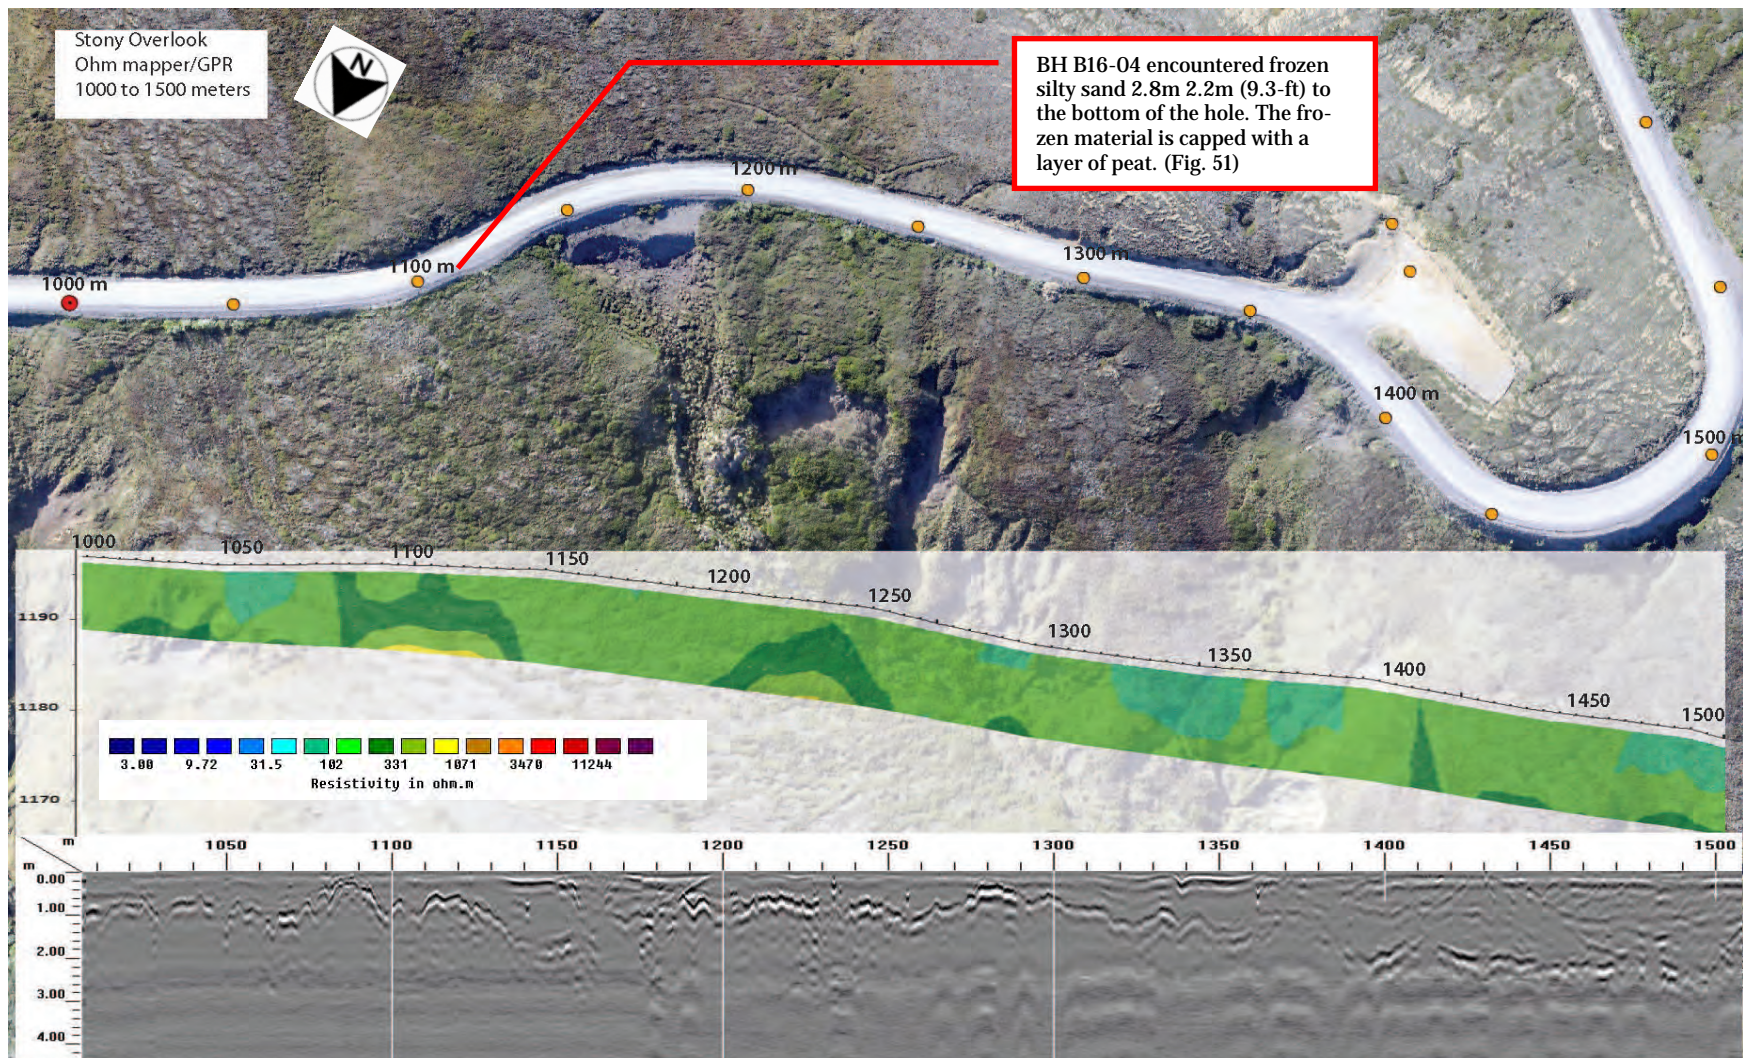
Figure 41. Stony Overlook, 1000m to 1500m (3280-ft to 4921-ft). The ohm-m values are very low through the entire depth and length of the section. Slightly elevated ohm-m levels are seen at extreme depth at 1100m and 1250m and can be inferred to exist at extreme depth at 1300m and 1400m to 1500m. Drilling at 1100m encountered frozen silty sand to the bottom of the hole. The GPR again reports a strong (+, -, +) phase reversal in the near surface, inferred to be the native surface prior to road construction. A deep fill section is seen at approximately 1150m and deep fill is seen starting at approximately 1300m and extending to the end of the section, presumably this deep fill section of 2.0m (6.6-ft) was required to make grade on the switch-back turn. Chaotic bedrock structure is not seen below the presumed native surface.

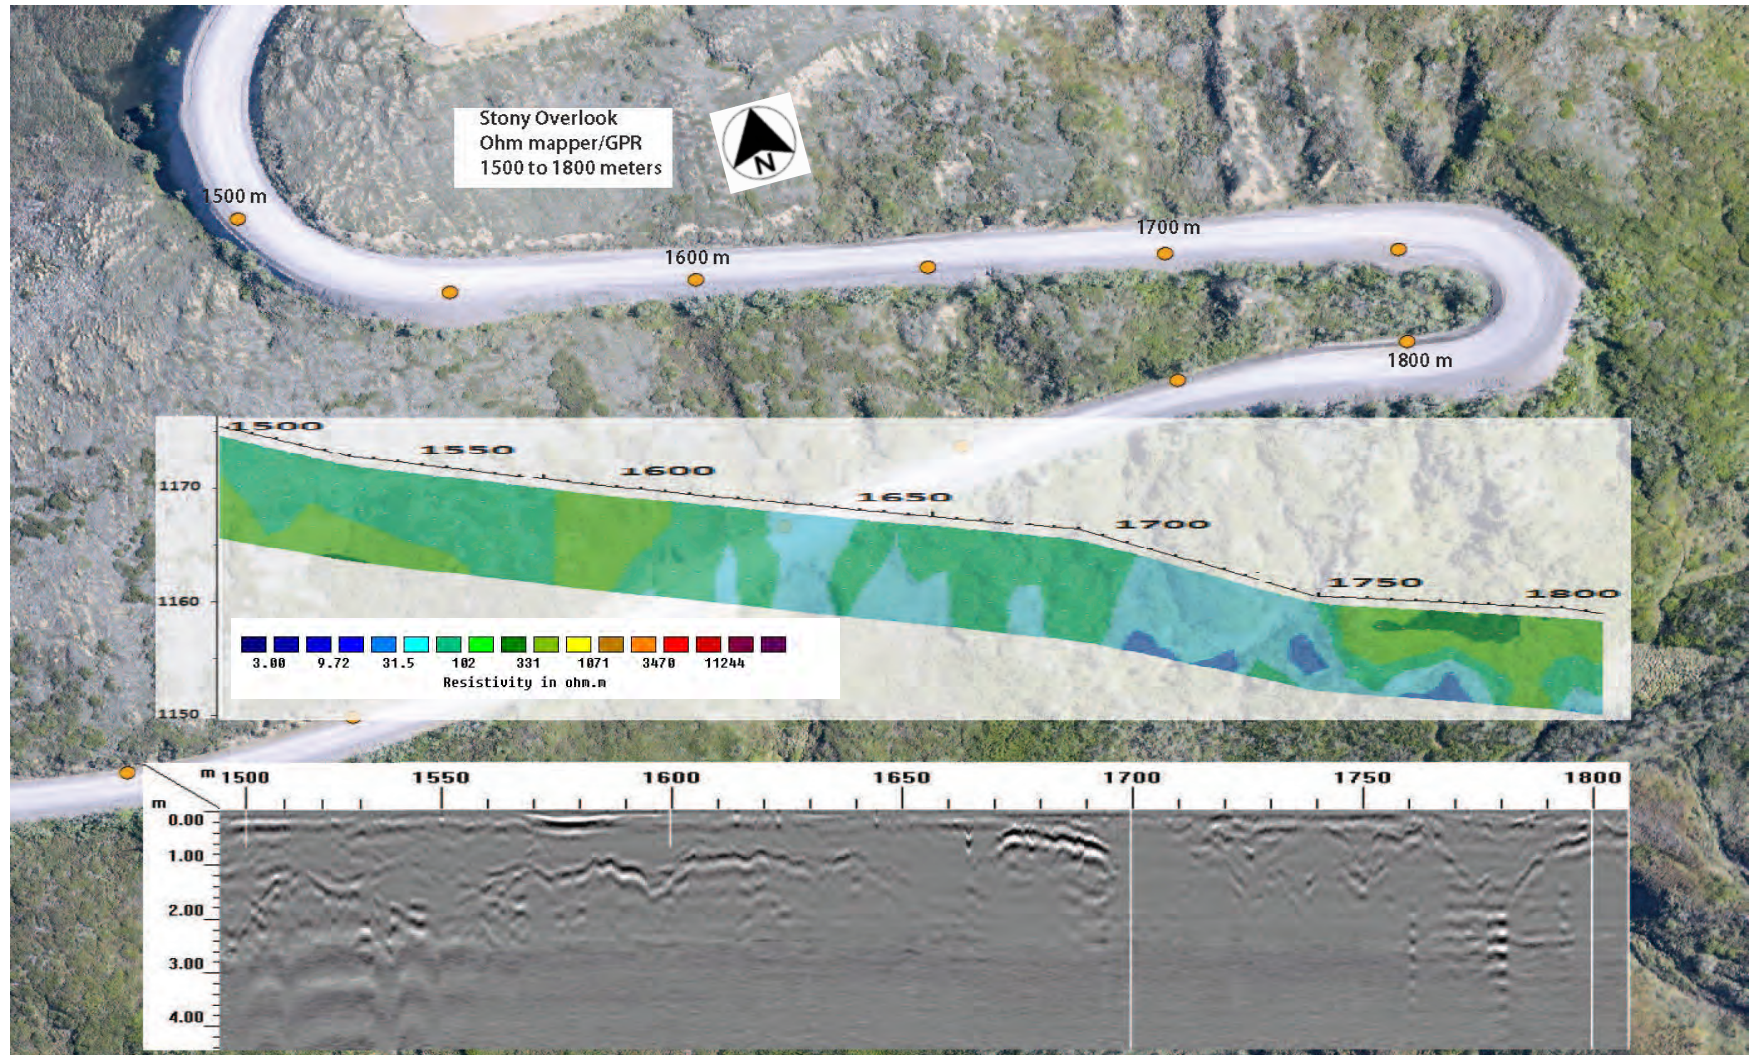
Figure 42. Stony Overlook, 1500m to 1800m (4921-ft to 5906-ft). Very low ohm-m values continue, with moist/wet conditions or high conductivity bedrock from 1625m to 1650m to 1750m. Coincidentally the GPR returns are smeared at these locations strongly indicating radar energy absorption due to water or other material. The GPR indicates the deep fill section noticed at the end of the previous section for the switch-back turn continues starting at 1500m and ending at approximately 1675m.

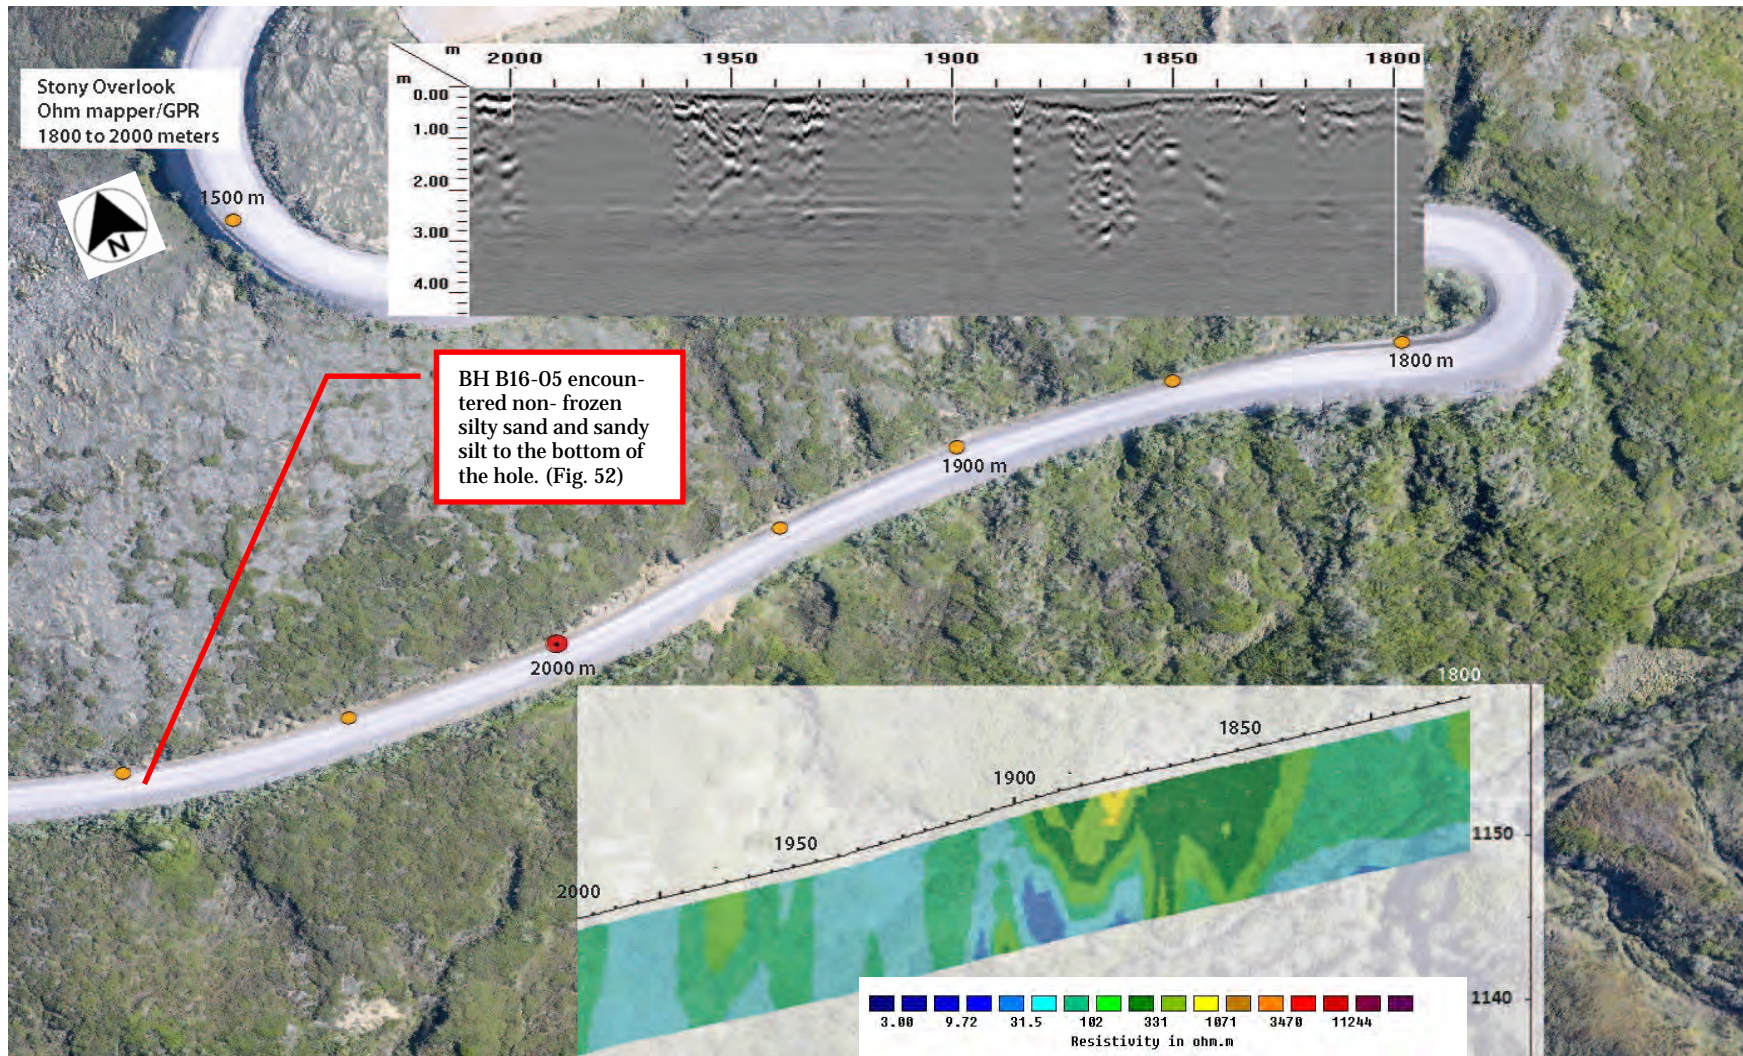
Figure 43. Stony Overlook, 1800m to 2000m (5906-ft to 6562-ft). Very low ohm-m values are recorded on this section leading down to the final switch-back. Moist/wet conditions or high conductivity bedrock are inferred at depth at 1800m to 1850m and at 1900m, also throughout the depth from 1925m to 2000m. A slightly high resistivity anomaly exists at 1880m, and based on the GPR returns we infer this to be a drainage appurtenance. The GPR is not remarkable in this section.

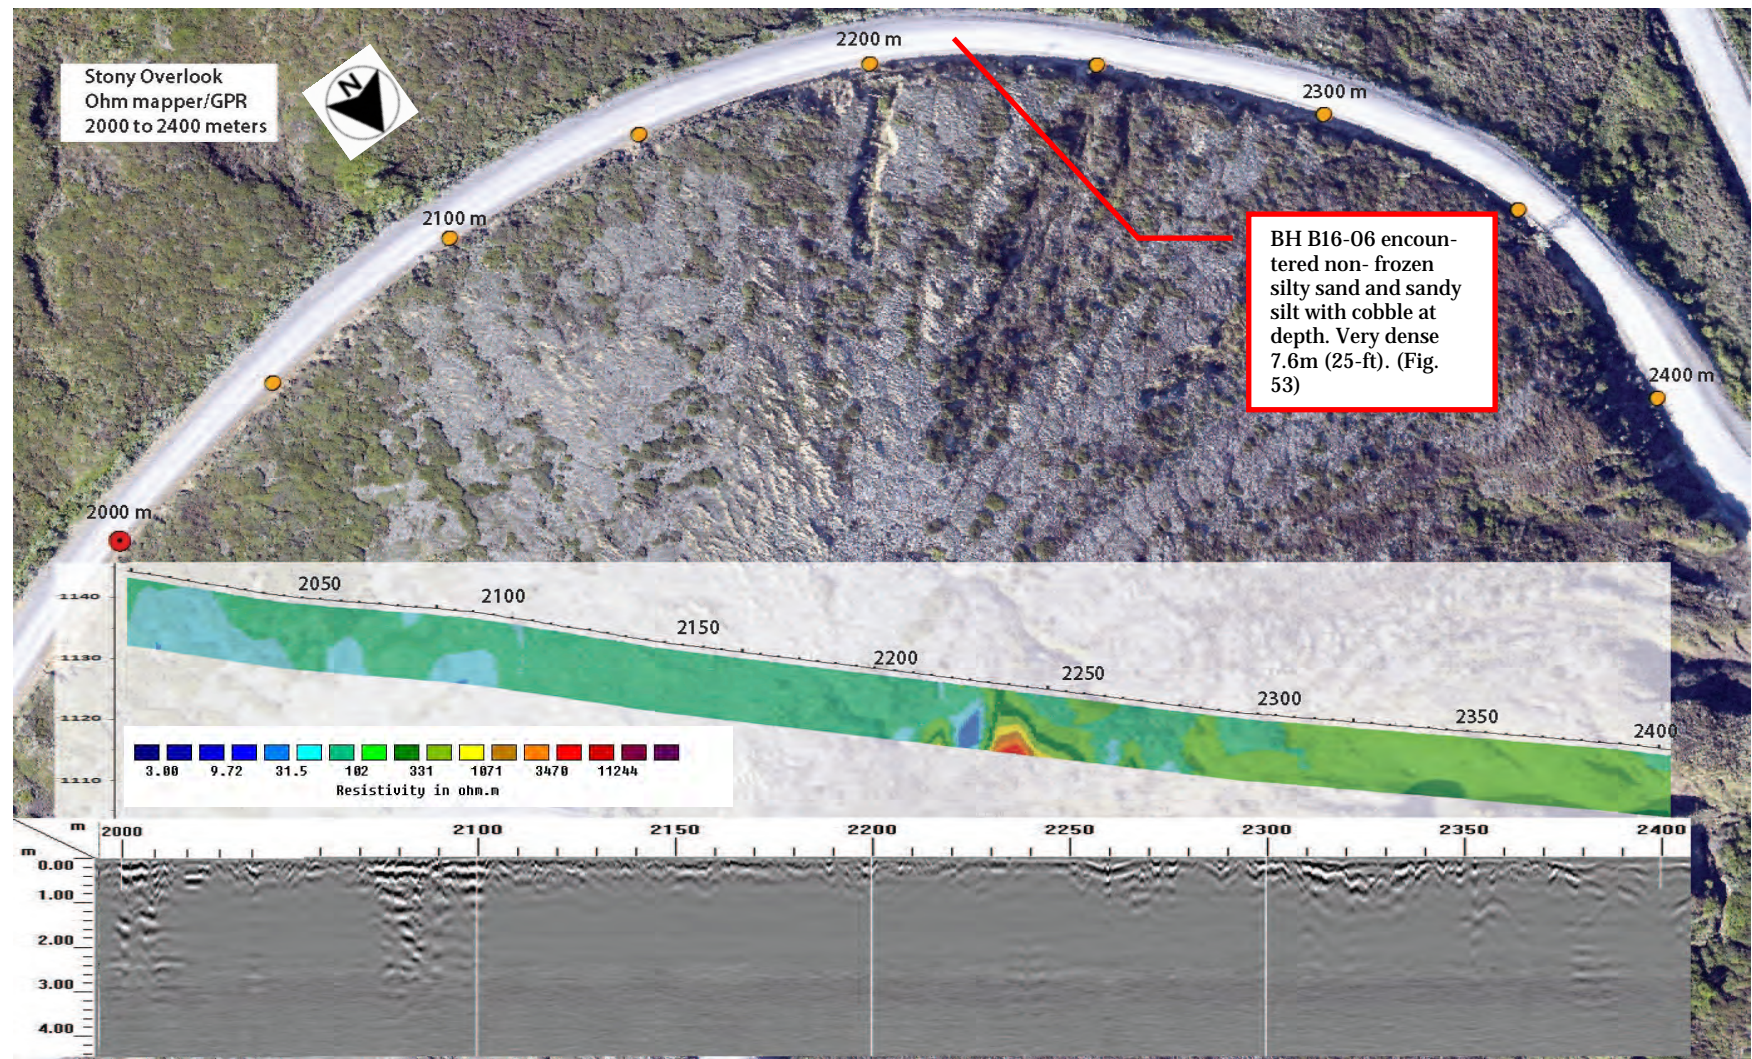
Figure 44. Stony Overlook, 2000m to 2400m (6562-ft to 7874-ft). The ohm-m values for this section are again very low, with possibly moist/wet conditions, or high conductivity bedrock existing from 2000m to 2300m. A very high resistivity anomaly exists at 2225m and lies too deep to be a drainage or other roadway appurtenance. Drilling at this location encountered non-frozen sediments. After 2300m the very low ohm-m values increase slightly. The GPR reflections are not remarkable in this section.

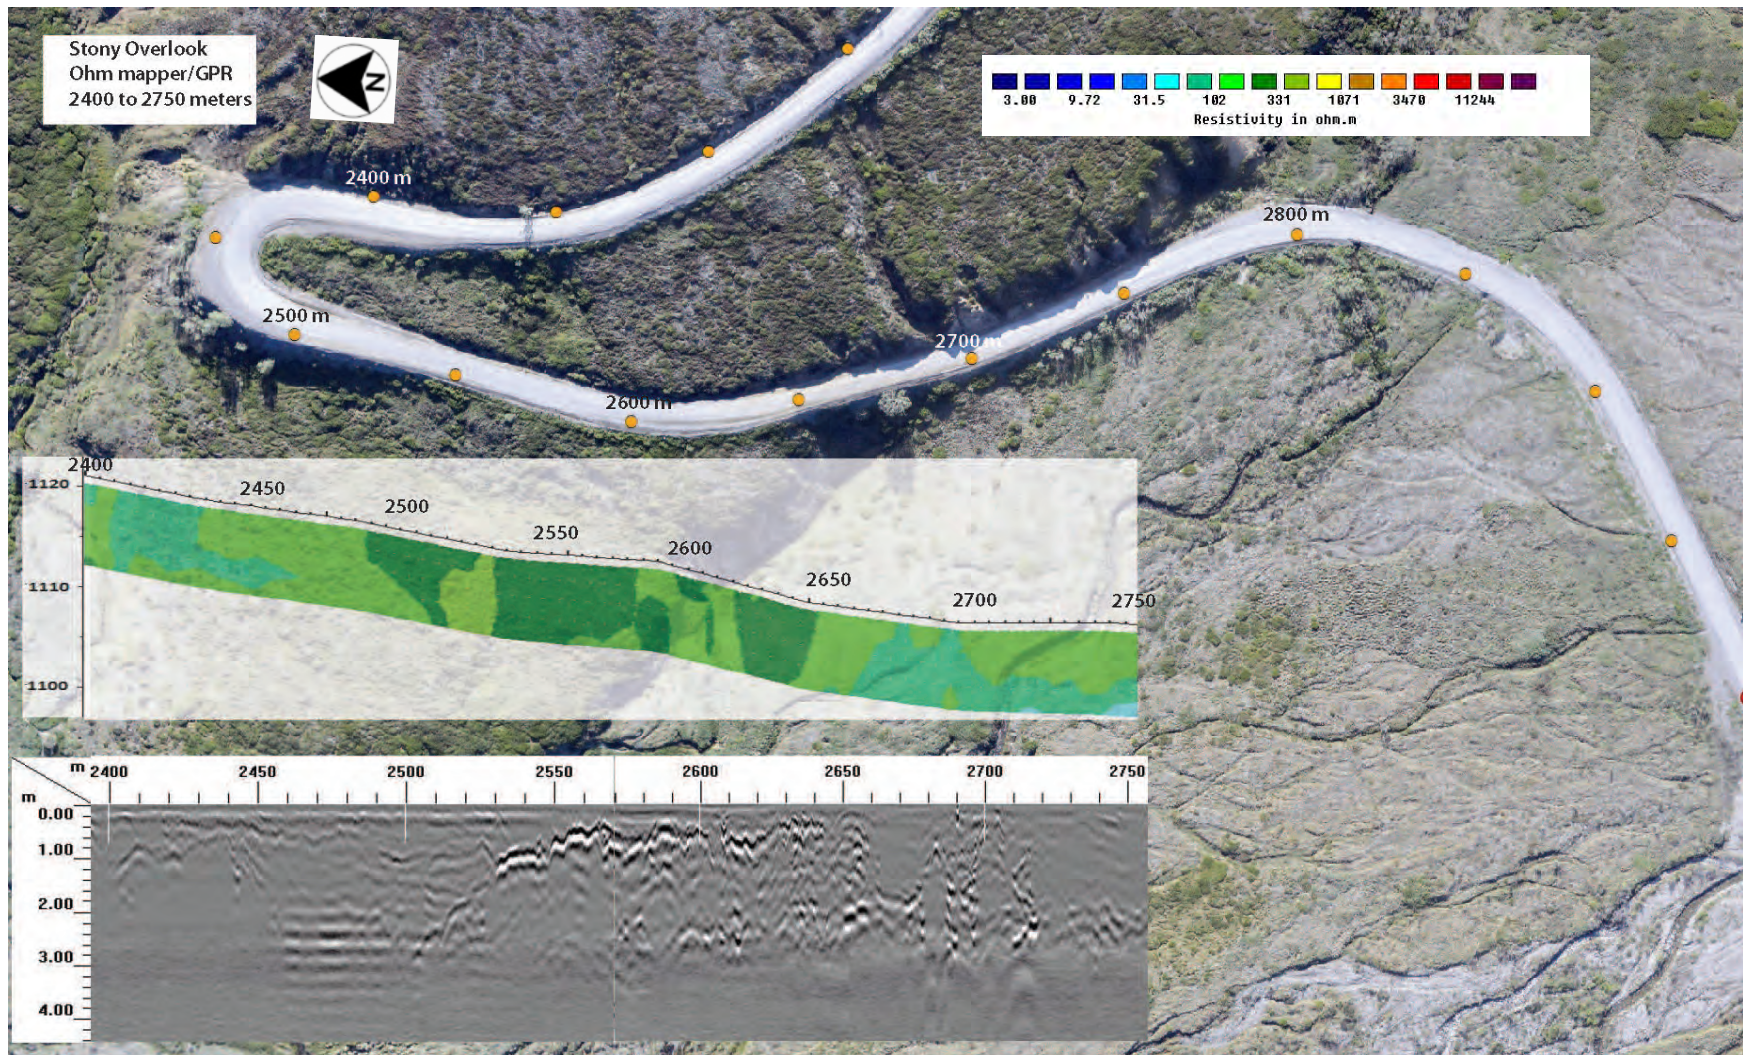
Figure 45. Stony Overlook, 2400m to 2750m (7874-ft to 9022-ft). The ohm-m values for this section are again very low, with possibly moist/wet conditions, or high conductivity bedrock existing for the full section and depth. The GPR imaging reports good imaging of chaotic structure with two distinct reflectors with one at 1.0m (3.2-ft) depth and the other at 2.5m (8.2-ft) depth, or this could be very coarse grained sediment material (outwash or till?). The GPR reflections are strongest where the ohm-m values are higher, indicating wet conditions may prevail elsewhere and the subsurface water is absorbing the radar energy.

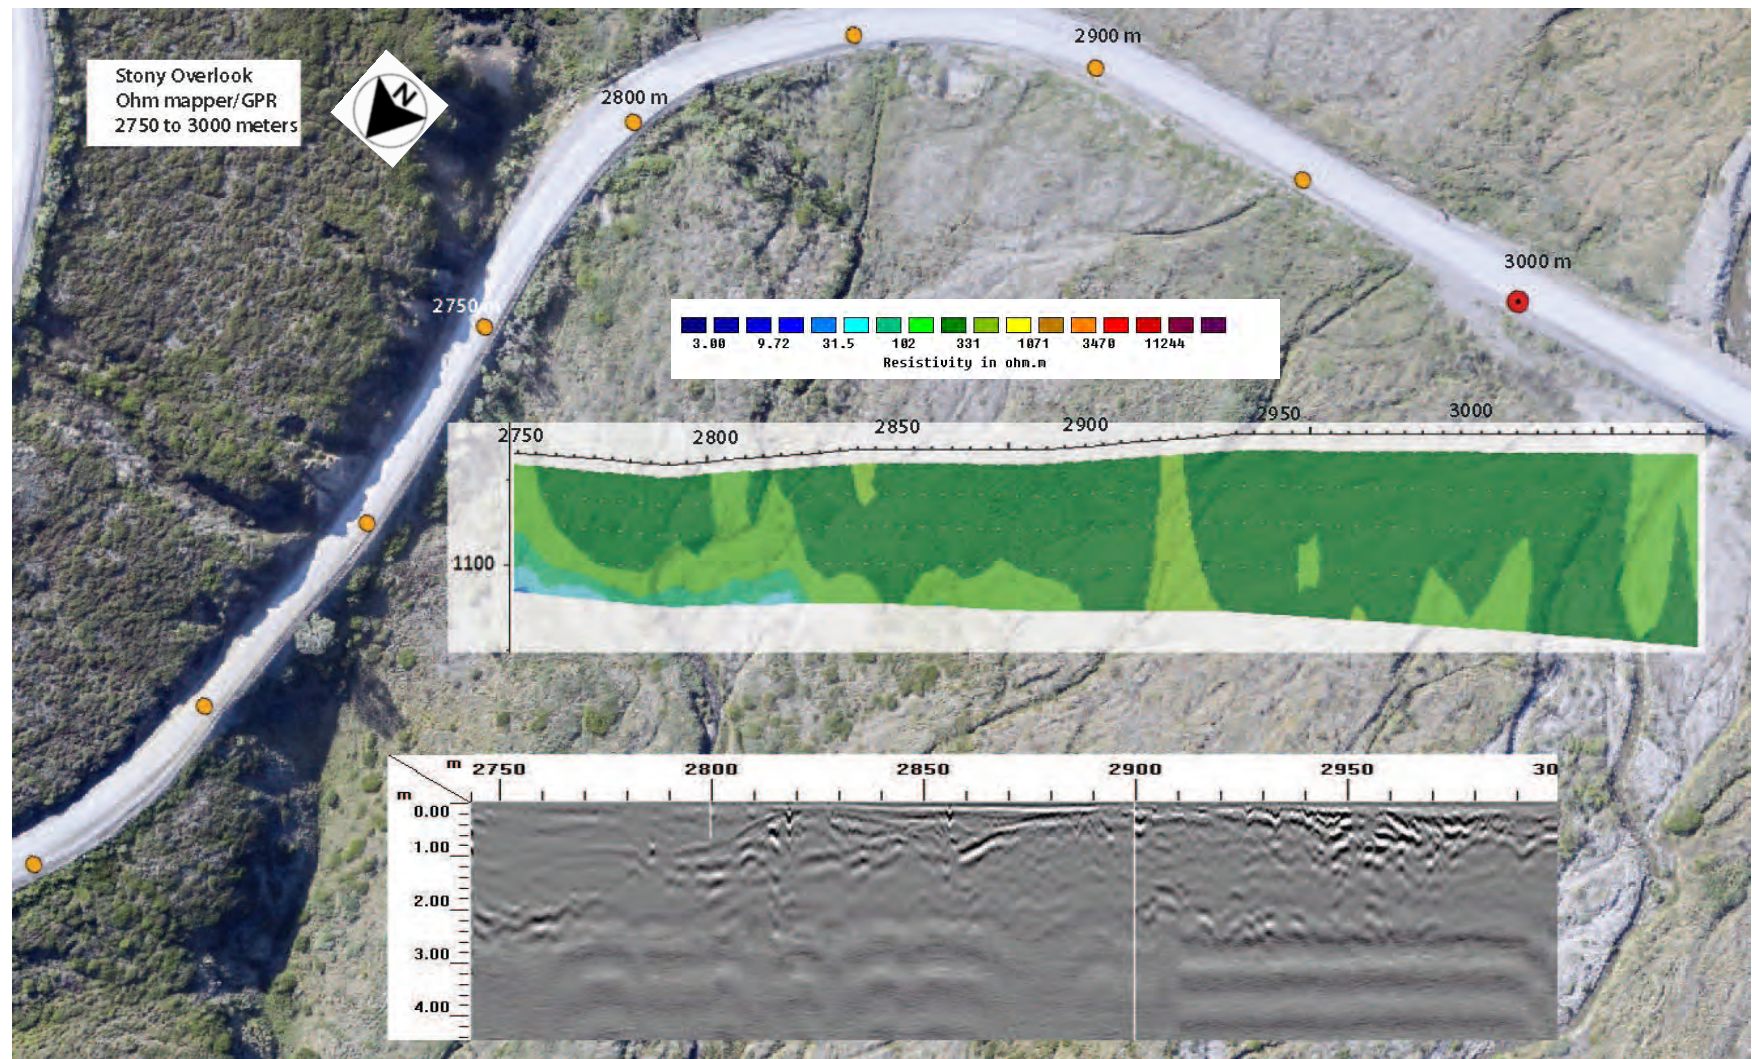
Figure 46. Stony Overlook, 2750m to 3000m (9022-ft to 9843-ft), end of transect. Low ohm-m values dominate this section, with very low values at depth from 2750m to 2825m. The GPR reports good reflections in the near surface with improving clarity of signal with distance along the section.

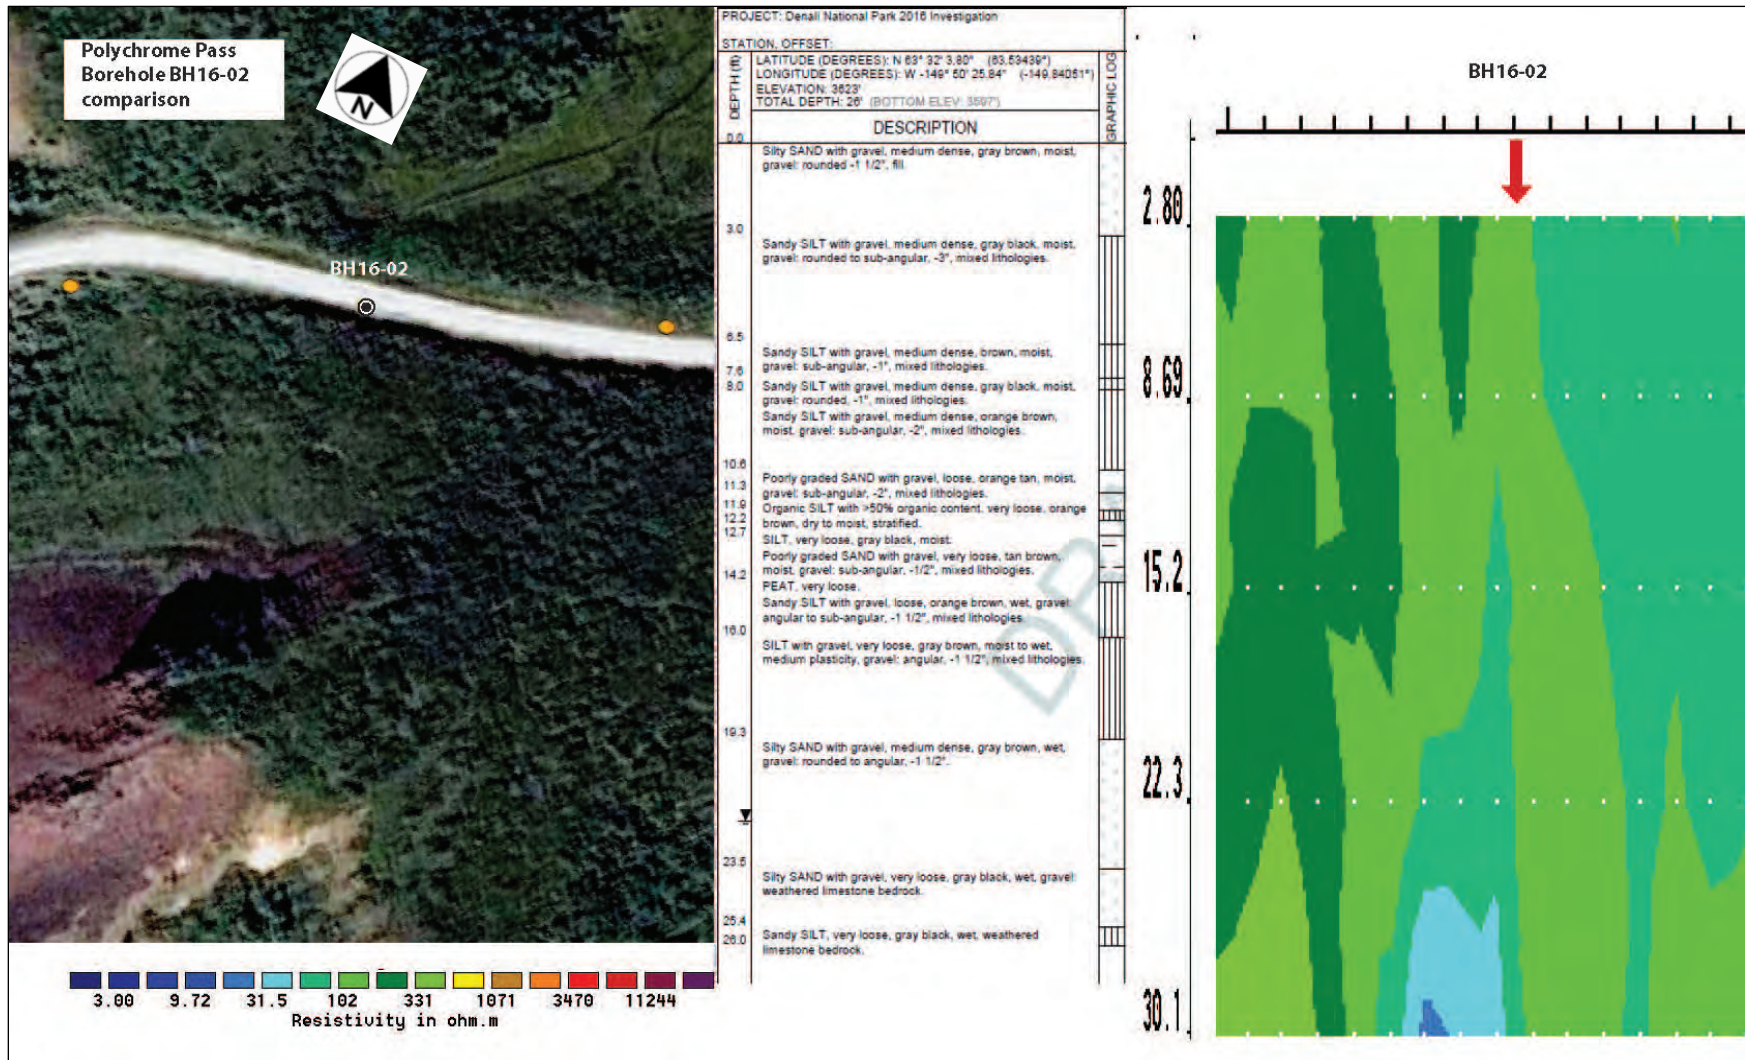
Figure 49. BH16-02 Polychrome Pass. Ohm-m values are very low consistent with the drilling results of silts, sands and peats, indicative of very wet soils.

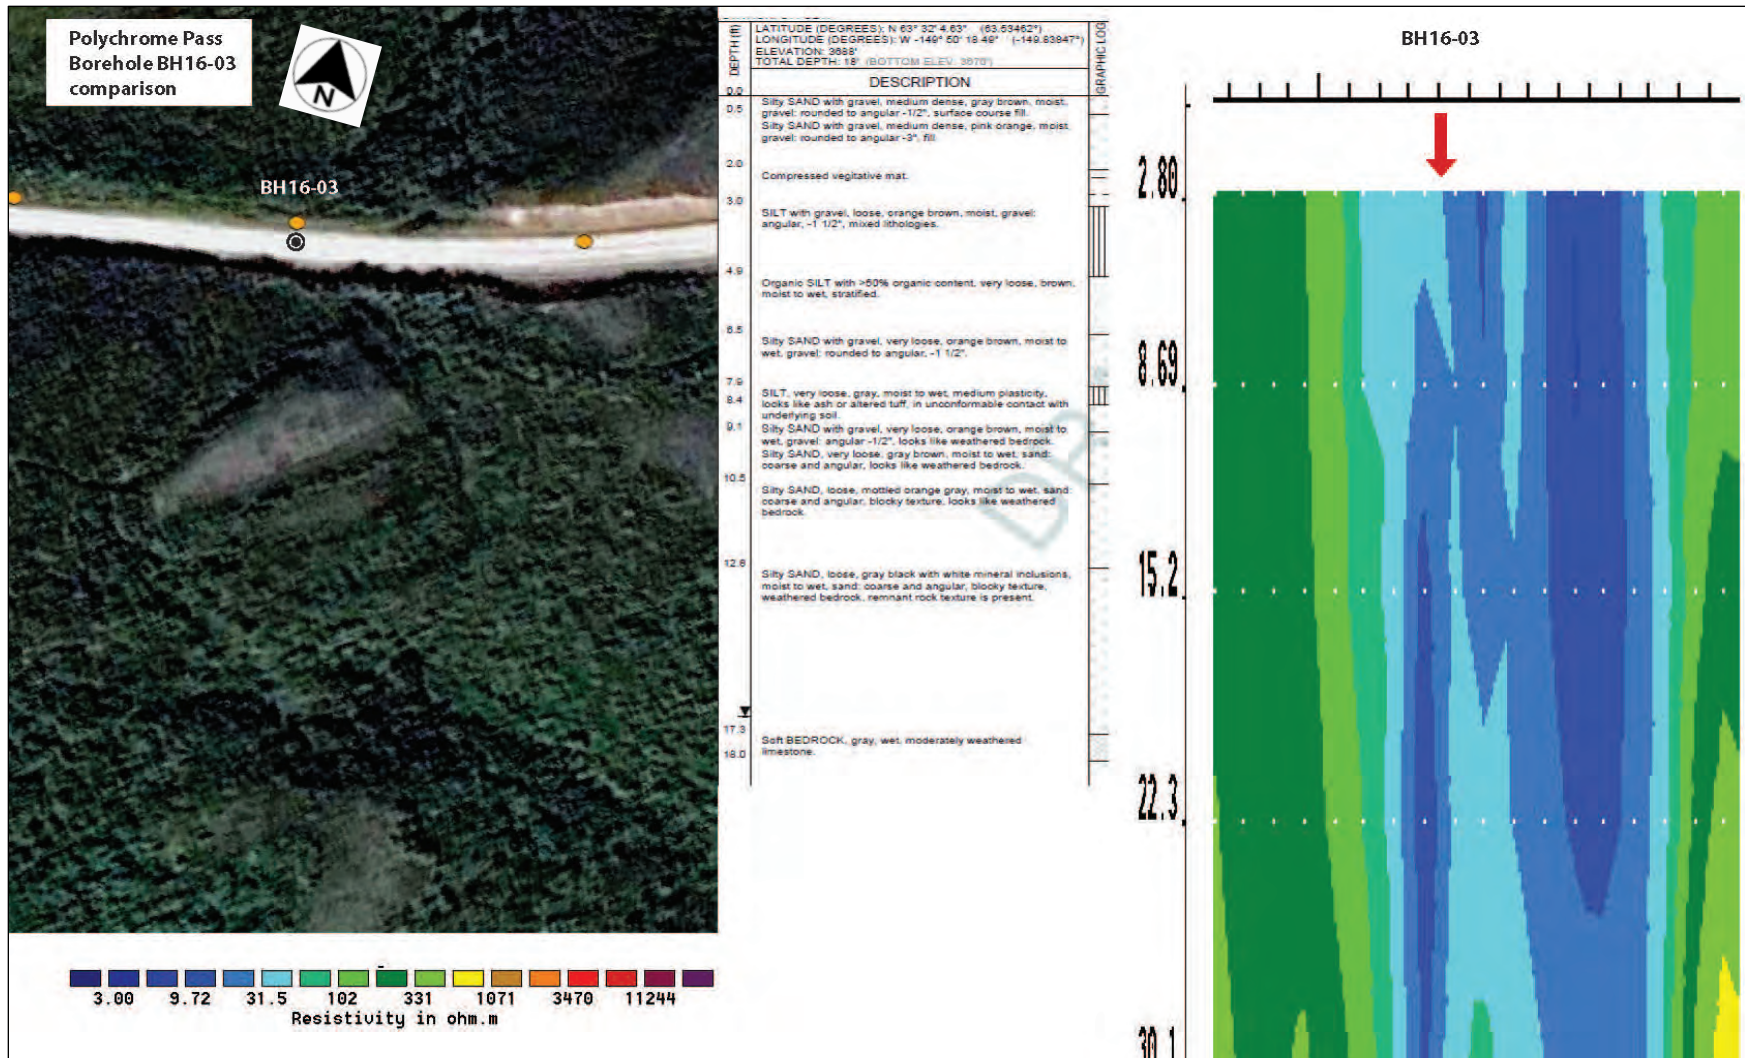
Figure 50. BH16-03 Polychrome Pass. Ohm-m values are very low, consistent with the drilling results of wet silts and sands, indicative of very wet soils.

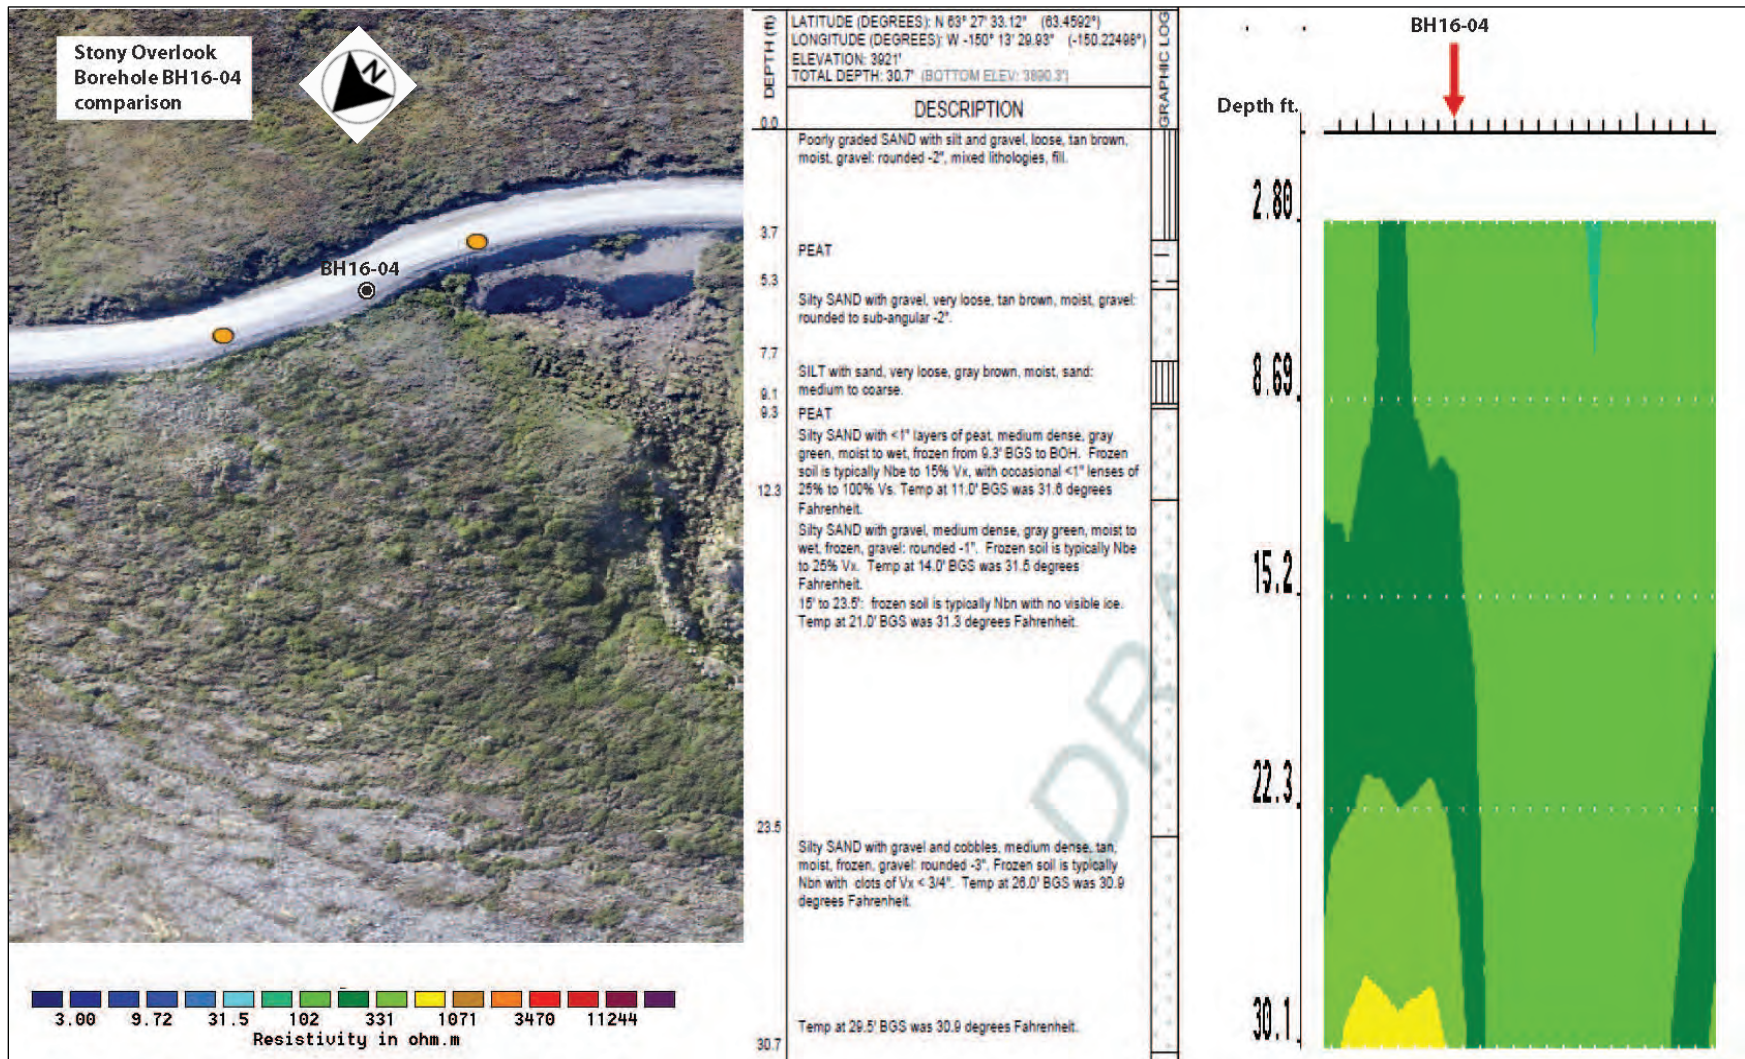
Figure 51. BH16-04 Stony Overlook. The ohm-m values are low at the top of the borehole and this is consistent with the drilling results of thawed silty sands with peat. The hole is frozen from 9.3' to BOH. The frozen material consists of silty sands and gravel, which based on the ohm-m values indicates this coarse grained material is not ice-rich, consistent with coarse grained sediments.

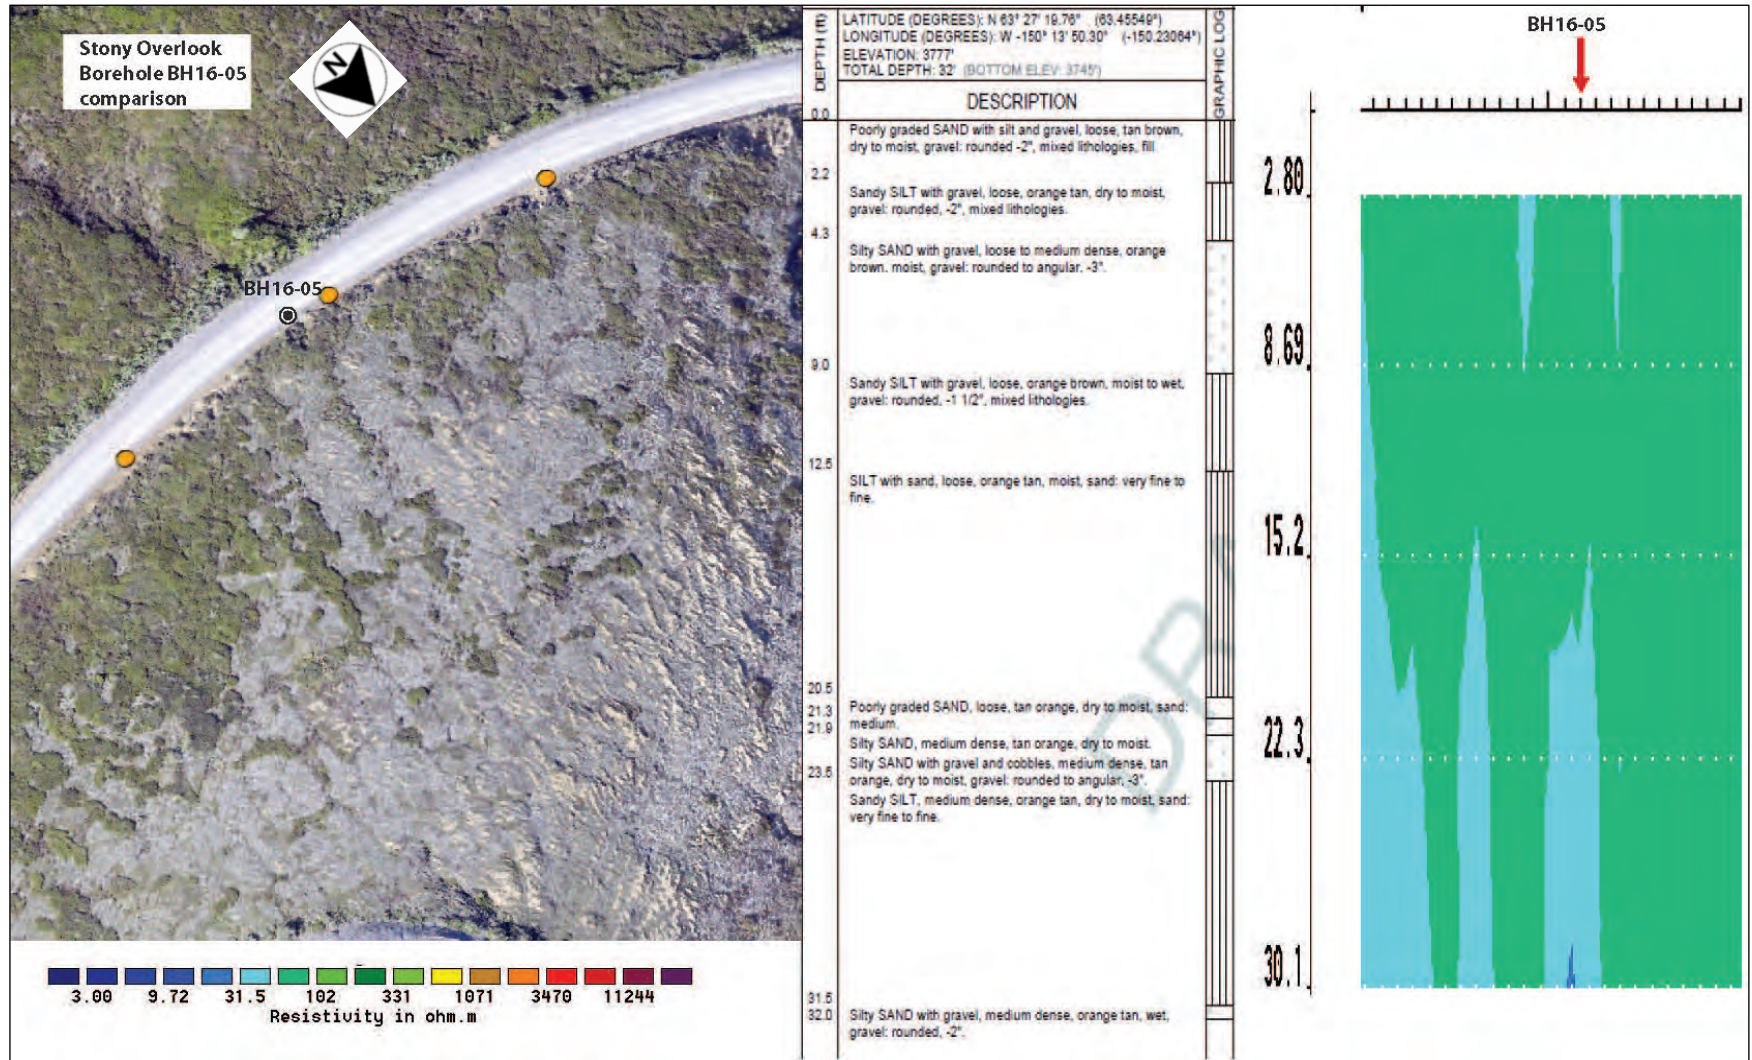
Figure 52. BH16-04 Stony Overlook. The ohm-m values are low at the top of the section becoming very low at the bottom of the section. This is consistent with the drilling results where sandy silt and silty sand was encountered down to 23', becoming more wet with gravel.
