Geotechnical Report No. 11-20

**Pretty Rocks Landslide
2018-2019 Geotechnical Investigation and Conceptual
Design Alternatives Report**

**AK NPS DENA 10(45)
Denali National Park, Alaska
August 2020**

U.S. DEPARTMENT OF TRANSPORTATION
FEDERAL HIGHWAY ADMINISTRATION

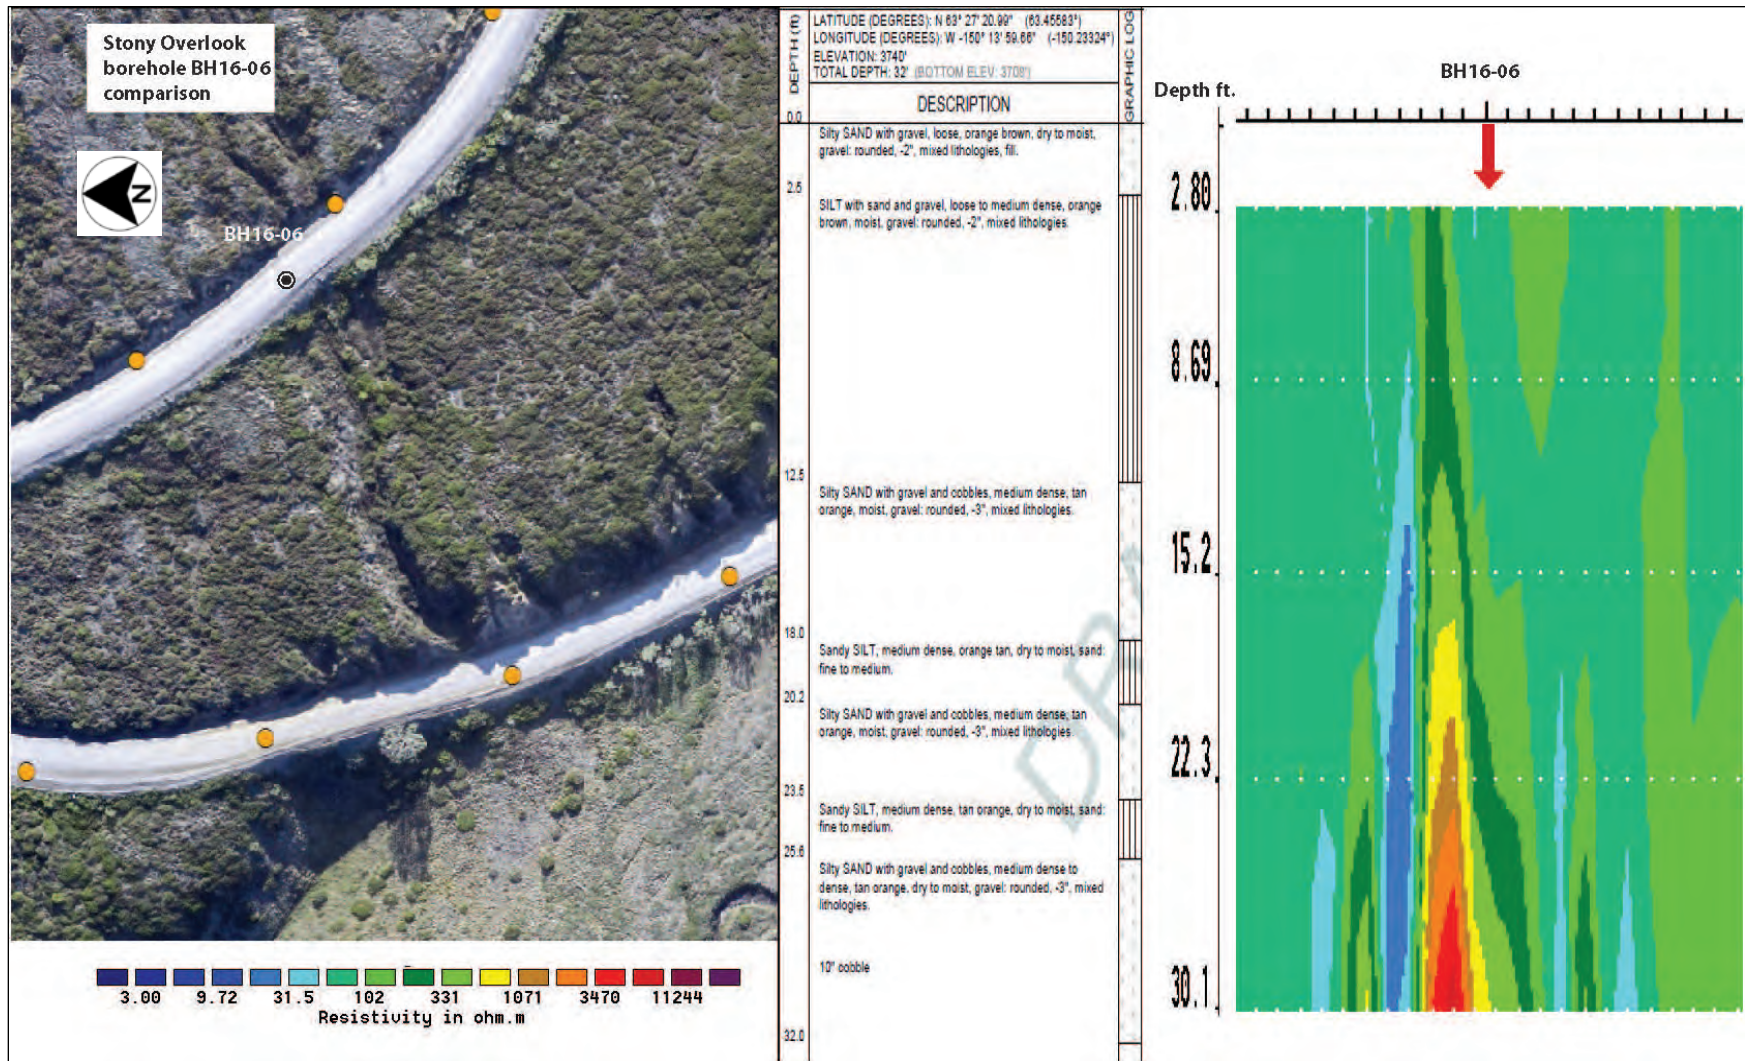
Figure 53. BH16-06 Stony Overlook. The ohm-m values at the top of the section are consistent with the drilling results where silty sands and gravel were encountered down to 23'. Silty sands and larger cobble were encountered down to the bottom of the hole, but no frozen material. At approximately 17' the ohm-m values dramatically increase to very high values, within a vertically narrow anomaly suggesting massive ice or an isolated highly resistive material, such as a manmade roadway appurtenance, which neither was encountered in the drilling.

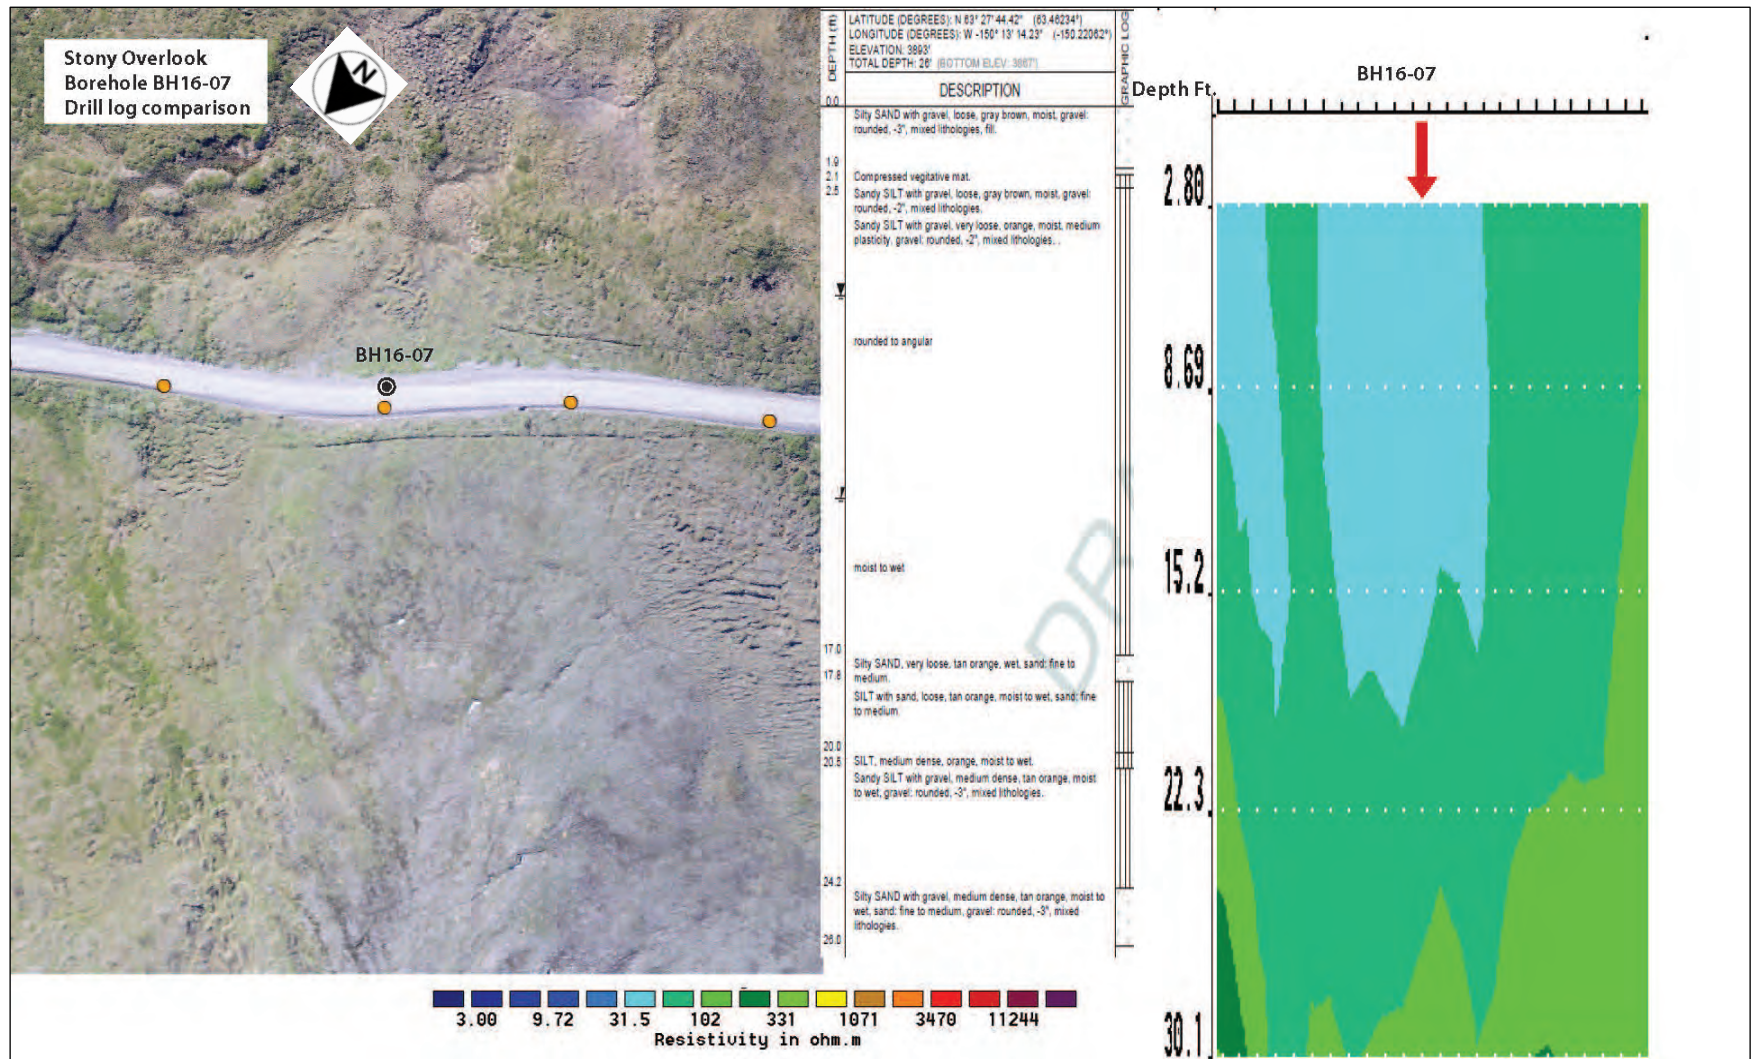
Figure 54. BH16-07 Stony Overlook. The ohm-m values are very low at the top of the section indicating coarse grained wet conditions, and the values increase moderately to the bottom of the section. The drilling results indicate sandy silts with gravel and moist to wet down to the bottom of the hole.

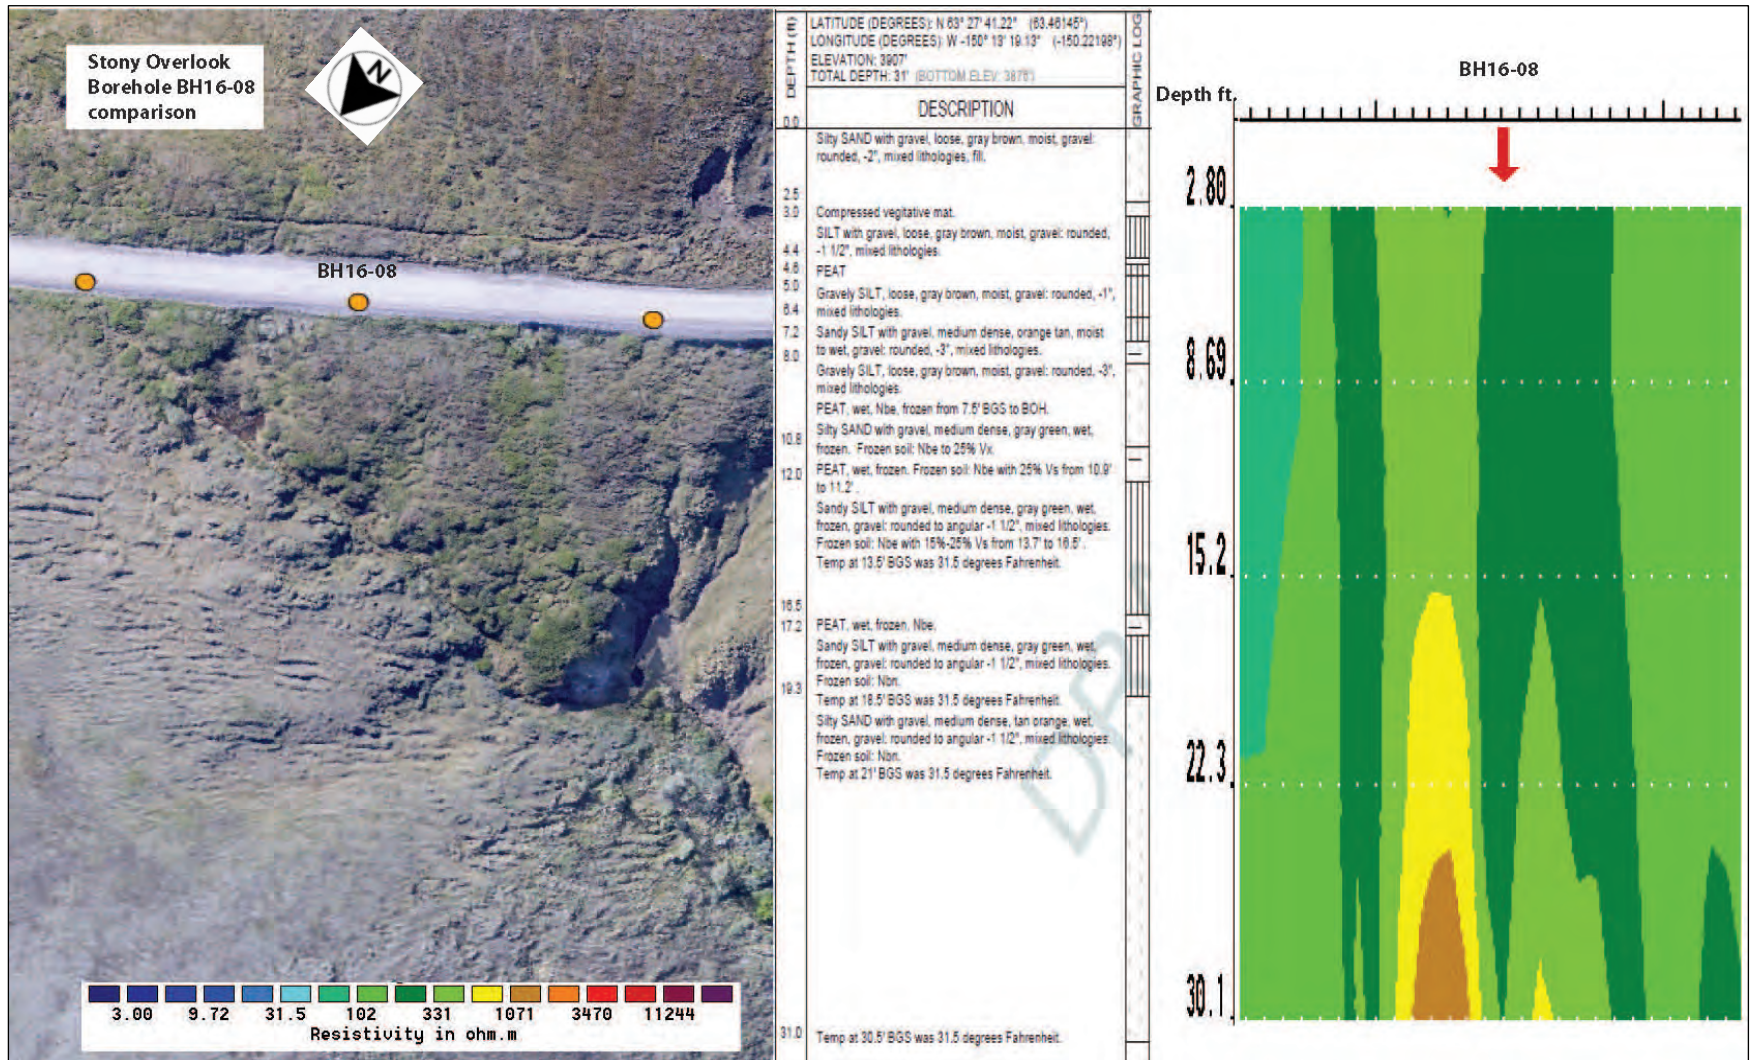
Figure 55. BH16-08 Stony Overlook. The ohm-m values are moderate at the top of the section, and at 15' the values increase significantly in a broader vertical anomaly. This is consistent with the drilling results which indicate thawed gravelly silts and sandy silts with peat down to 7.5', with frozen sandy silts and gravel, with peat, down to the BOH.

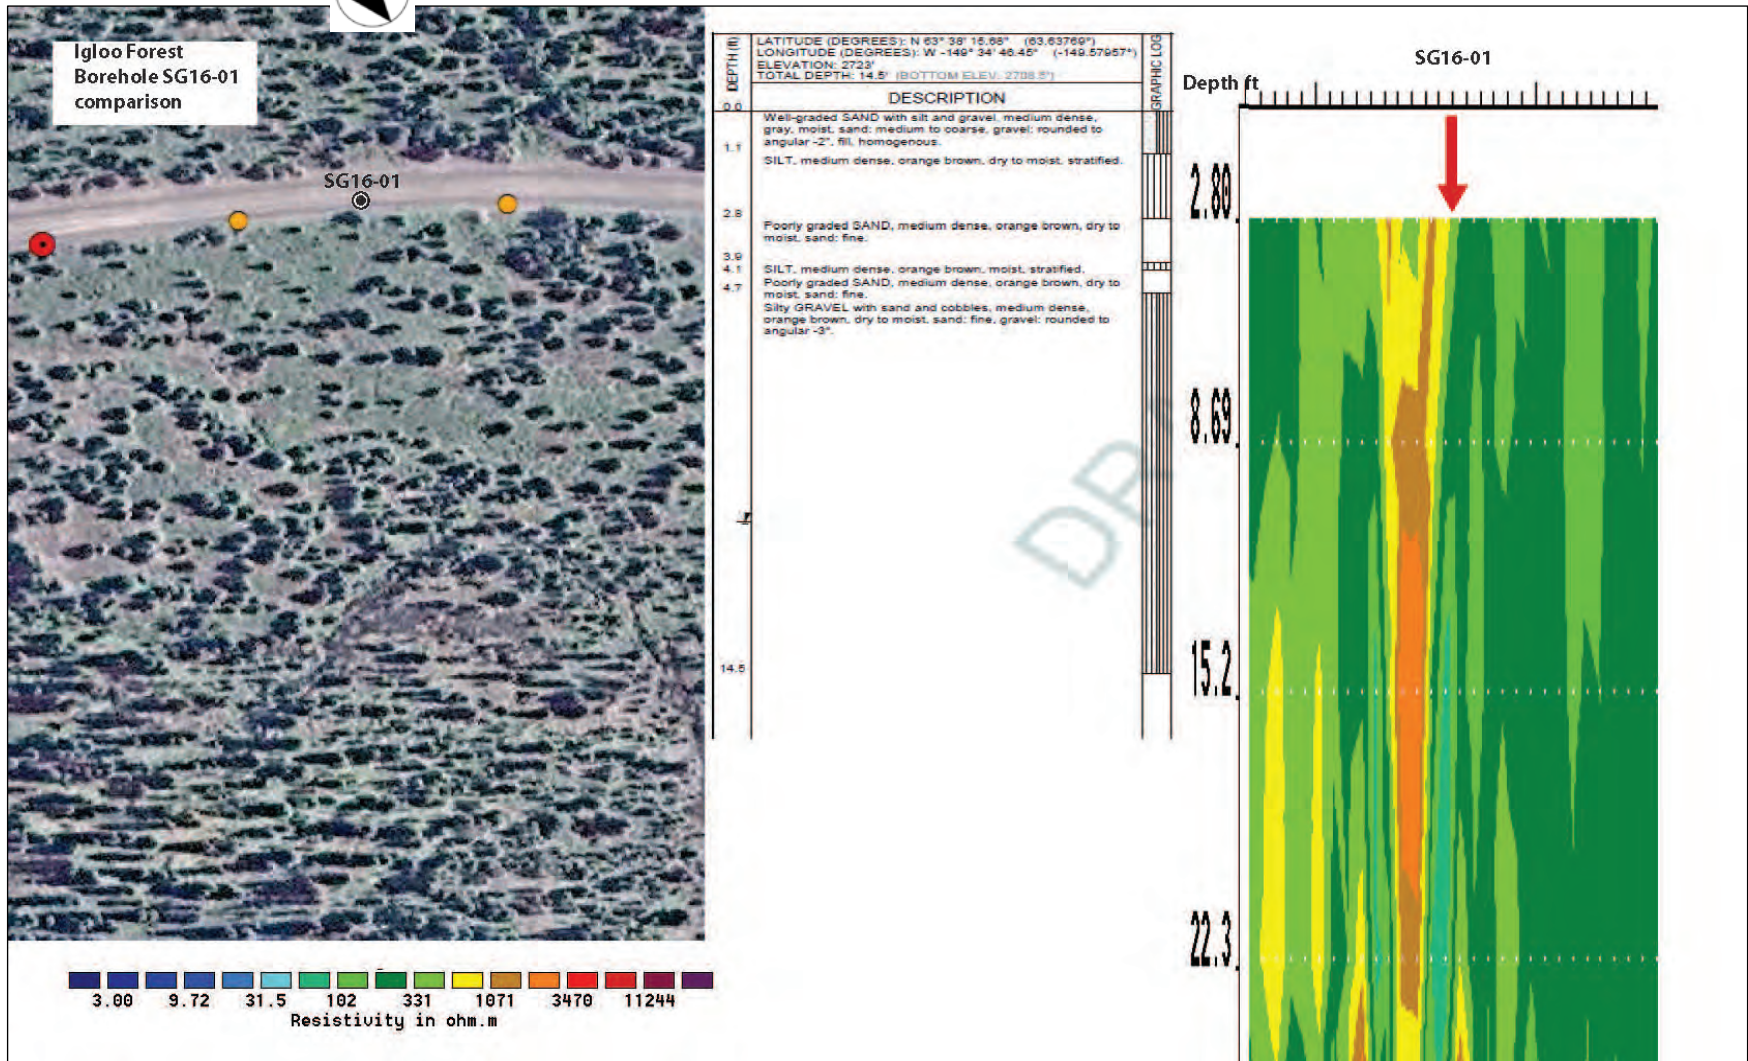
Figure 56. SG16-01 Igloo Forest. The ohm-m values are moderate to high from the top of the section to the bottom. The drilling results indicate dry to moist silty sands and gray poorly graded. The dry coarse grained, poorly graded sediments may be the cause of this anomaly.

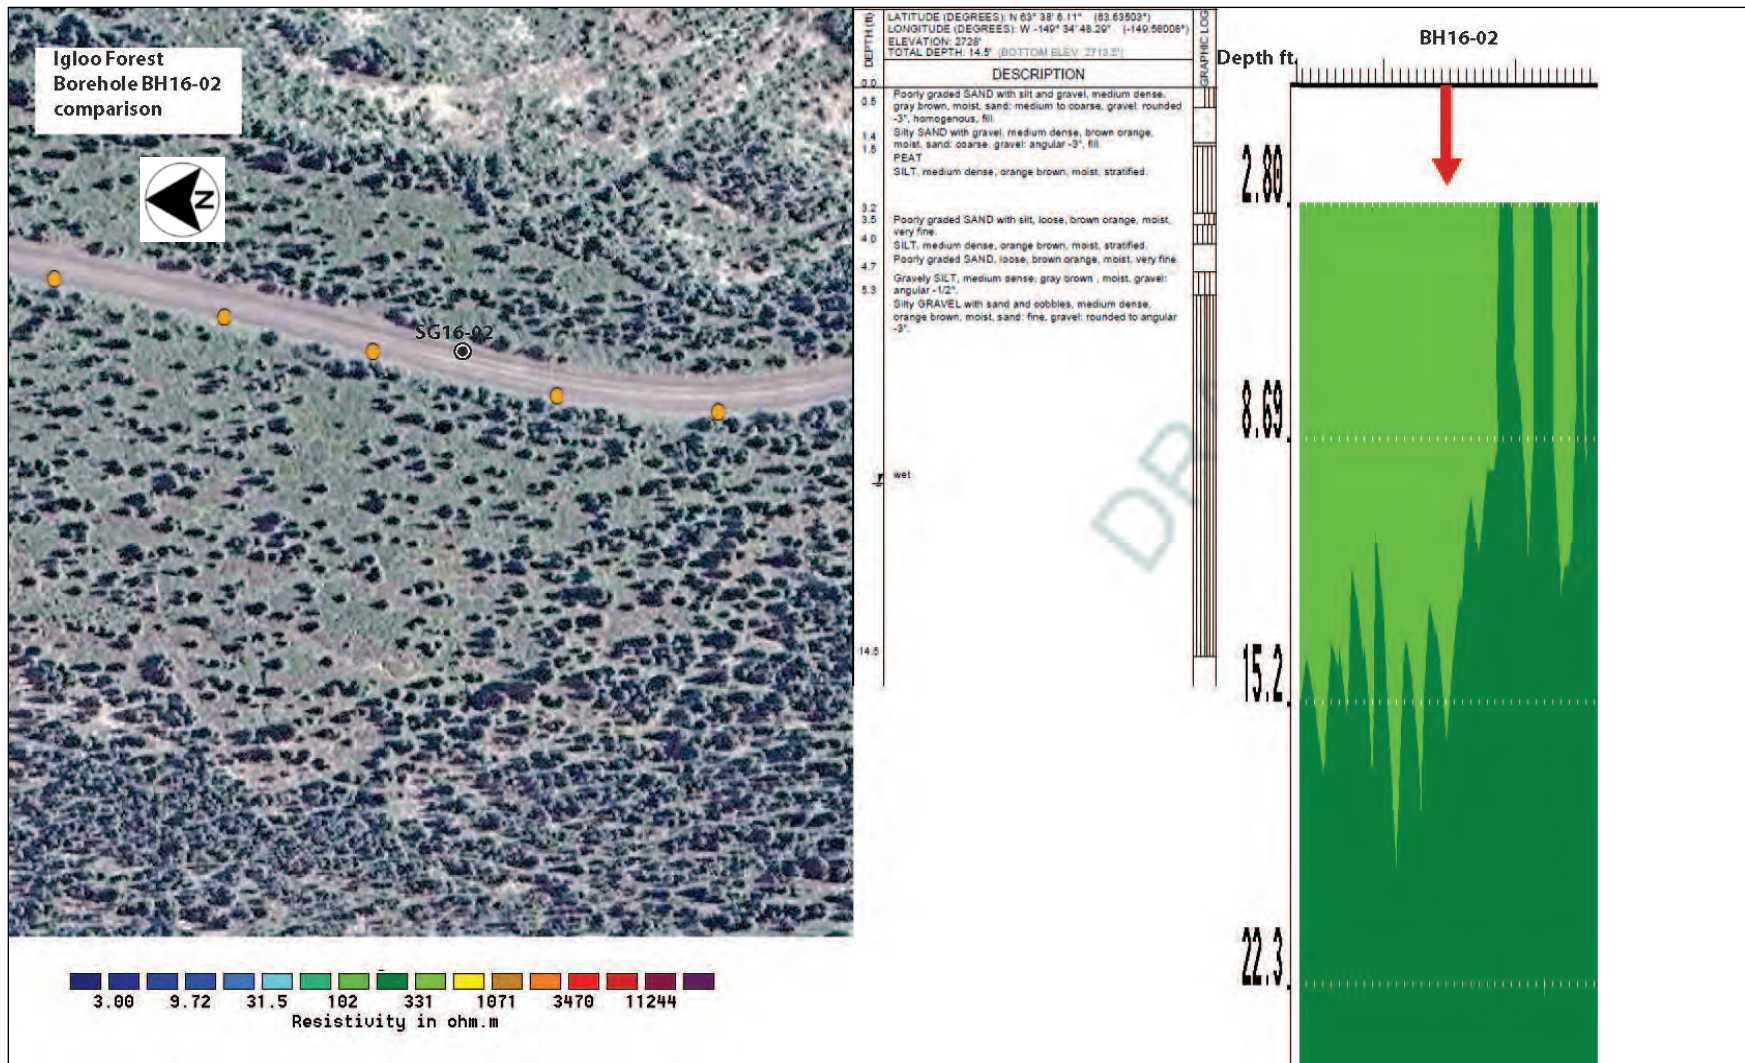
Figure 57. SG16-02 Igloo Forest. The ohm-m values are low from the top to the bottom of the section. This is consistent with the drilling results which found silty sands and gravels, moist to wet.

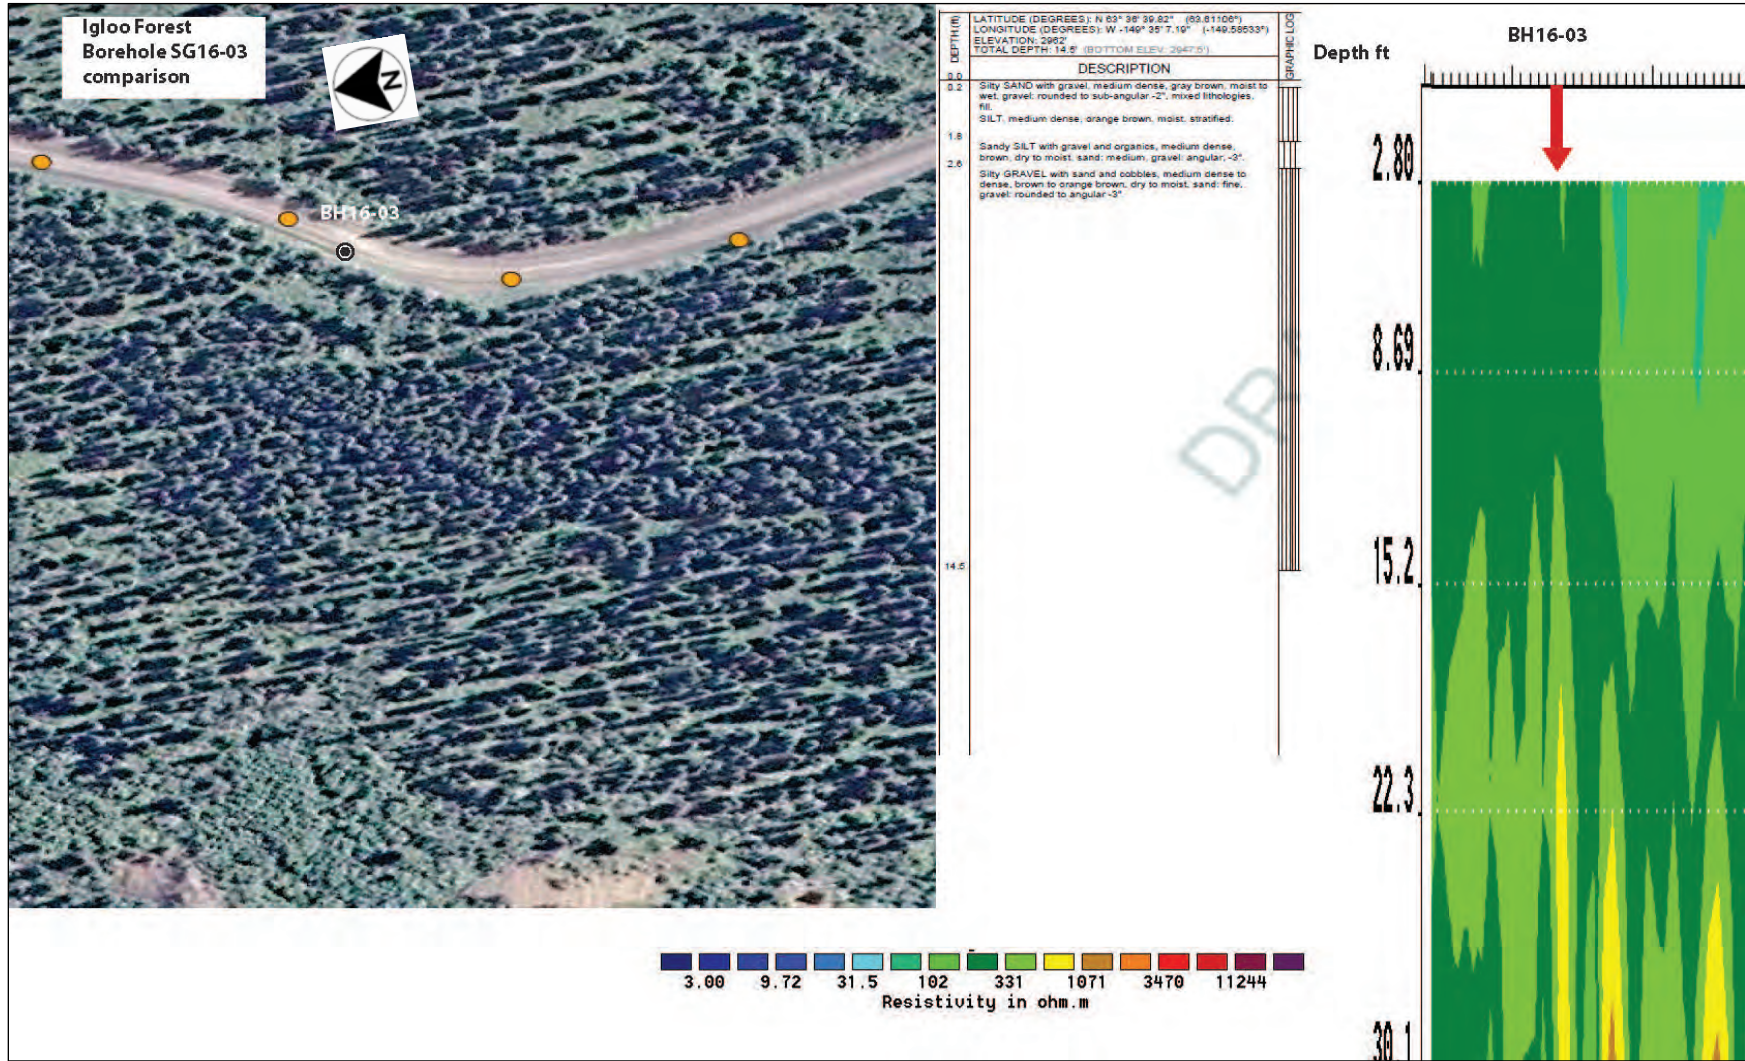
Figure 58. SG16-03 Igloo Forest. The ohm-m values are low at the top of the section, with moderate value anomalies at the lower portion of the section. This coincides with the drilling results as they indicate silty sands and gravels down to the BOH at 14.5'.

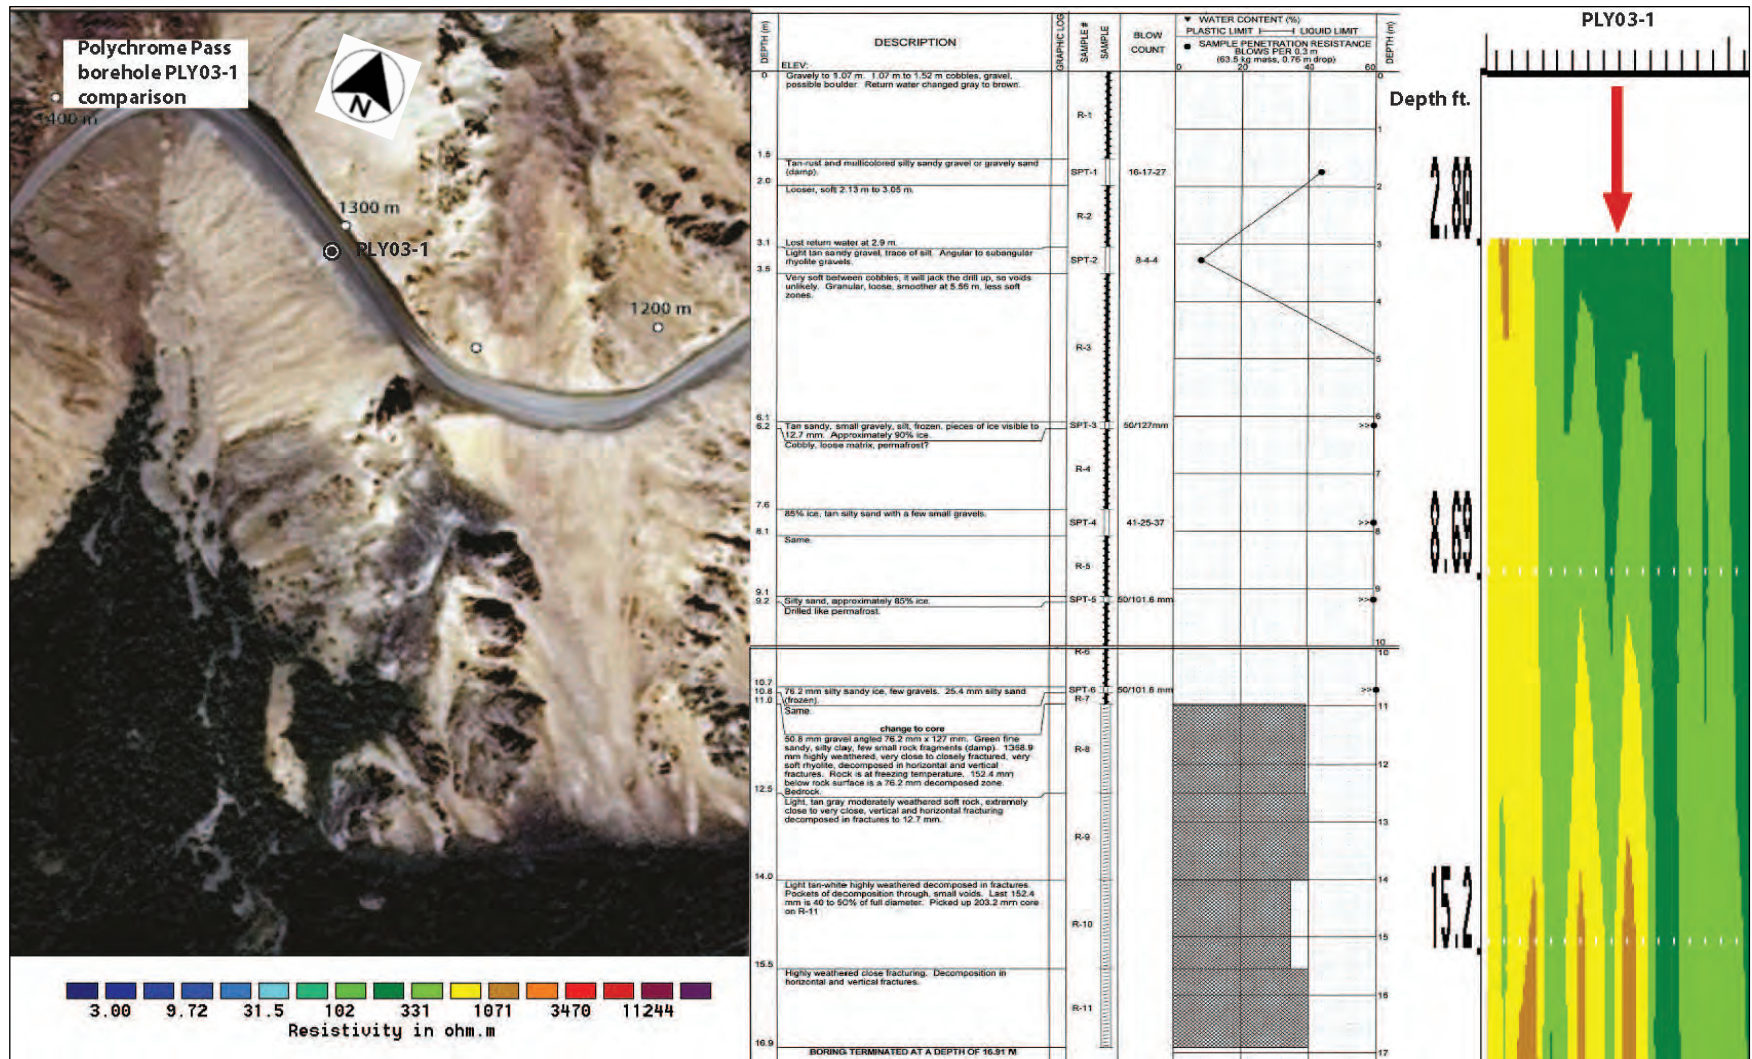
Figure 59. PLY03-1, Pretty Rocks. **Note, the drill log is in meters while the resistivity results are reported in feet. The ohm-m values are low at the top of the section and increase with depth of the section. Gravel and loose soil was logged at the top of the hole and this is consistent with the ohm-m results which change to moderate to high values at 8 ft. (2.5m). Ice and frozen material was logged starting at 6.1m (20 ft.), and this is consistent with the ohm-m values. The drilling changed to coring at 11m so we assume at this point all ice and permafrost comes to the surface thawed.

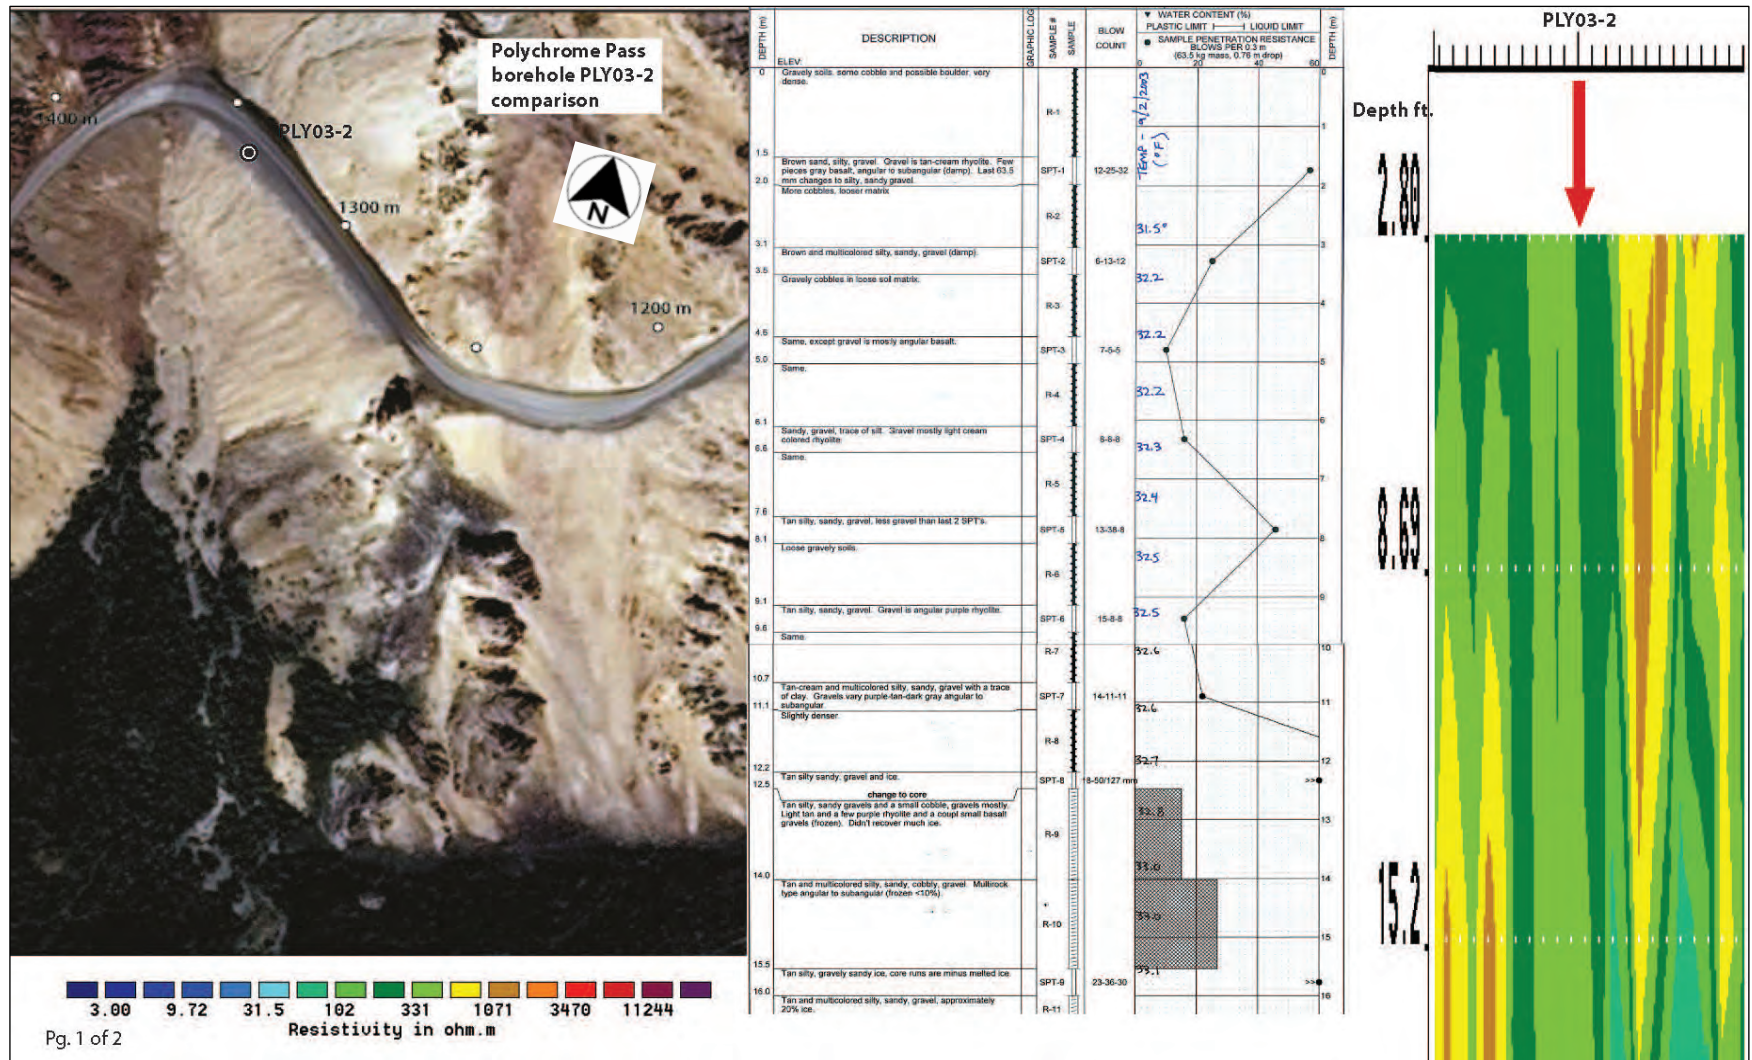
Figure 60. PLY03-2a, Pretty Rocks. **Note, the drill log is in meters while the resistivity results are reported in feet. The ohm-m values are low at the top of the section and increase with depth of the section. The ohm-m values are low at the top of the section and down to 17' as shown in this split section. The drill log reports thawed silty gravelly materials and this is consistent with the ohm-m values.

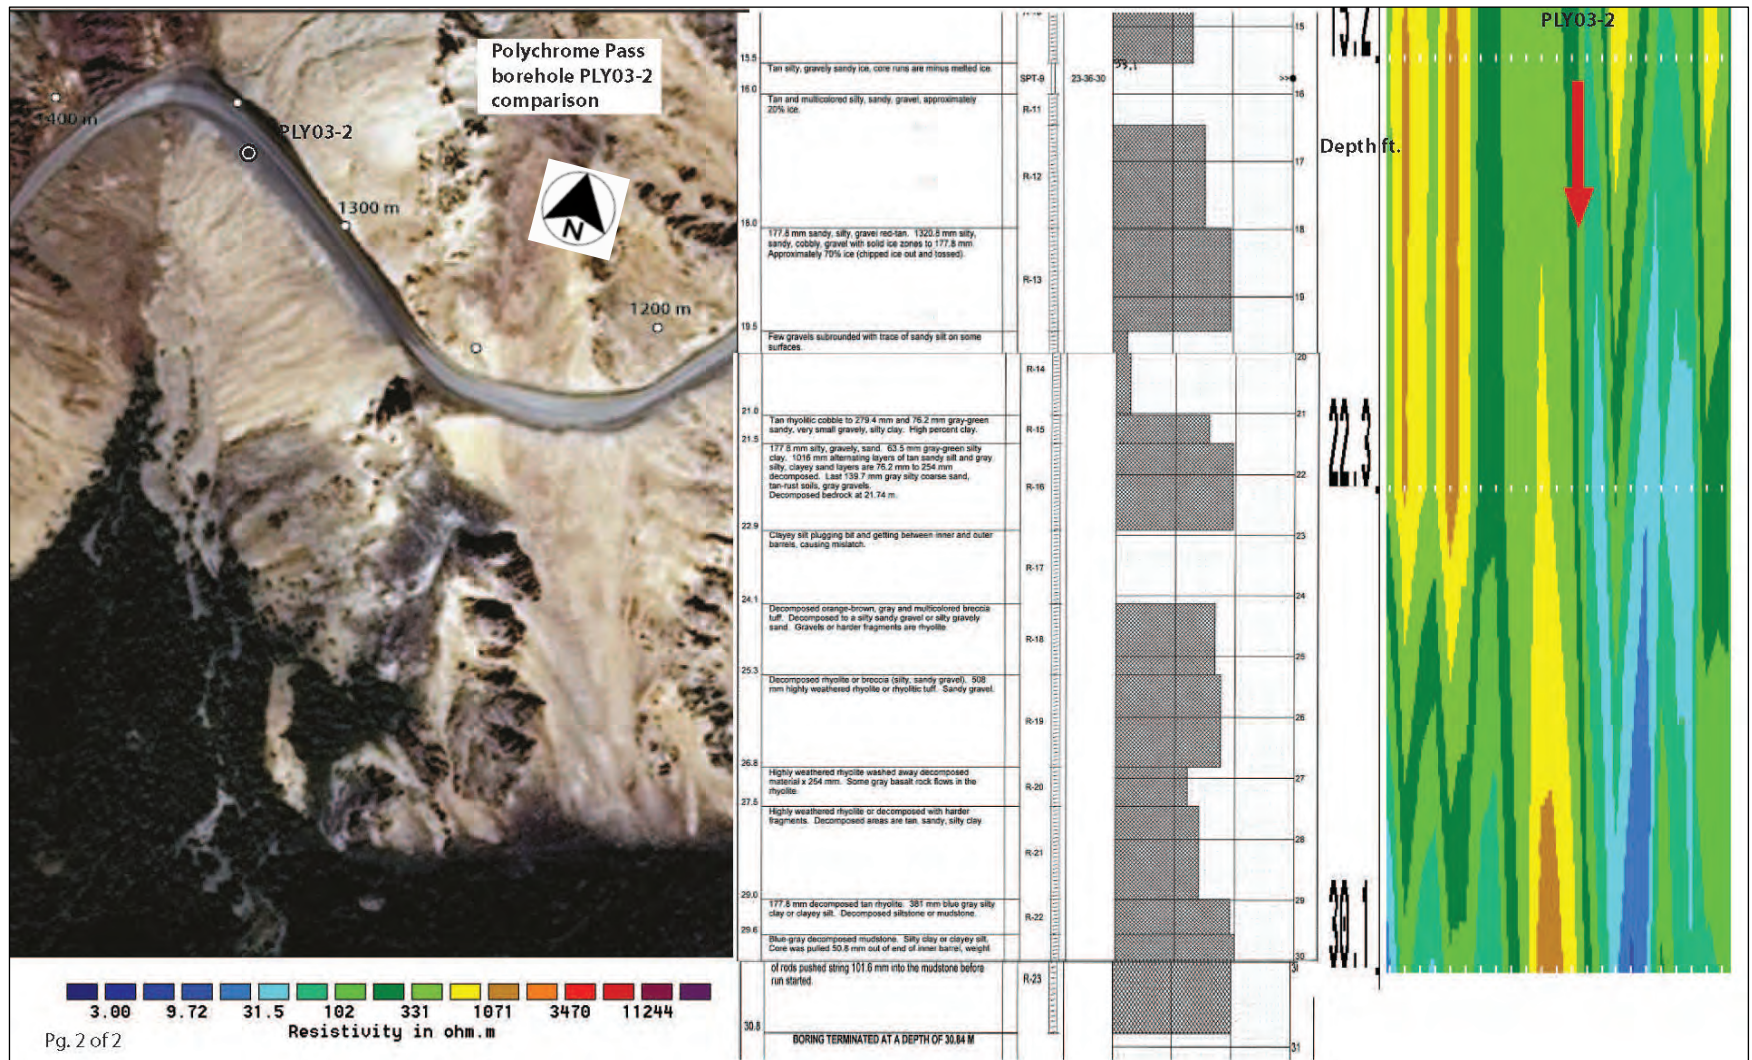
Figure 61. PLY03-2b, Pretty Rocks. ***Note, the drill log is in meters while the resistivity results are reported in feet. The drill log reports ice at 12.2m (40 ft.), and this is consistent with the much higher ohm-m values reported starting at approximately 30 ft. (10m).*

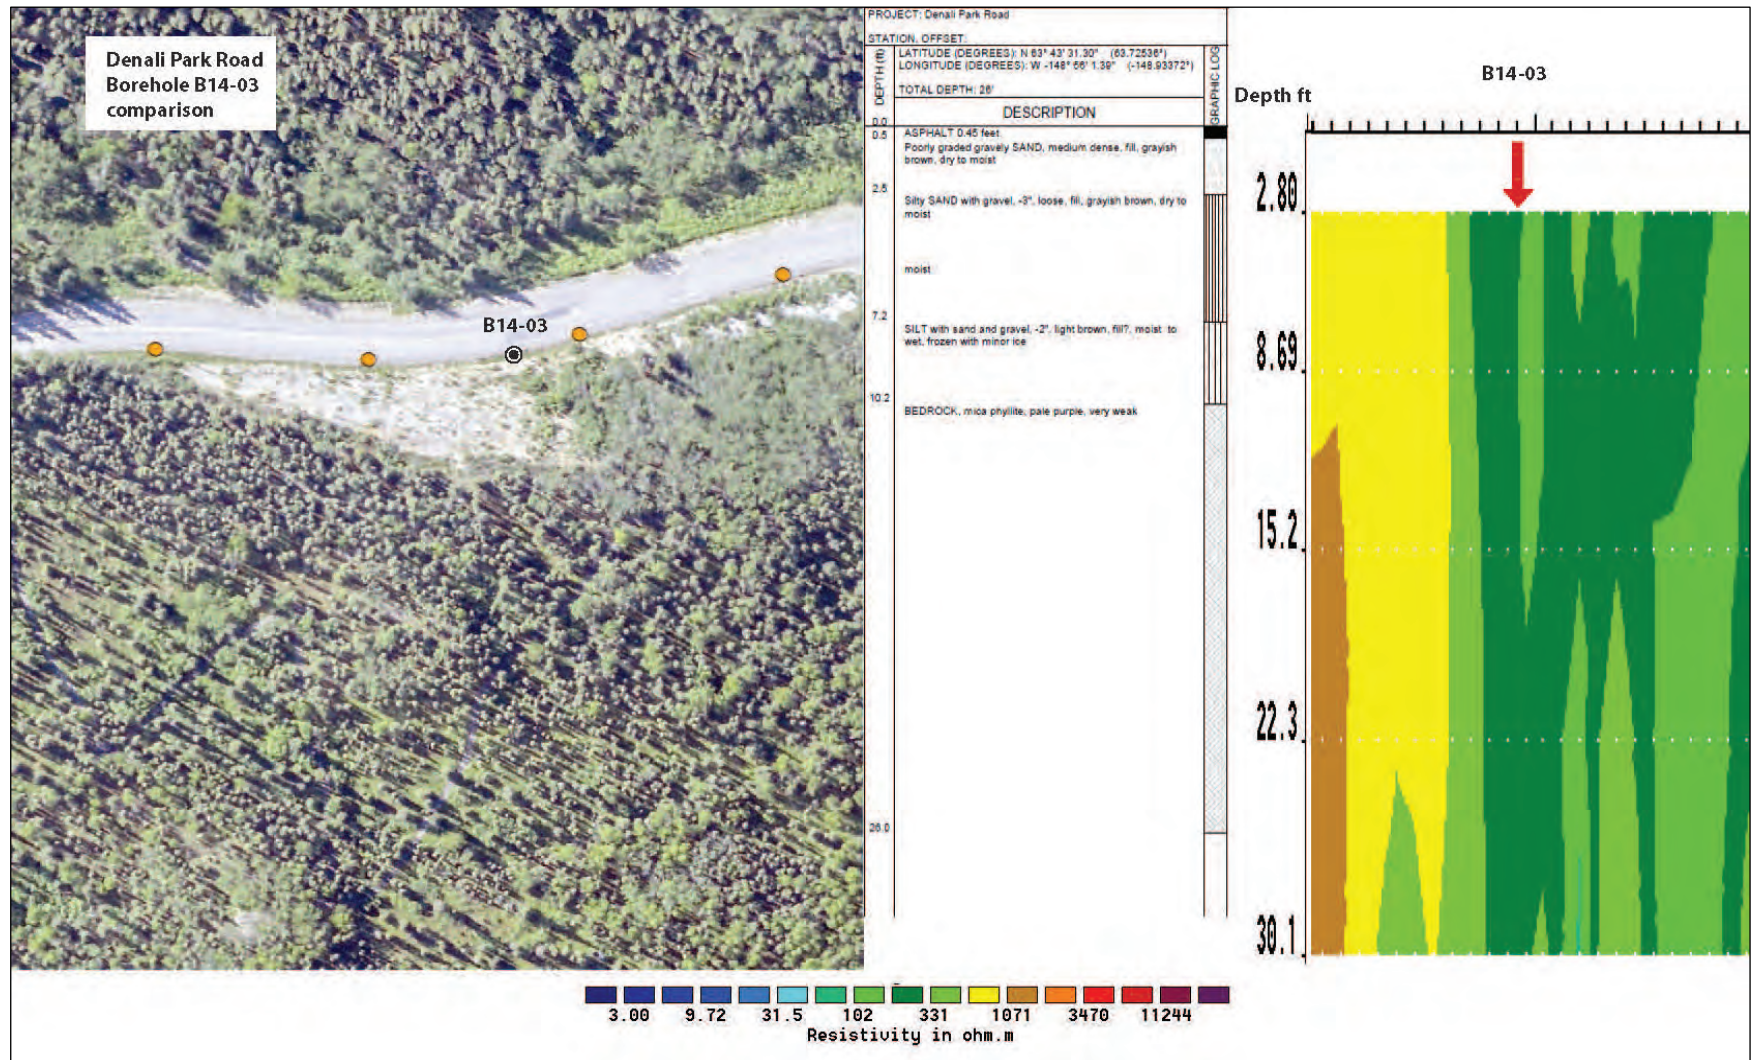
Figure 62. BH14-03 Denali Park Road. Low ohm-m values are reported from the top of the section to the bottom. The drill log reports mica schist at 10 ft., and which is generally known to be moderately resistive. We believe our plotting of the borehole on the pseudo-section may be in error. The definitive vertical boundary is not consistent with abrupt change from sediment to bedrock.

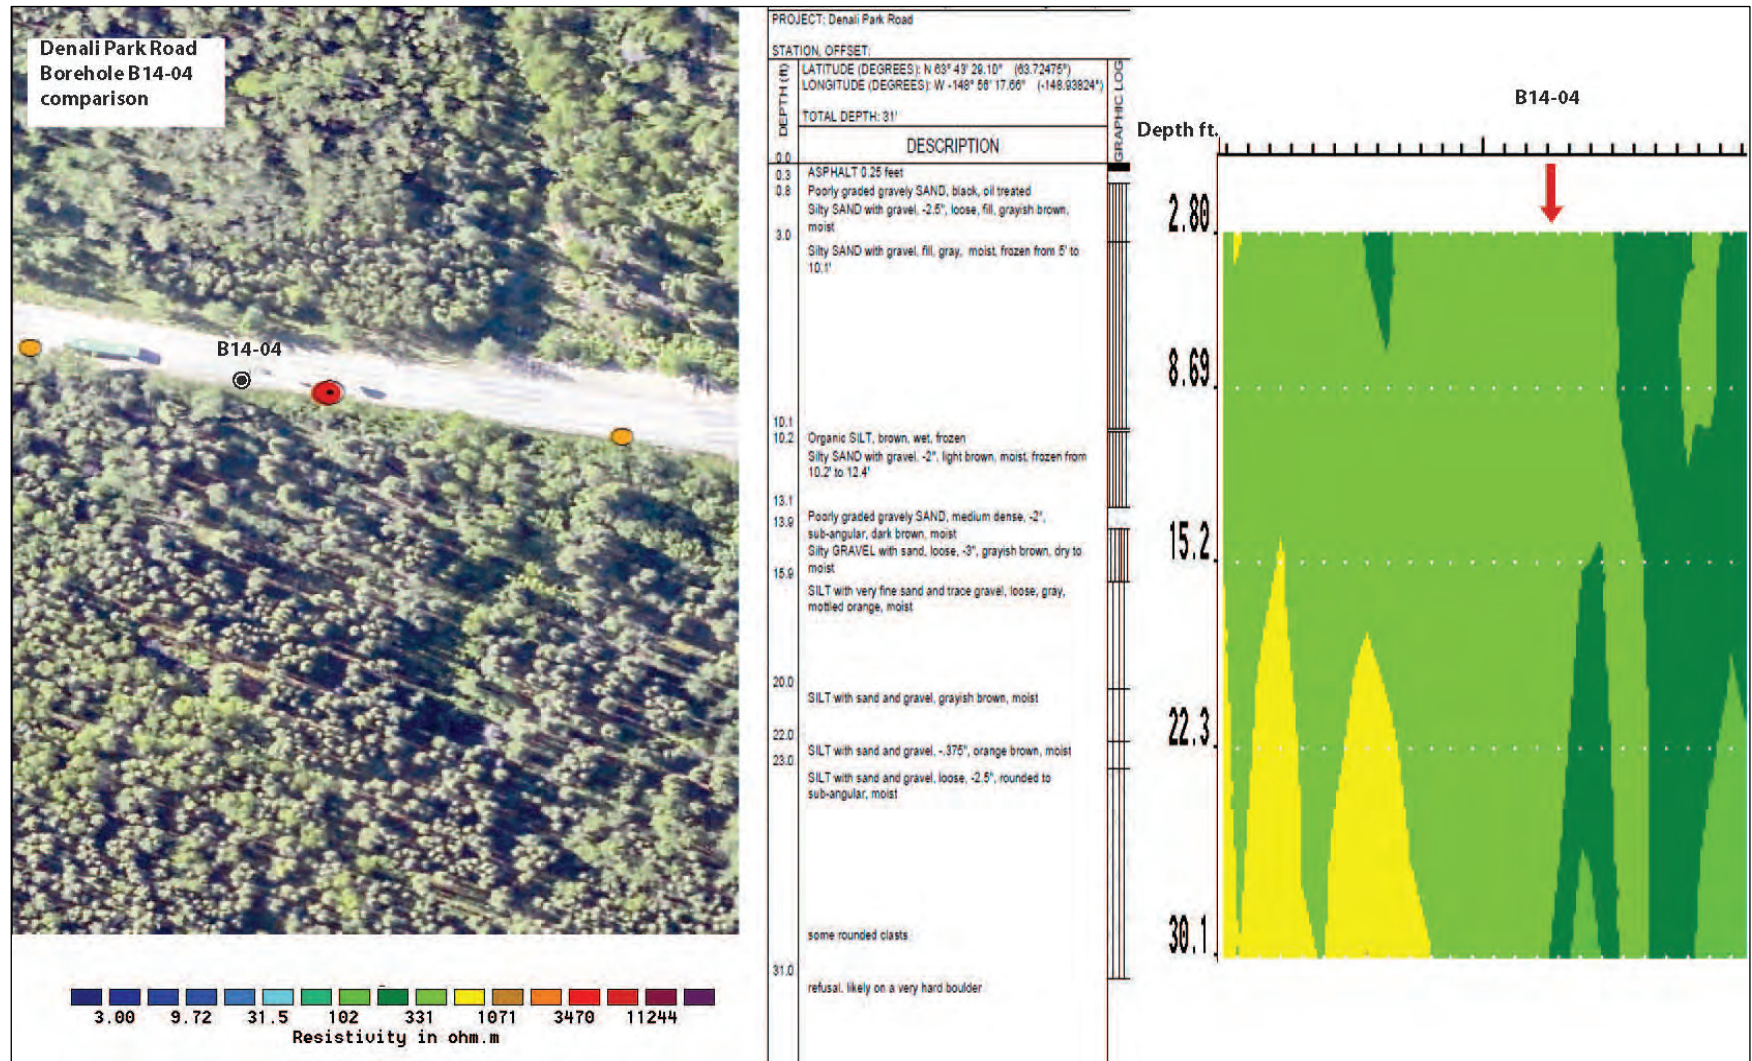
Figure 63. BH14-04 Denali Park Road. Low ohm-m values are reported from the top of the section to the bottom. The drill log reports silty sand and gravels, and moist. This is consistent with the ohm-m values.
