Geotechnical Report No. 11-20

**Pretty Rocks Landslide
2018-2019 Geotechnical Investigation and Conceptual
Design Alternatives Report**

**AK NPS DENA 10(45)
Denali National Park, Alaska
August 2020**

U.S. DEPARTMENT OF TRANSPORTATION
FEDERAL HIGHWAY ADMINISTRATION

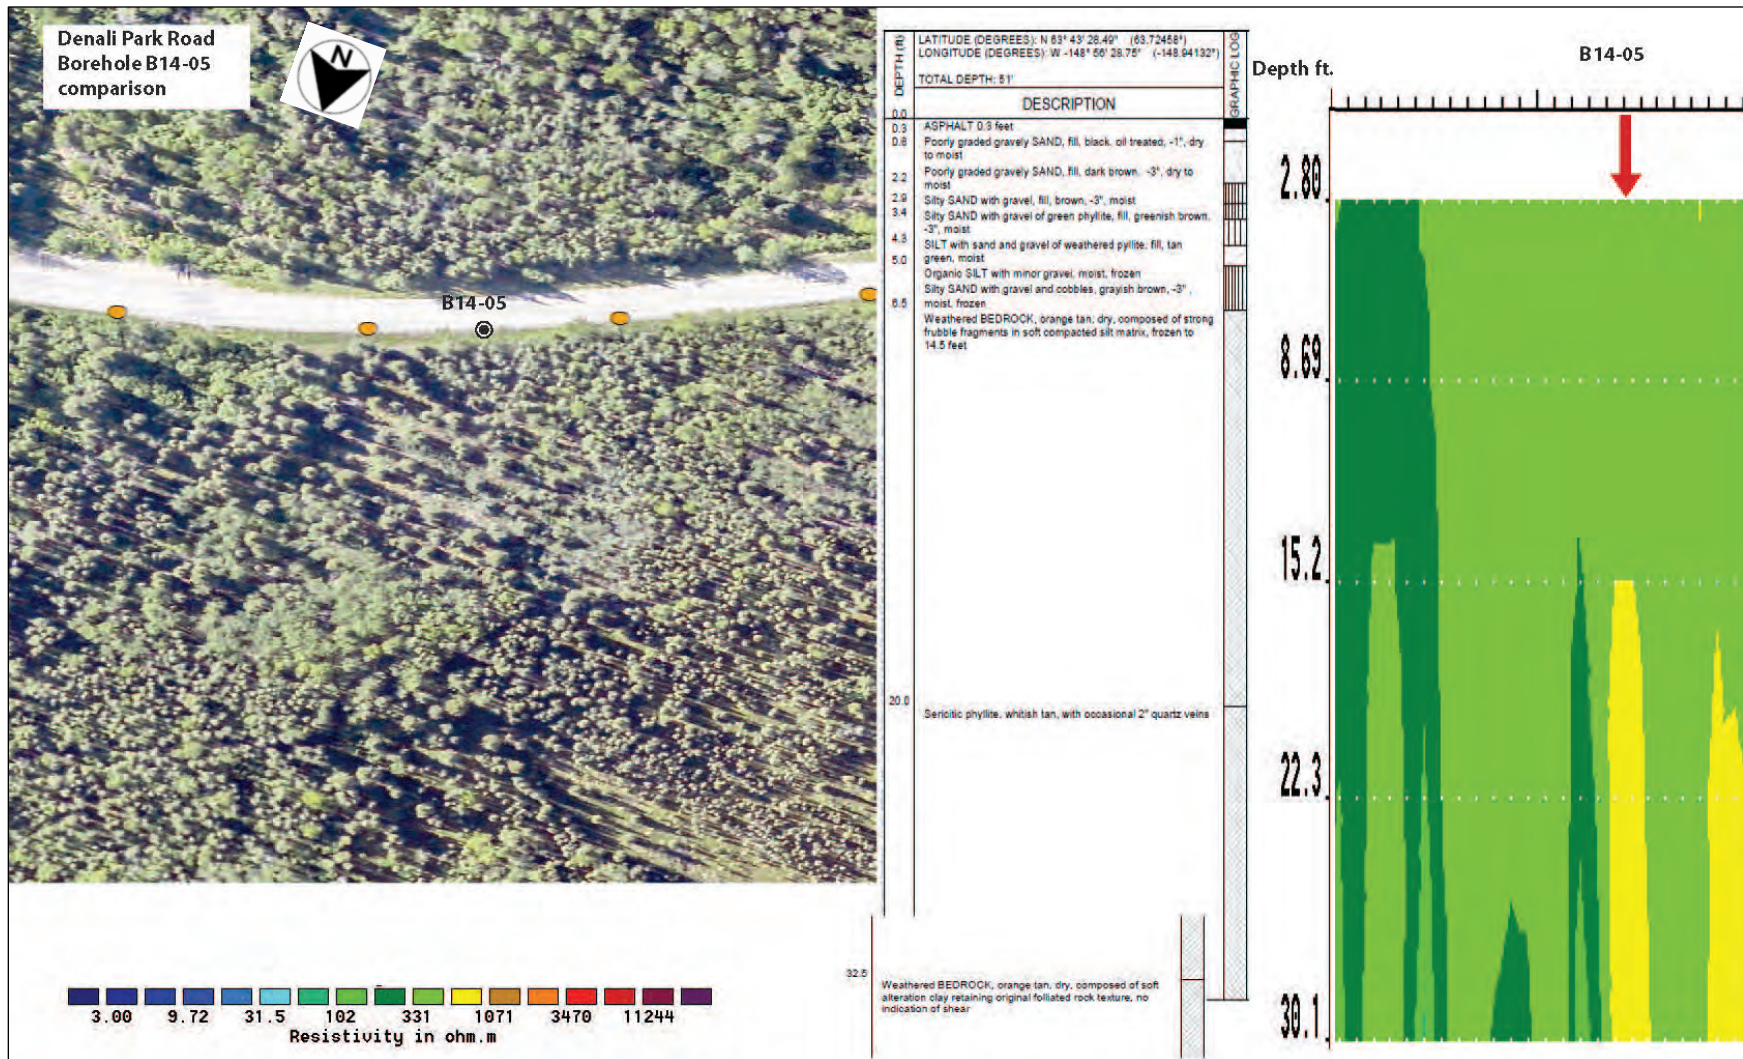
Figure 64. BH14-05 Denali Park Road. Low ohm-m values are reported from the top of the section to 15 ft. where moderate values are shown at the bottom of the section. The drill log reports silty sand and gravels, with frozen weather bedrock starting at 6.5 ft. down to 14.5 ft., and continues weathered bedrock down to the BOH at 32.5 ft.. The ohm-m values are not consistent with continuous bedrock at depth.

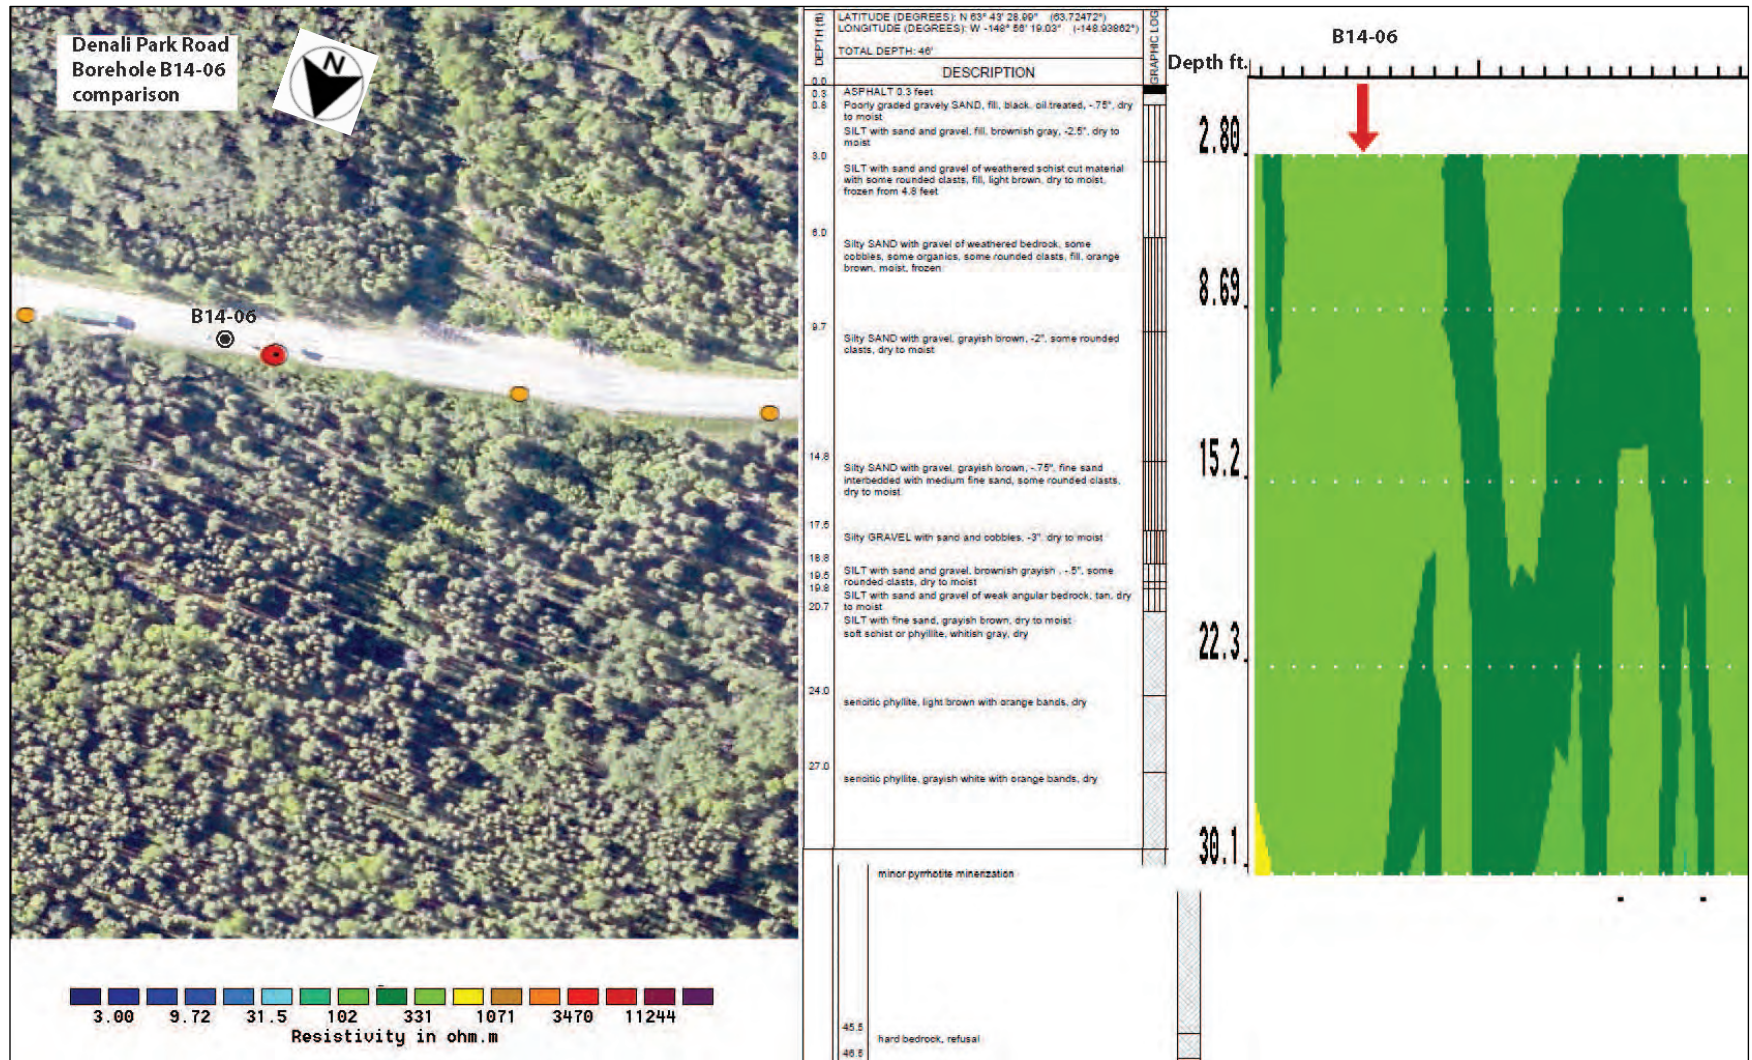
Figure 65. BH14-06 Denali Park Road. Low ohm-m values are reported for the entire depth of the section. The material logged in the drill hole is silty sand with some gravel, then dry phyllite bedrock at 24 ft.. The ohm-m values coincide with the borehole information, however we would expect to see some change in resistivity at the interface with the bedrock.

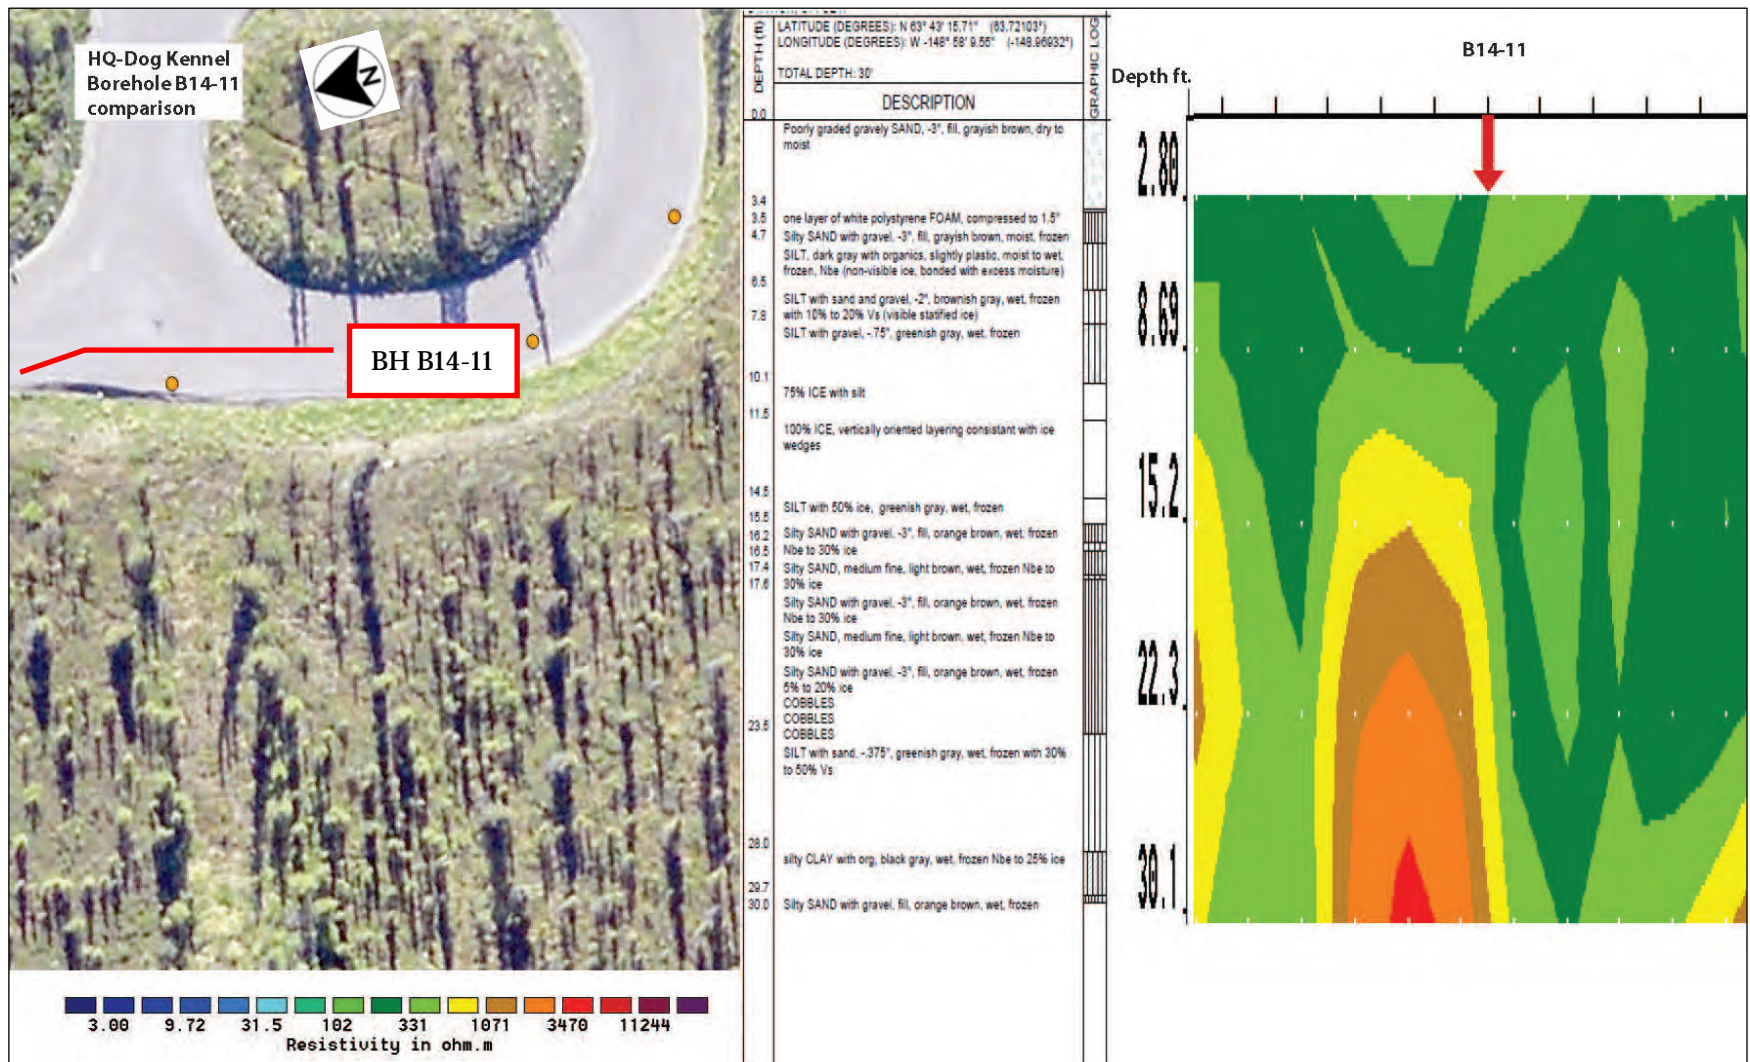
Figure 66. BH14-11 HQ/Dog Kennel Loop. The ohm-m values are low at the top of the section down to approximately 13 ft. where a rapid increase in resistivity occurs with depth, and the high resistivity anomaly is broad at the base and in close proximity to other high resistivity anomalies. The drill hole results indicate frozen soils with significant ice starting at 4.7 ft. and extending to the BOH at 30 ft.. The CCR results coincide very well with drill results.

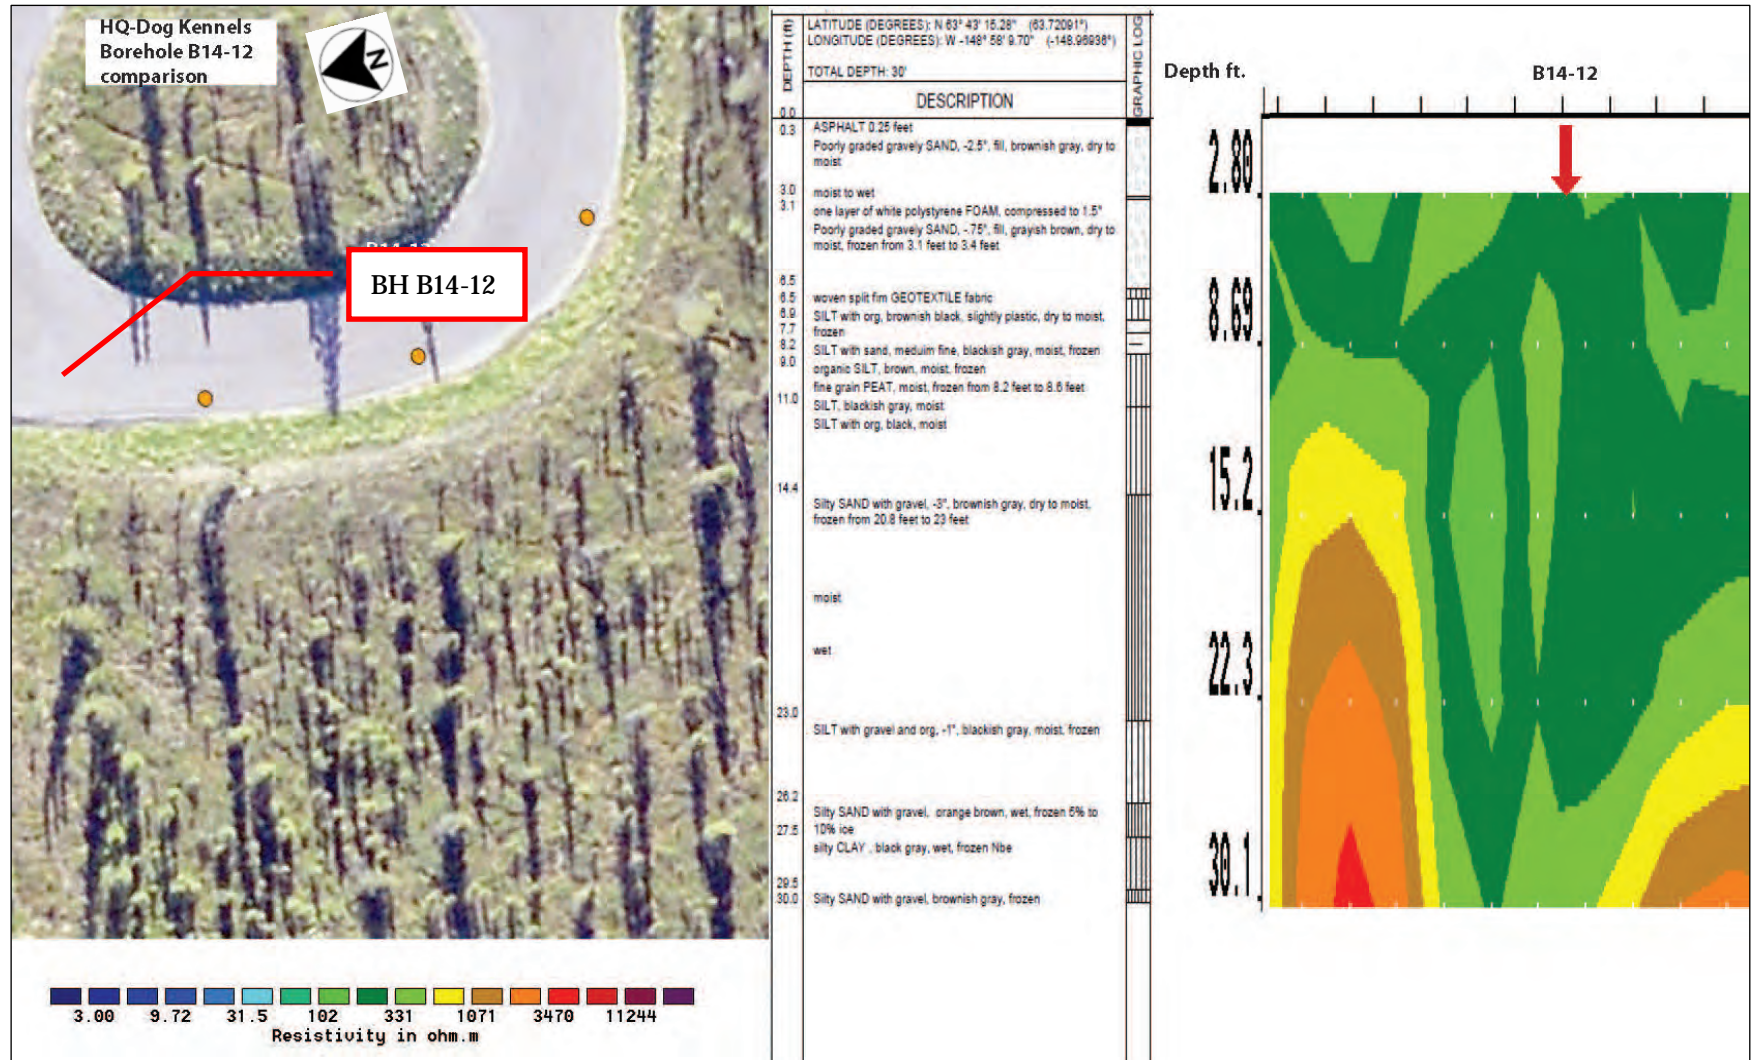
Figure 67. BH14-12 HQ/Dog Kennel Loop. This borehole does not fall directly in the path of the CCR transect, therefore some amount of proximity inference to BH14-11 must be made. The ohm-m values are low at the top of the section down to approximately 18 ft. where a rapid increase in resistivity occurs with depth, and the high resistivity anomaly appears to be broad at the base and in close proximity to other high resistivity anomalies. The drill hole results indicate frozen soils with significant ice starting at 6.9 ft. and extending to the BOH at 30 ft.. In general the CCR results for this area coincide very well with drill results, as these frequent high resistivity anomalies are inferred to be massive ground ice, possibly in the form of wedge ice. It would be expected the intervening soils between the wedge ice contains moderate to high ice contents both in matrix and possibly segregation ice.

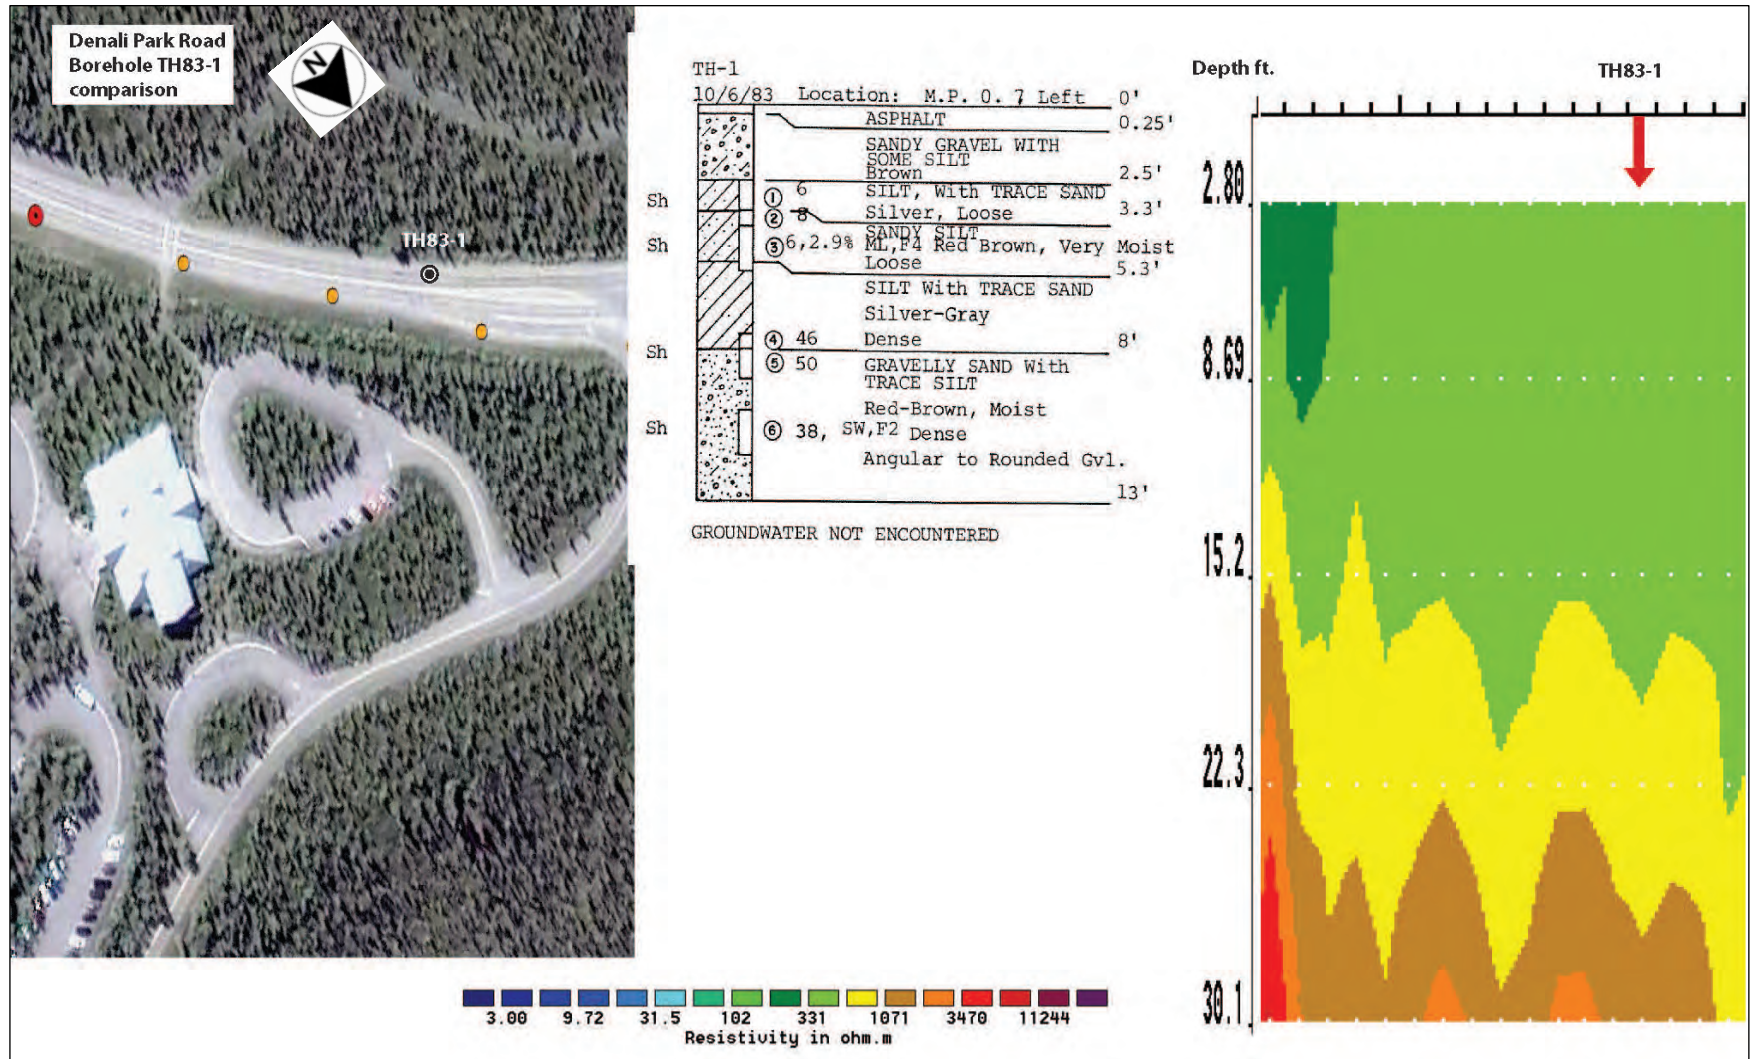
Figure 68. TH83-1 Denali Park Road. The ohm-m values are low at the top of the section. The drill hole reports down to only 13 ft., therefore the thawed sandy silt and gravelly sand coincide with the results.

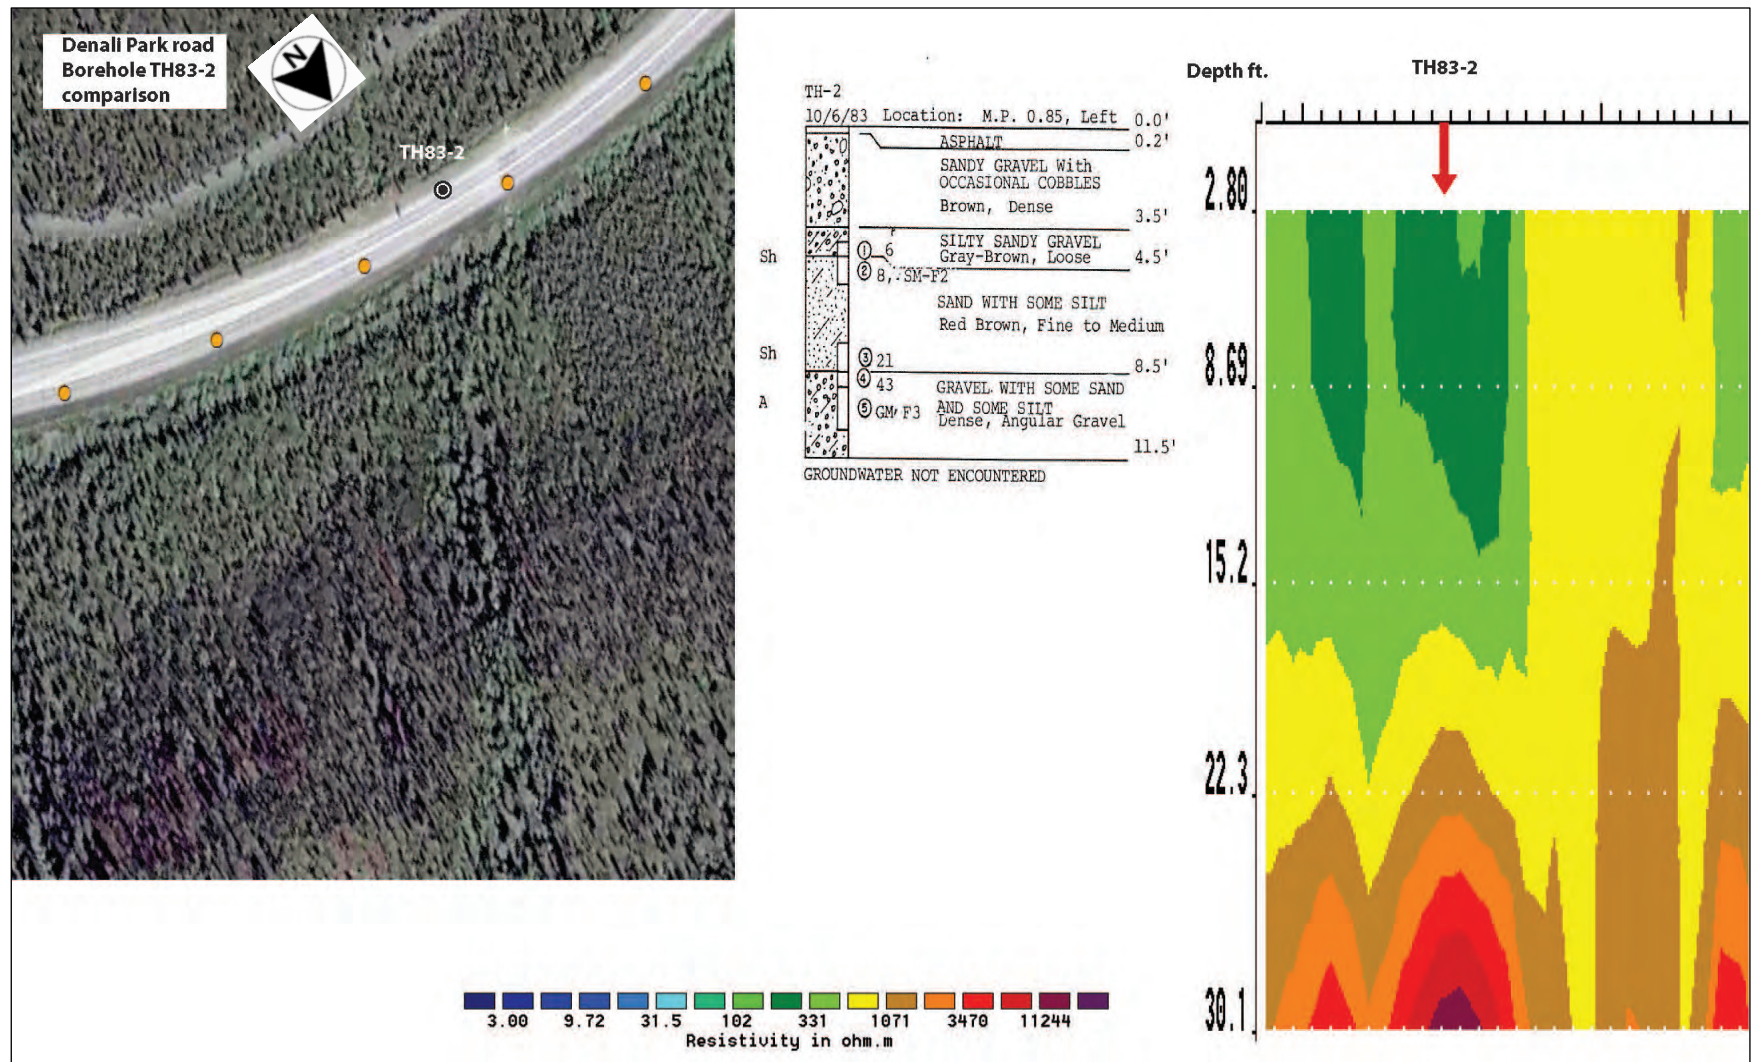
Figure 69. TH83-2 Denali Park Road. The ohm-m values are low at the top of the section but rapidly increase to very high values below the bottom of the borehole at approximately 16 ft., and laterally where a moderate high anomaly is directly adjacent to this borehole for the full depth of the section. The drill hole results report silty sandy gravel down to the BOH at 11.5 ft..

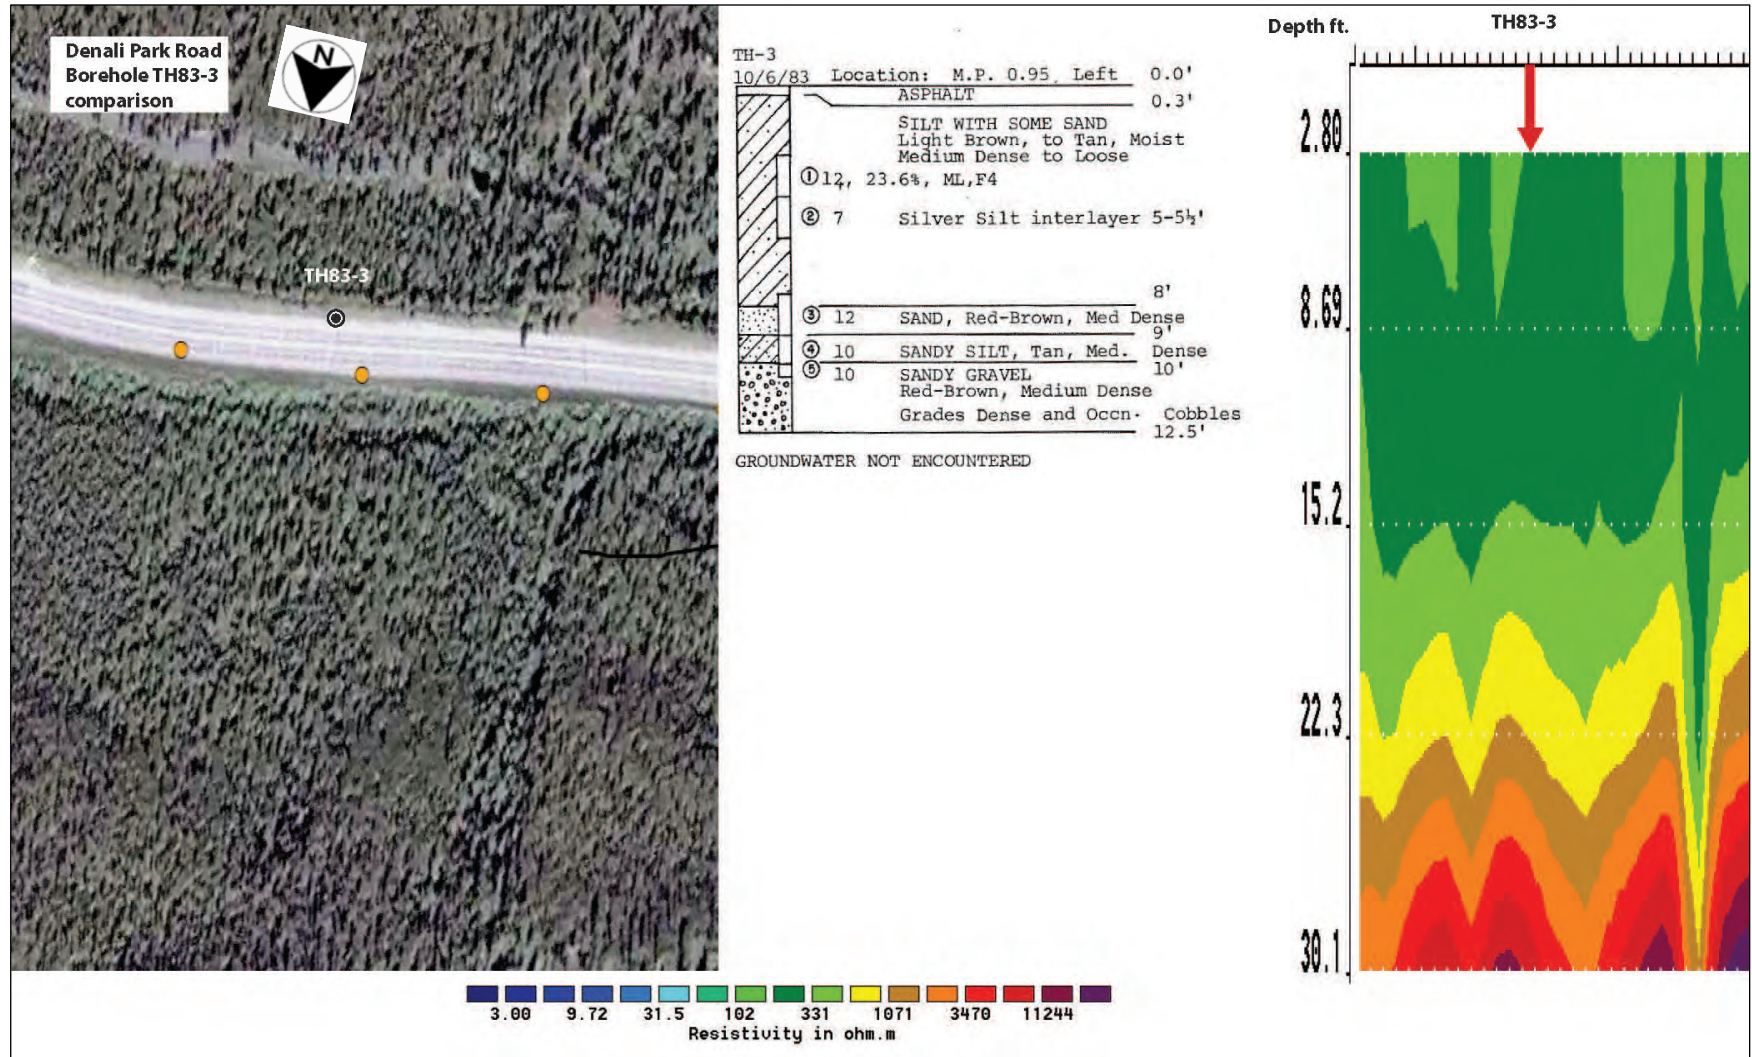
Figure 70. TH83-3 Denali Park Road. The ohm-m values are low at the top of the section but rapidly increase to very high values below the bottom of the borehole at approximately 17 ft. The drill hole results report silty sandy gravel down to the BOH at 12.5 ft..

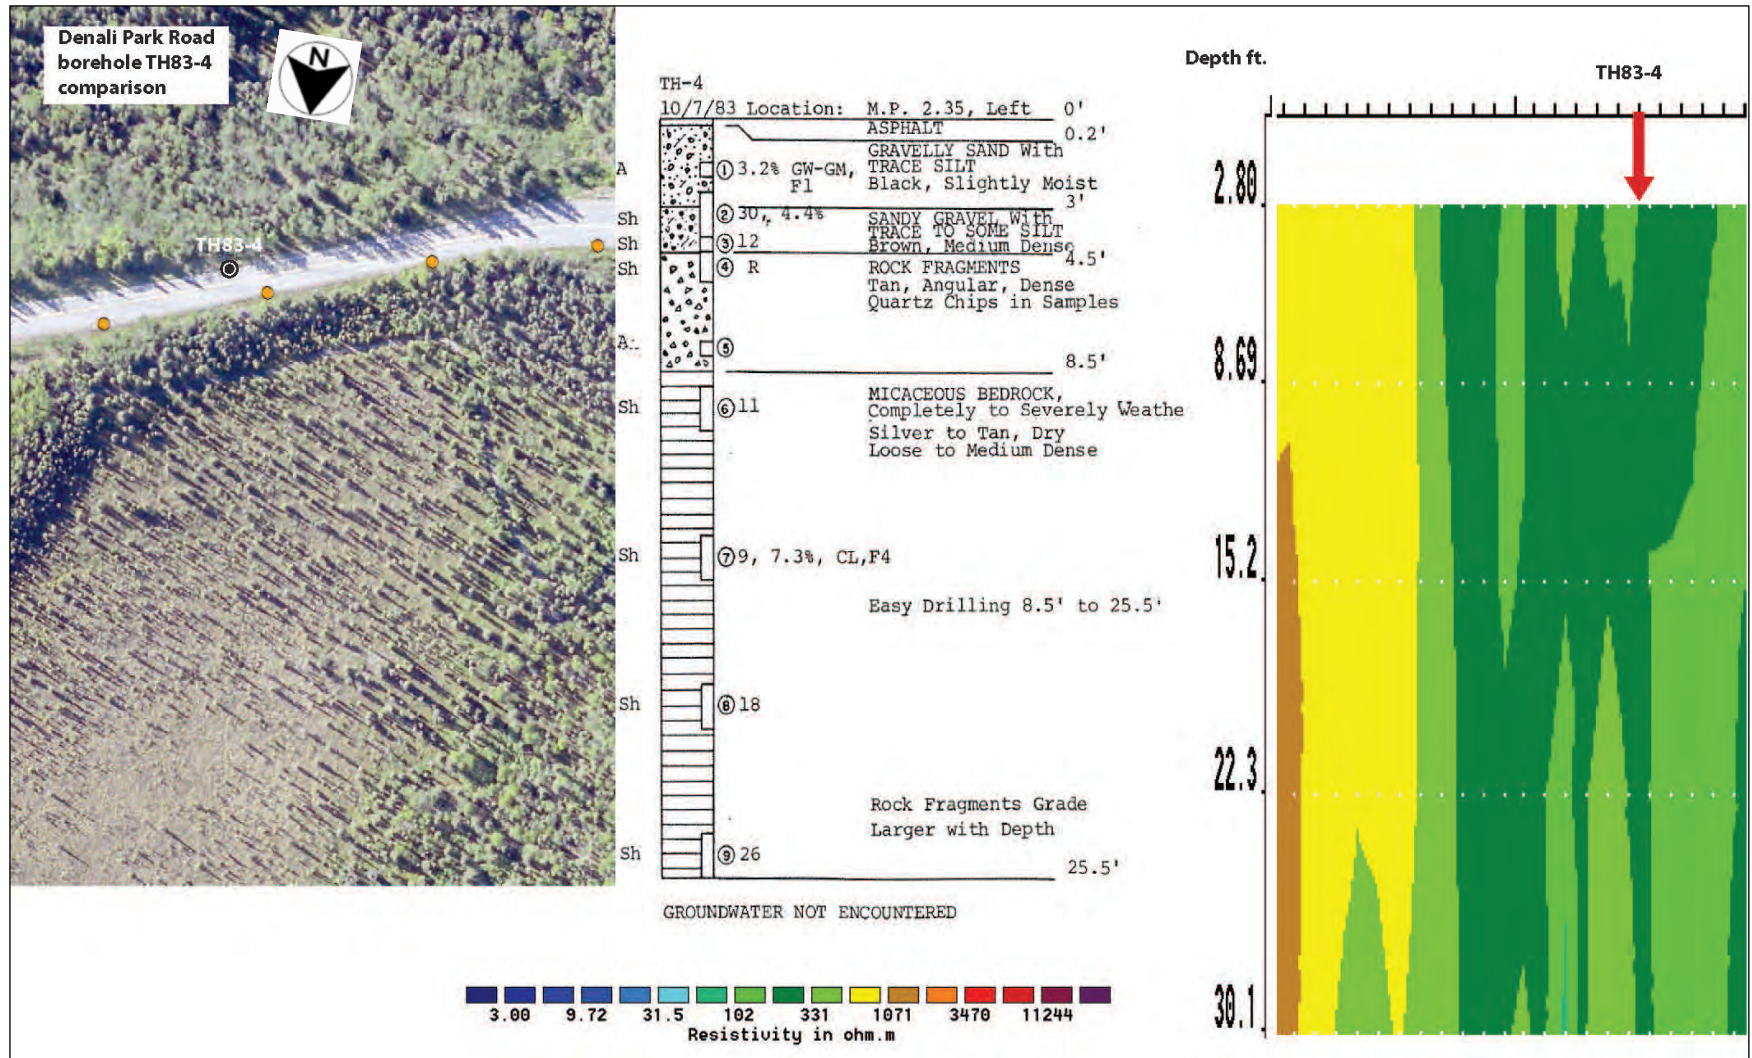
Figure 71. TH83-4 Denali Park Road. The ohm-m values are low to the full depth of the section. The drill hole reports silty sandy gravel down to 8.5 ft. with micaceous bedrock down to the BOH at 25.5 ft..

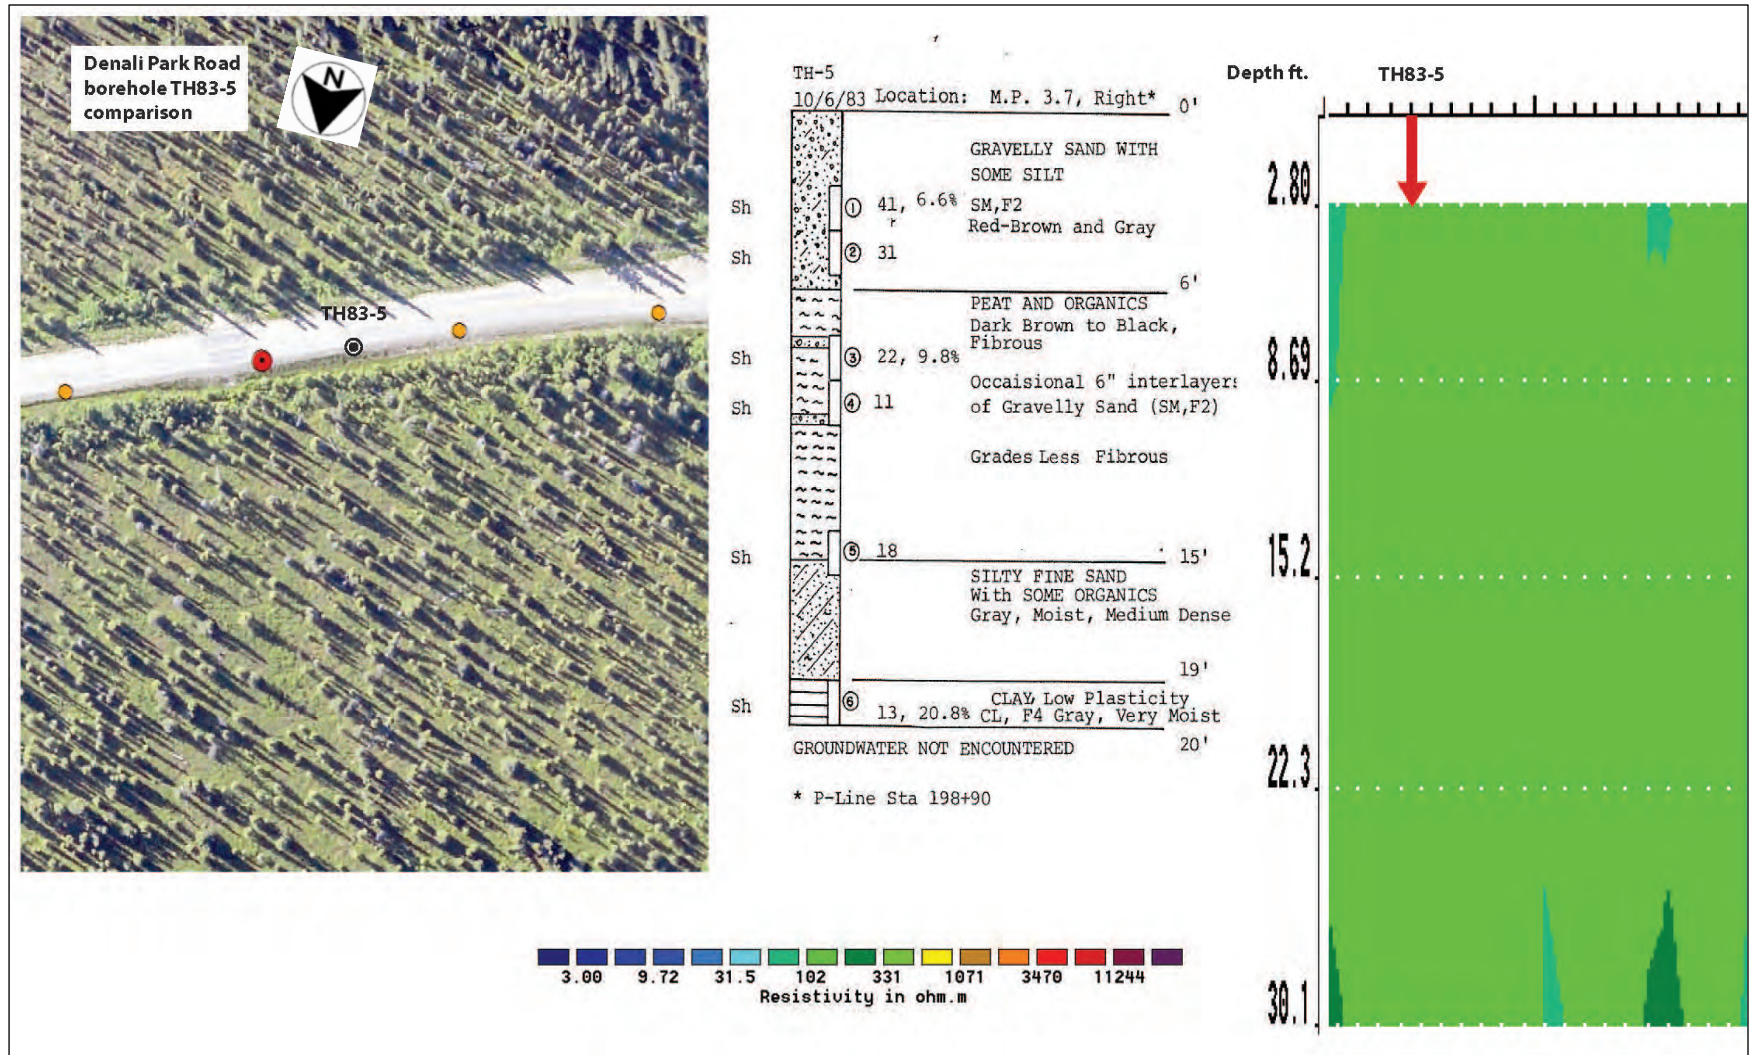
Figure 72. TH83-5 Denali Park Road. The ohm-m values are low for the full depth of the section, and in the immediate lateral vicinity. The drill hole reports a silt layer, peat and organics layer with some gravelly sand, and back to a silty sandy layer with organics. The drilled section becomes more moist with depth. The low resistivity response coincides with this drill report.

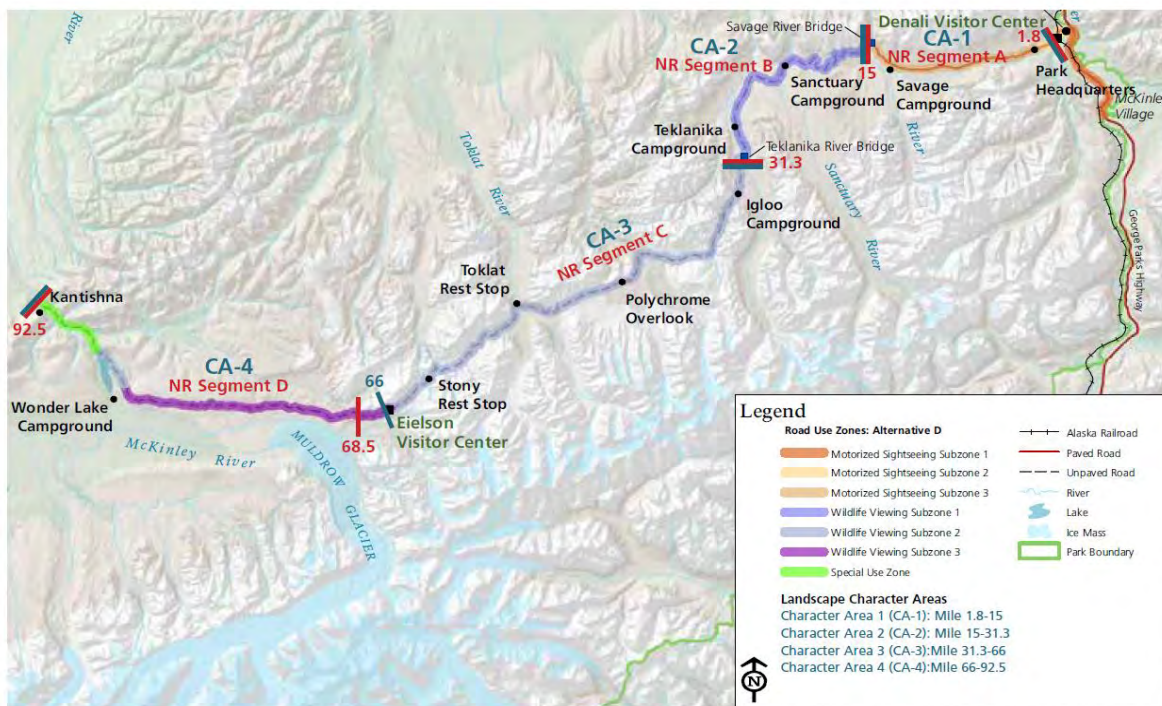
Figure 3-1. Roadway Maintenance (Provided by NPS during the May 5-7, 2020 EBRA meeting).

Condition State A: When considered over a 50-year life cycle, the total annual maintenance costs and activities are typical for the portion of the road known as NR Segment C (Figure 3-1) and stable (e.g., predictable); they are not escalating when compared to other parts of the road. Segments are in State A after initial construction and remain in State A if the type and frequency of issues addressed for NR Segment C, Mile Point (MP) 31-66, are not exceeded. The following actions appear typical and are periodically required at various sites along NR Segment C, as based on the presentation given to the EBRA panel by park maintenance staff:

- Partial use of permitted 11,000/cubic yards/year aggregate
- Raising road elevation 1 foot for settlement
- Management of drainage
- Some deep patch completed, more could be installed
- Occasional rockfall
- Small slumps above and below road
- Debris flow cleanup.

Note that Figure 3-1 shows a 'telescoping' road section in the direction of Kantishna, such that maintenance activities and expectations are different in CA-1 (NR Segment A) than in CA-4 (NR Segment D). Typical vs. exceptional maintenance is based on activities reported during the EBRA within approximate limits of CA-3 (NR Segment C).
