The Four Pillars of FoRRRwD

PROVEN COUNTERMEASURES

Focus on Reducing Rural Roadway Departures

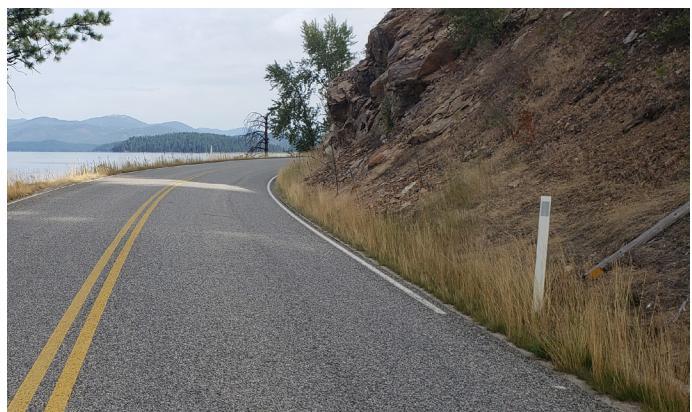
Figure 1. Edge lines and delineators improve visibility on horizontal curves. Source: Matt Mulder, Bonner County, Idaho.

Because horizontal curves are locations with a greater risk of a roadway departure, Bonner County used LHSIP funds to improve visibility at curves using edge lines and delineators on 31 roadways.

Before this effort, county roads often only had center lines striped and did not have edge lines due to limited budget. Bonner County prioritized installation of edge lines and delineators on horizontal curves based on risk factors, including degree of curvature, traffic volumes, and crash history. The edge lines are a durable pavement marking (methyl methacrylate) with a 10-year expected life. Delineators are installed at a 200-ft spacing (closer on sharp curves), are lowcost, can be installed by maintenance crews, and are visible in snow conditions.

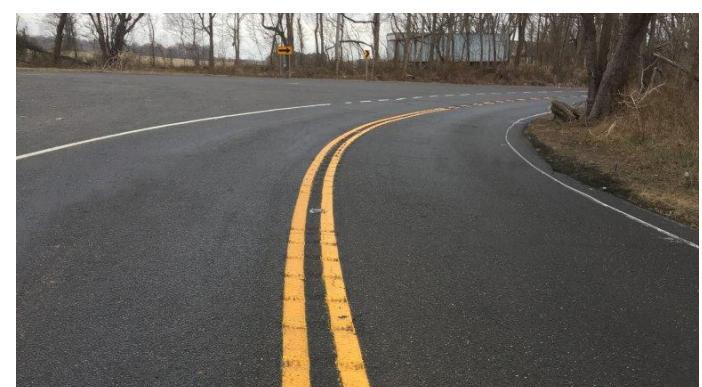
Figure 2. Center line rumble stripes in Mercer County reduce head-on crashes. Source: George Fallat, Mercer County, New Jersey.

To identify and prioritize treatment locations, Mercer County used crash data available through the New Jersey Department of Transportation and conducted a network analysis for head-on and run-off-road crashes. Furthermore, the county identified roads that were resurfaced within the past five years, focusing on roadways with good pavement condition. The objective was to avoid installations where the rumble stripes would be filled in by any scheduled milling and resurfacing projects. Following the analysis, Mercer County installed nearly 6 miles of center line rumble stripes on 18 segments of roadway, varying in length from 1,000 ft. to 4 miles.

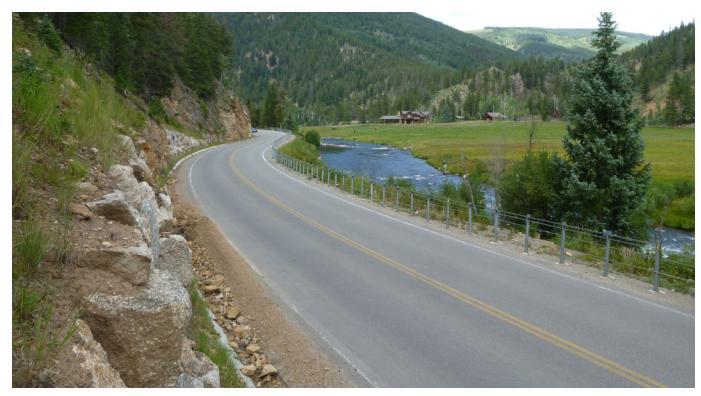
Figure 3. A high-tension cable barrier preserves views of the landscape while shielding vehicles from a steep drop-off. Source: FHWA.

Since Taylor River Road is a county-owned road that goes through a national forest, Gunnison County partnered with Central Federal Lands (CFL) and the National Forest to identify a potential solution to shield vehicles from the drop-off toward the river. It was clear that the roadway needed a barrier based on known crashes where vehicles were removed from the river. There are several types of barrier that CFL uses, such as w-beam, steel-backed timber, concrete, and high-tension cable barrier. The agencies weighed the benefits and drawbacks of each type and decided to use a high-tension cable barrier. The cable barrier allows for unobstructed views of the landscape, without sacrificing safety. The cable barrier also allows snow to be plowed over and through it, unlike a w-beam guardrail, and fallen rock is more easily brushed off the roadway past the cable barrier. Another benefit of the cable barrier is the shallow profile, which allows more usable roadway width for bicyclists and RVs.

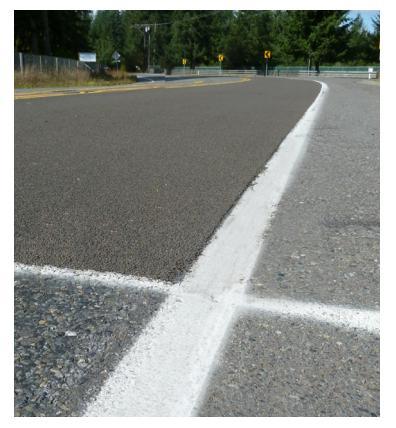
Figure 4. HFST at a Thurston demonstration site. Source: FHWA.

To prioritize locations for HFST, the county used risk factors for arterial and collector roads including posted speed limit of 50 mph or more, traffic volumes, presence of horizontal curves, and shoulder type and width. Thurston County had no prior experience with HFST and worked with the Washington Local Technical Assistance Program (LTAP) and FHWA to coordinate a peer exchange and pilot project. The peer exchange featured an HFST installation demonstration applied by Thurston County traffic and road maintenance crews, and was followed by a detailed overview of HFST by national experts. This and other installations across the country have demonstrated that quality HFST installations can be obtained with automated, semi-automated, or hand application. Thurston County's success with hand application can be attributed to the use of demonstration pilot sites and learning from other's experiences through the peer exchange. Quality materials and construction practices are needed regardless of application method.

projects at horizontal curves have seen substantial reductions in average crashes per year, including 46 percent for total lane departure crashes, 70 percent for wet lane departure crashes, and 100 percent for fatal and serious injury lane departure crashes.

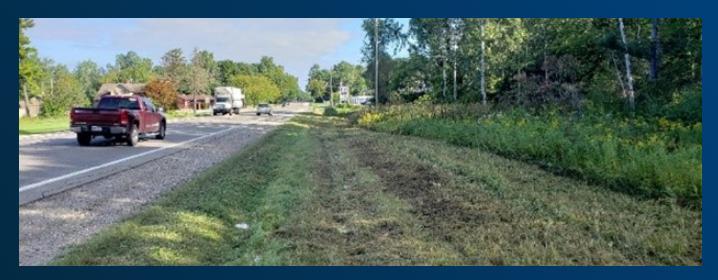
Figure 5. Roadside tree removal is followed up with mowing to reduce the chances of fixed-object crashes. Source: Destain Gingell, Lapeer CRC.

To combat this problem, Lapeer County established a proactive tree removal and trimming program. The program uses a systemic approach to identify locations throughout the roadway network based on risk factors like higher posted speed limits, vertical and horizontal curves, and poor sight distance. To prioritize locations, focus was on removing trees closest to the road, in critical locations such as the outside of horizontal curves, dead or leaning trees, and areas where canopy prohibited sunlight from drying the road surface. Lapeer CRC also established a roadside mowing program for the entire right-of-way that follows up on segments recently cleared to prevent growth of new trees.

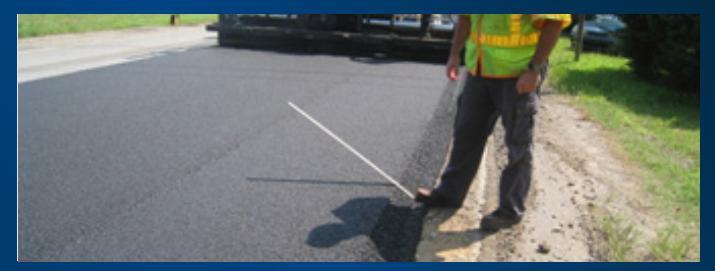
Figure 6. Paving a Delaware roadway with SafetyEdgeSM. After paving, a graded shoulder will become flush with top of the pavement, covering the sloped edge. Source: FHWA.

The SafetyEdgeSM can help save lives by allowing drivers who drift off highways to return to the road safely due to the edge of the pavement being shaped to 30 degrees, instead of a vertical dropoff. DelDOT first implemented SafetyEdgeSM in a resurfacing project on a narrow, rural collector in 2010. The project was about 5 miles long and included repair of extensive cracking and distortion, widening the pavement from approximately 20 feet to 22 feet, and providing a 2-inch warm-mix asphalt overlay with SafetyEdgeSM.
